Final Reclamation and Stormwater Inspection

Operator: WESTERN OPERATING COMPANY

Location ID: 313928

Inspection Photos
Location Name: Max Peterson #8A
Location ID: 313928

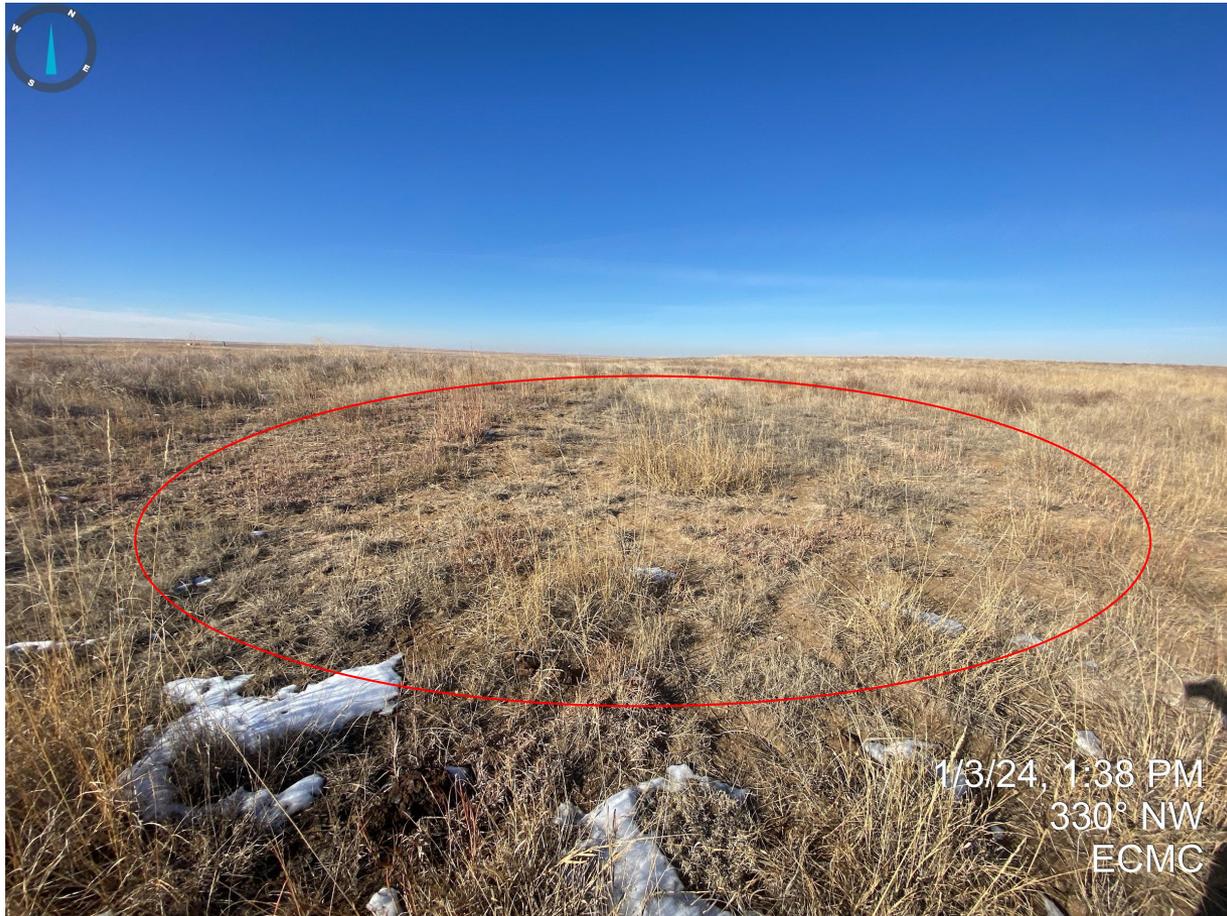
Photo 1. Taken from the southern portion of the location. The location is experiencing areas of bare/exposed soils due to non-uniform vegetation cover.

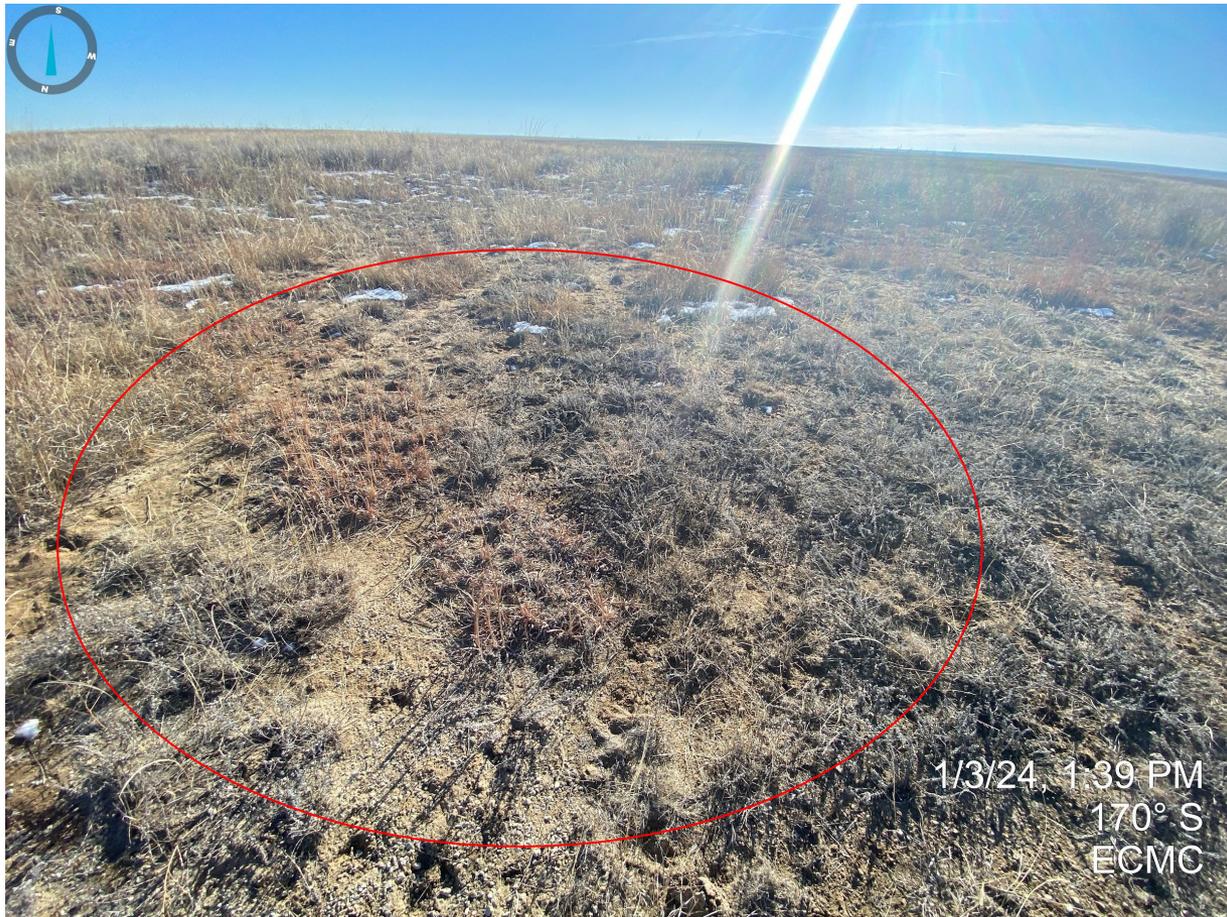
Photo 2. Taken from the northern portion of the location; see comments in Photo 1.

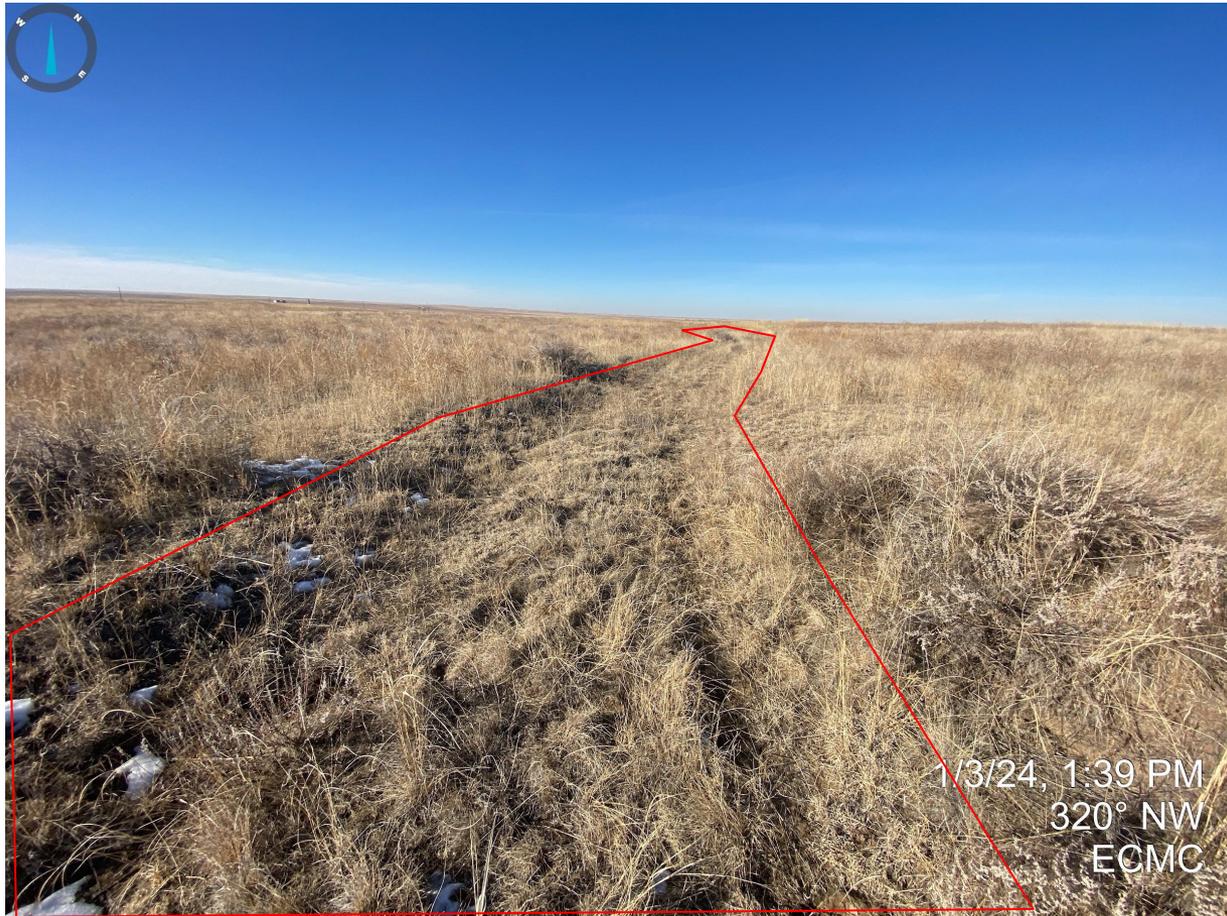
Photo 3. Looking north from the location along the access road. It does not appear that the access road has been contoured/regraded to reflect pre-disturbance levels

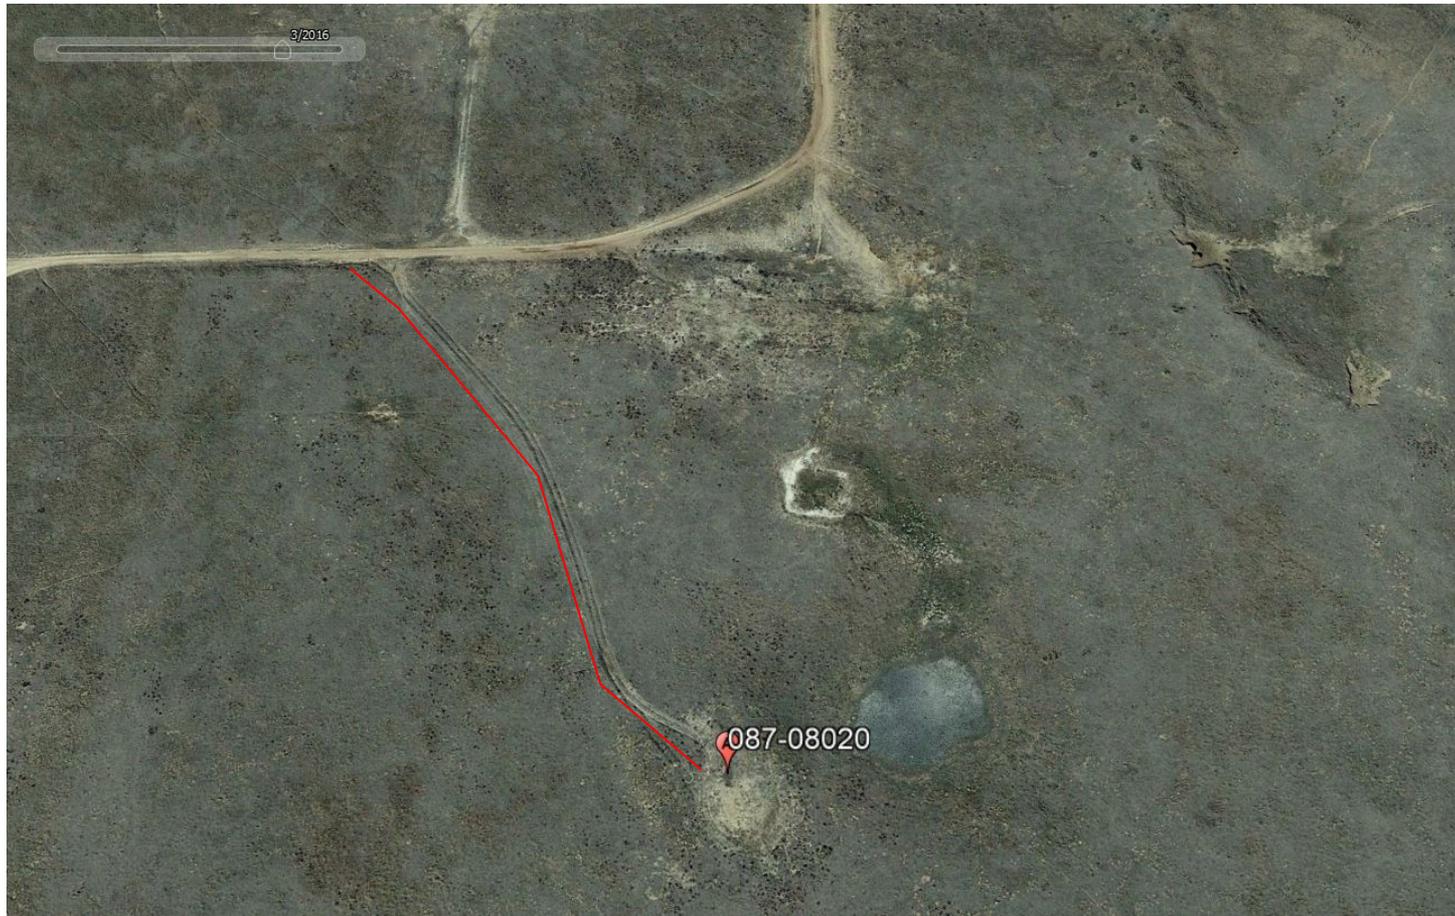
Photo 4. Google Earth aerial imagery (circa 03/2016) illustrating the access road (outlined in red) that will need to be properly reclaimed per Rule 1004 (e.g. contoured, regraded, revegetated etc).
