# Inspection Photos

Loc: 484587

Operator: WESTERN OPERATING COMPANY

Inspection Date: 1/10/2024

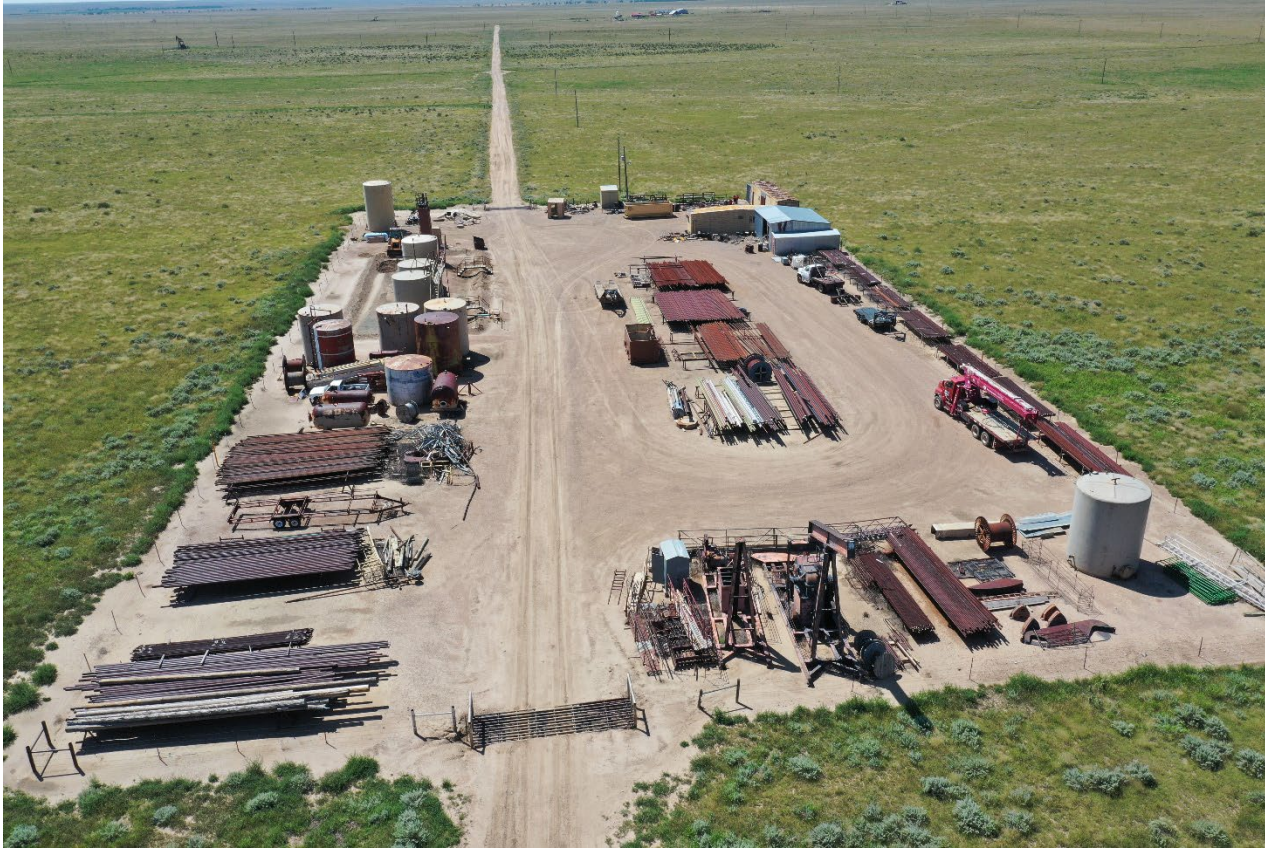
**Photo 1.** Drone aerial photo facing west toward the PYLES offsite tank battery and storage yard. The use of this location as a storage yard is prohibited per the rules. All unused equipment and supplies must be removed and interim reclamation must be performed.

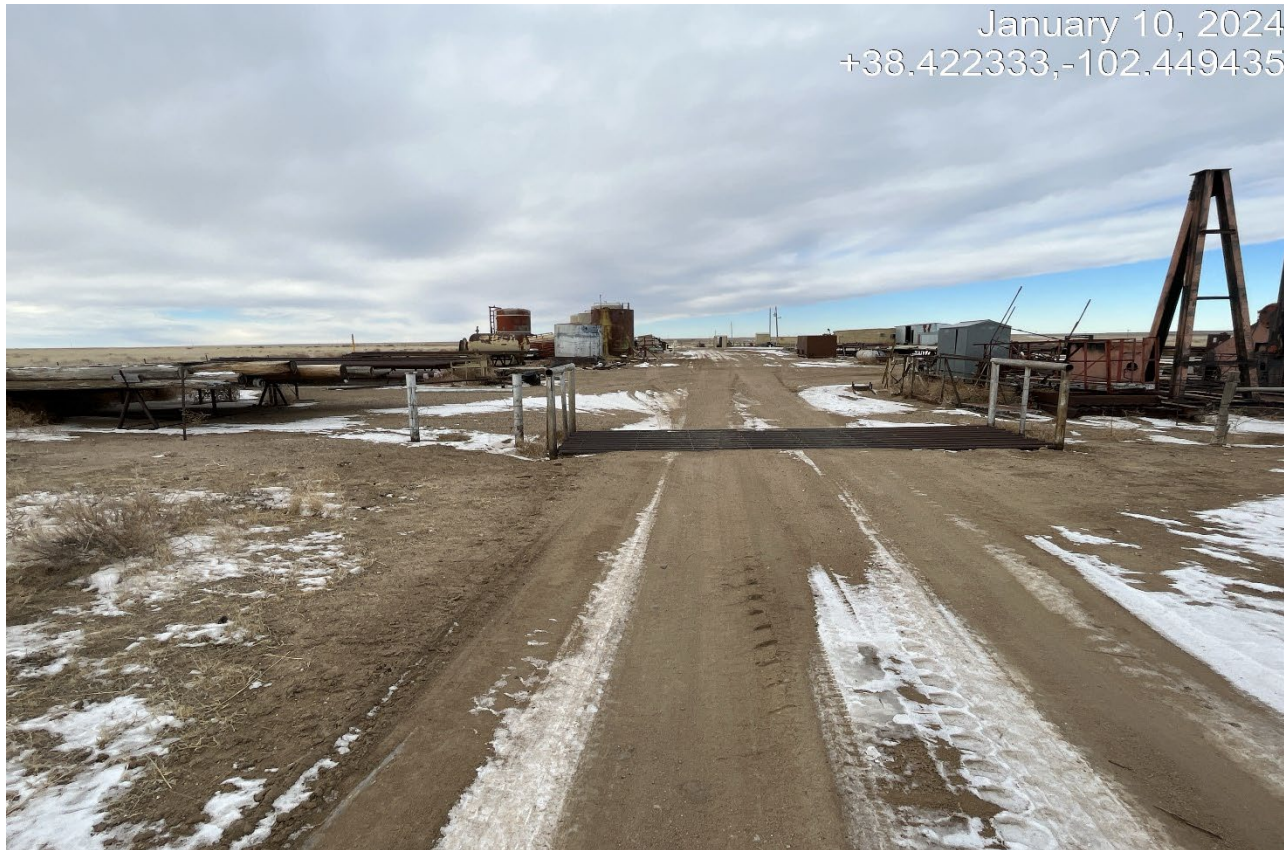
**Photo 2.** Facing west toward the tank battery facility. There is unused equipment being stored on location that needs to be removed. All equipment and supplies not necessary for use on this Oil and Gas Location is prohibited per Rule 606 and 1003.a.

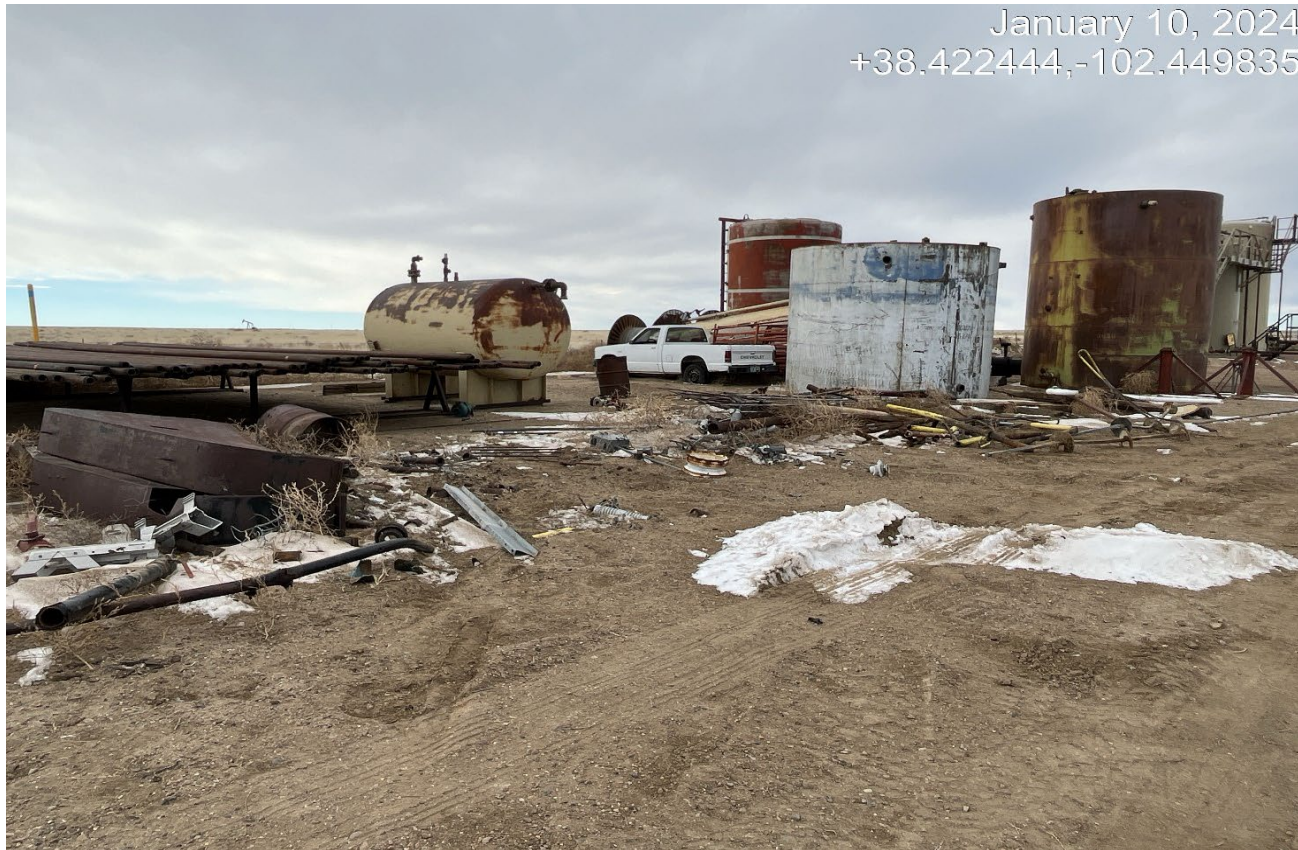
**Photo 3.** Facing southwest at the location. There is equipment and a vehicle that appears to have been sitting unused at this location for awhile. There is various supplies and bent scrap metal which appears to be unusable material.

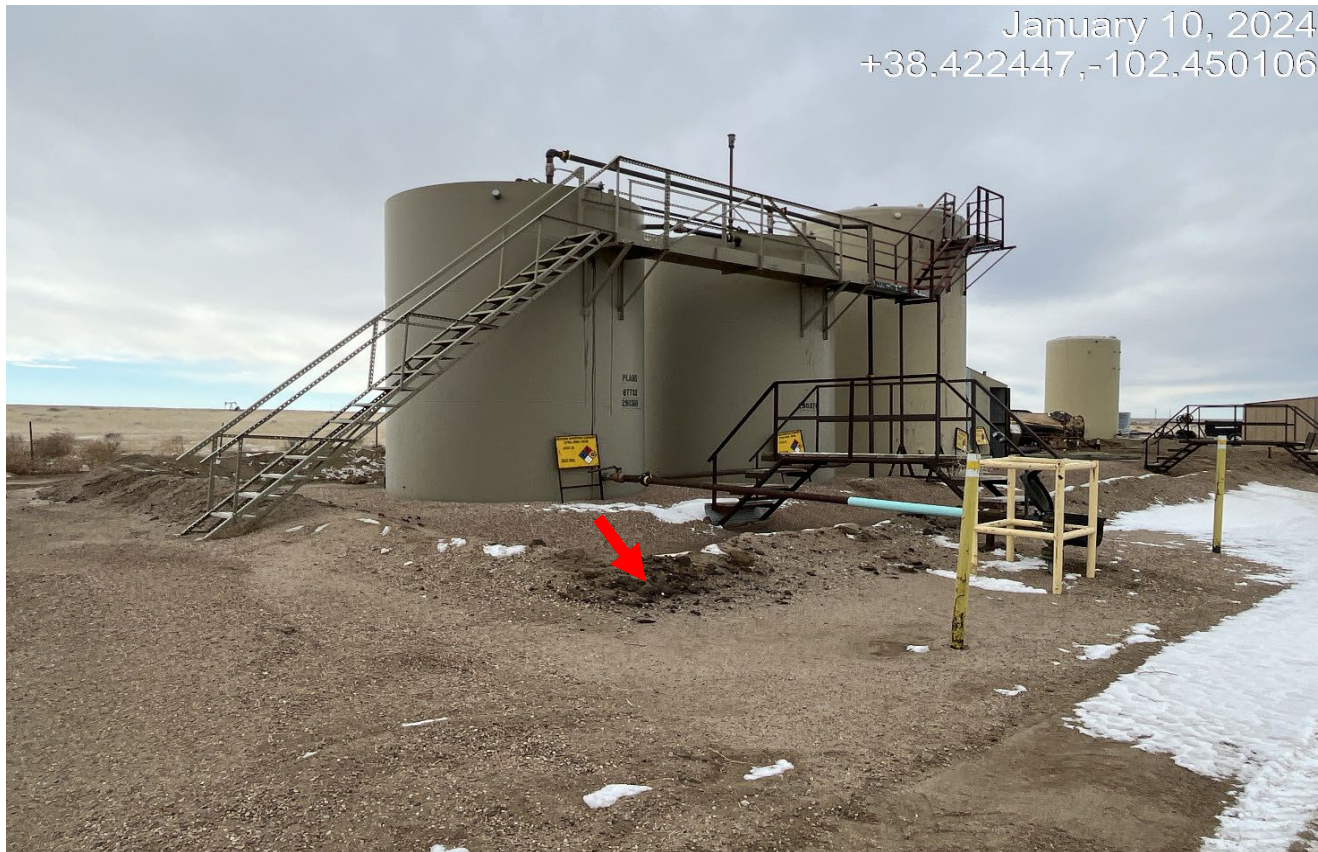
**Photo 4.** Facing toward the PYLES offsite tank battery at the location. Stained soil was removed from the outlet area. There is hardened hydrocarbon substances shown at red arrow.

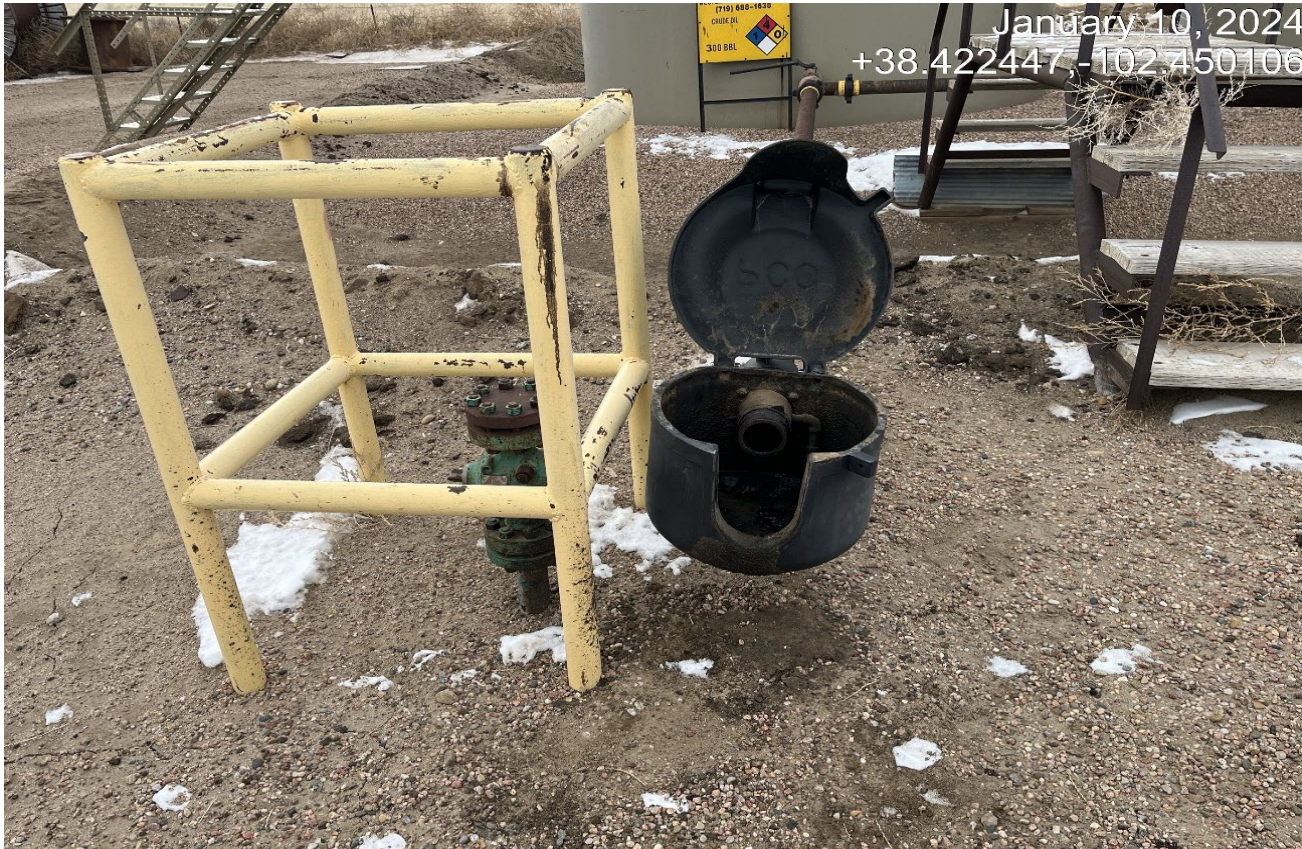
**Photo 5.** There is oil stained soils at the pipe outlet which is not in containment and the lid was left open.

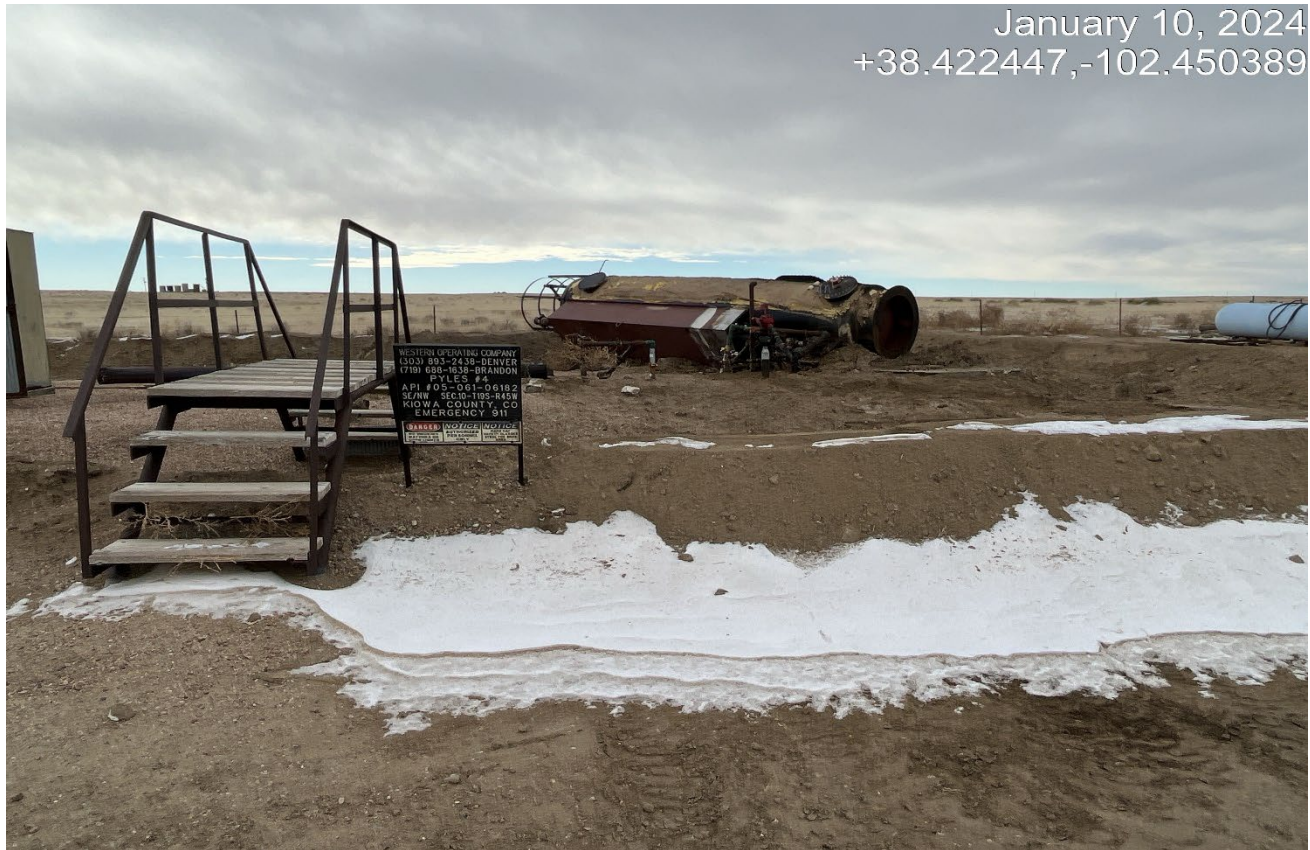
**Photo 6.** Facing toward the vertical heater treater which has fallen over and had a recent fire.

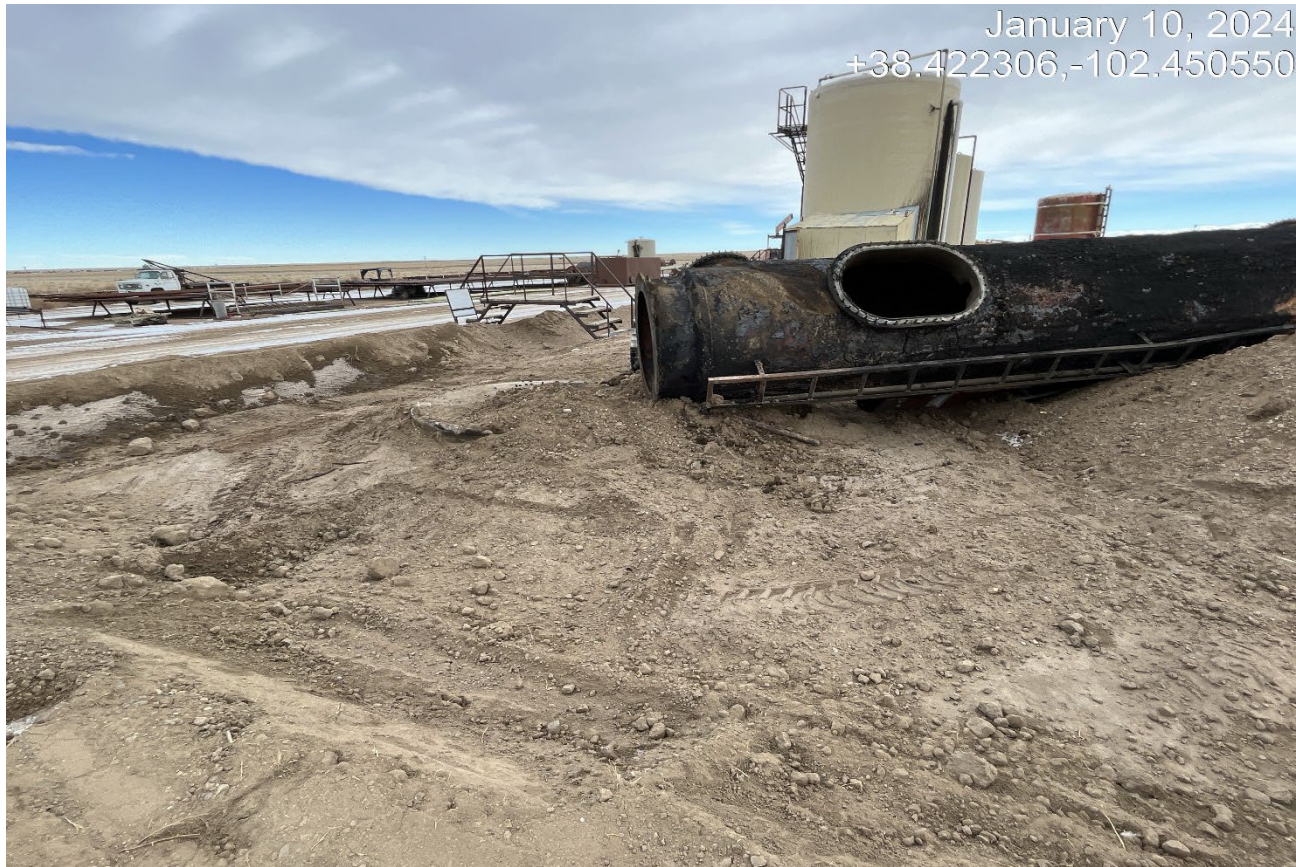
**Photo 7.** Facing northeast toward the heater treater which was burned during a recent fire. The treater has since fallen over and needs to be removed if it is no longer functional.

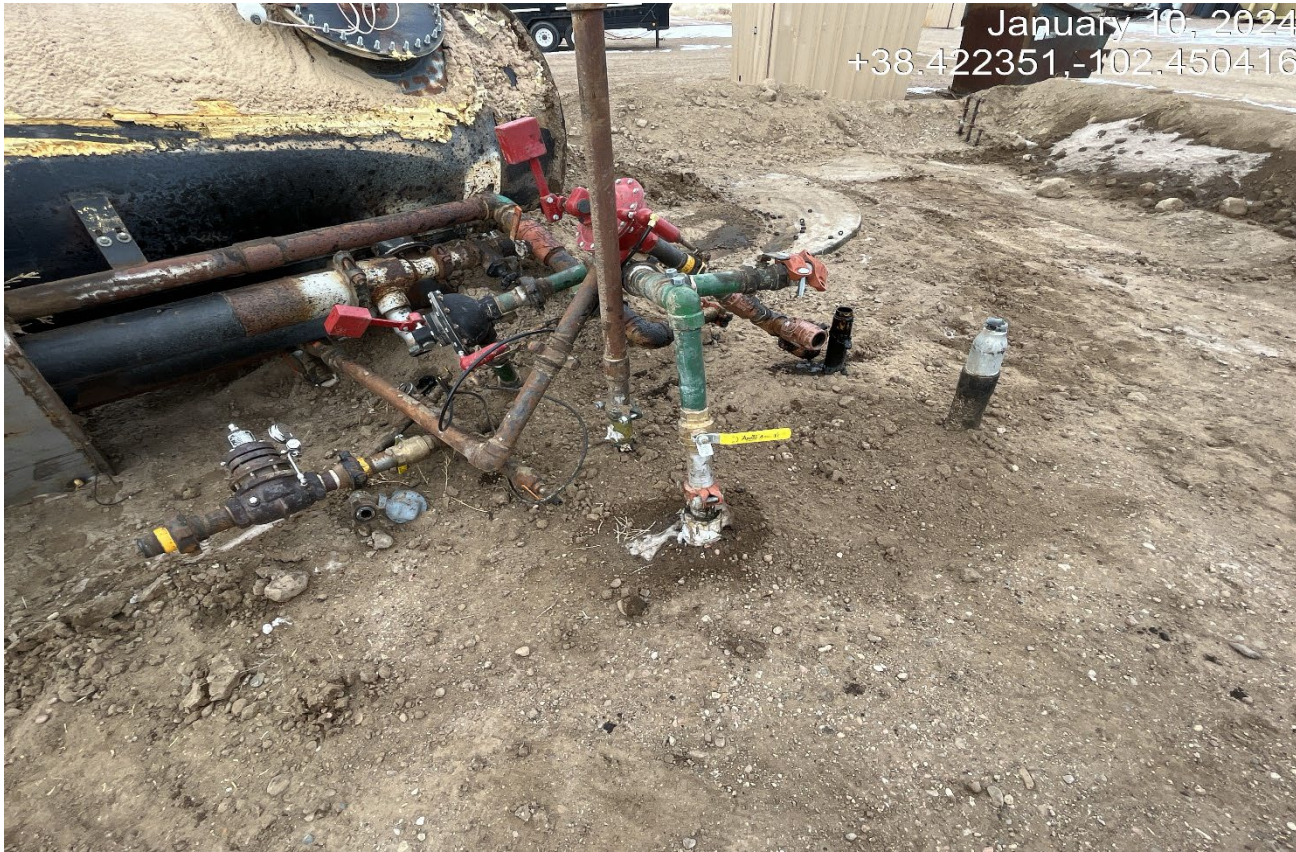
**Photo 8.** There is oil stained soils at the pipe connections where the treater fell over.

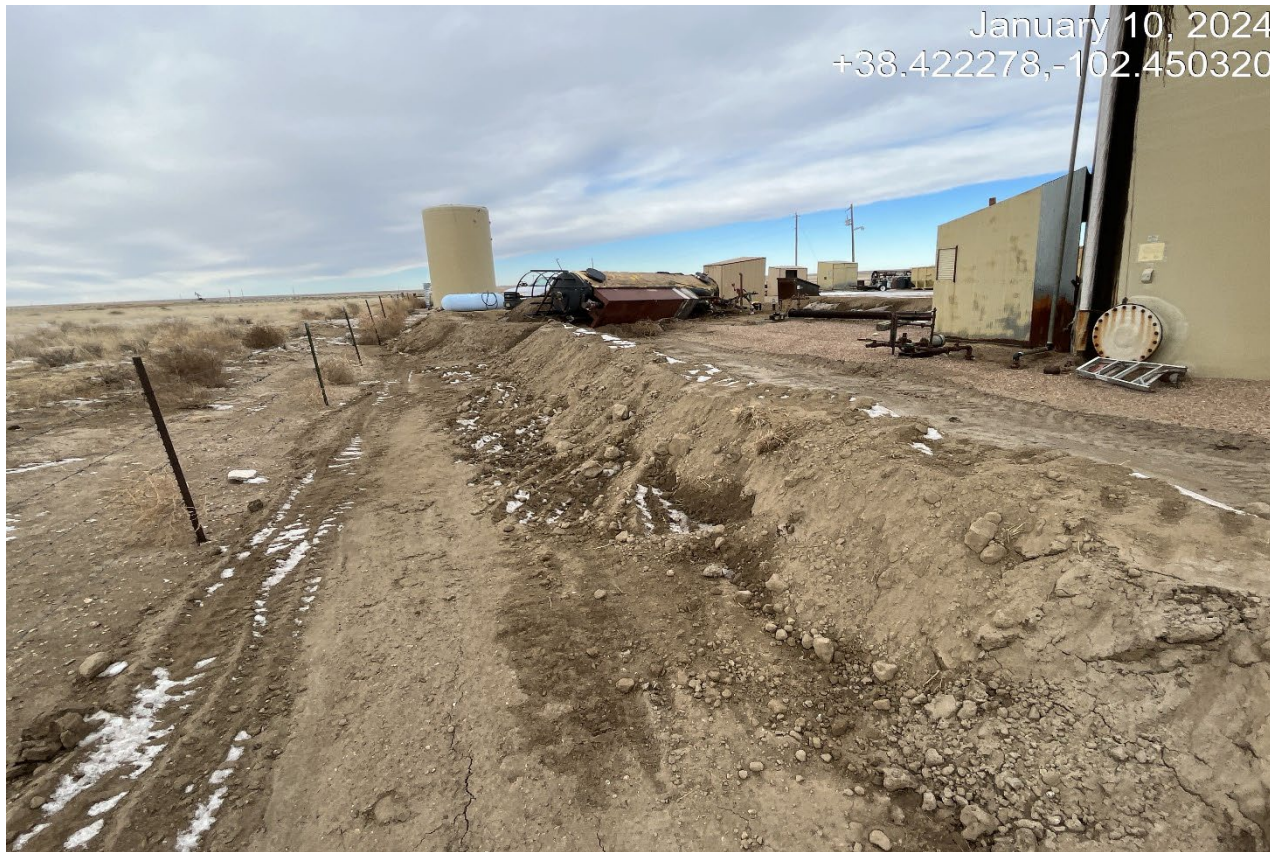
**Photo 9.** Facing west at the south side of the location and backside of the tank battery. The berms around the tank battery are not compacted for impermeability.

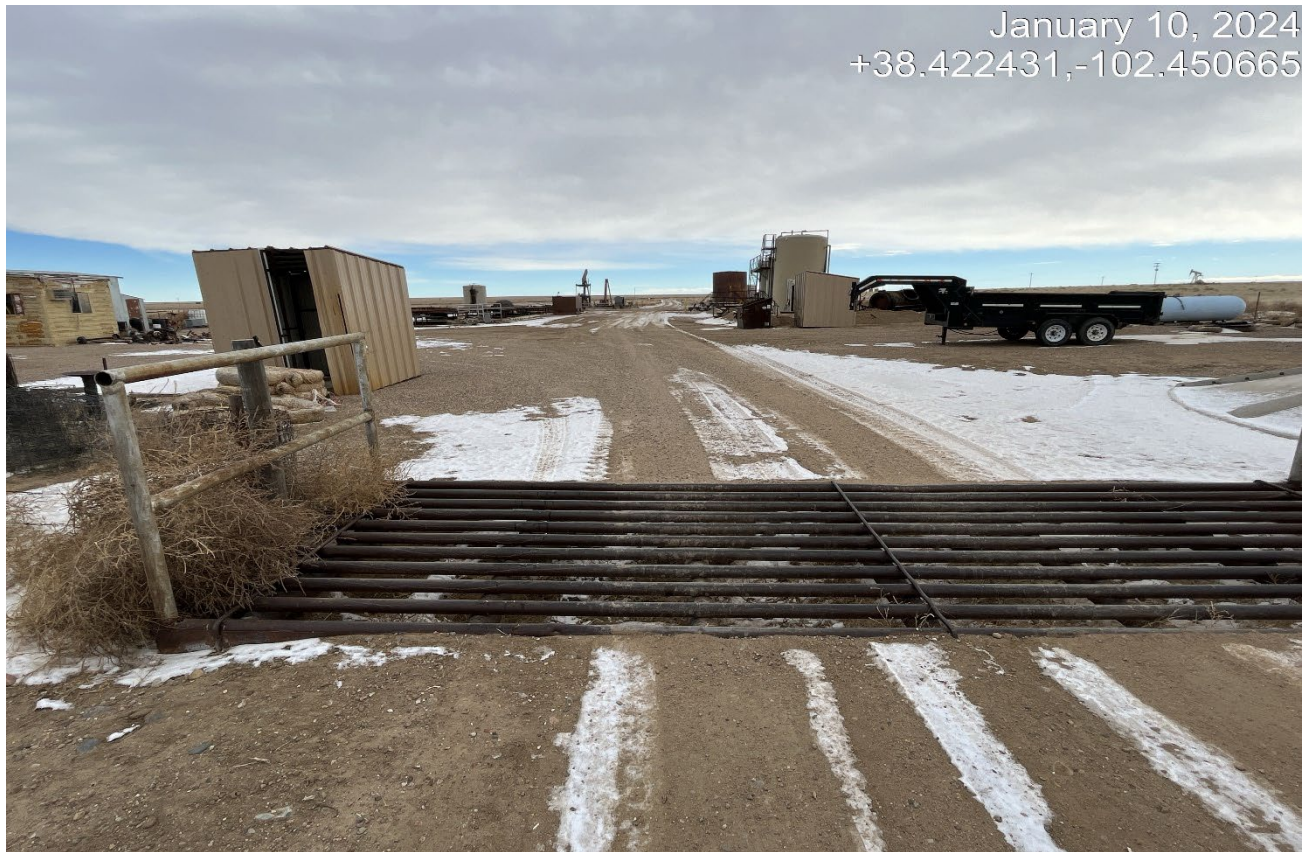
**Photo 10.** Facing east toward the tank battery facility being used as a storage yard.

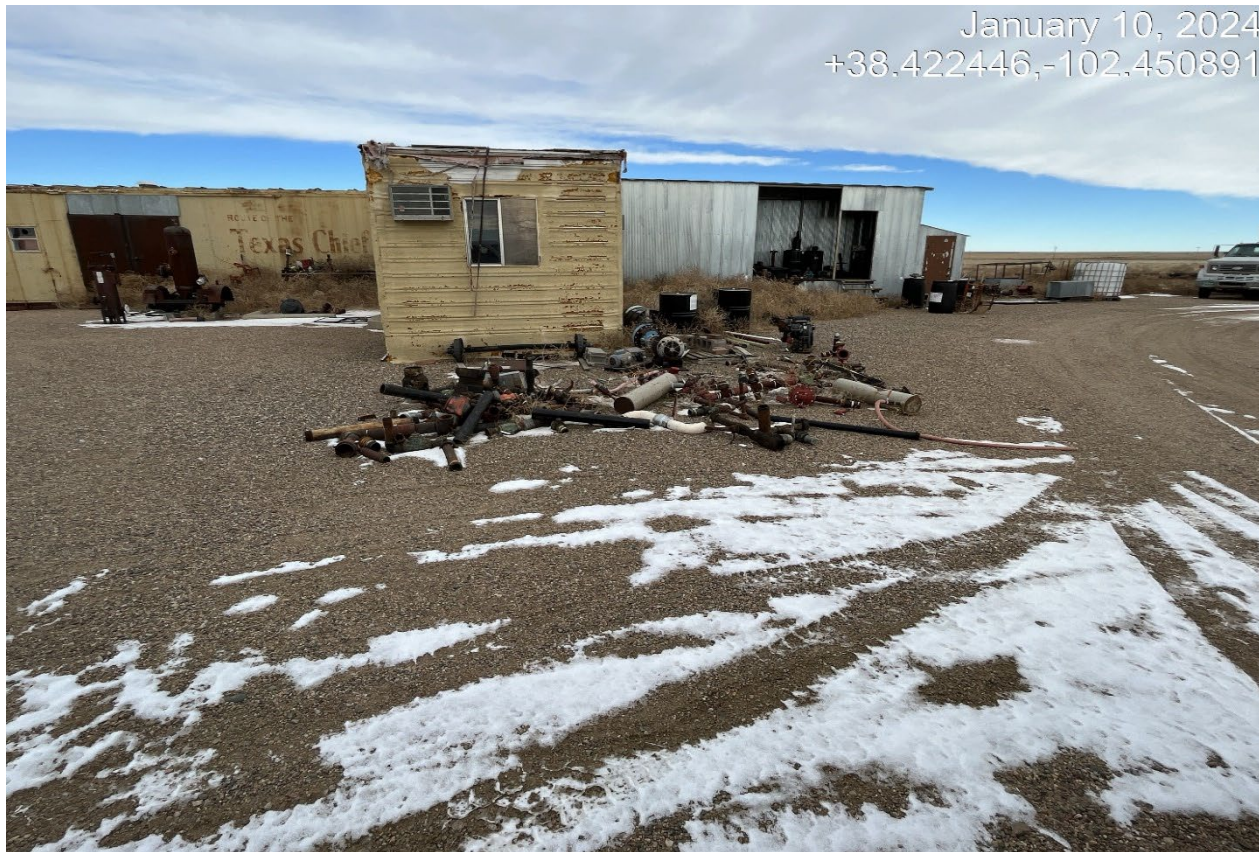
**Photo 11.** Facing toward the north side of the location. There is various parts and debris laying on the ground not stored in a workman like manner.

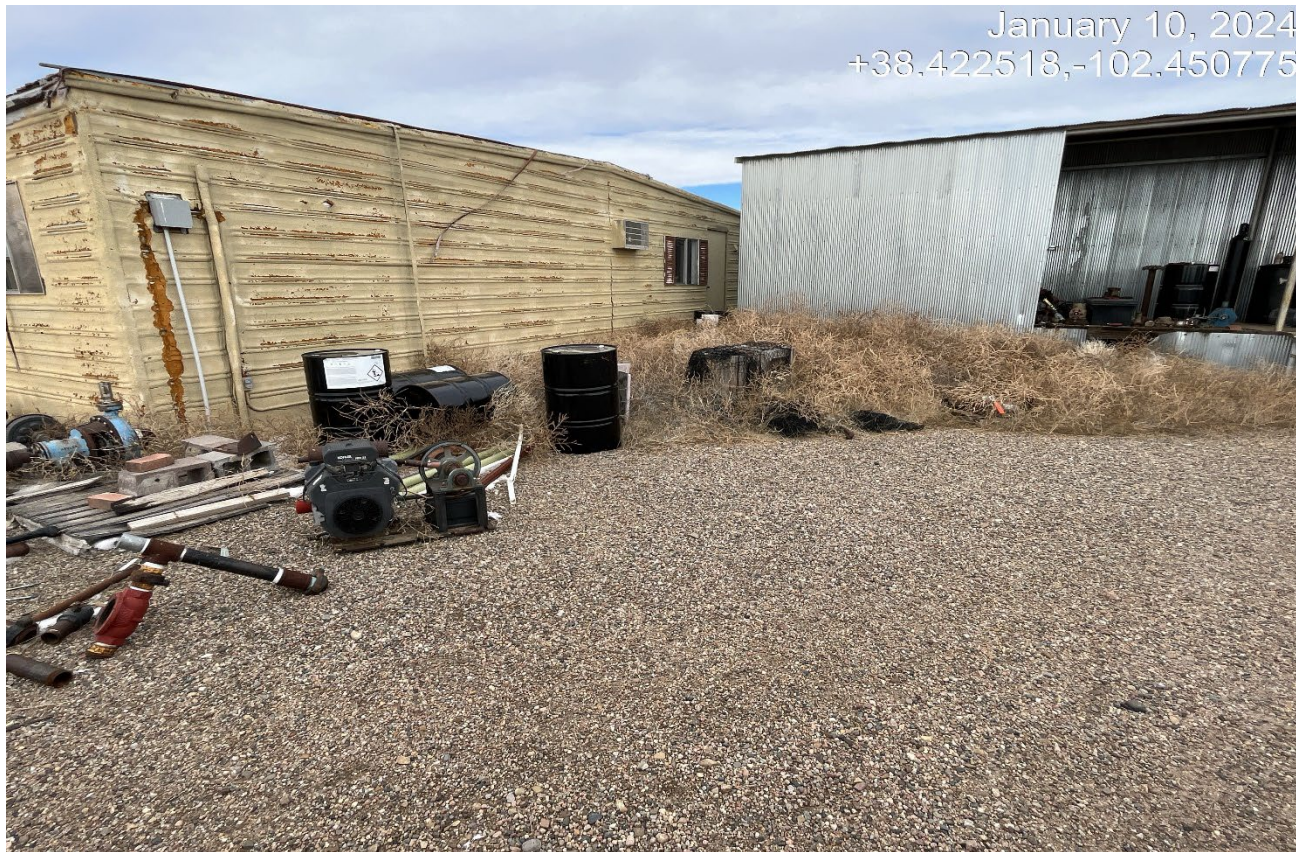
**Photo 12.** There is various parts and supplies being stored on location. All equipment and supplies not necessary for use on this Oil and Gas Location is prohibited per Rule 606 and 1003.a. There is tumbleweed debris piled in the corner which is a fire hazard.

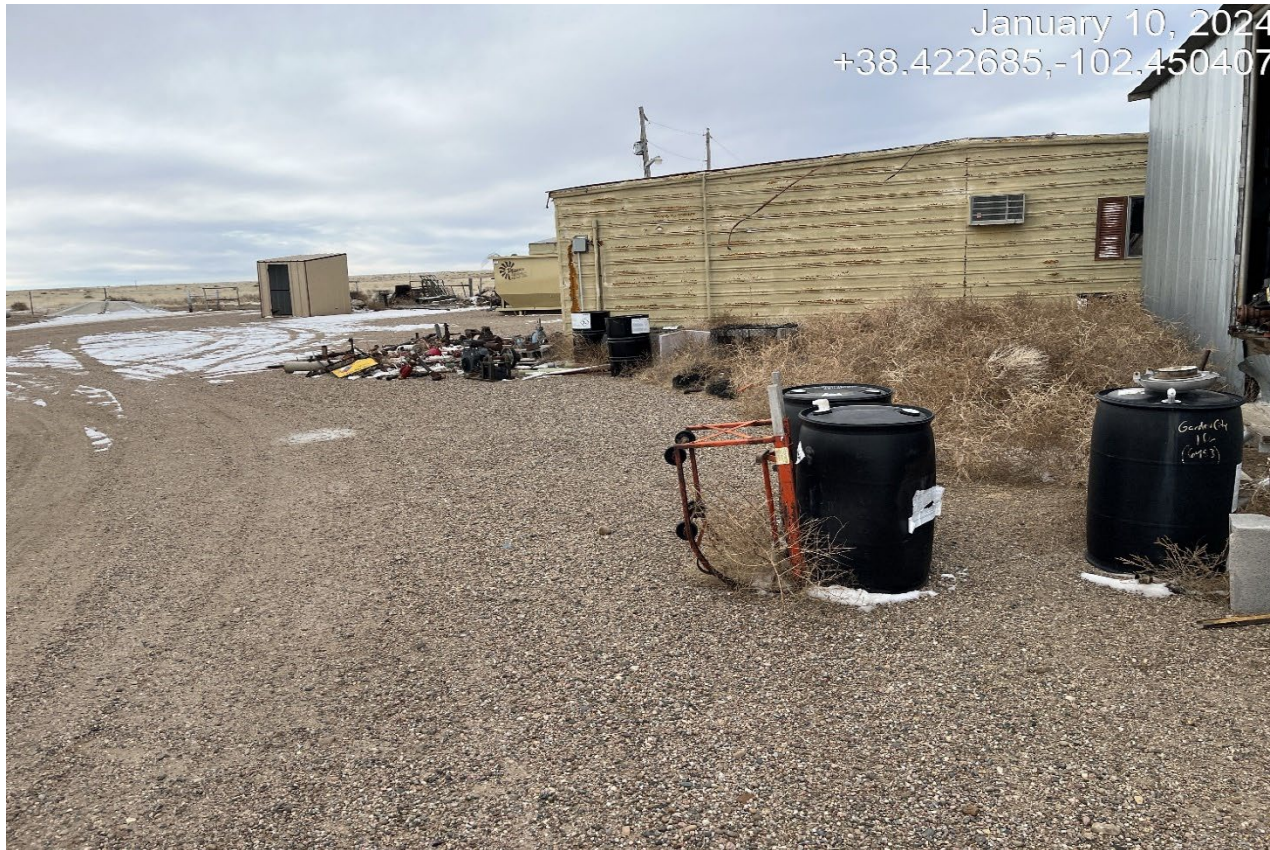
**Photo 13.** There are several chemical barrels on location with faded labeling and no secondary containment. Various pipe, supplies, and debris stored on location.

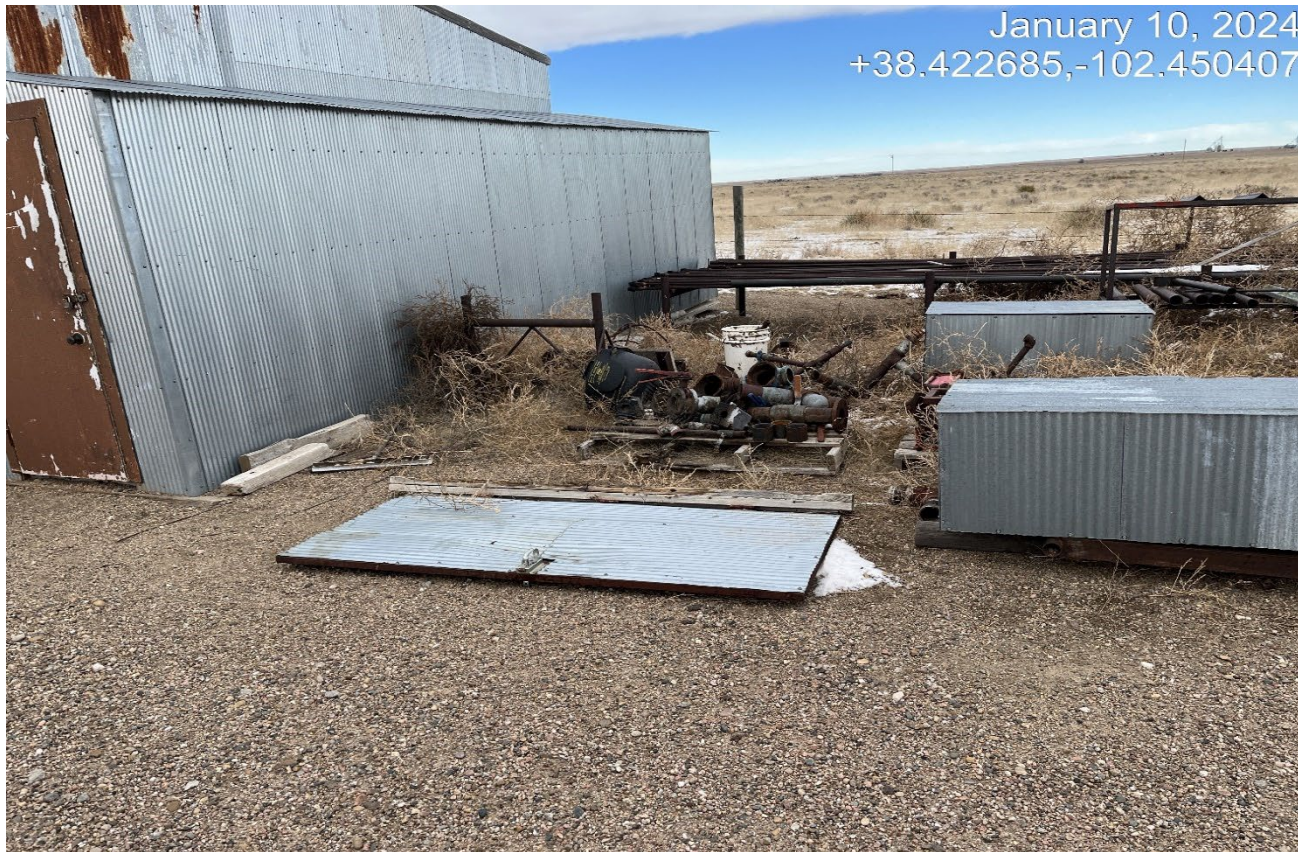
**Photo 14.** There is various parts and supplies being stored on location. All equipment and supplies not necessary for use on this Oil and Gas Location is prohibited per Rule 606 and 1003.a. There is various supplies and bent scrap metal which appears to be unusable material.

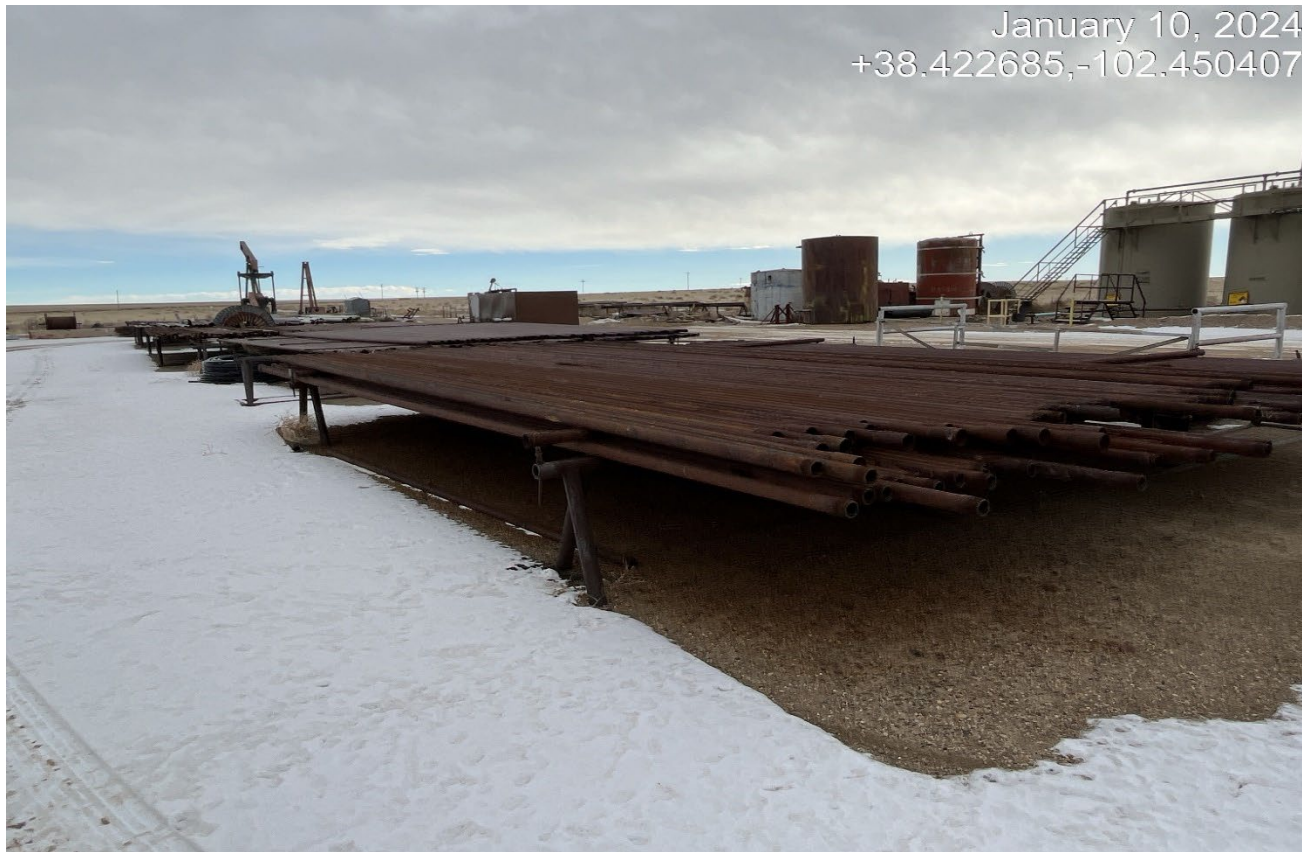
**Photo 15.** Facing southeast at the north side of the location. There is storage of unused drilling pipe, trailers, ect. All equipment and supplies not necessary for use on this Oil and Gas Location is prohibited per Rule 606 and 1003.a.

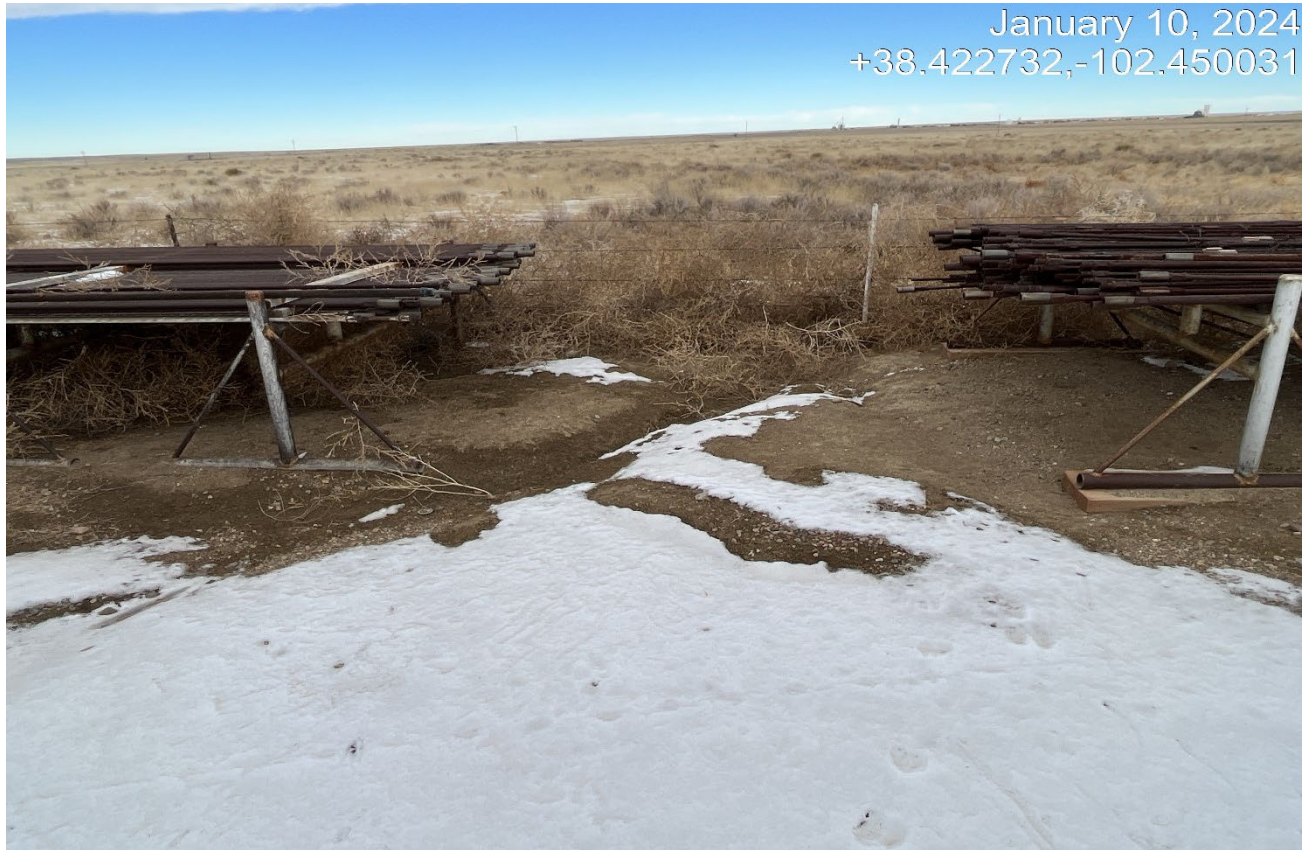
January 10, 2024  
+38.422732,-102.450031

**Photo 17.** Facing toward the north central side of the location. There is an erosion channel beginning to develop in this area which is transporting sediment offsite.

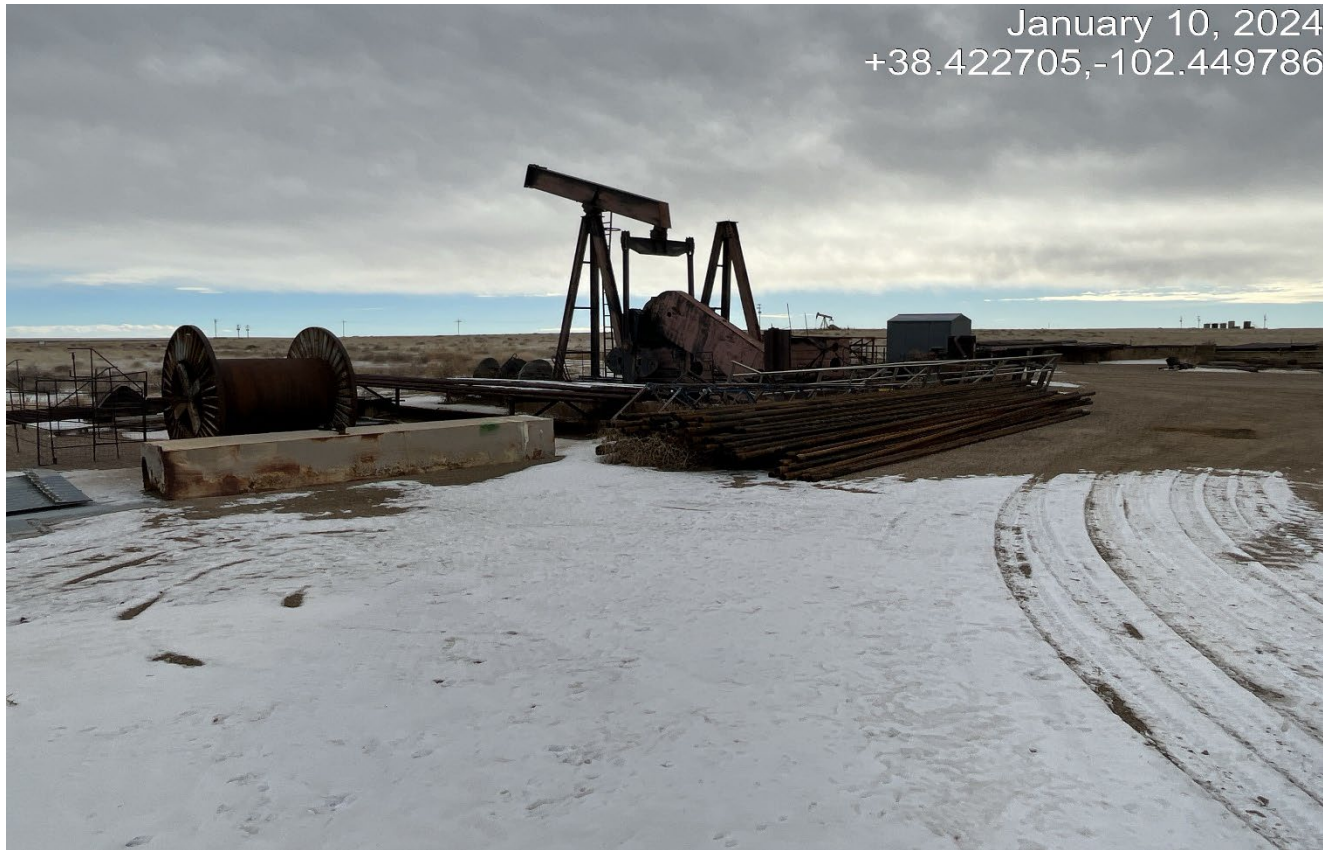
**Photo 17.** Facing southeast at the location PYLES offsite tank battery and storage yard. The use of this location as a storage yard is prohibited per the rules.

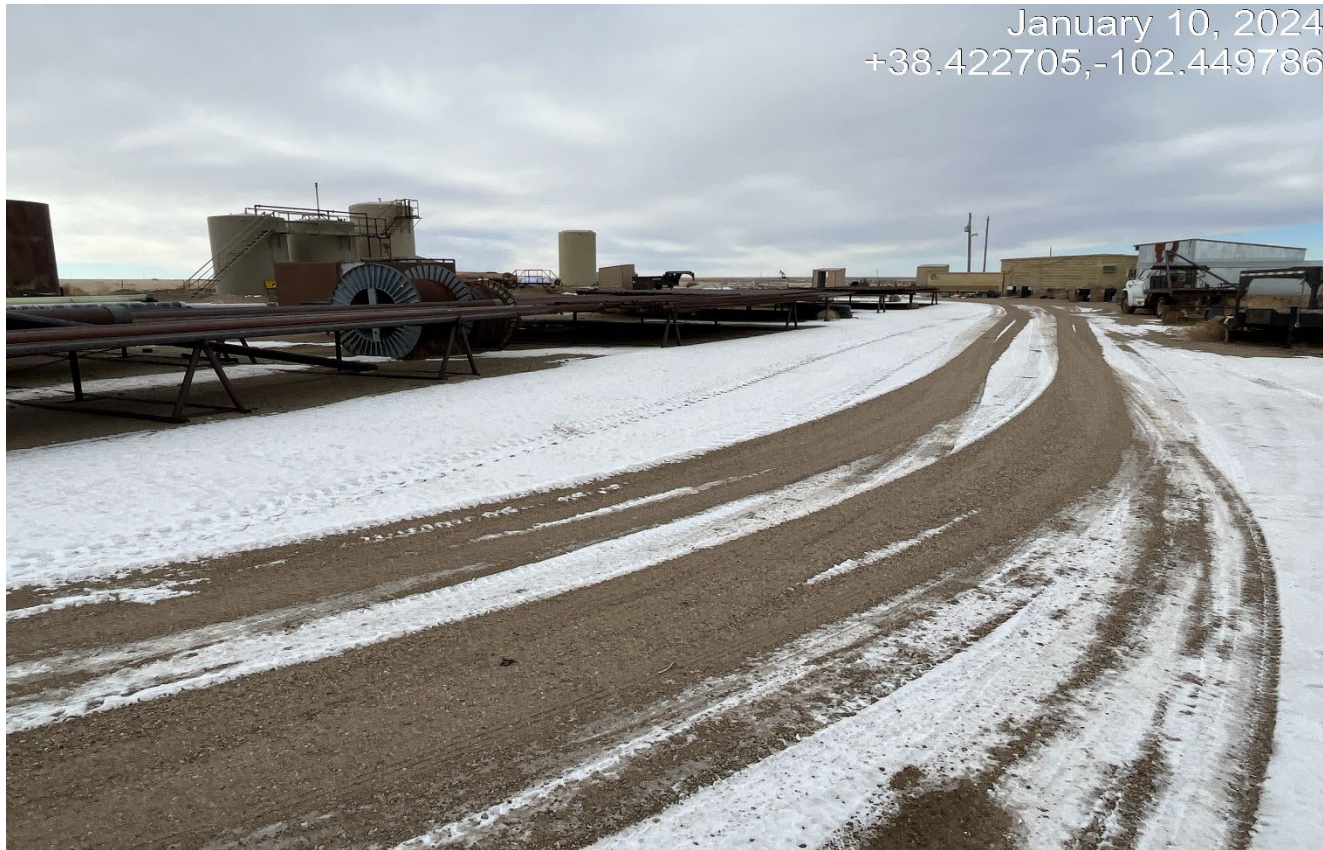
January 10, 2024  
+38.422705,-102.449786

**Photo 18.** Facing southwest at the location PYLES offsite tank battery and storage yard. The use of this location as a storage yard is prohibited per the rules.
