Final Reclamation and Stormwater Inspection

Location ID: 331920

Inspection Document #: 713900251

Inspection Photos
Location Name: PSC 8-9
Location ID: 331920

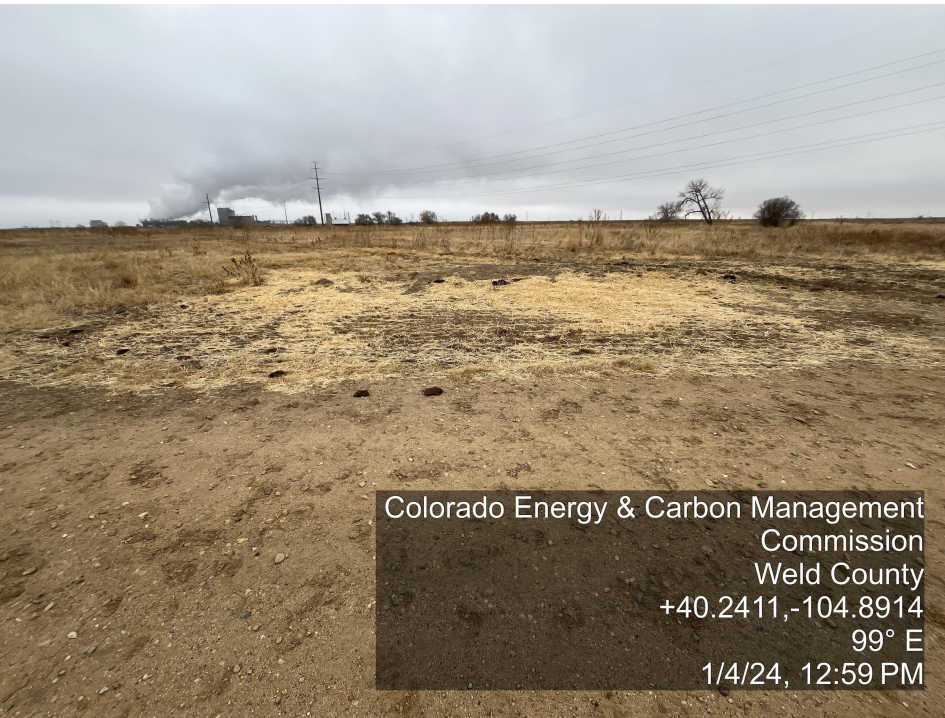
Photo 1. The photo was taken at the start of the access road facing East. The photo illustrates some reclamation activity right along the main road with seeding rows and crimped straw.

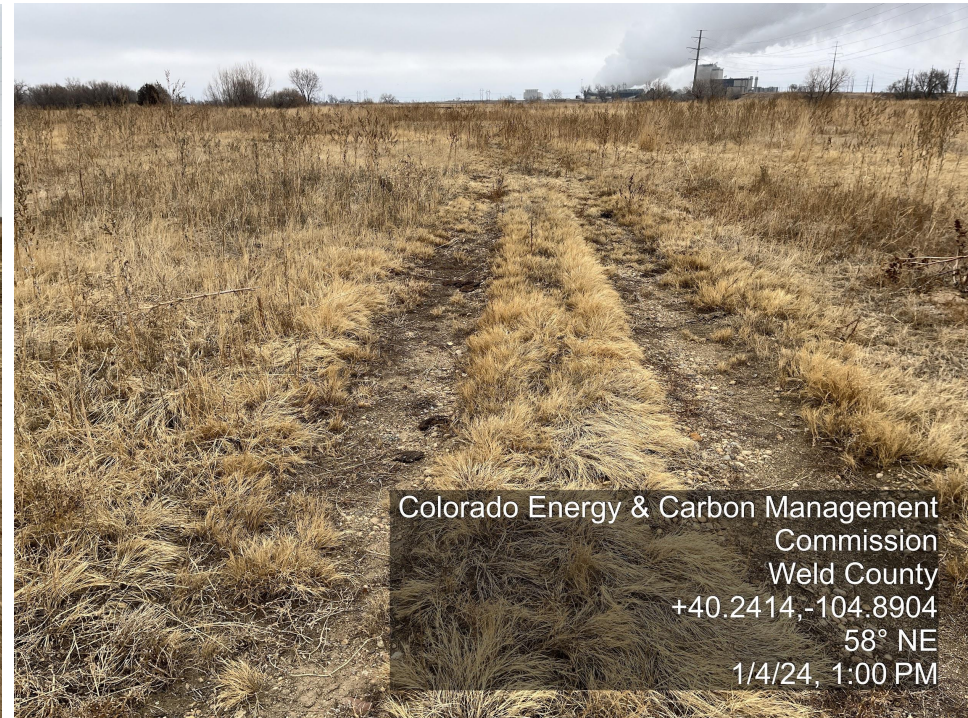
Photo 2. The photo was taken along the access road facing Northeast. The photo illustrates the access road has not been reclaimed with gravel and tire tracks remaining.

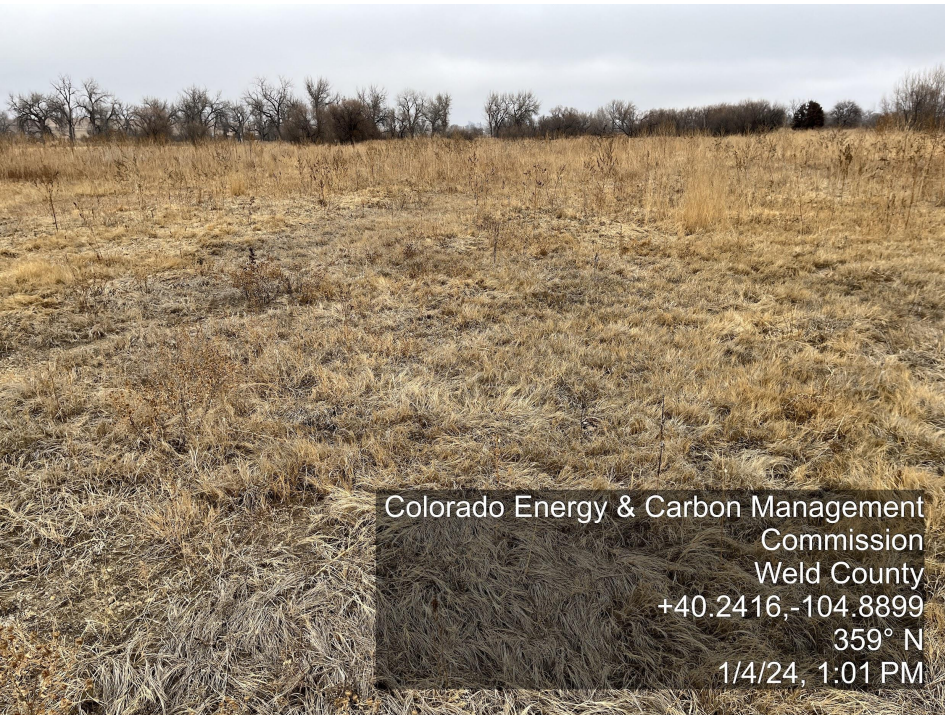
Photo 3. The photo was taken at the well location facing North. The photo illustrates the location is dominated by saltgrass.

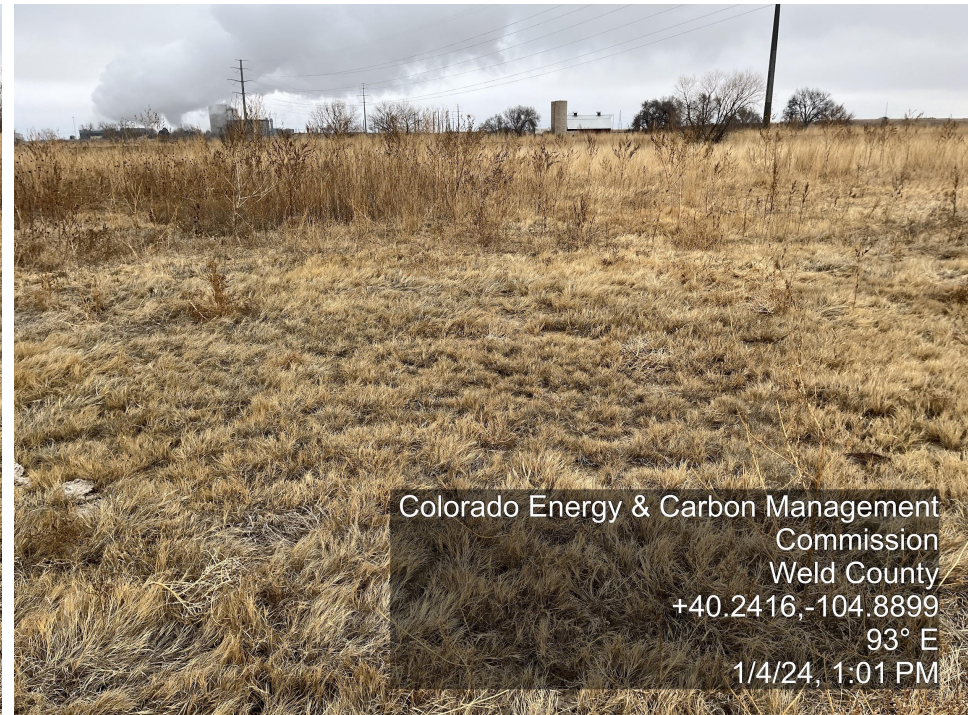
Photo 4. The photo was taken at the well location facing East. Refer to the comment for photo 3.

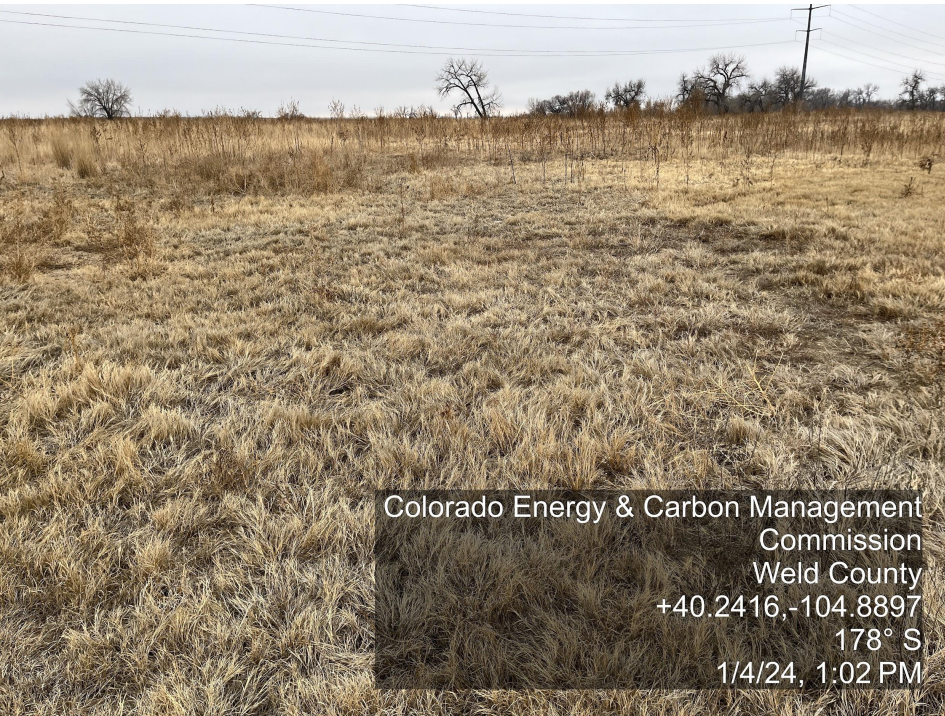
Photo 5. The photo was taken at the well location facing South.
Refer to the comment for photo 3.

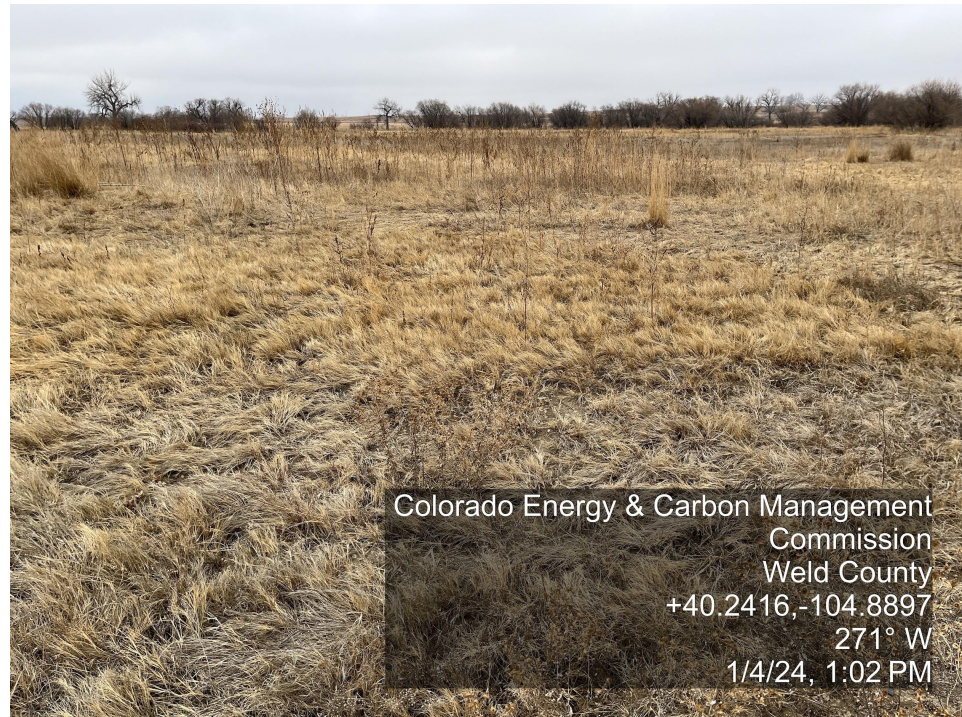
Photo 6. The photo was taken at the well location facing West.
Refer to the comment for photo 3.

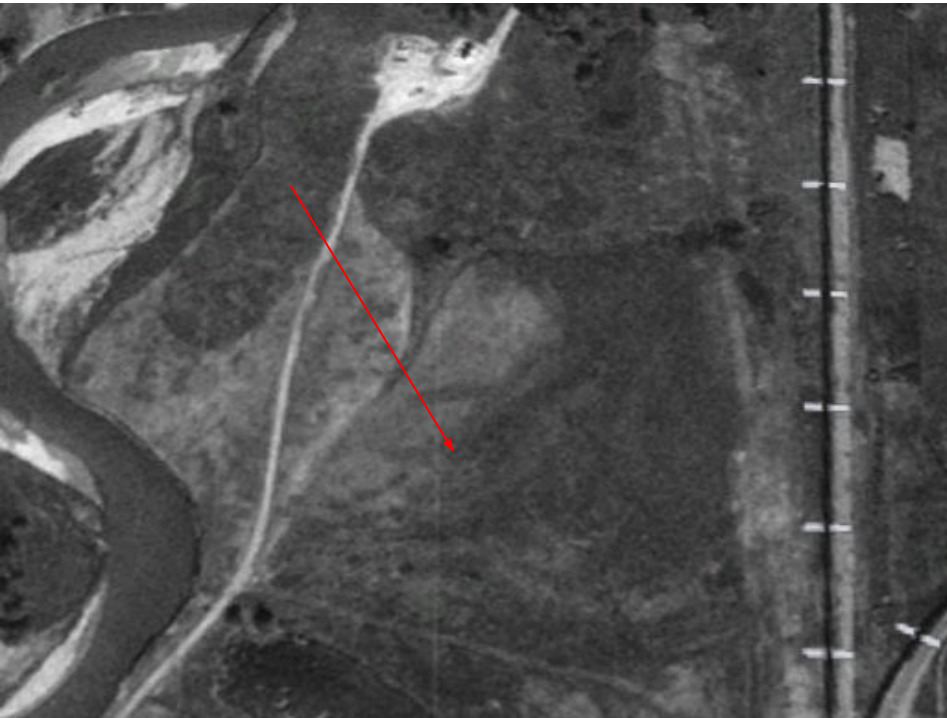
Photo 7. The is Google Earth imagery from 10/1999. The photo illustrates there was no access road prior to oil and gas activities.

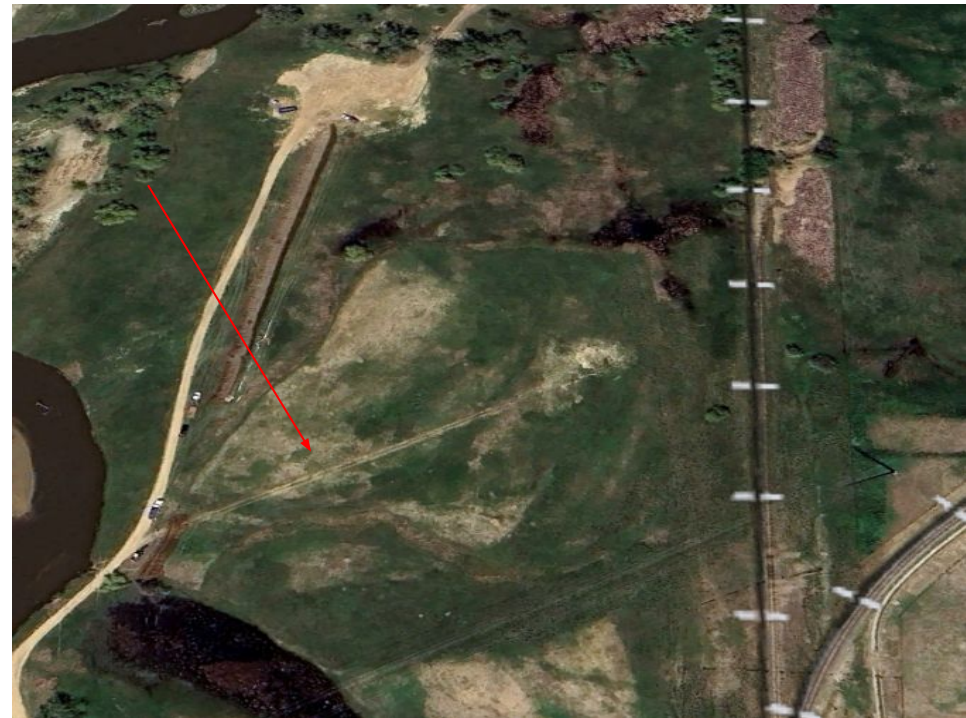
Photo 8. The is Google Earth imagery from 05/2023. The photo illustrates the access road.
