Final Reclamation and Stormwater Inspection

Operator: Kerr McGee Oil & Gas Onshore LP - 47120

Location ID: 328213

Inspection Photos
Location Name: Bell L12-3
Location ID: 328213

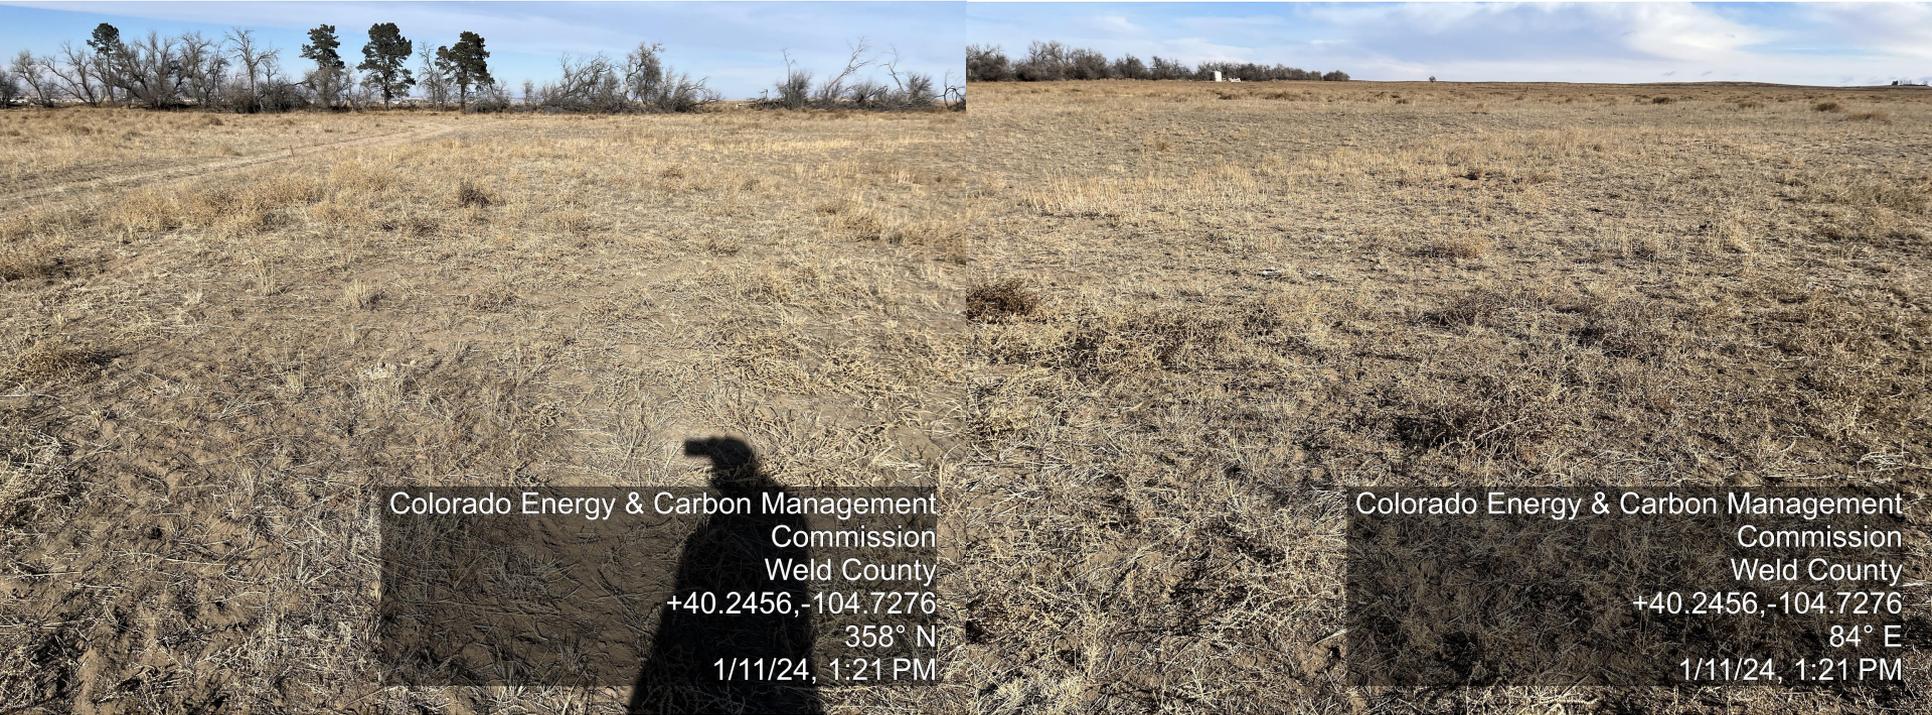
Photo 1. The photo was taken at the well location facing North. The photo illustrates the northern area of the well location has been mowed.

Photo 2. The photo was taken at the well location facing East. The photo illustrates some russian thistle at the well location and that it has been mowed.

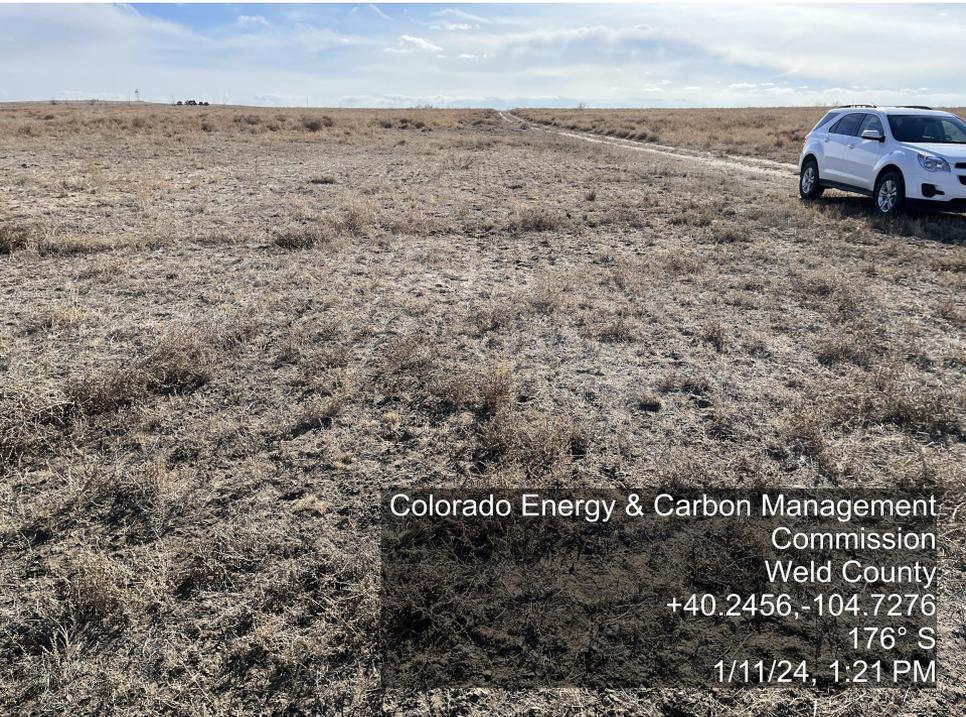
Colorado Energy & Carbon Management
Commission
Weld County
+40.2456,-104.7276
176° S
1/11/24, 1:21 PM

Photo 3. The photo was taken at the well location facing South. The photo illustrates the well location has been mowed and appears to have been interseeded however there is still russian thistle growing at the location.

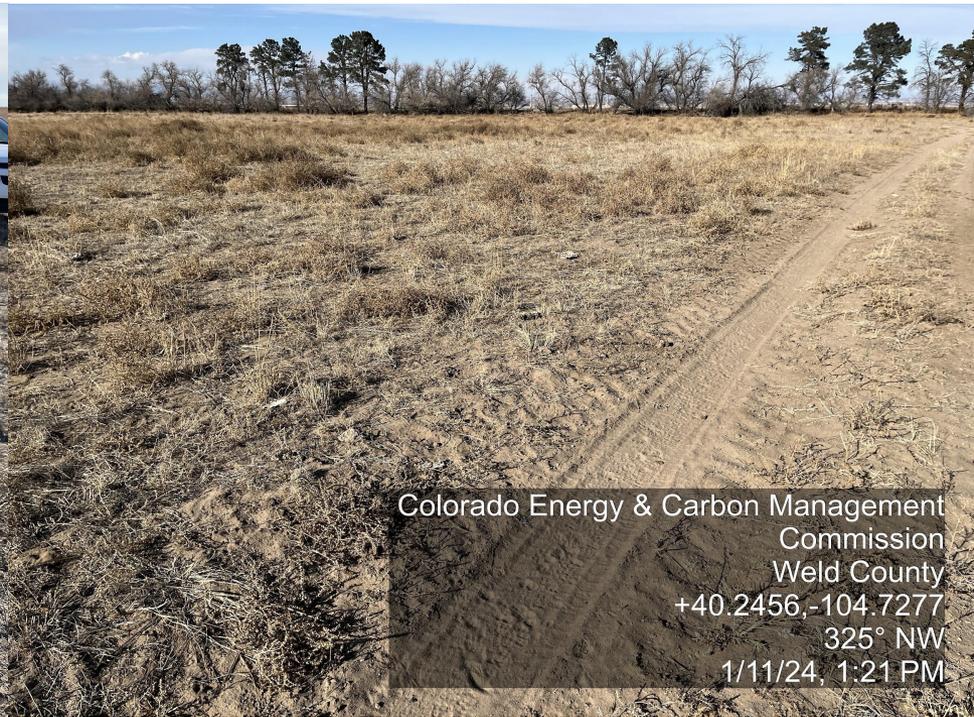
Colorado Energy & Carbon Management
Commission
Weld County
+40.2456,-104.7277
325° NW
1/11/24, 1:21 PM

Photo 4. The photo was taken at the well location facing Northwest. Refer to the comment from photo 2.

The photo also illustrates the access road running through the well location.

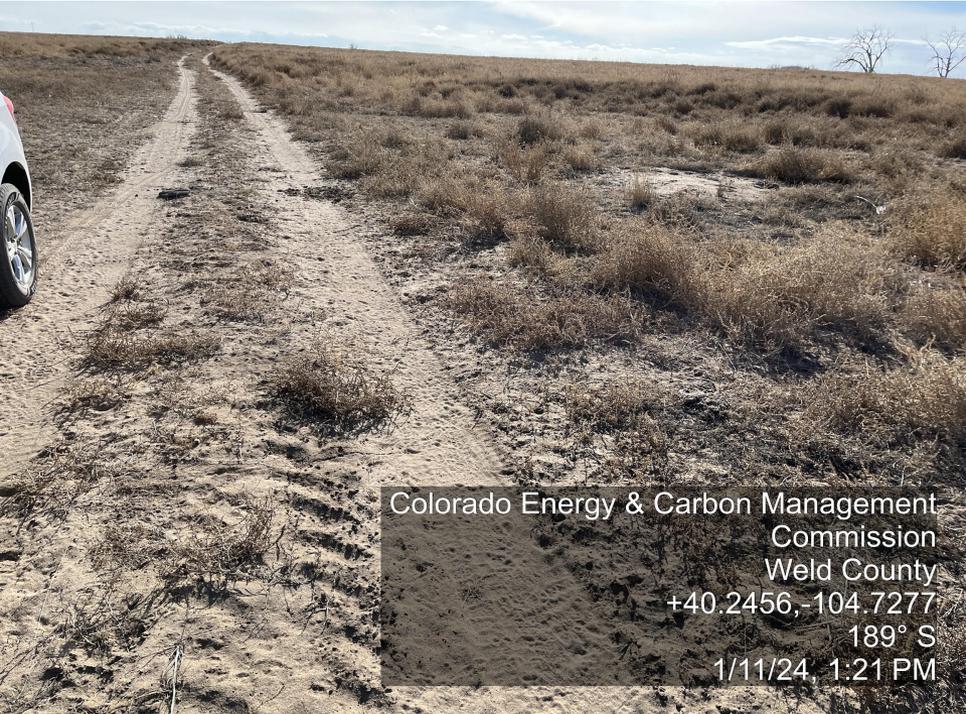
Colorado Energy & Carbon Management
Commission
Weld County
+40.2456, -104.7277
189° S
1/11/24, 1:21 PM

Photo 5. The photo was taken at the well location facing South. The photo illustrates the access road and the Southwest corner of the well location that is dominated by russian thistle.
