Inspection Photos

Operator: TEP ROCKY MOUNTAIN LLC #96850

Location ID: 335743

Inspection Doc: 696205527

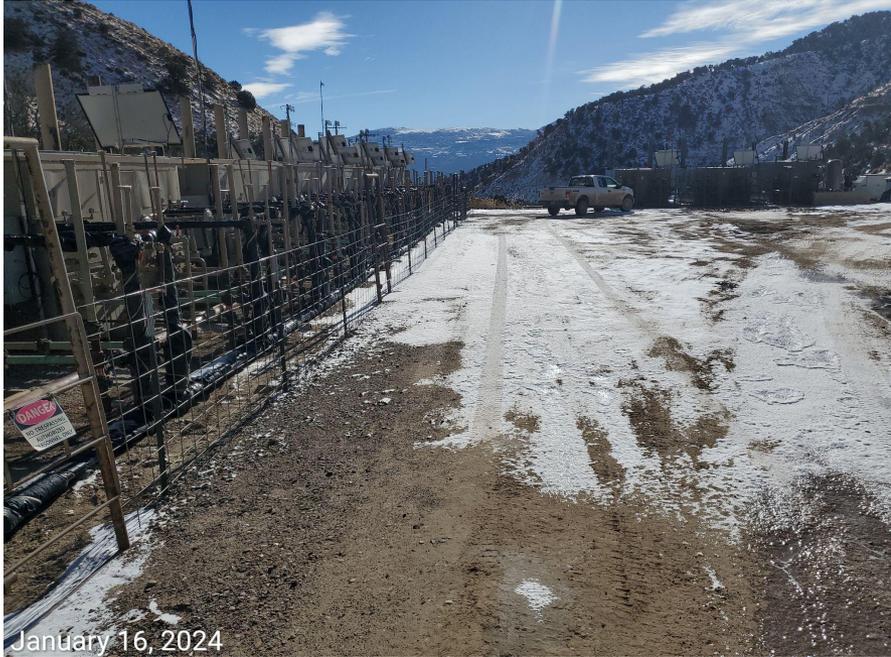
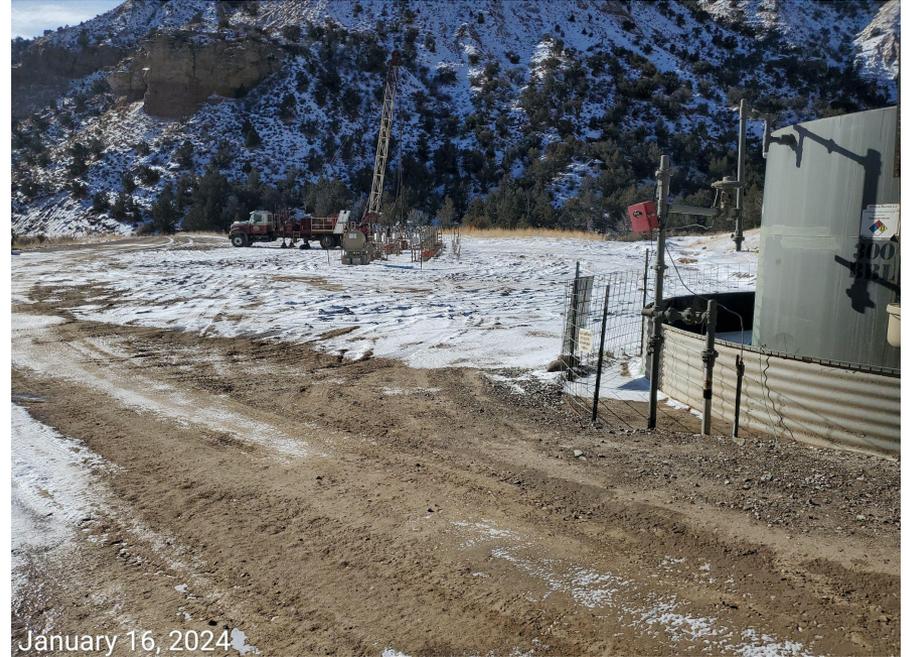
Photo 1: Photos taken from the north end of the Location. Photos provide an overview of the Location from south and southwest.

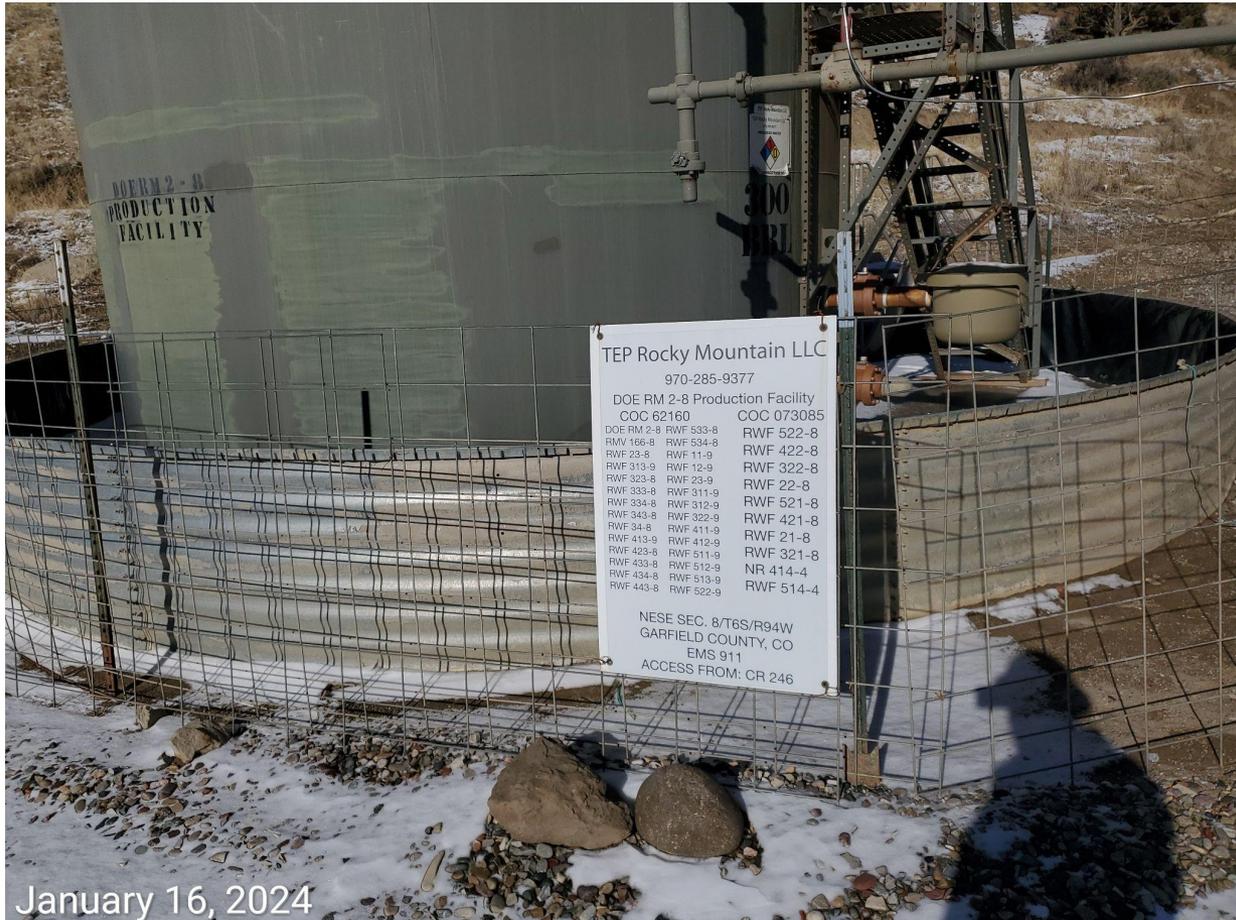
Photo 2: Signage at tank battery missing required well API information.

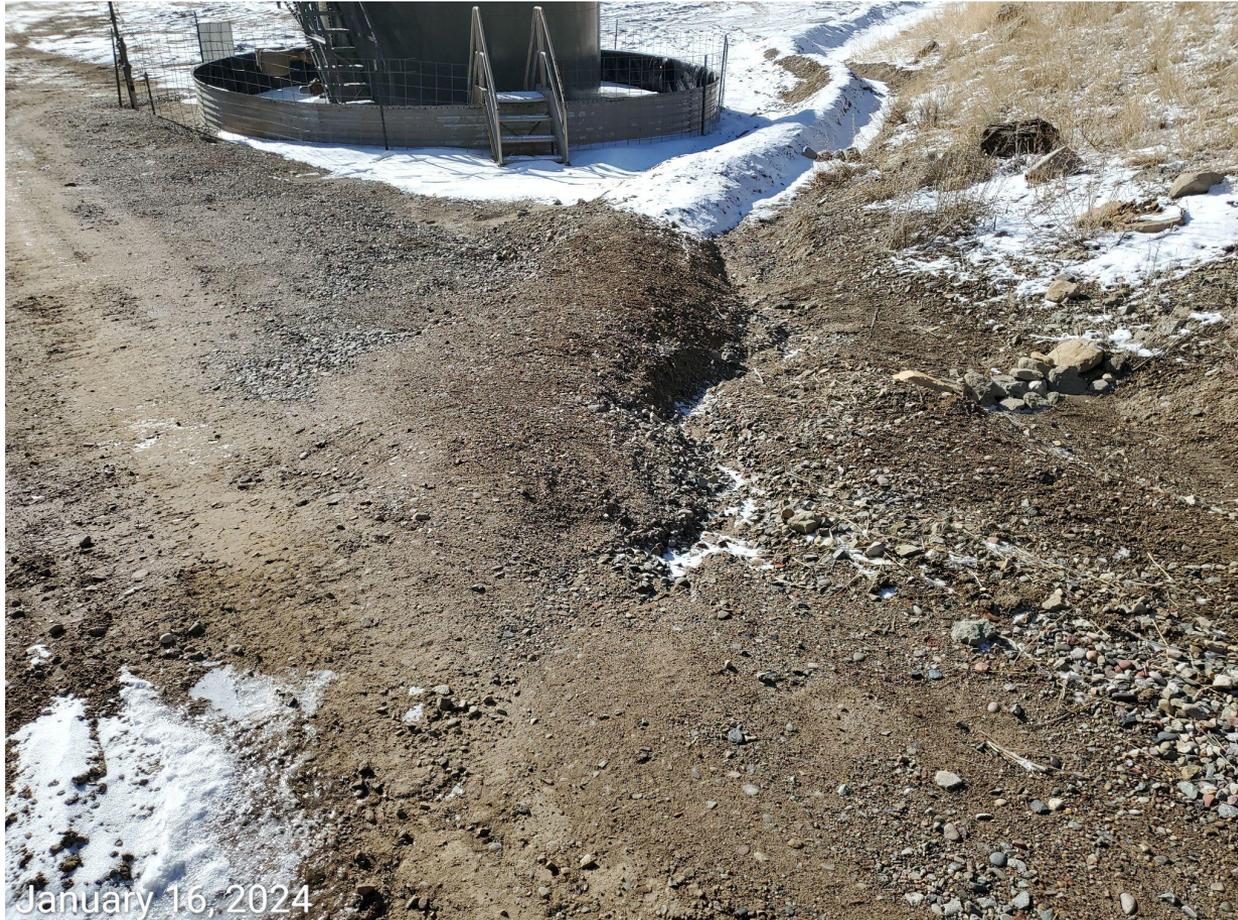
Photo 3: Erosion degradation developing along access road.

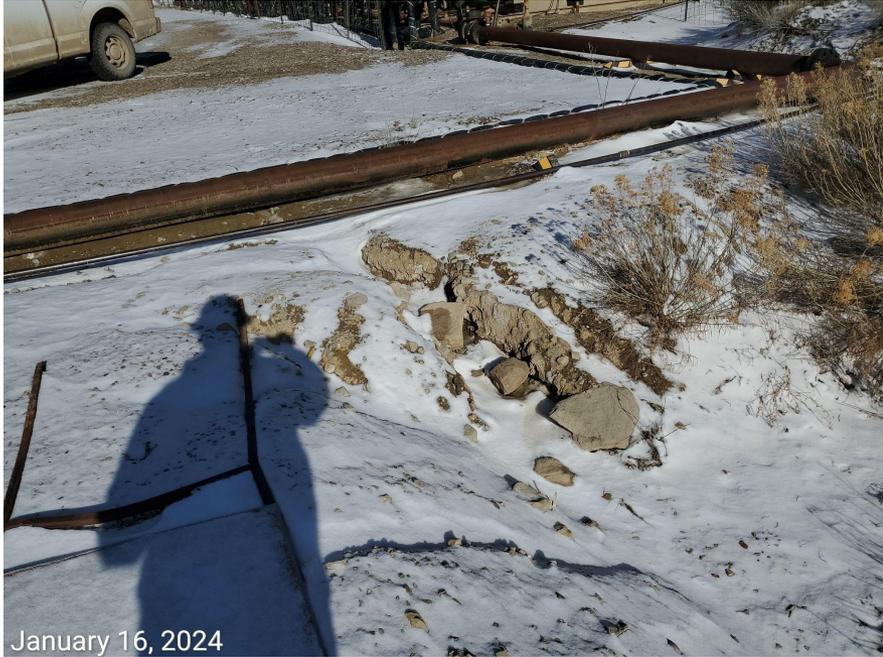
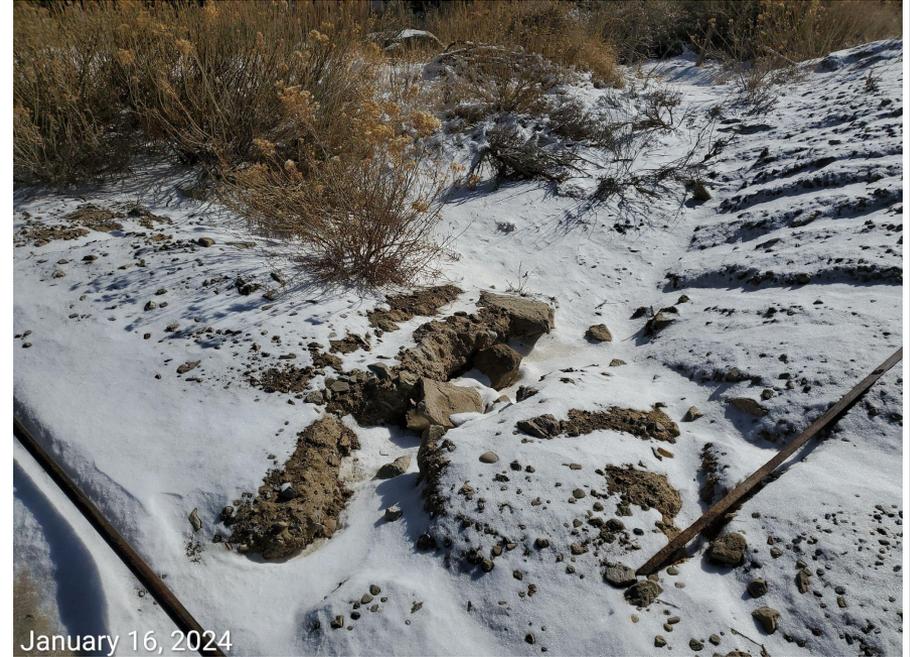
Photo 4: Photo taken from the east end of the Location. Photo shows BMPs to manage runoff are inadequate, resulting in erosion degradation.

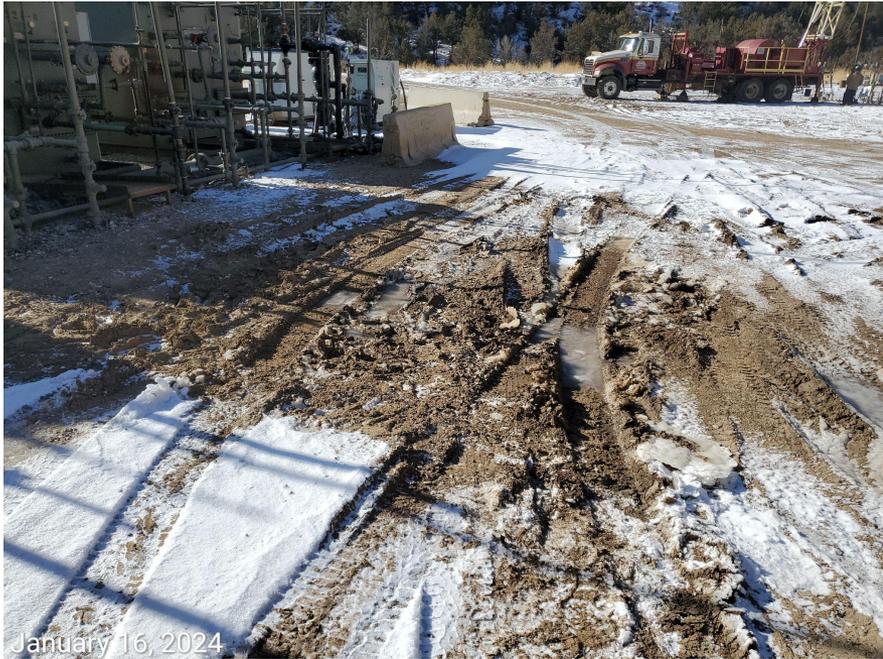
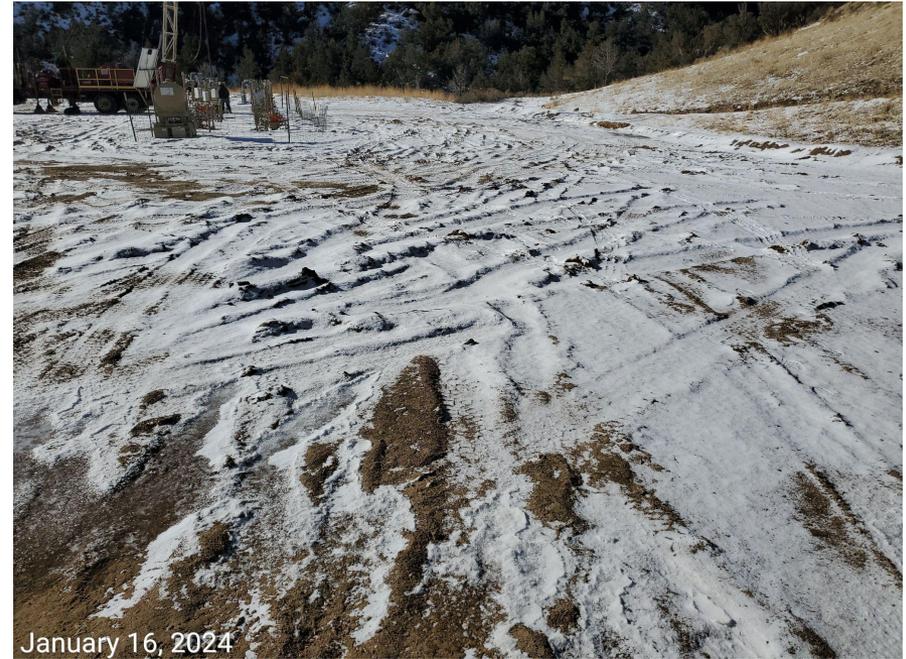
Photo 5: Photos examples showing BMPs to stabilize the working pad surface, as well as to minimize erosion, degradation or off-site sediment transport are missing or insufficient; WPS lacks stabilization.

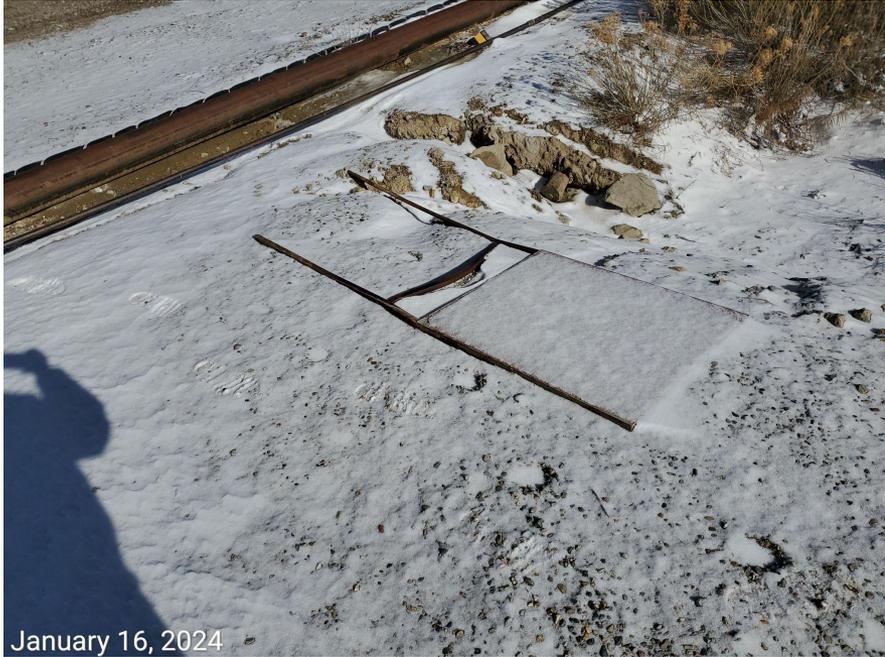
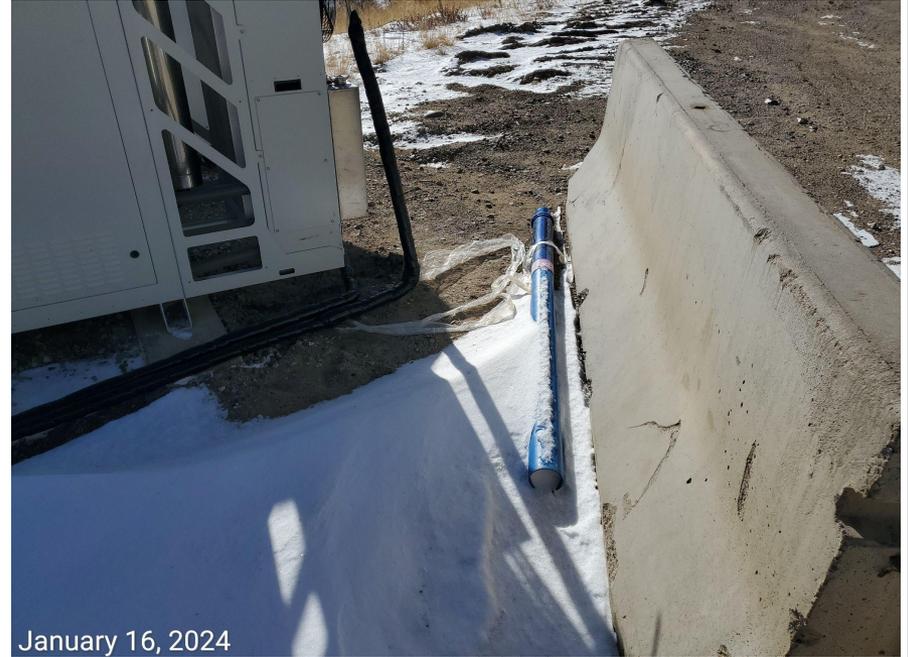
Photo 6: Unused sign, post and plastic trash.

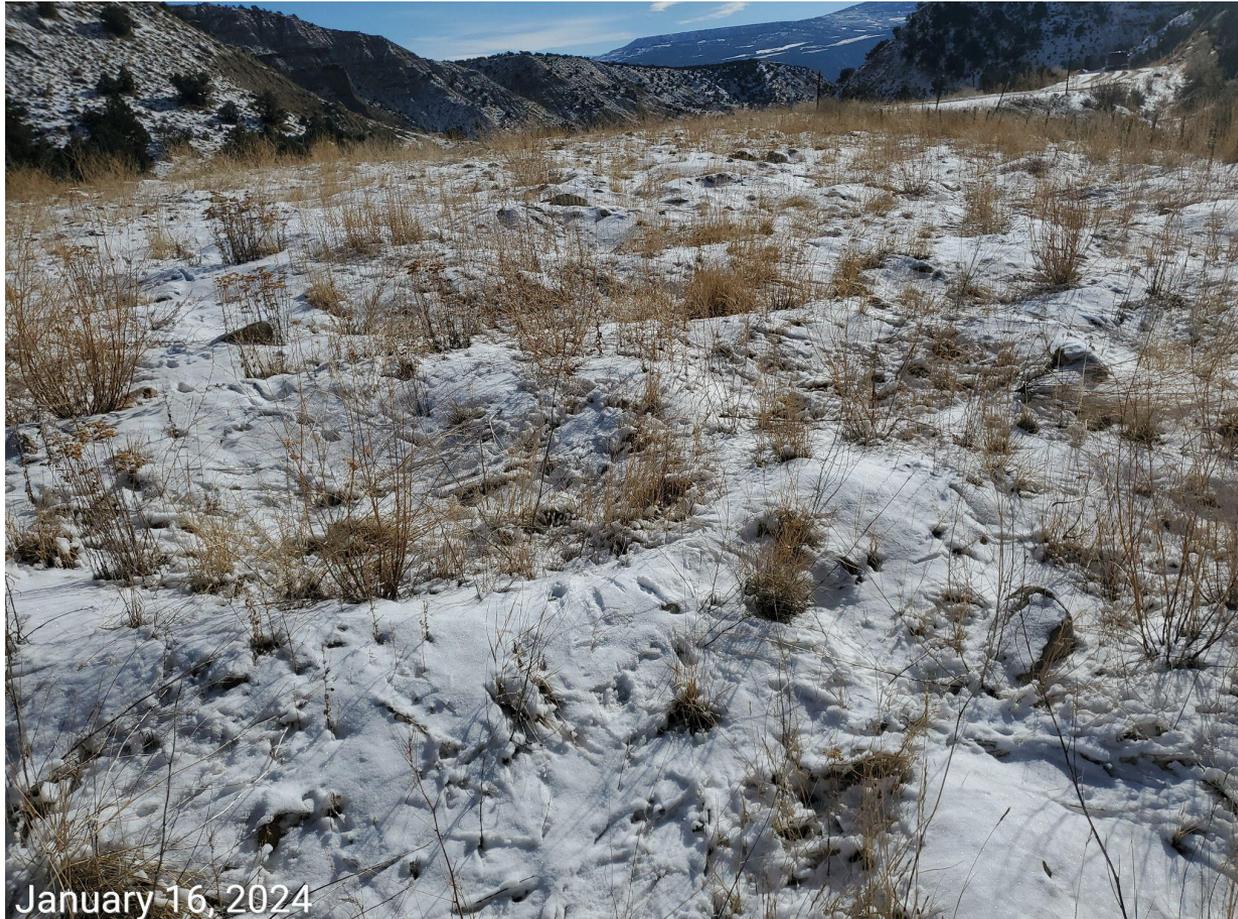
Photo 7: Photo taken from the interim areas. Limited inspection due to snow cover; desirable plant establishment is evident; interim areas appear to be progressing towards 1003 standards.
