Inspection Photos

Operator: TEP ROCKY MOUNTAIN LLC #96850

Location ID: 335637

Inspection Doc: 696205529

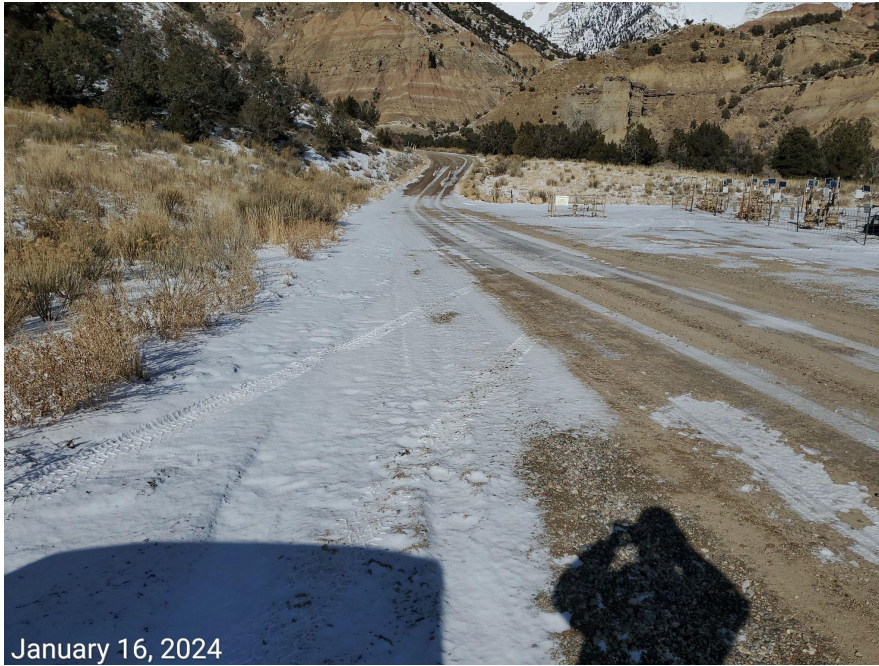
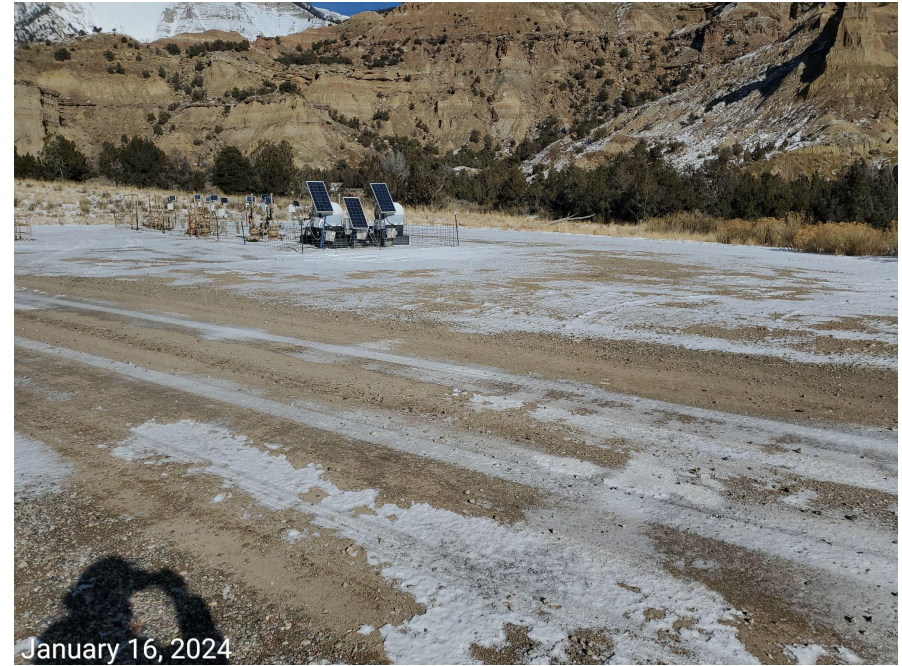
Photo 1: Photos 1-2 taken from the west end of the Location. Photos provide an overview of the location from north, northeast, southeast to south.

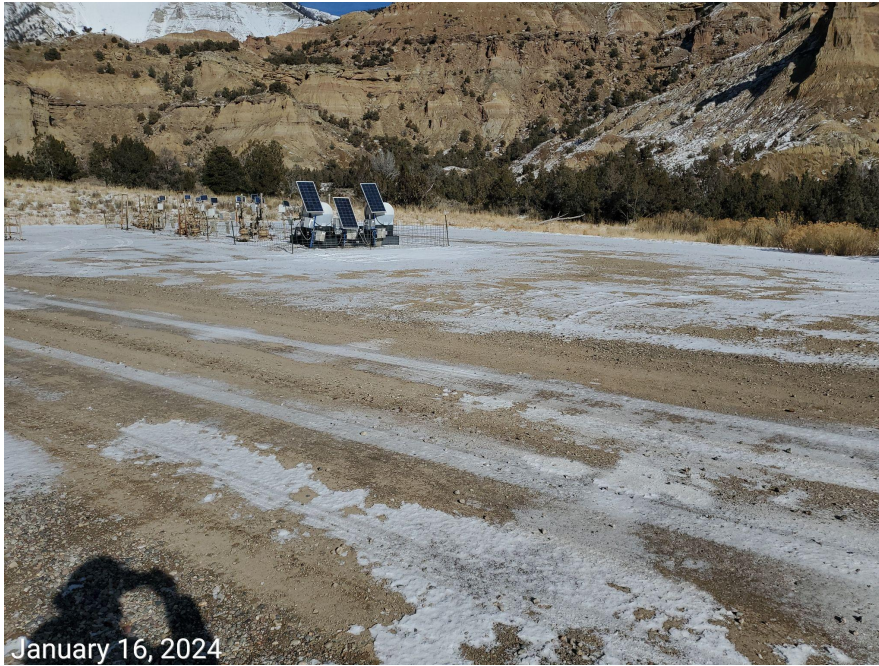
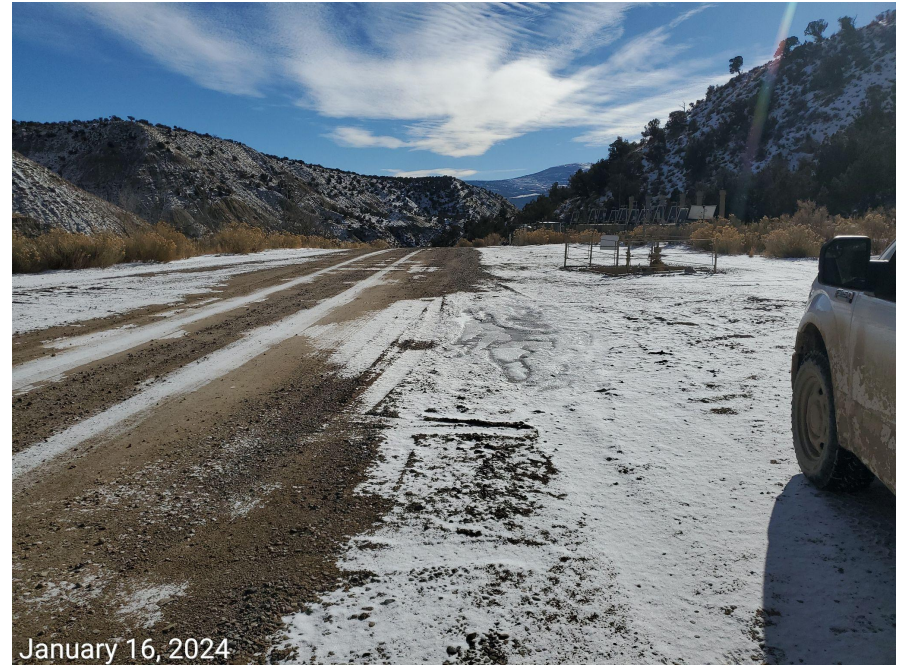
Photo 2: See comments under photo 1.

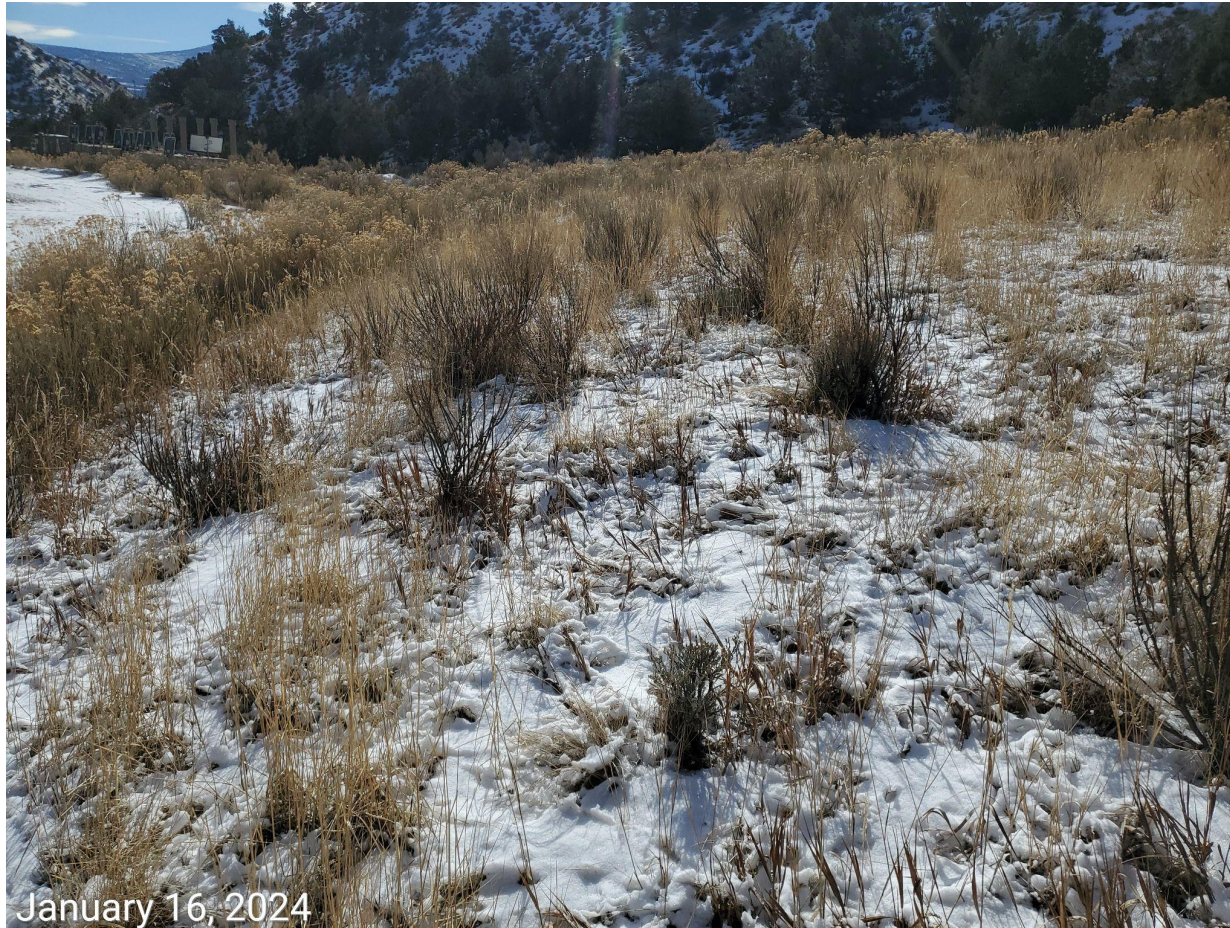
Photo 3: Photo example of vegetation establishment over the interim areas.

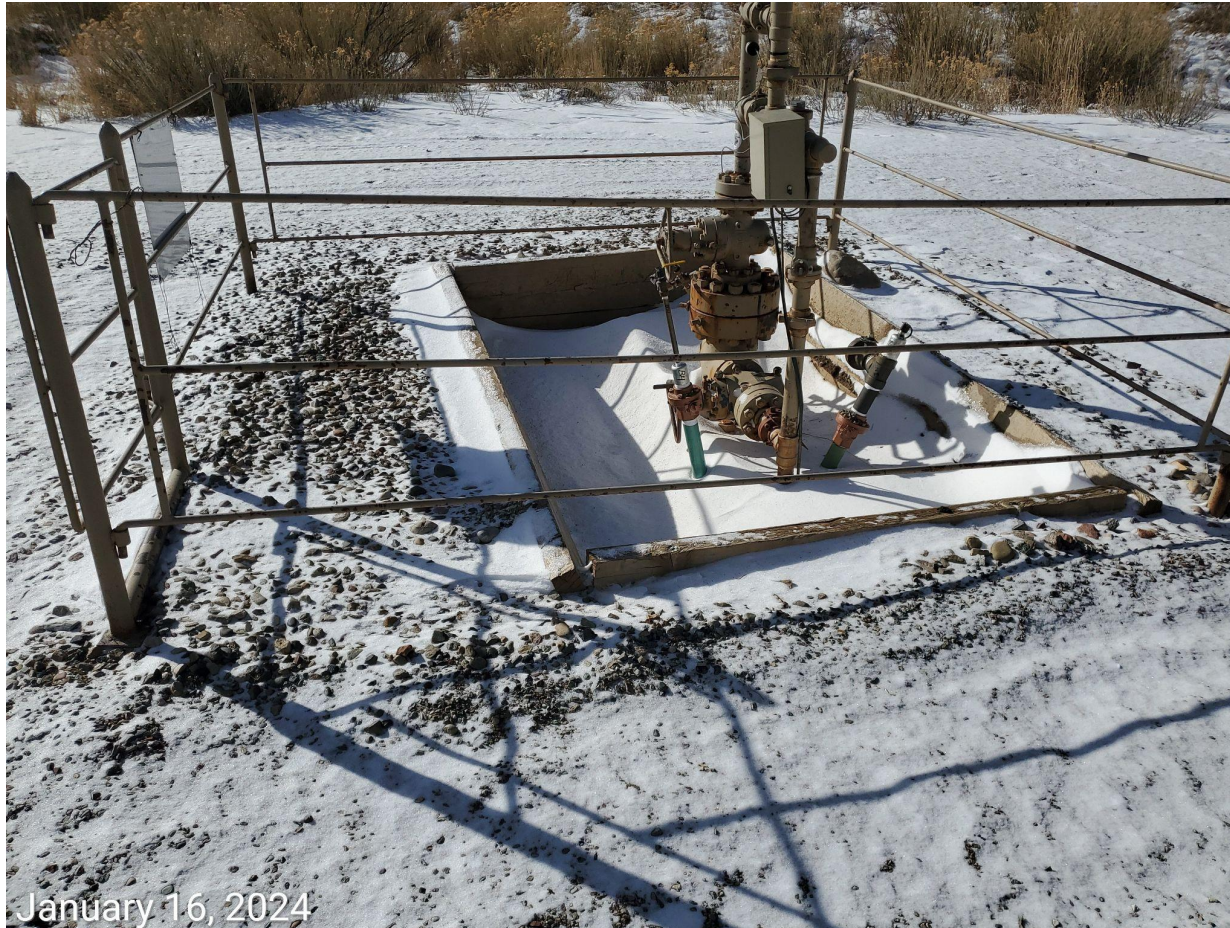
Photo 4: Cellar at well API 045-06486. Cellar has not been backfilled or covered; BMPs to minimize wildlife ingress or egress are missing or insufficient.
