Inspection Photos

Operator: TEP ROCKY MOUNTAIN LLC #96850

Location ID: 335777

Inspection Doc: 696205533

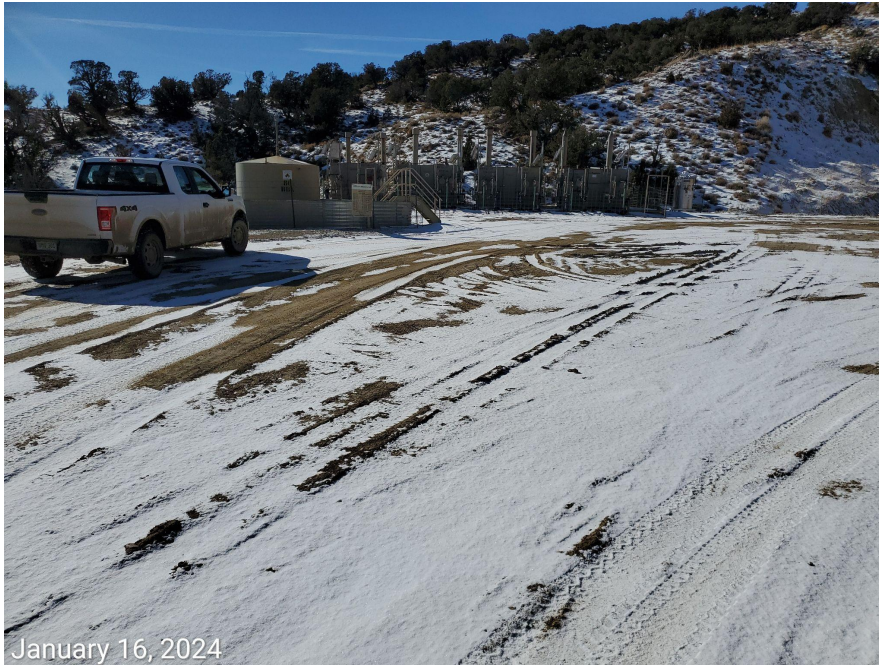
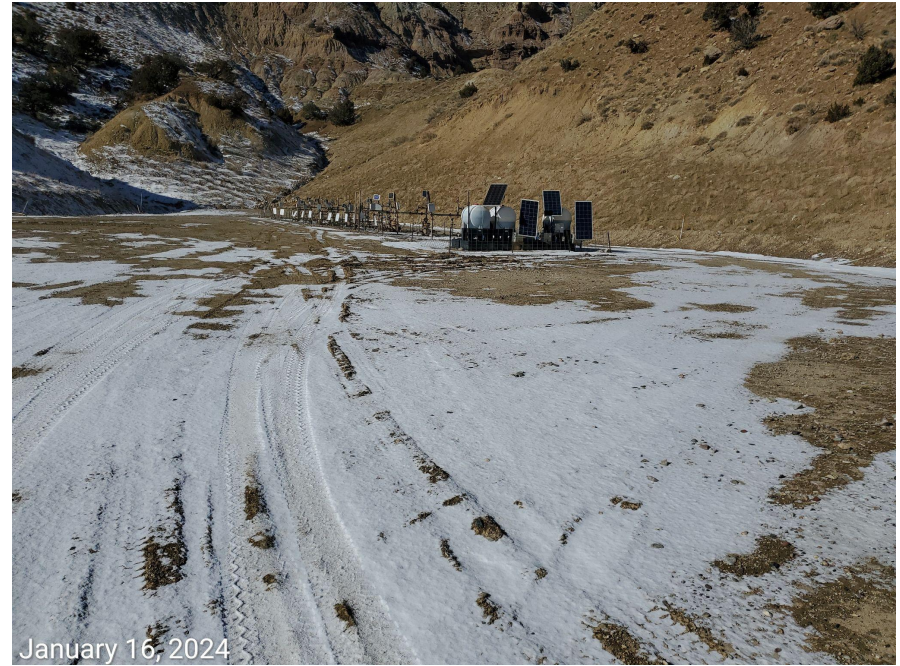
Photo 1: Photos taken from the east end of the Location. Photos provide an overview of the Location from southwest to west.

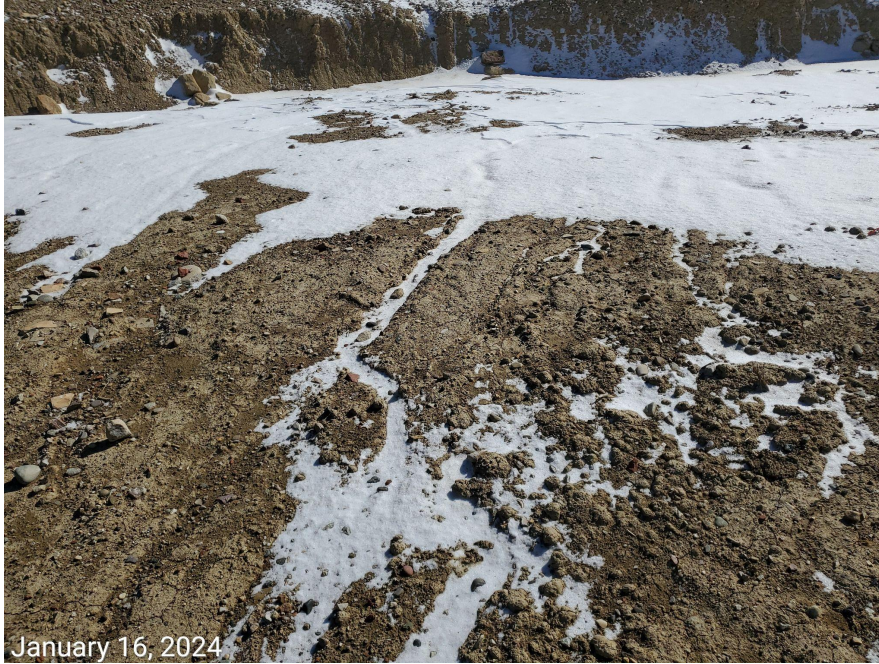
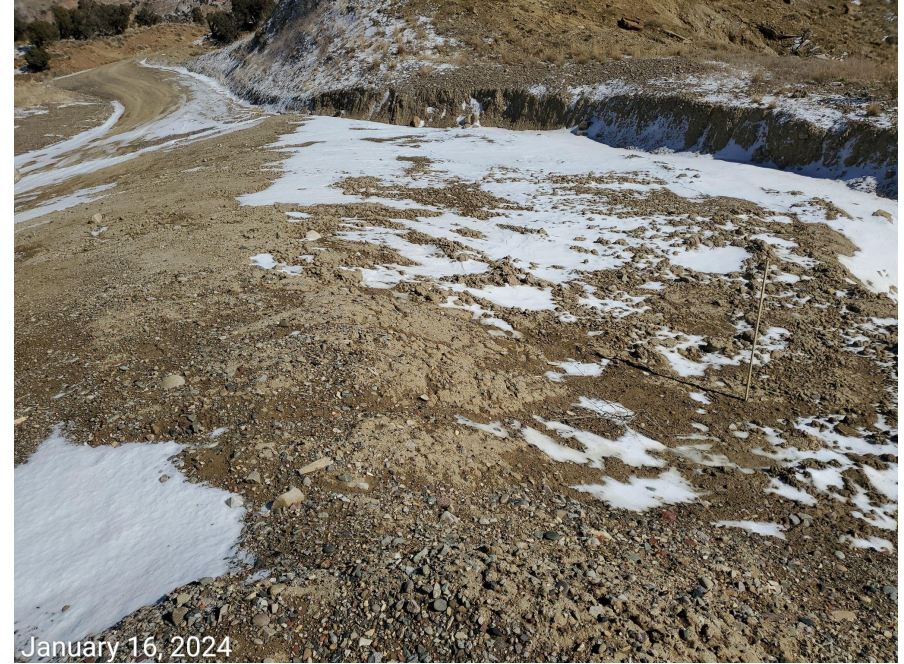
Photo 2: Photos taken from the east end of the Location; erosion degradation evident along slopes. BMPs to minimize erosion, degradation and sediment transport are missing or insufficient.

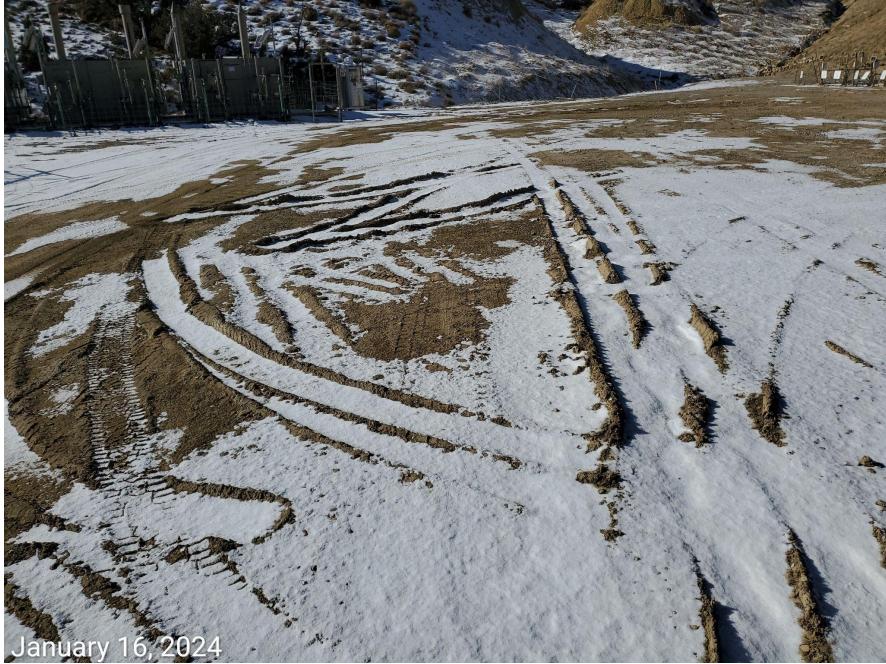
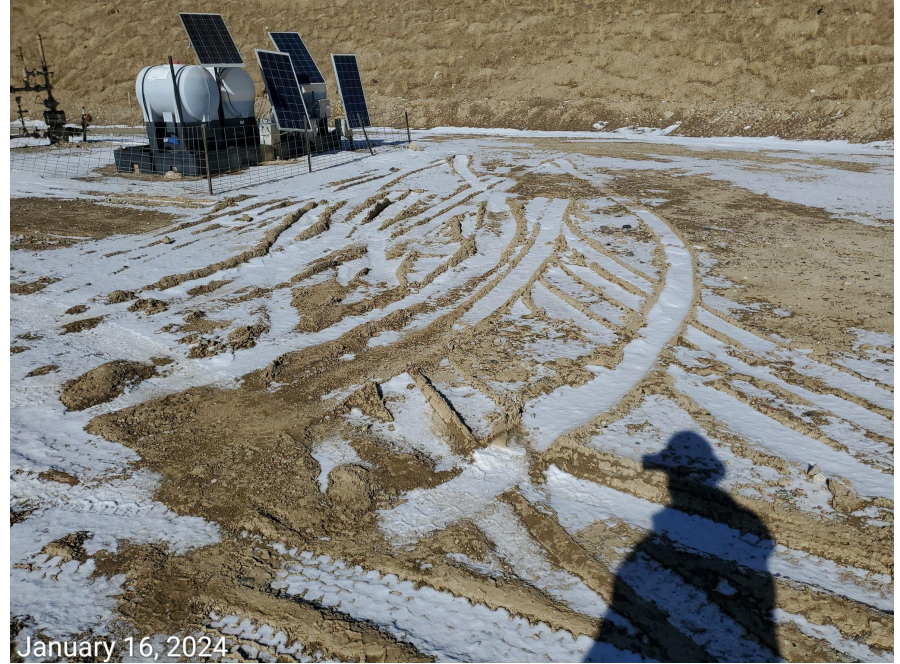
Photo 3: Photos examples show erosion degradation (tracking, ruts). BMPs to stabilize the working pad surface, and to minimize erosion, degradation and sediment transport are missing or insufficient.

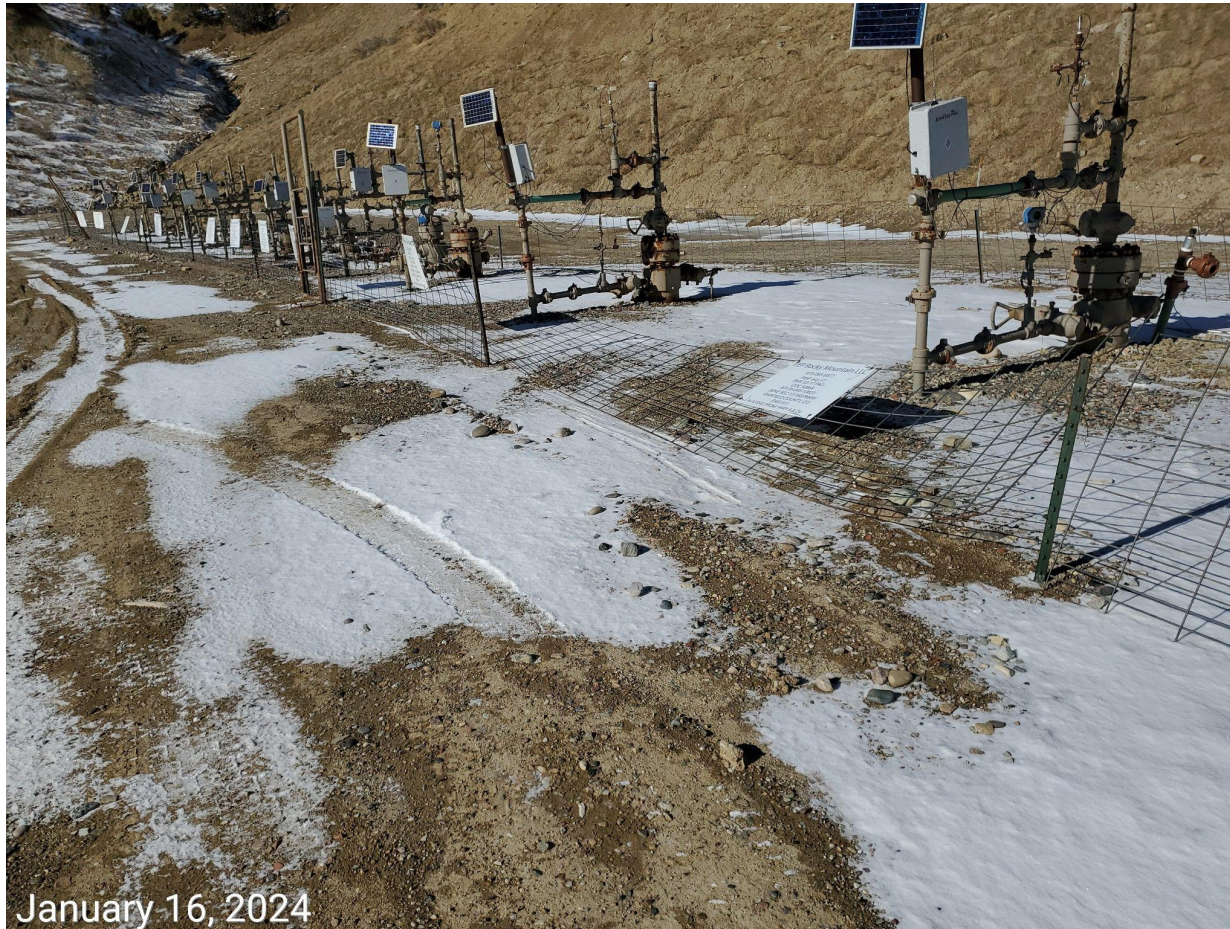
Photo 4: Fence at wells in disrepair.
