# Inspection Photos

**Operator:** TEP ROCKY MOUNTAIN LLC #96850

**Location ID:** 335453

**Inspection Doc:** 696205537

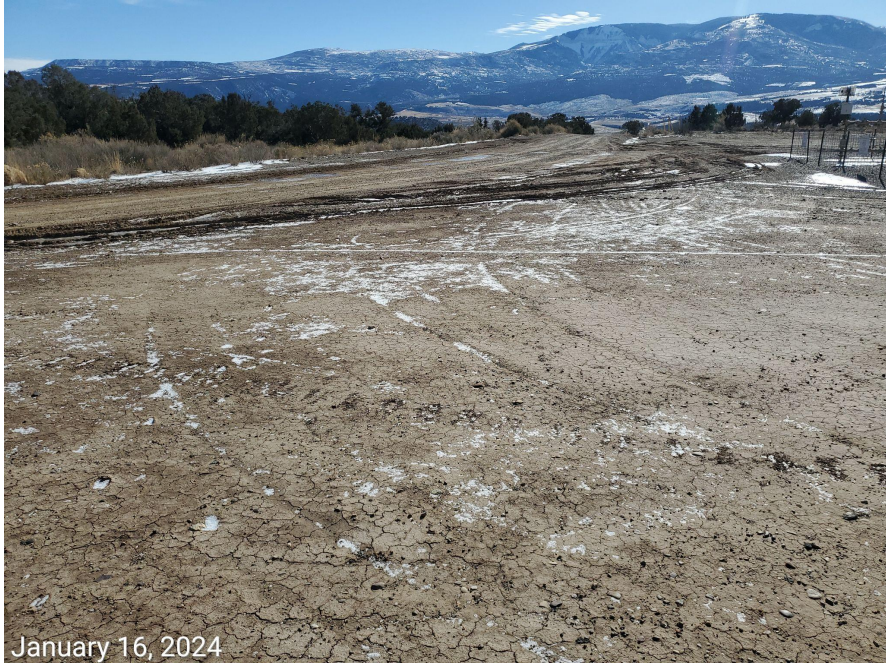
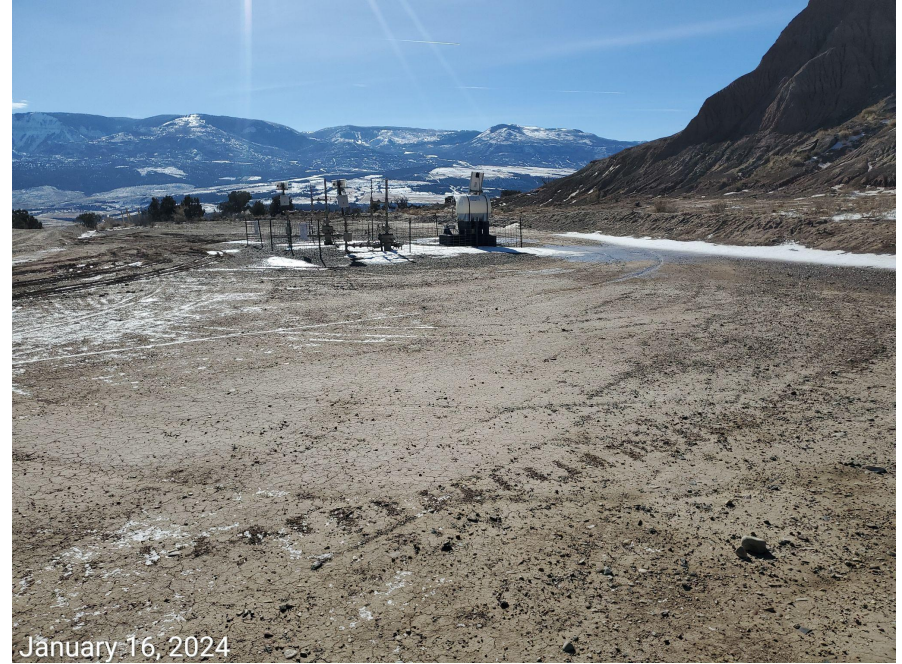
**Photo 1:** Photos taken from the northern working pad surface of the Location. Photos provide an overview of the Location from southeast to southwest. Photos also examples showing BMPs to stabilize the working pad surface, as well as to minimize erosion, degradation and off-site sediment transport are missing or insufficient.

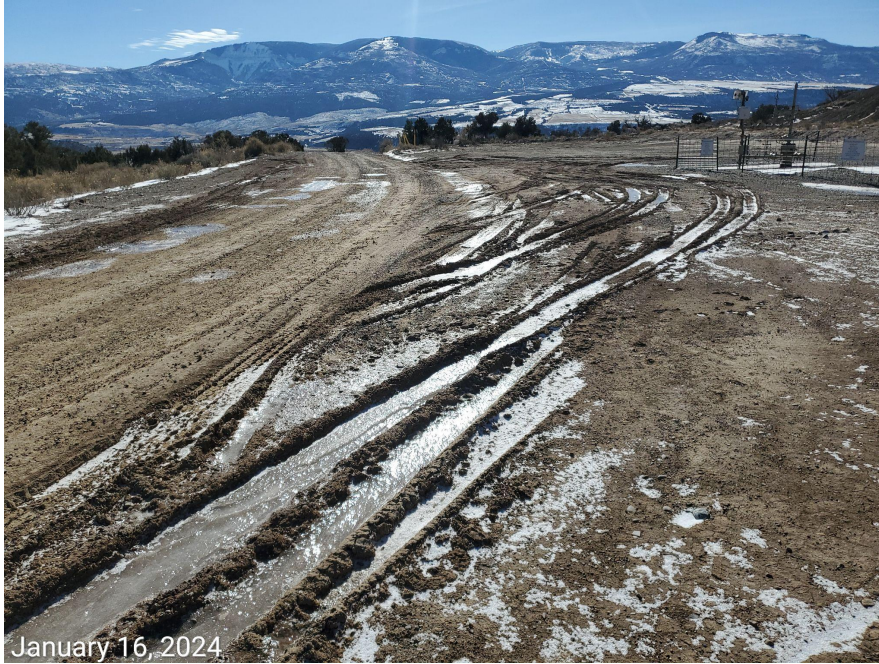
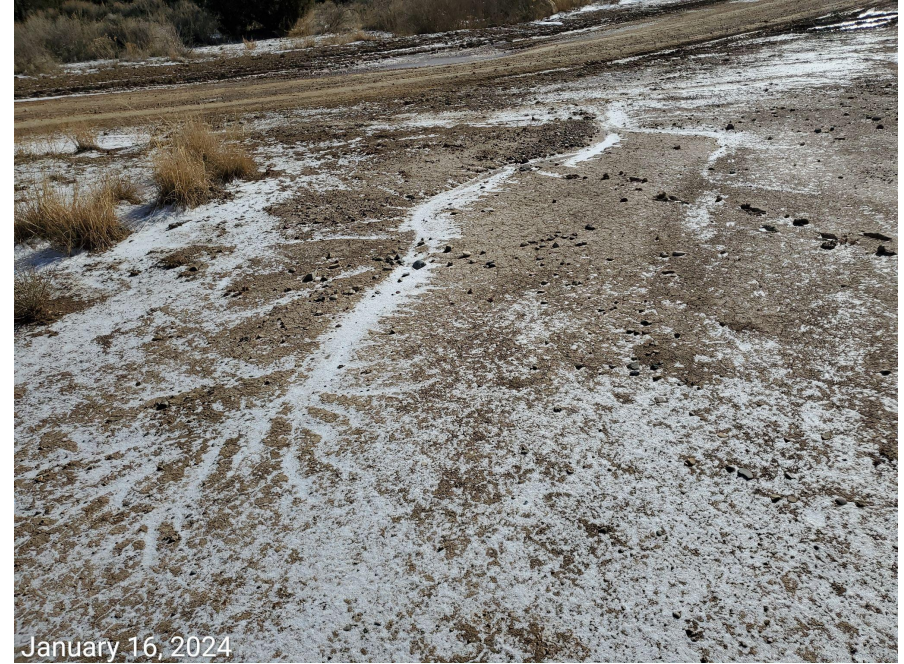
**Photo 2:** See comments under photo 1.
