Final Reclamation and Stormwater Inspection

Operator: Kerr McGee Oil & Gas Onshore LP - 47120

Location ID: 328326

Inspection Photos
Location Name: Bell L12-20
Location ID: 328326

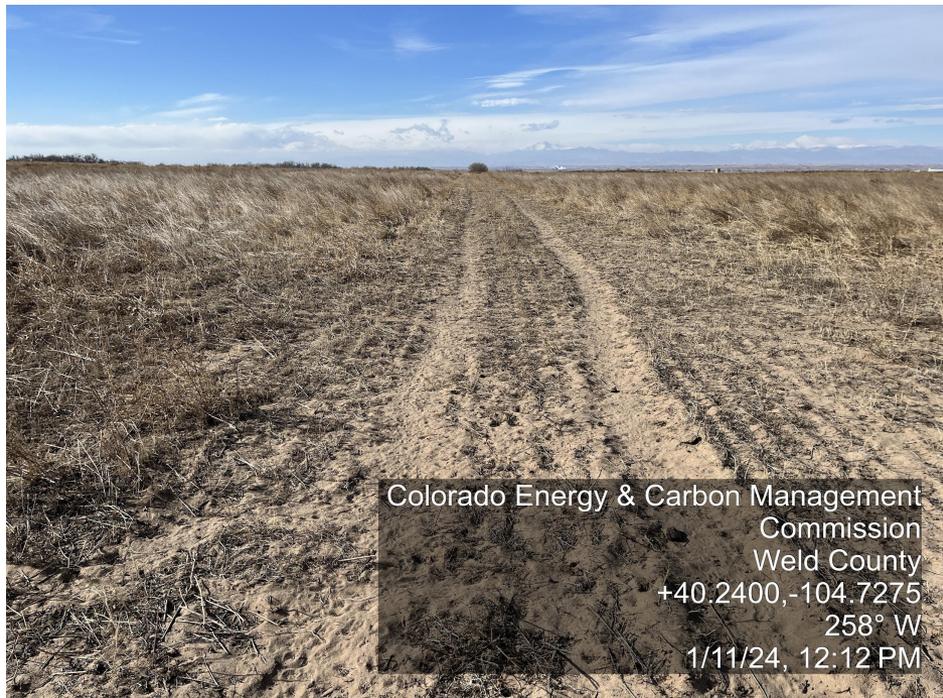
Photo 1. The photo was taken at the well location facing West. The photo illustrates the access road has some evidence of interseeding however large portions of bare soil.

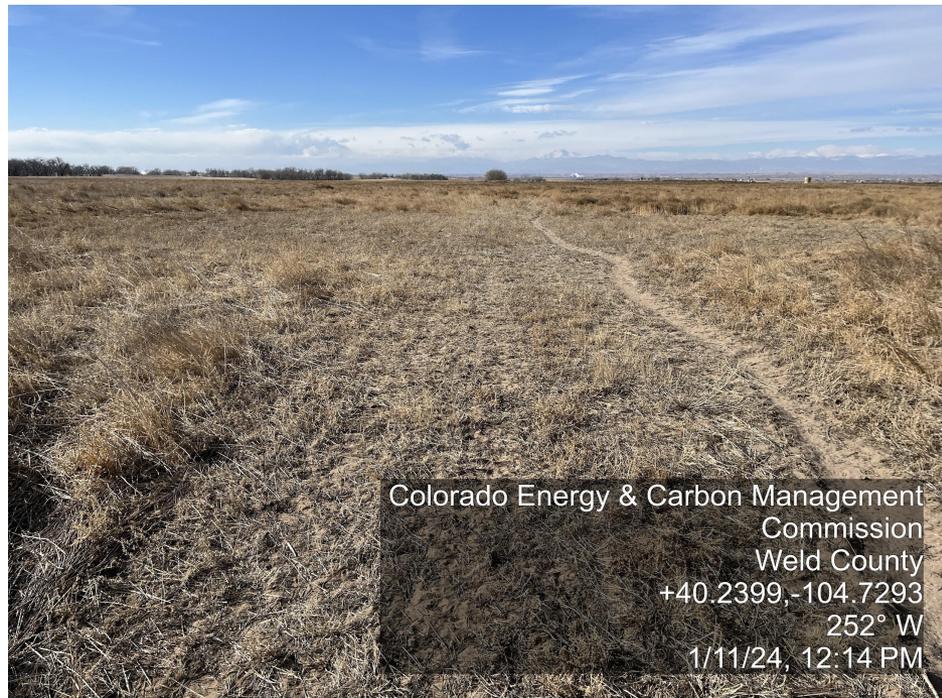
Photo 2. The photo was taken at the well location facing West. The photo illustrates the well location from where the access road enters it on the East side.

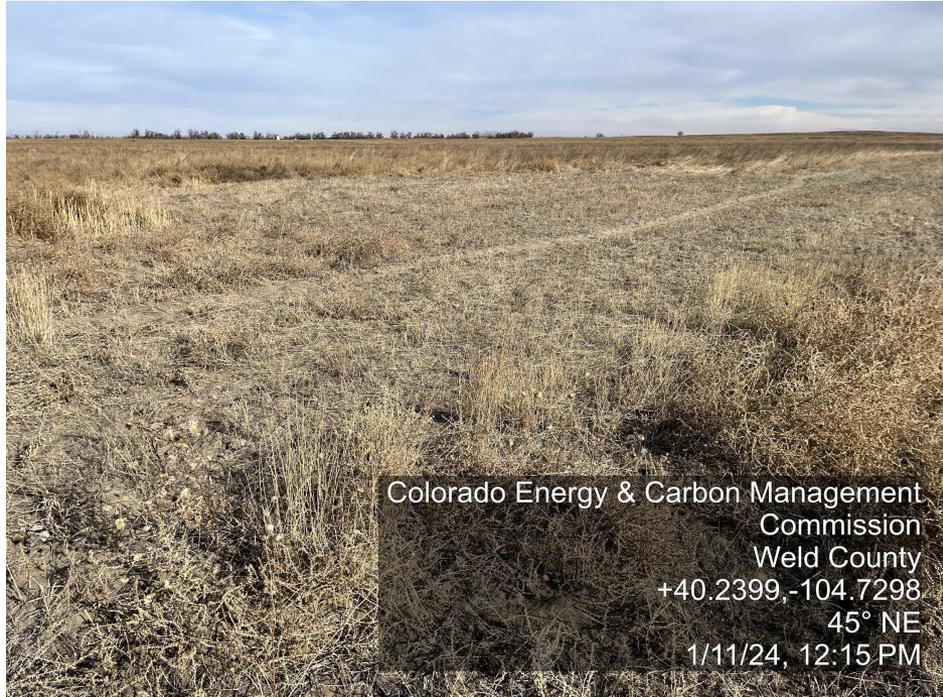
Photo 3. The photo was taken at the well location facing Northeast. The photo illustrates a portion of the well location has been managed with evidence of mowing and interseeding however a large portion is dominated by Russian thistle.

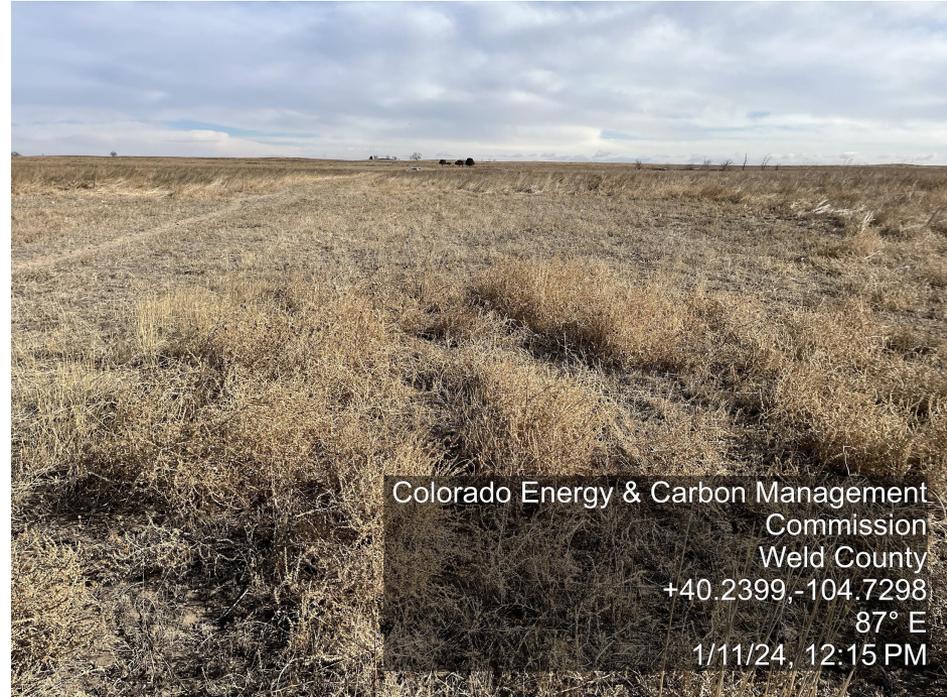
Photo 4. The photo was taken at the well location facing East. Refer to the comment for photo 3.

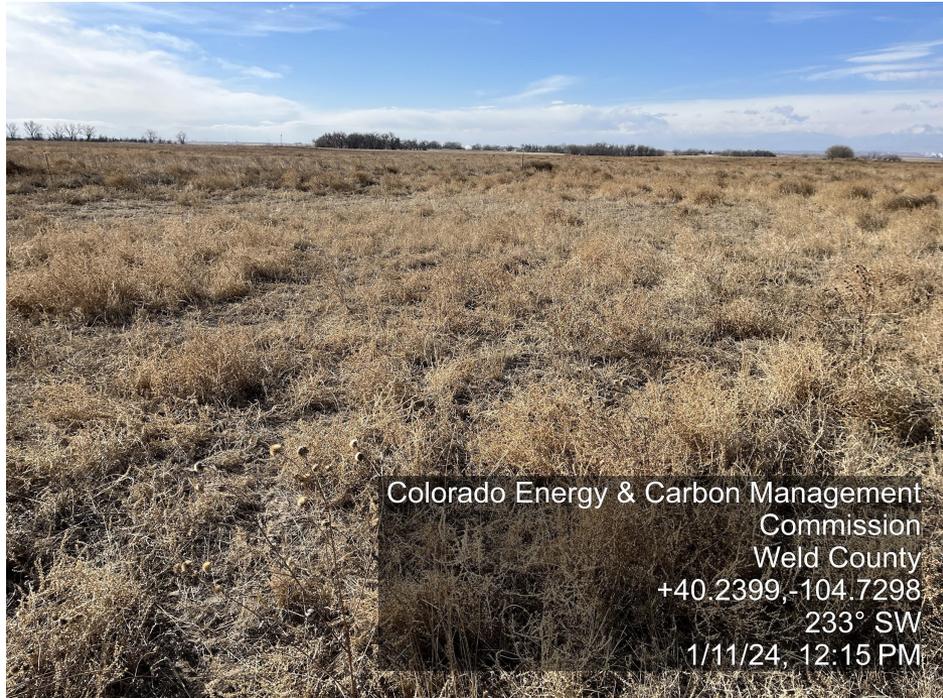
Photo 5. The photo was taken at the well location facing Southwest. The photo illustrates the well location on the West side is dominated by Russian thistle.

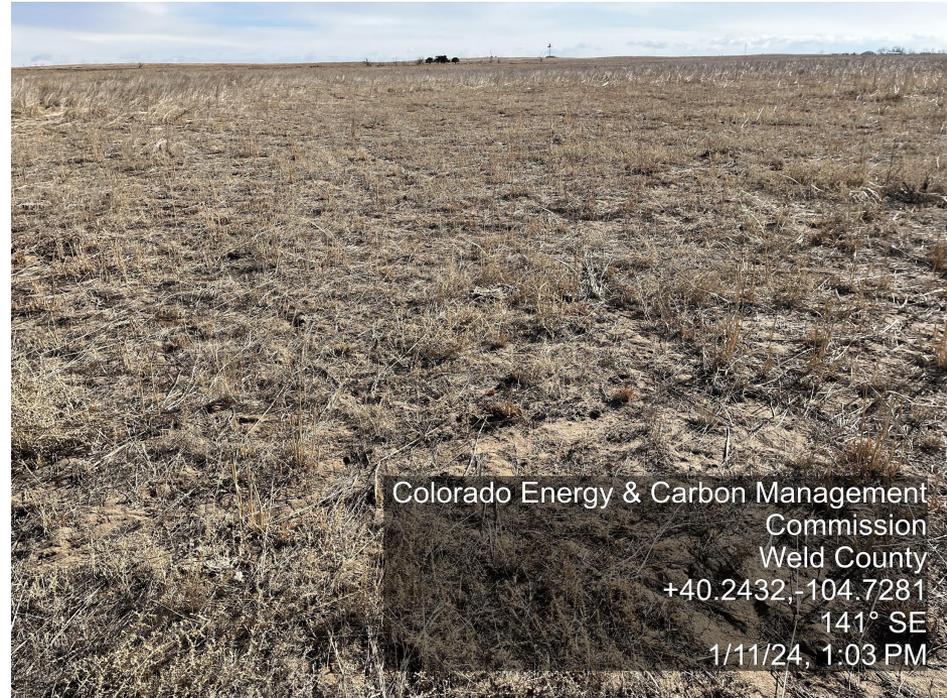
Photo 6. The reference photo was taken near the well location facing Southeast.
