# Inspection Photos

**Operator:** CAERUS PICEANCE LLC #10456

**Location ID:** 334670

**Inspection Doc:** 696205567

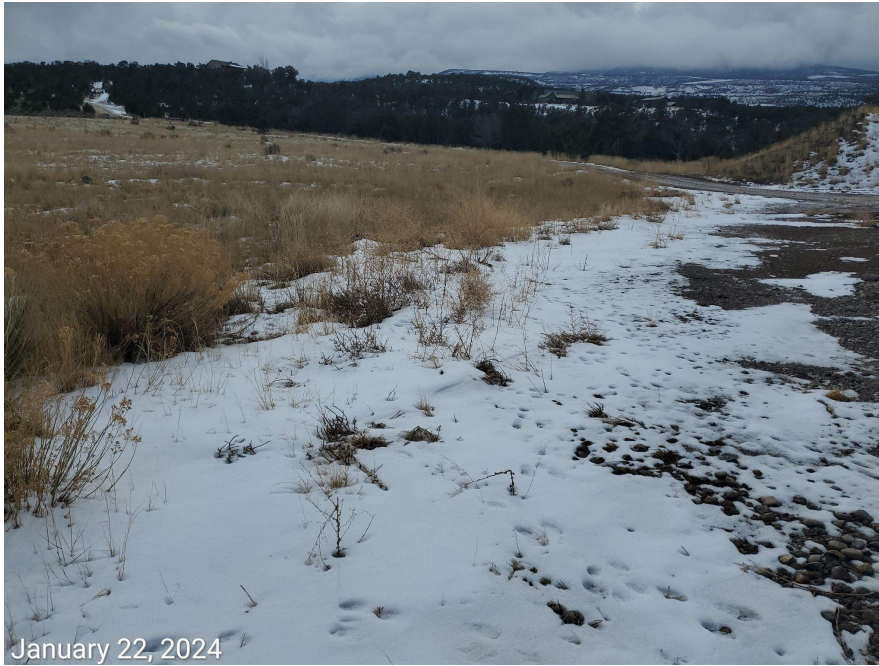
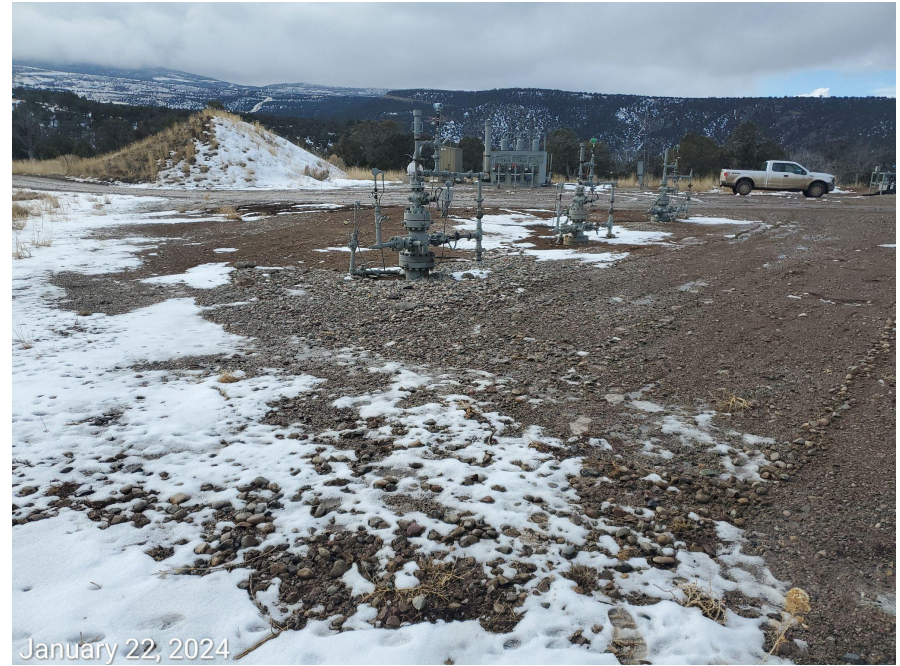
**Photo 1:** Photos 1-2 taken from the east end of the Location. Photos provide an overview of the Location from southwest, northwest, north to northeast.

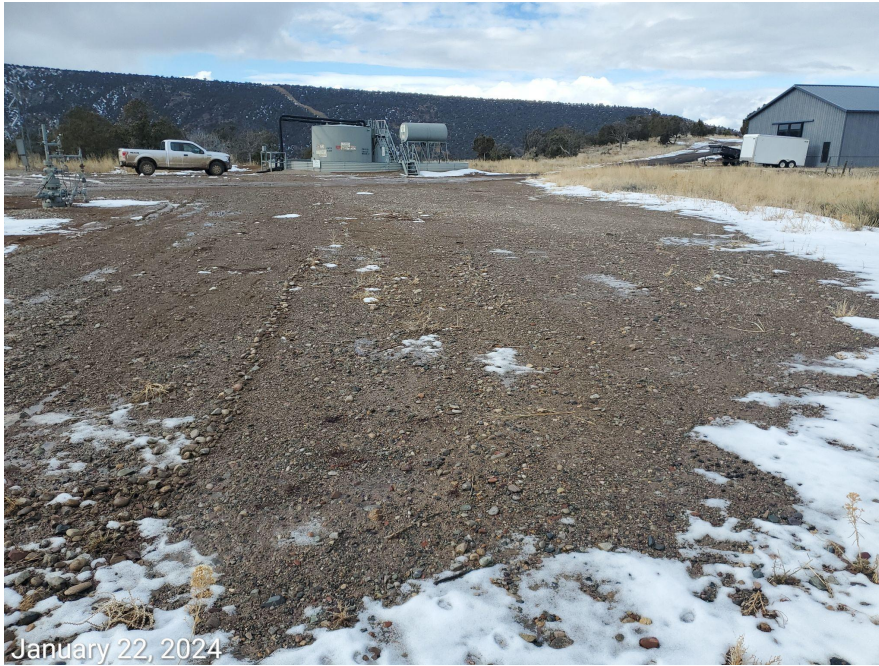
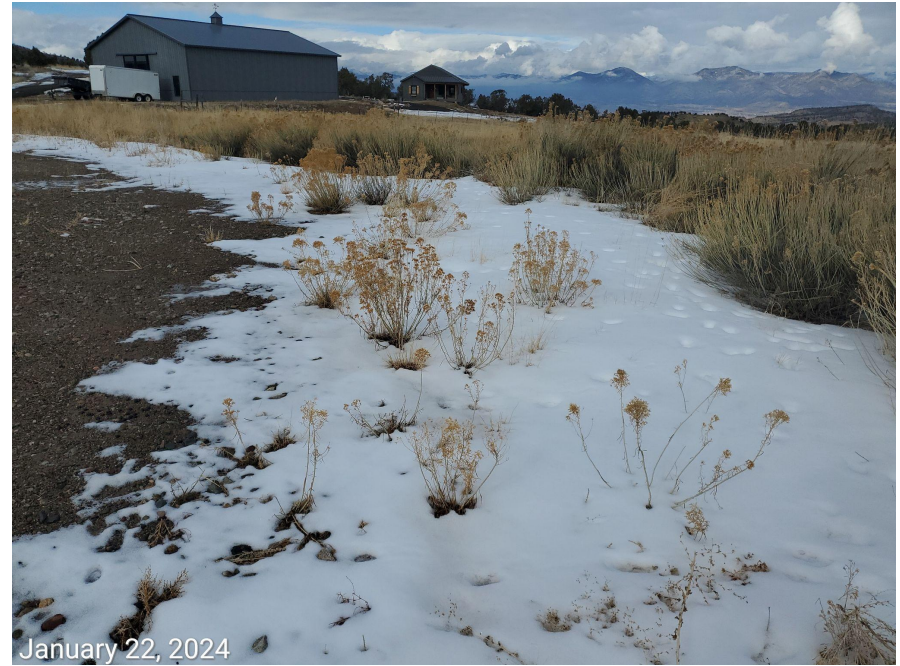
**Photo 2:** See comments under photo 1.

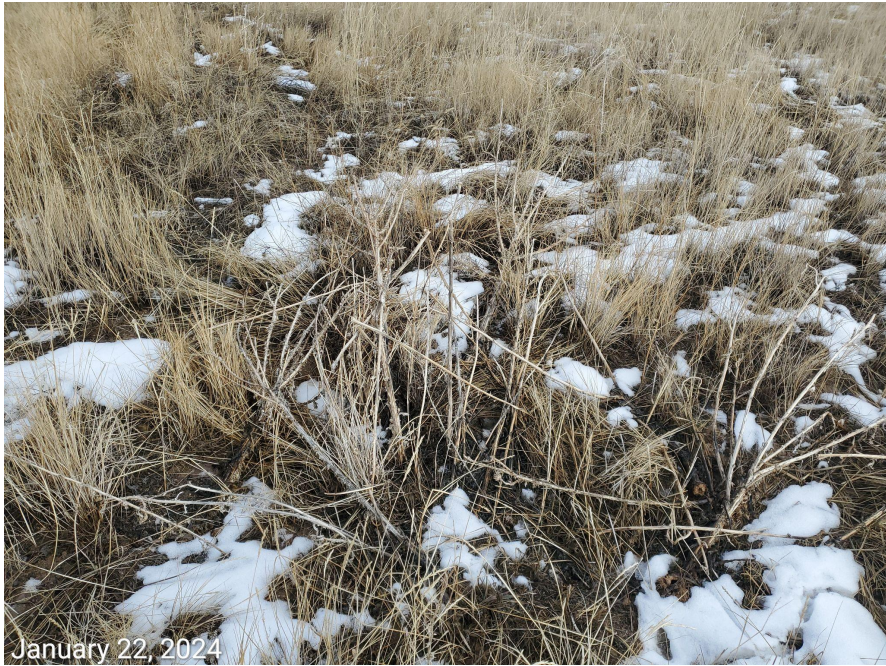
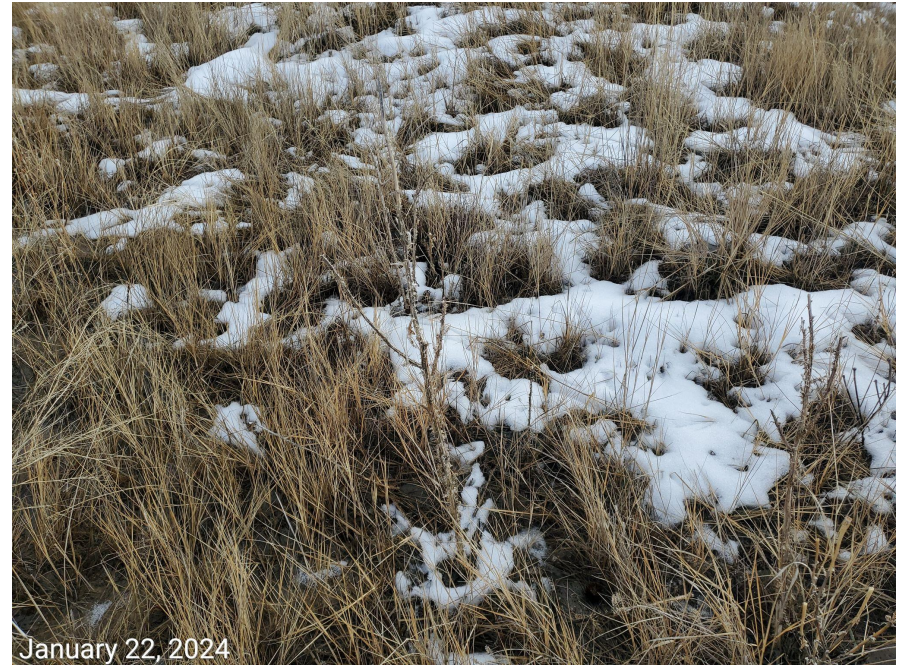
**Photo 3:** Photos taken from the interim areas. Photos examples showing Noxious weed (Musk thistle) remnants established during the prior growing season. Additional weed management efforts required during the 2024 growing season.

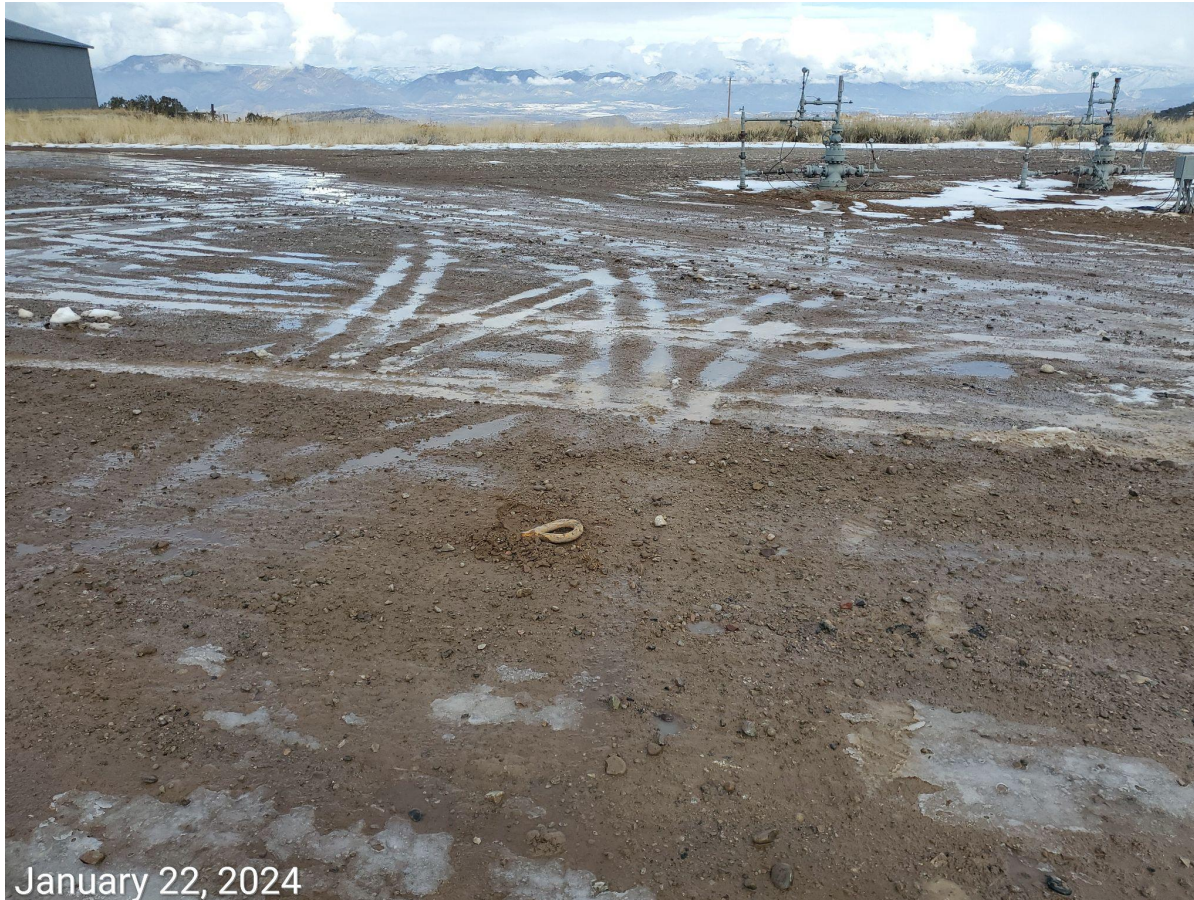
**Photo 4:** Photo example showing unmarked anchors on the Location.

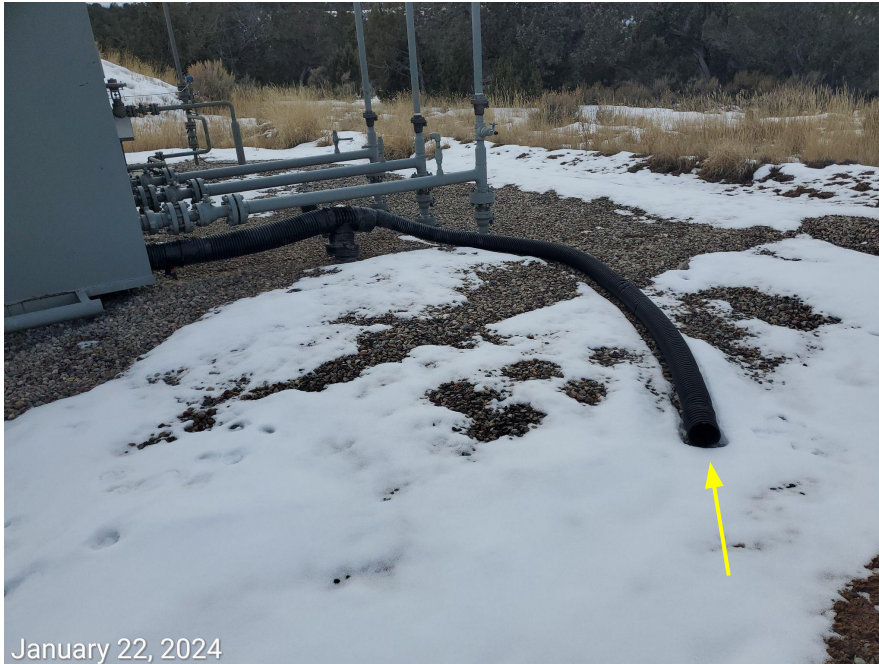
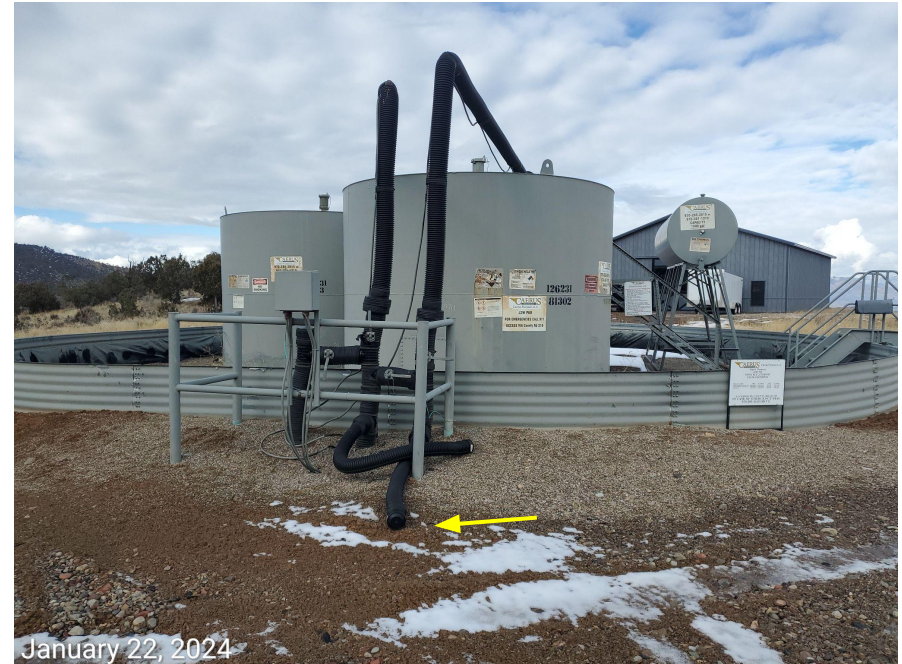
**Photo 5:** Photo left shows piping at separator equipment lacks BMPs to prevent wildlife entry; pipe is open ended. Photo right example showing piping at tank battery Location with adequate wildlife protection BMPs at piping.

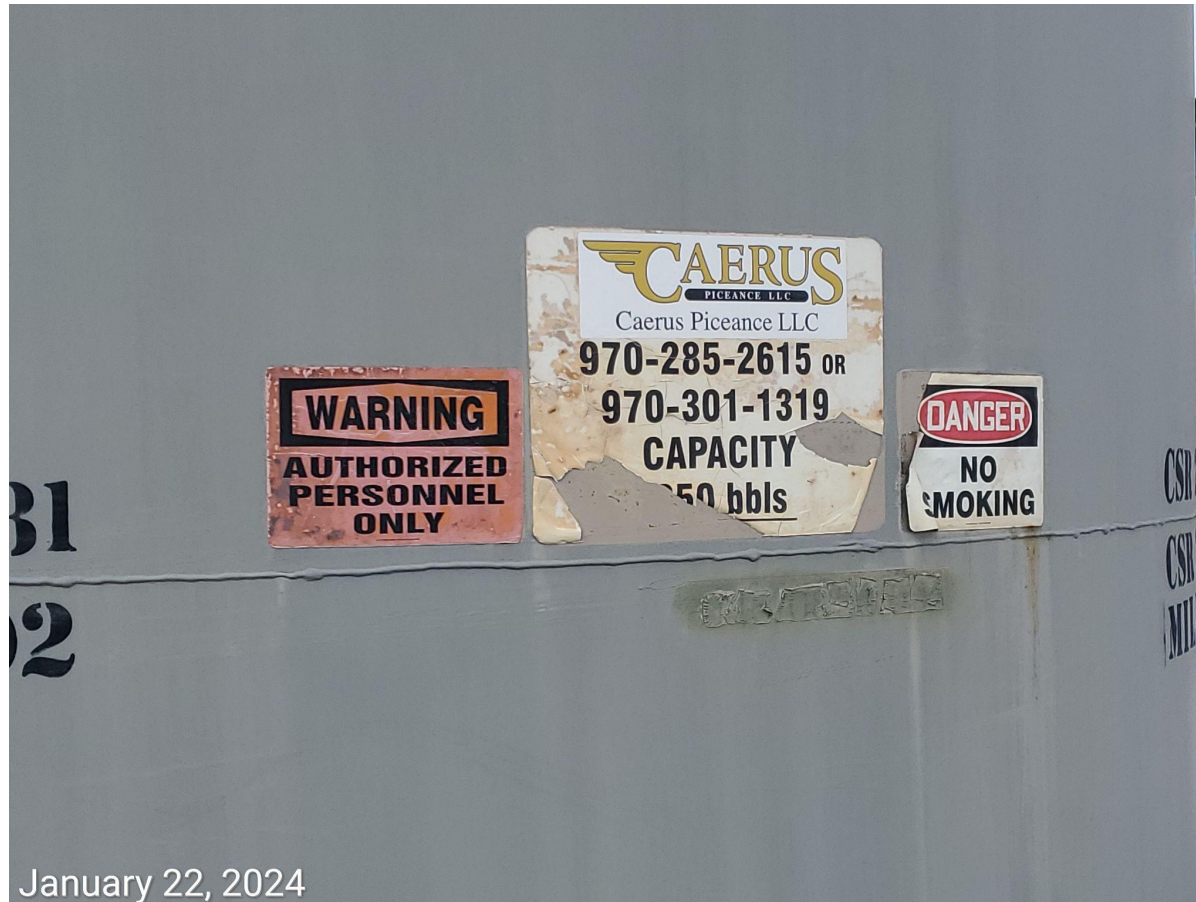
**Photo 6:** Capacity information at tank no longer legible.
