# Inspection Photos

**Operator:** CAERUS PICEANCE LLC #10456

**Location ID:** 334642

**Inspection Doc:** 696205573

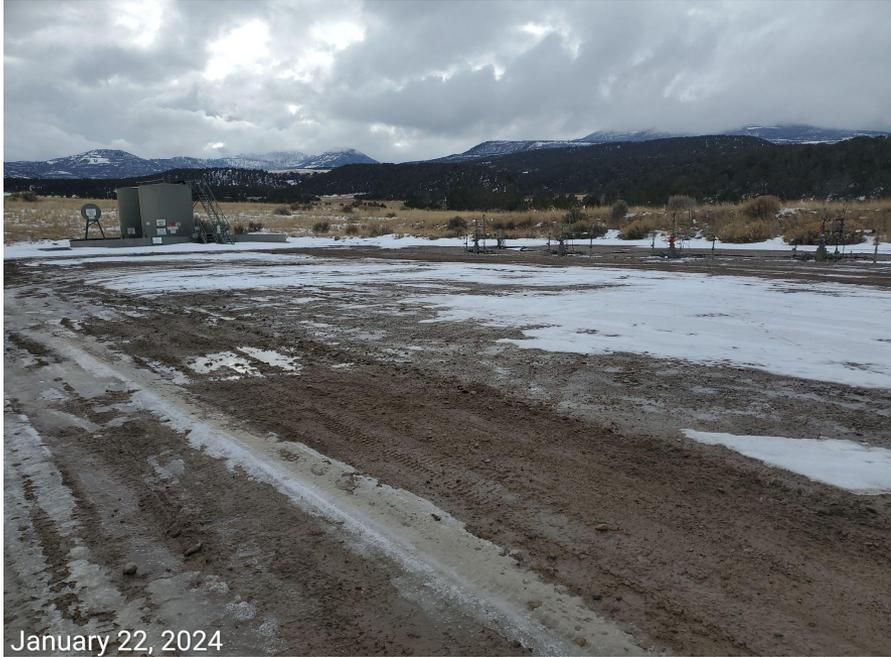
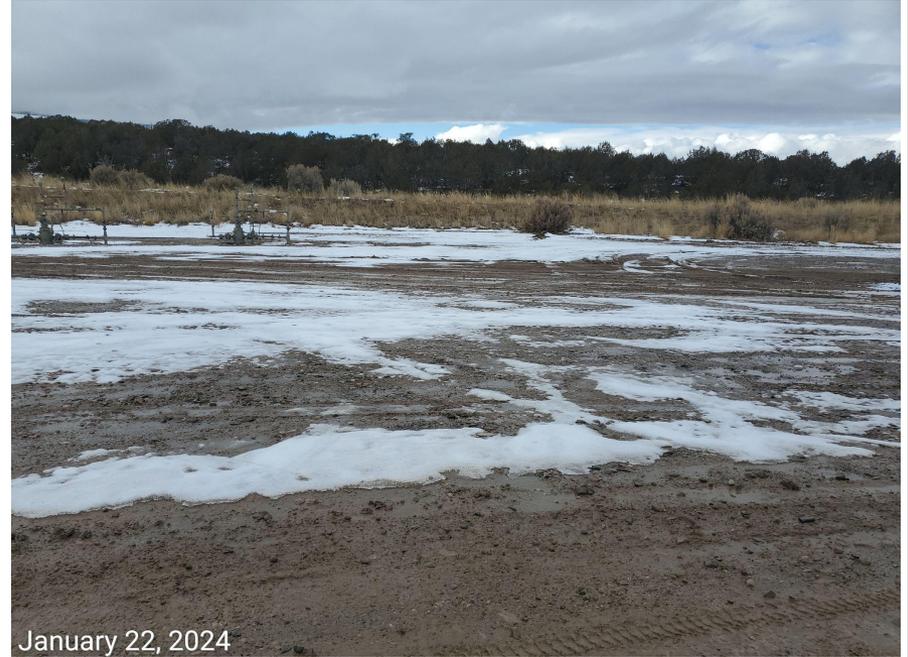
**Photo 1:** Photos 1-2 taken from the east end of the Location. Photos provide an overview of the Location from southwest to northwest..

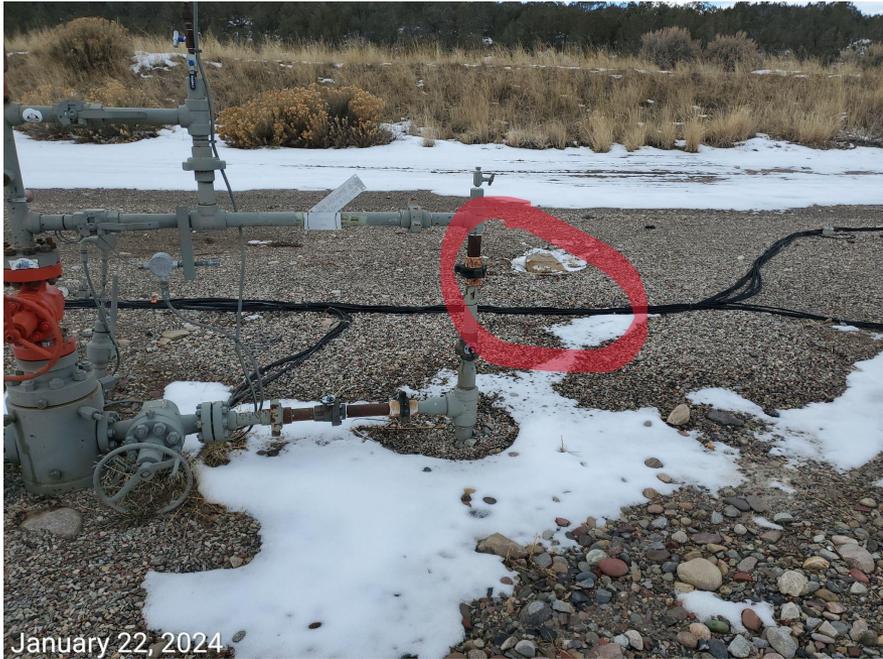
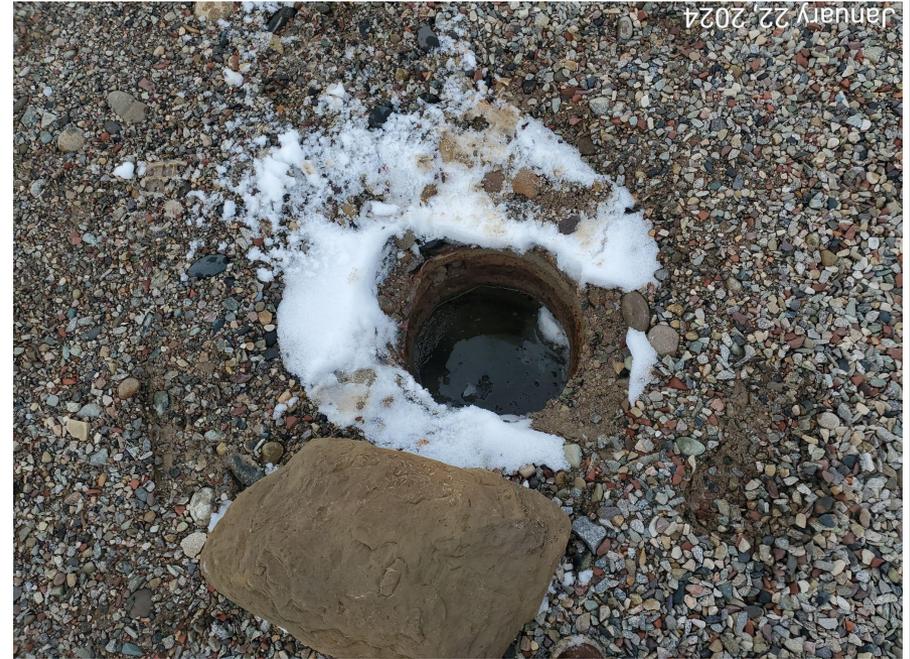
**Photo 2:** Mousehole used during drilling operations left on Location and covered with a rock; reclamation specialist replaced rock upon completion of inspection for safety purposes. Mousehole requires removal/backfilling

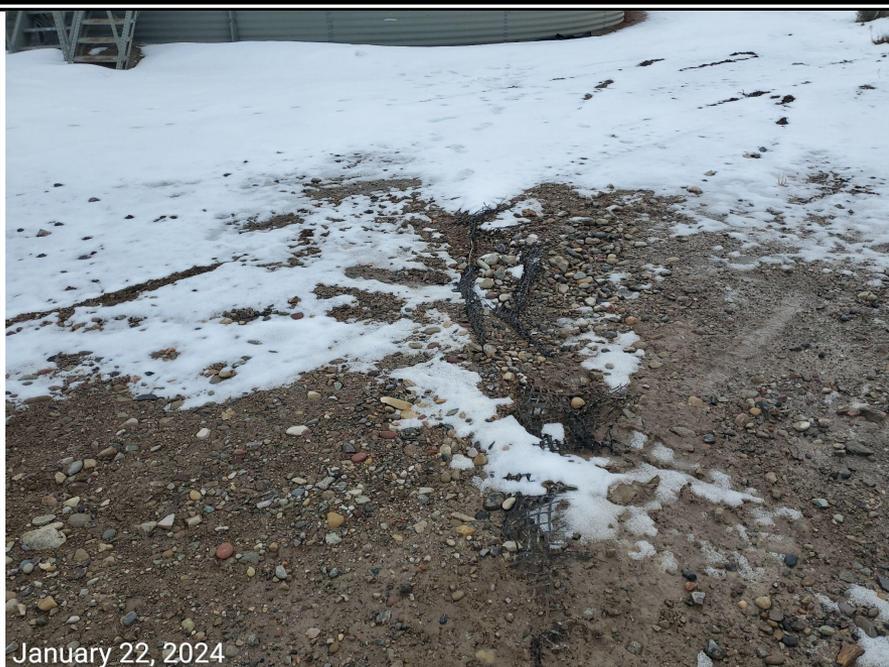
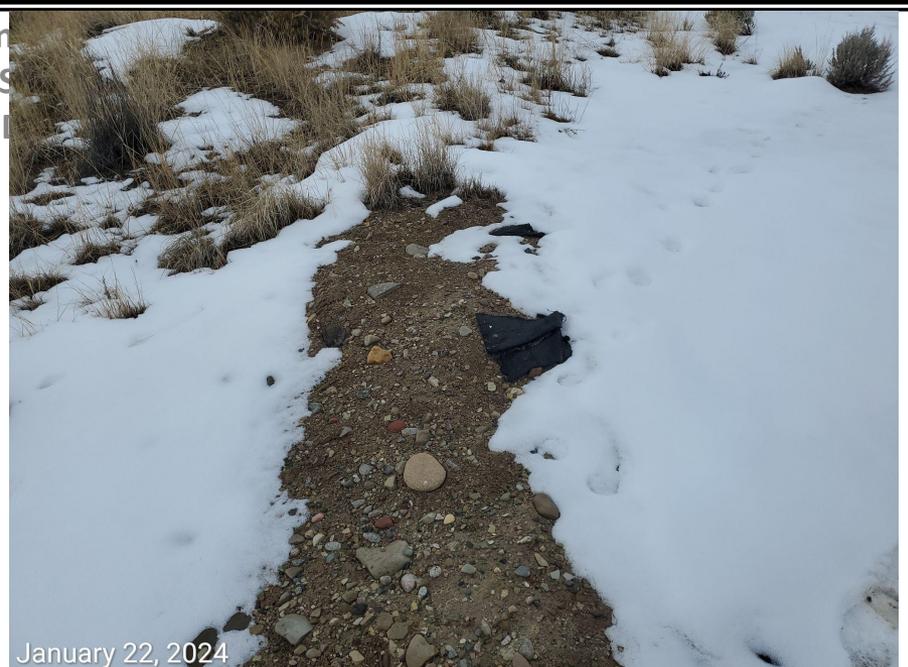
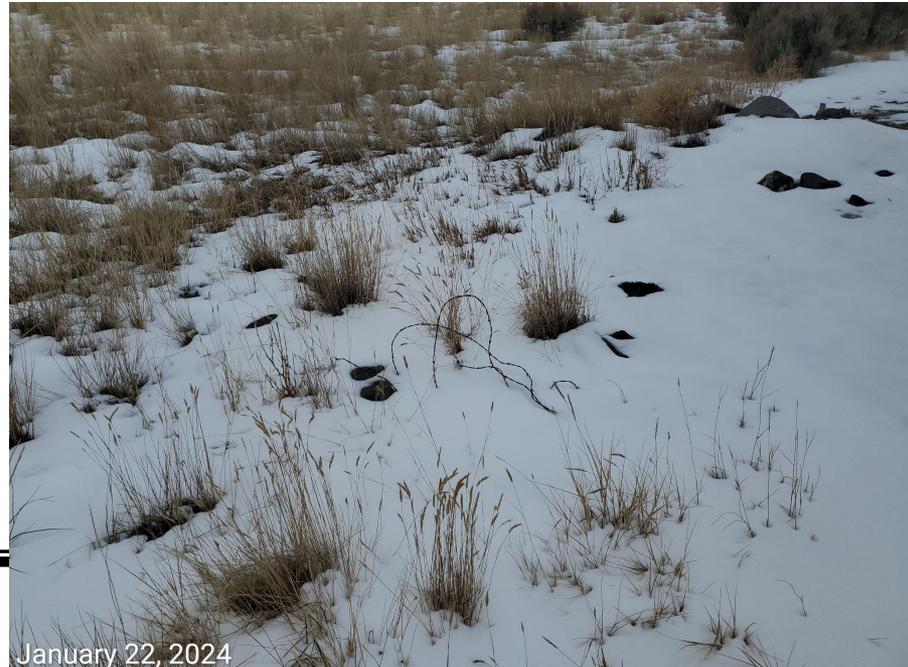
**Photo 3:** Photos examples showing various trash/debris observed on the Location.

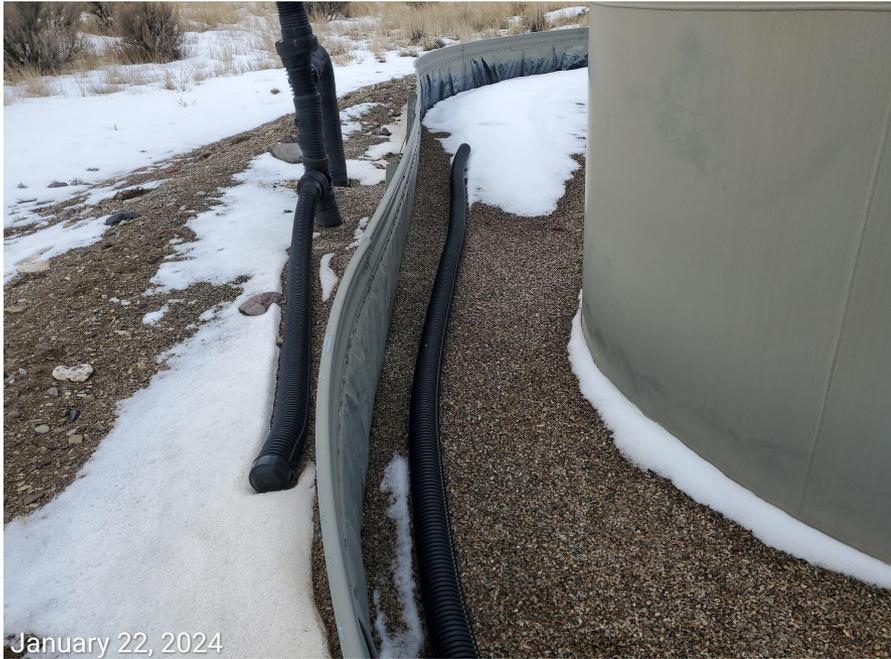
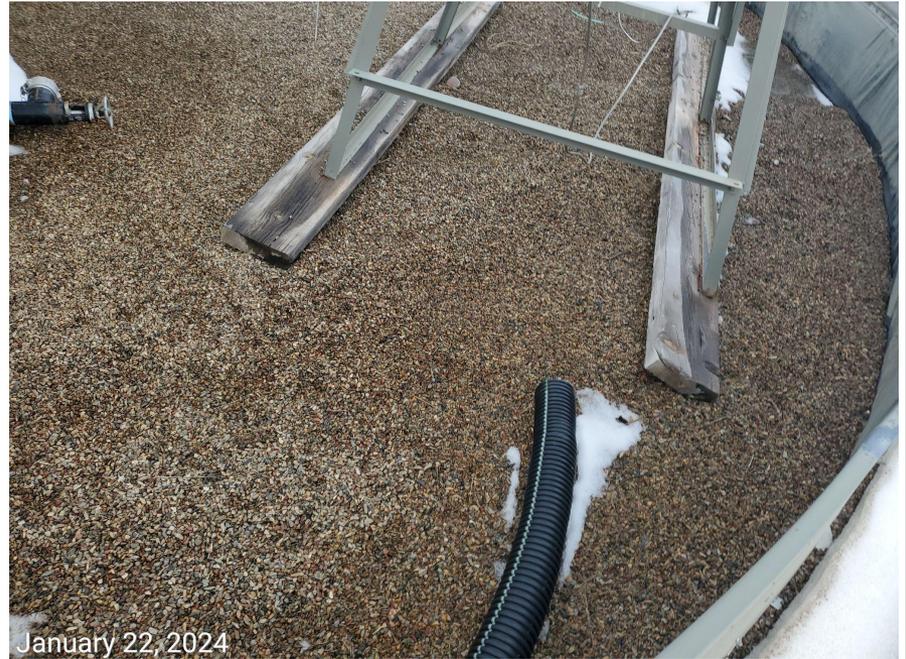
**Photo 3:** Unused pipe stored within the battery facility's containment BMP.
