Final Reclamation and Stormwater Inspection

Operator: Vista Operating Inc - 100128

Washington County, CO

Location Name: Scottie-Hickert 34-33

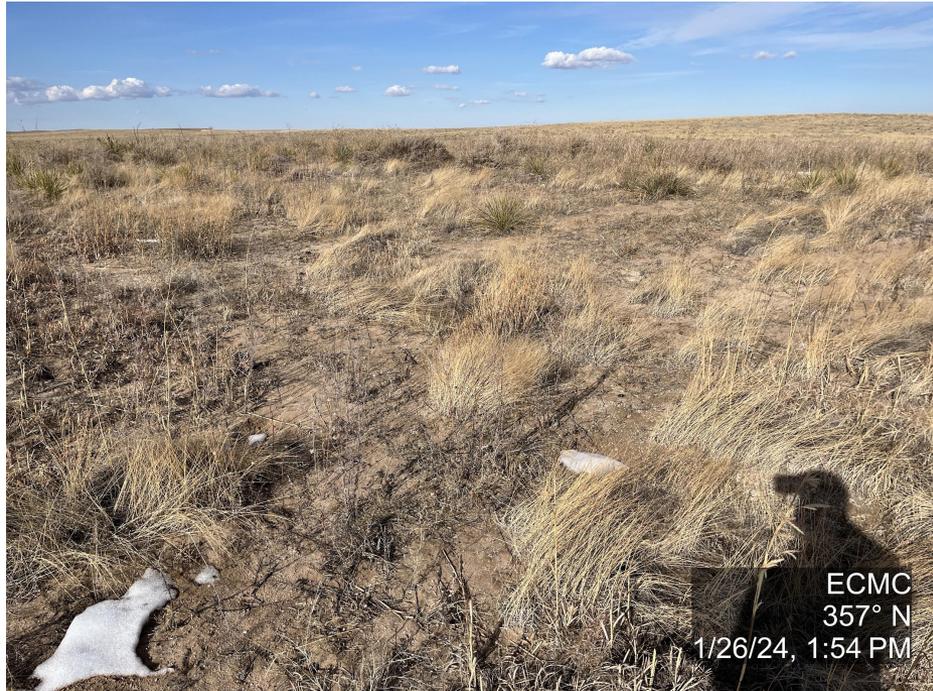
Photo 1. The photo was taken at the well location facing North. The photo illustrates the well location meets final reclamation standards.

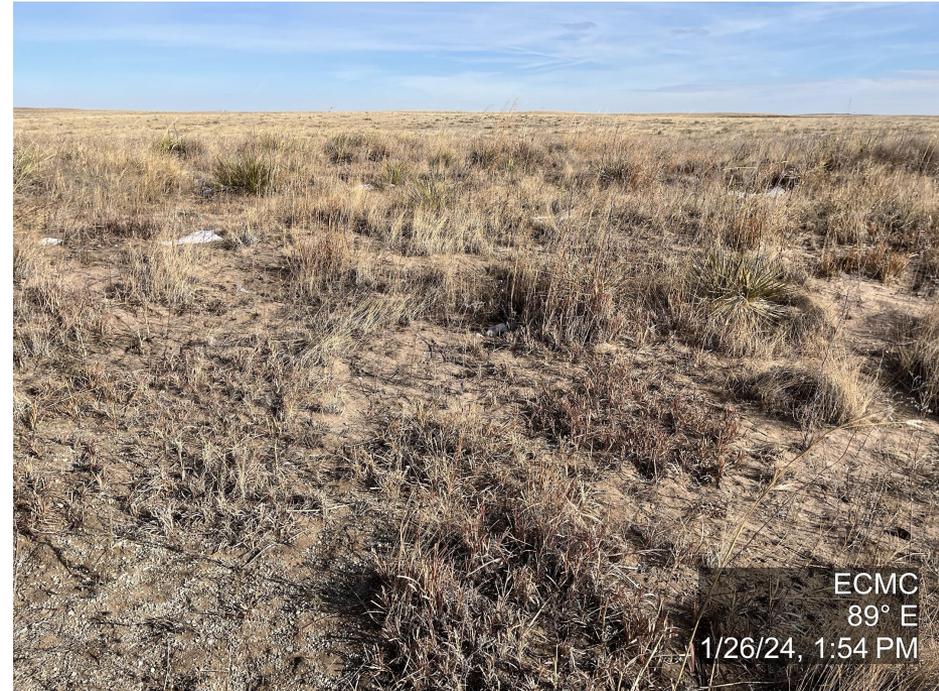
Photo 2. The photo was taken at the well location facing East. Refer to the comment for photo 1.

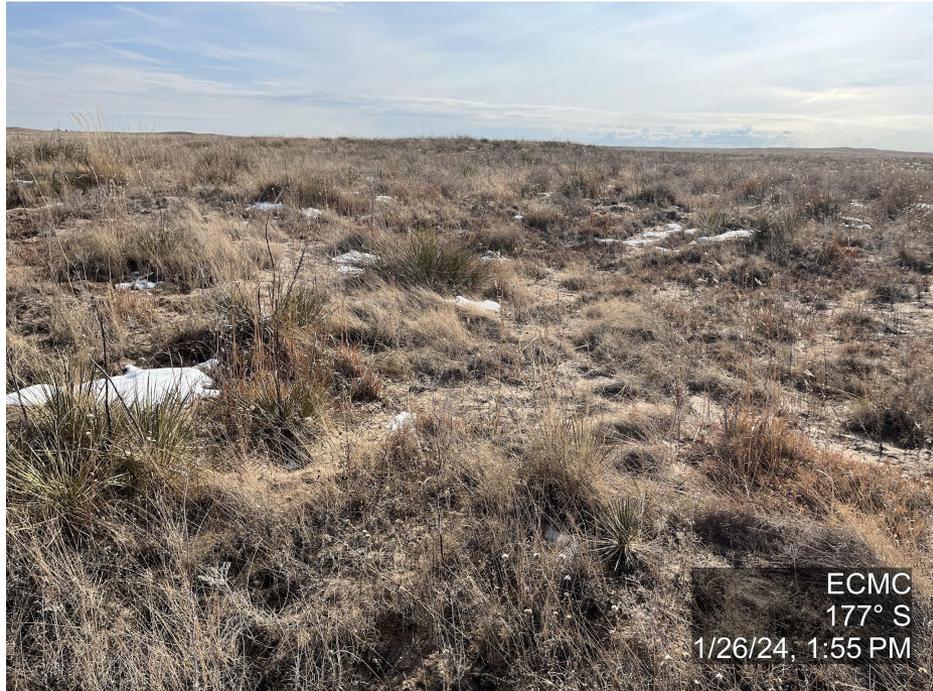
Photo 3. The photo was taken at the well location facing South. Refer to the comment for photo 1.

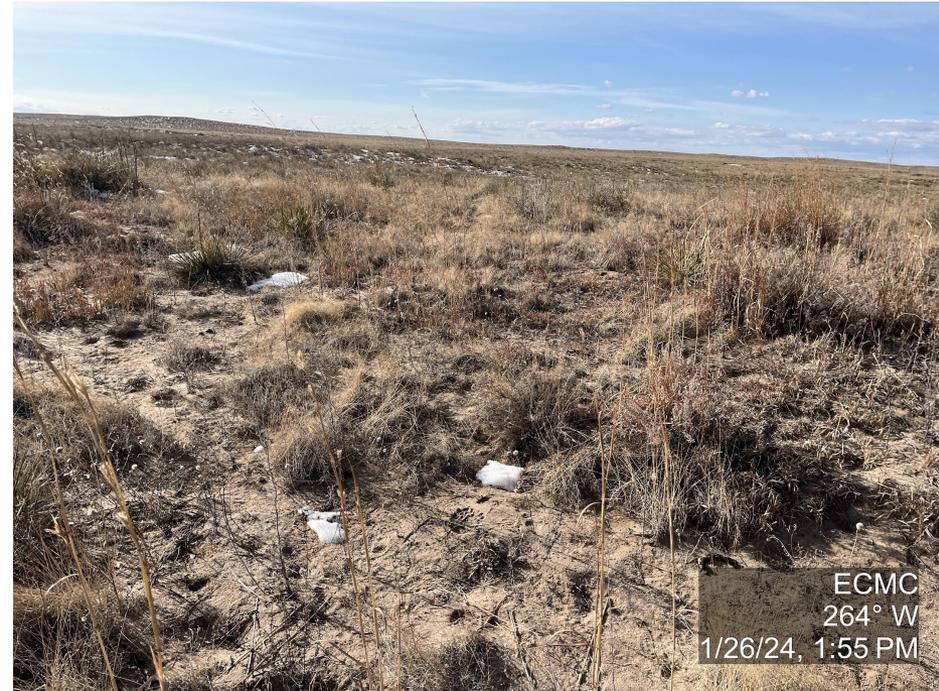
Photo 4. The photo was taken at the well location facing West. Refer to the comment for photo 1.

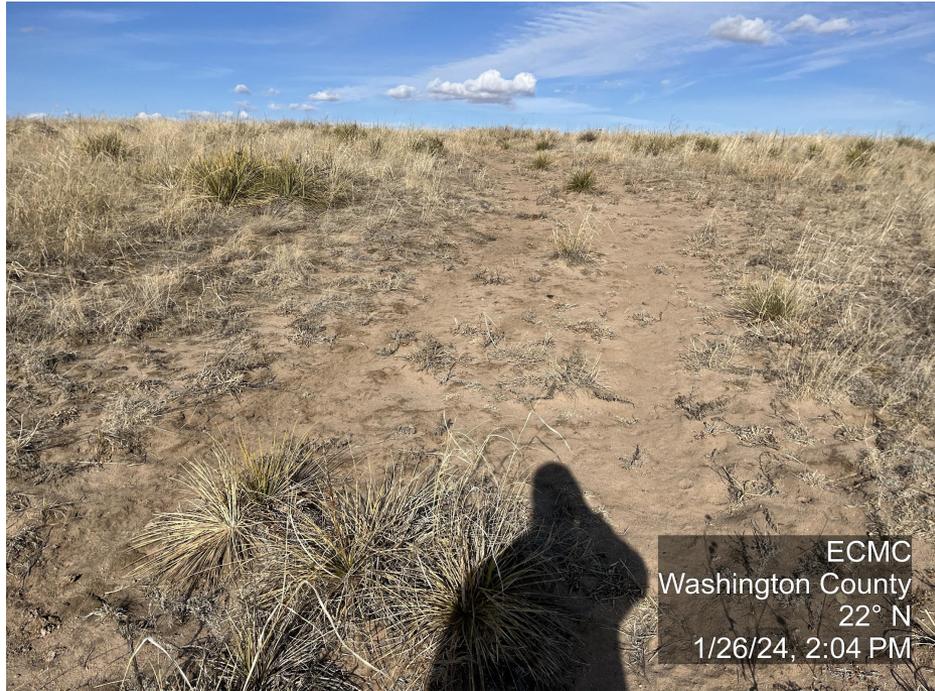
Photo 5. The photo was taken at the well location facing North. The photo illustrates a point along the access road that is not vegetated that demonstrates several areas on the access road do not meet reclamation standards.

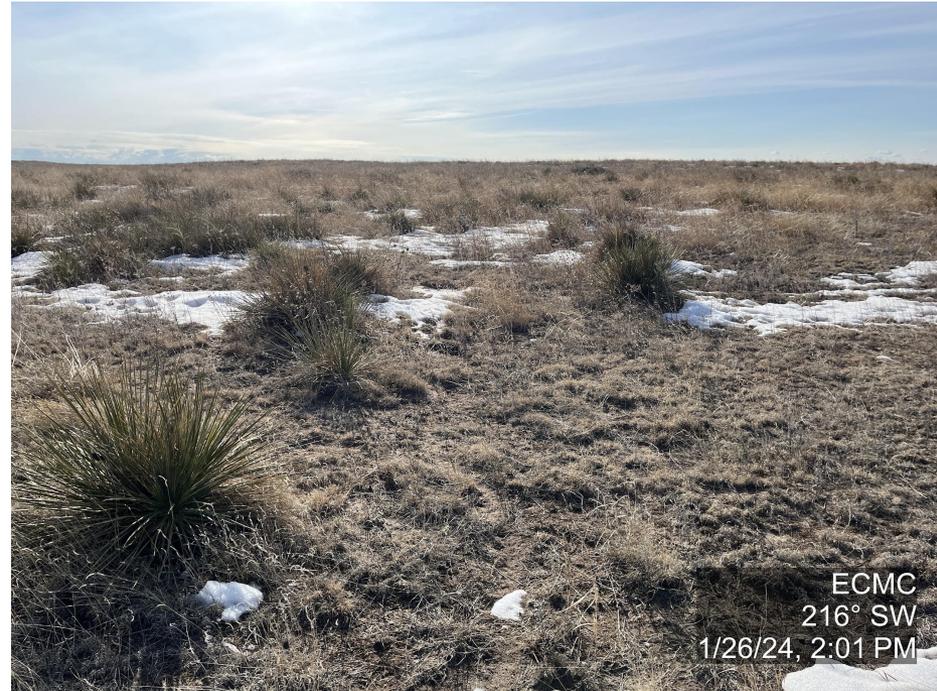
Photo 6. The reference photo was taken near the well location facing Southwest.

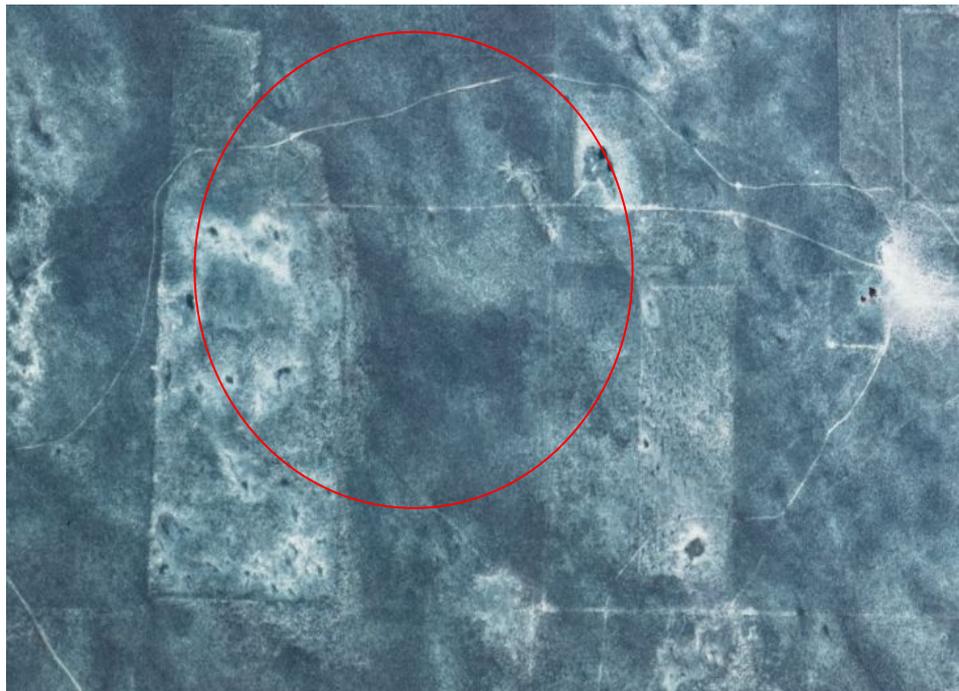
Photo 7. The photo is USGS imagery from 09/02/1980. The photo illustrates there were no access roads prior to O&G activities where Well API #121-10874 and #121-10873 were spud.

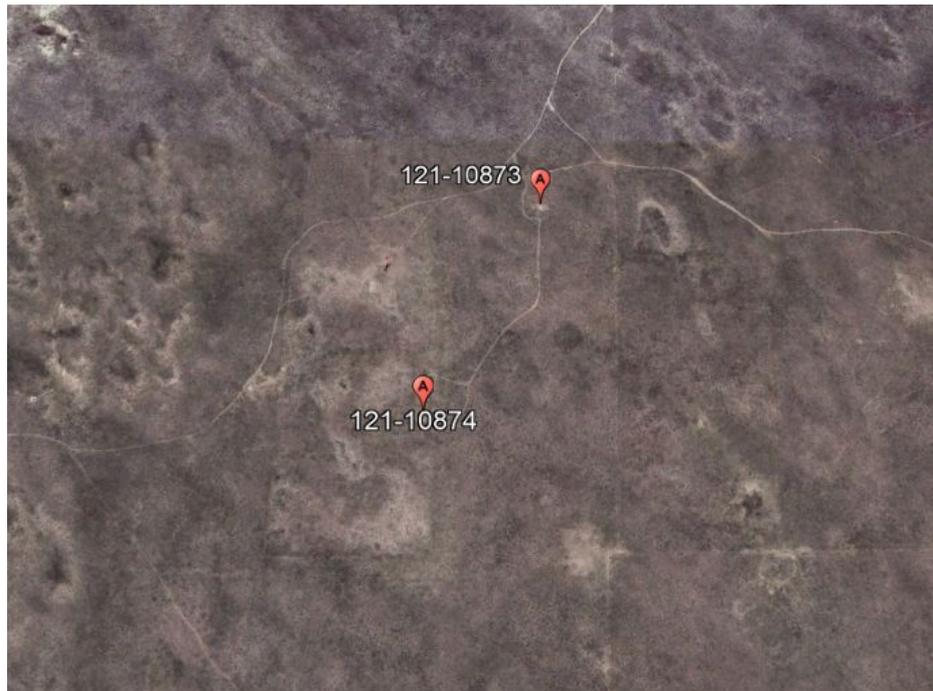
Photo 8. The photo is from Google Earth imagery from September of 2023 and illustrates the access roads still visible between the two wells.
