# Inspection Photos

Loc: 381172

Operator: CITATION OIL & GAS CORP

Inspection Date: 2/7/2024

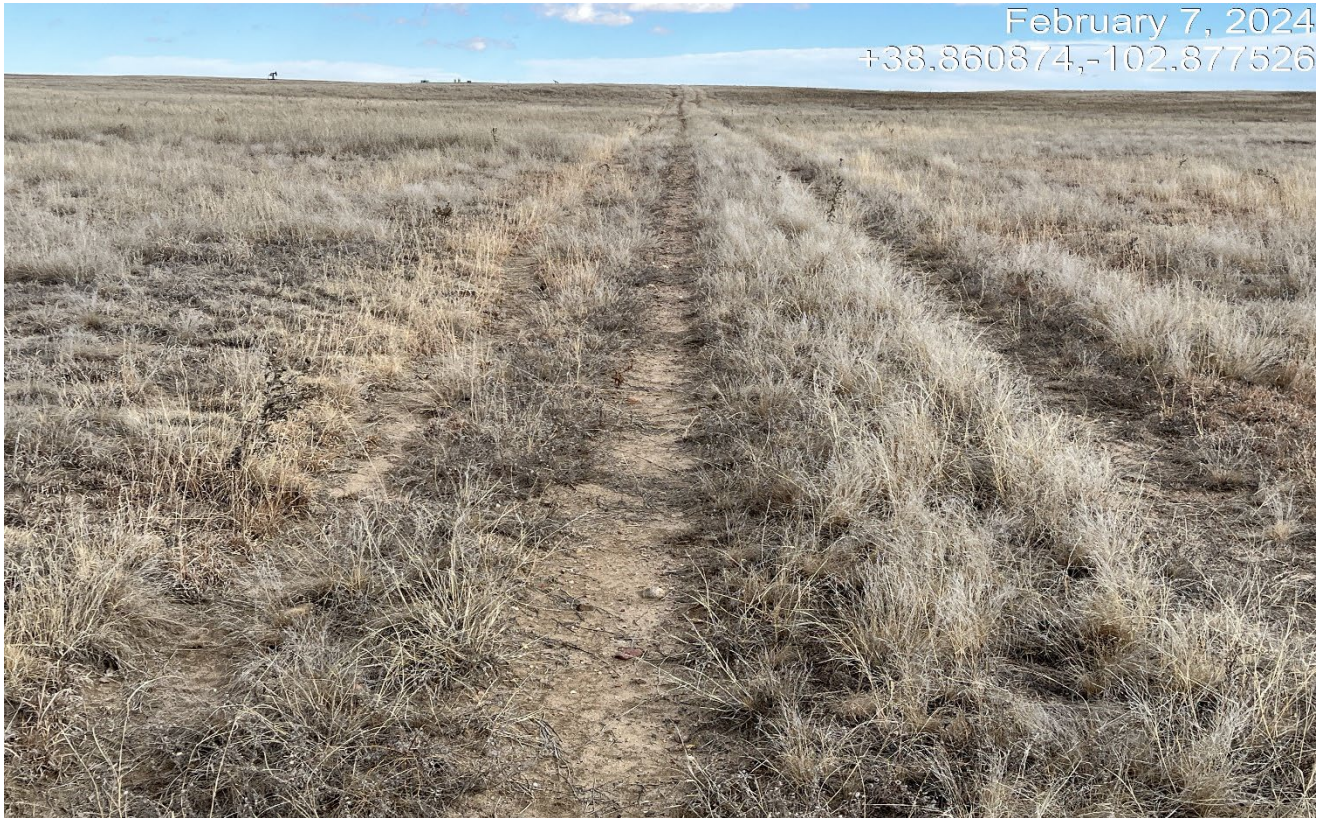
**Photo 1.** Facing northeast along the two track access road. Ripping of the along the two track should be performed to all revegetation to occur.

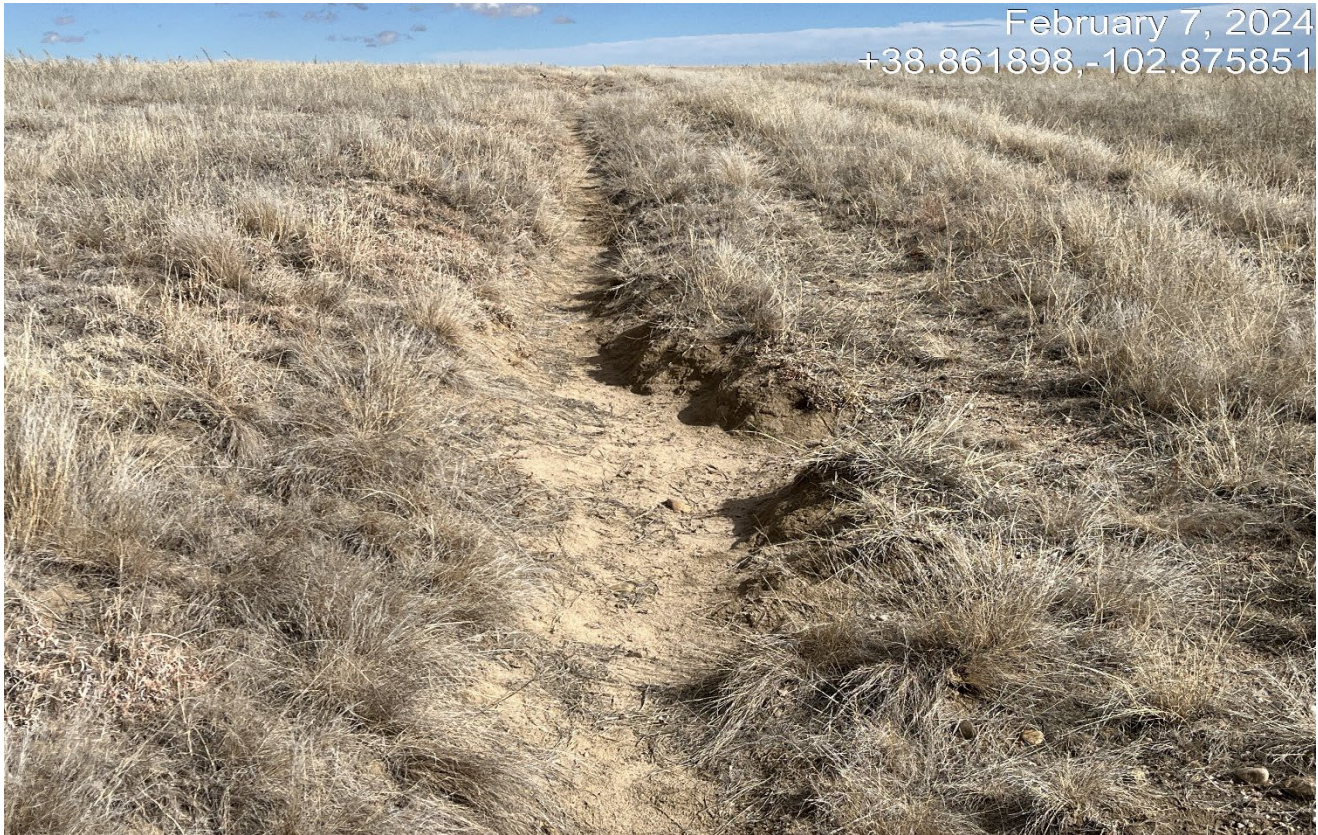
**Photo 2.** There is an erosion channel along the road closer to the location that needs to be repaired.

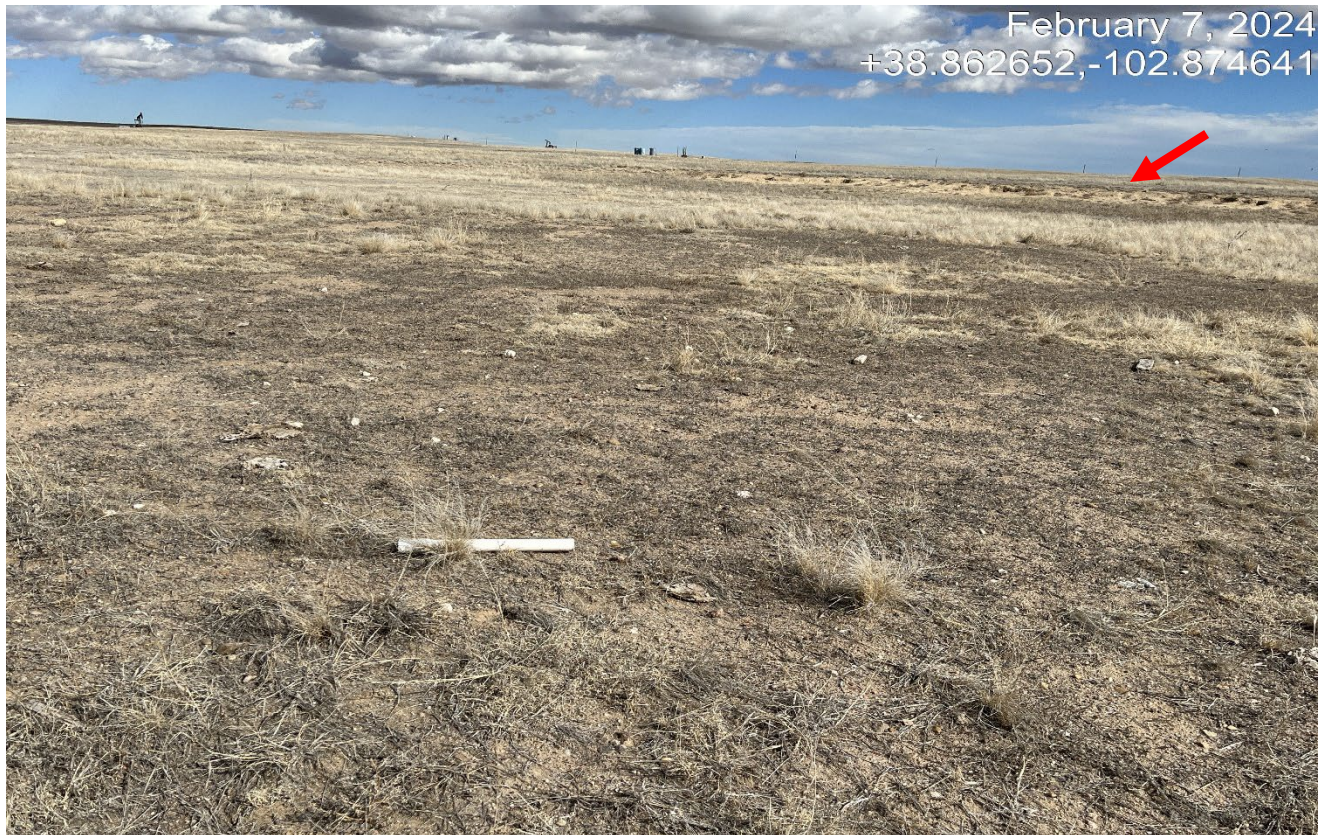
**Photo 3.** Facing northeast at the location. This area has not been reclaimed and perennial vegetation has not established. The cut slope can be seen at the red arrow.

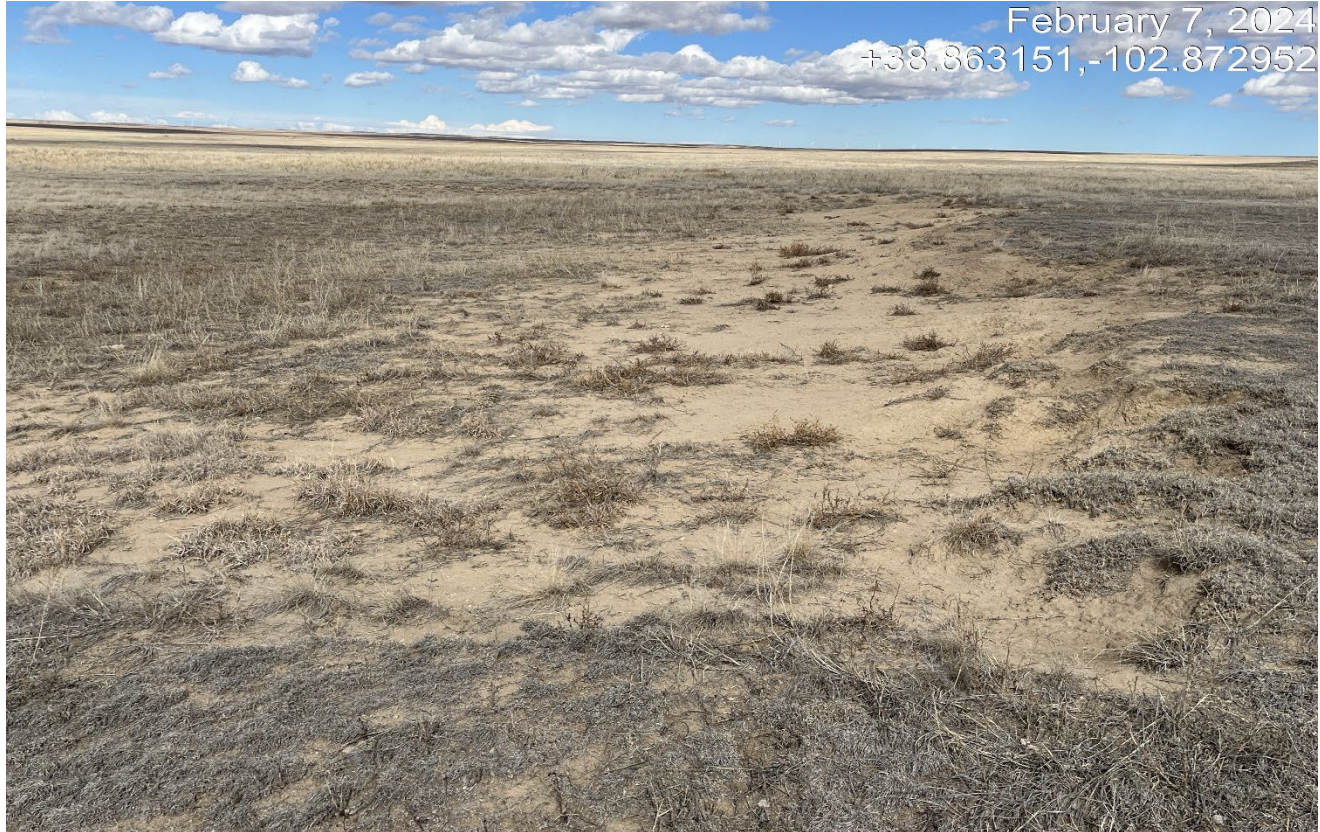
**Photo 4.** Facing north along the cut slope which is eroded and has not been regraded back to approximate grade..

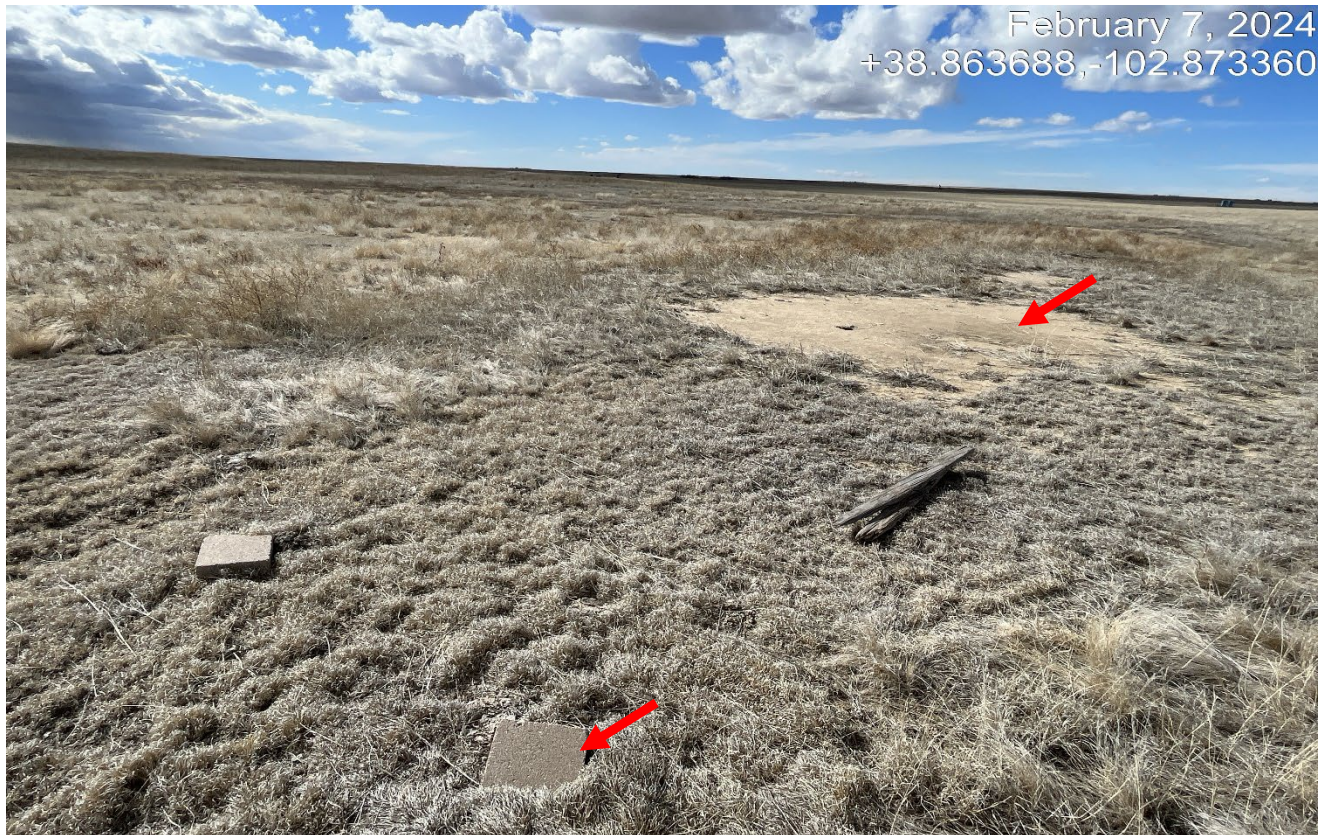
**Photo 5.** North side of the location facing southwest. There is some cement block debris and a bare area shown at red arrows.

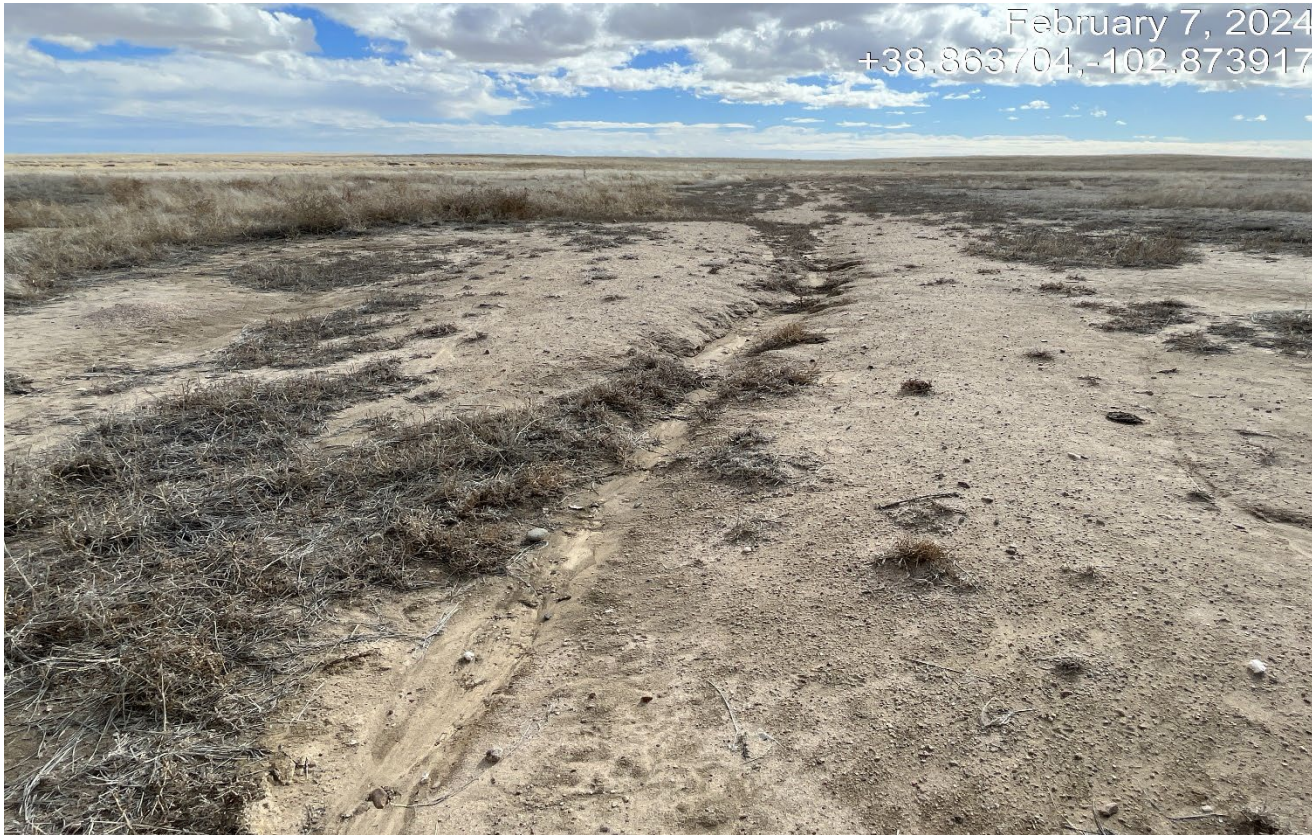
**Photo 6.** Northwest side of the location facing southeast. There is an erosion channel along this area and soils are bare of vegetation.

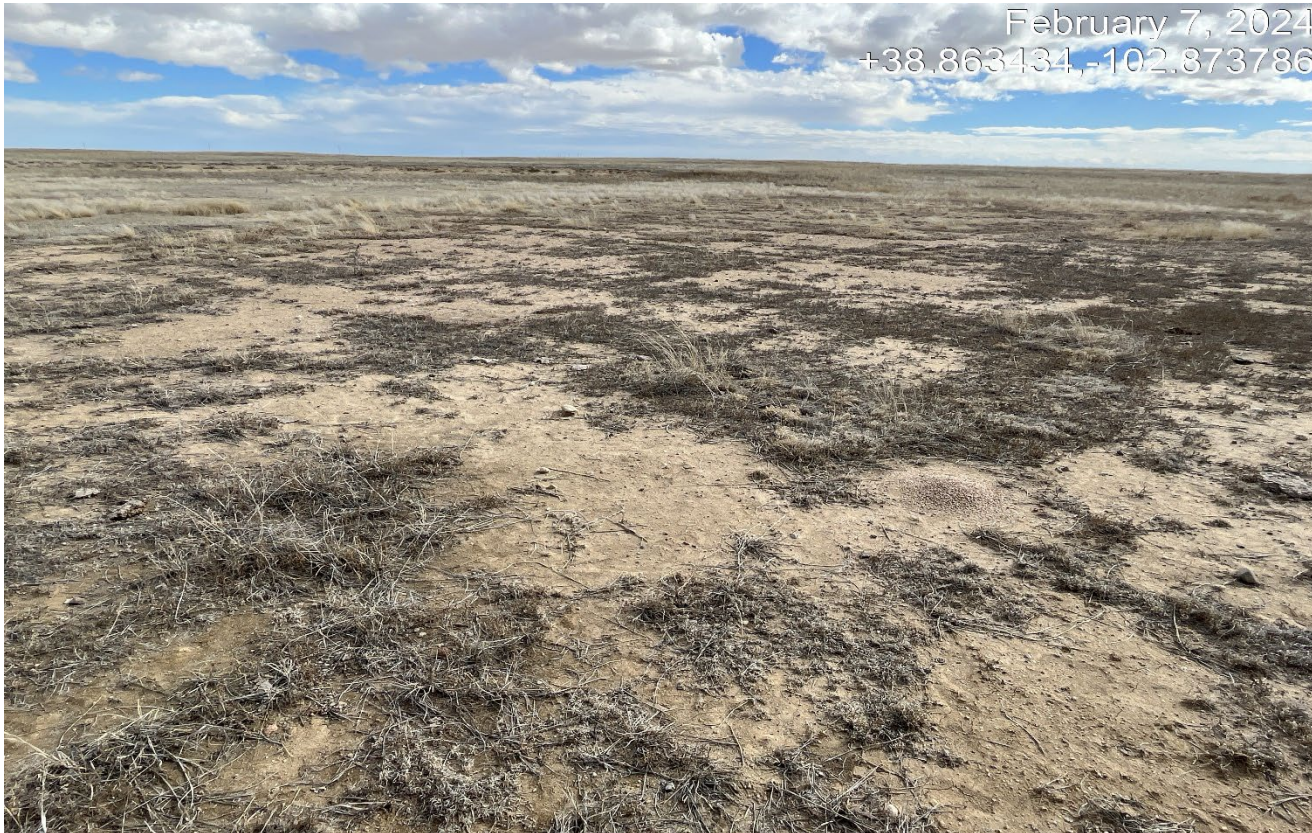
**Photo 7.** Facing east at the location. The location has not been reclaimed and perennial vegetation has not established.

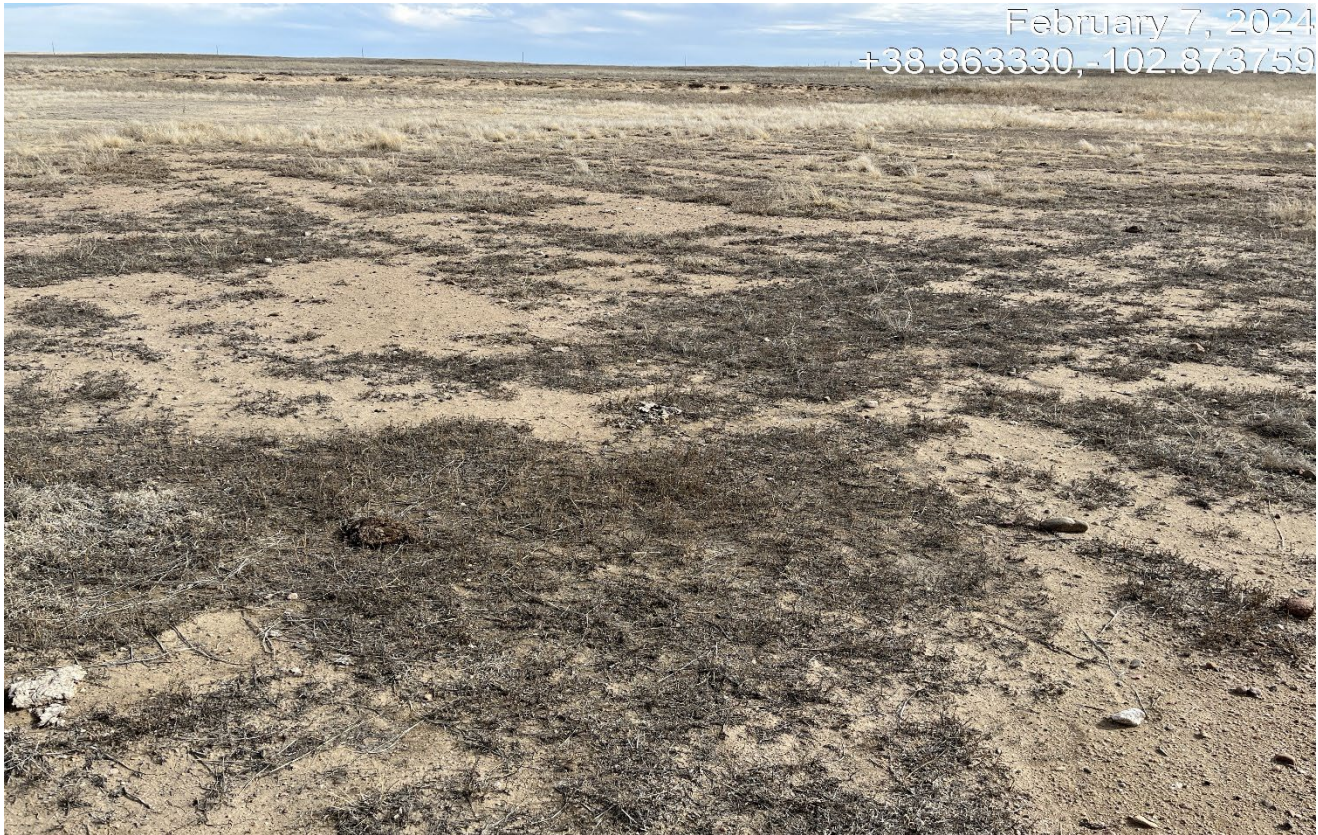
**Photo 8.** Facing east at the location. The location has not been reclaimed and perennial vegetation has not established.
