Inspection Photos

Loc: 309618

Operator: KTM OPERATING LLC

Inspection Date: 2/13/2024

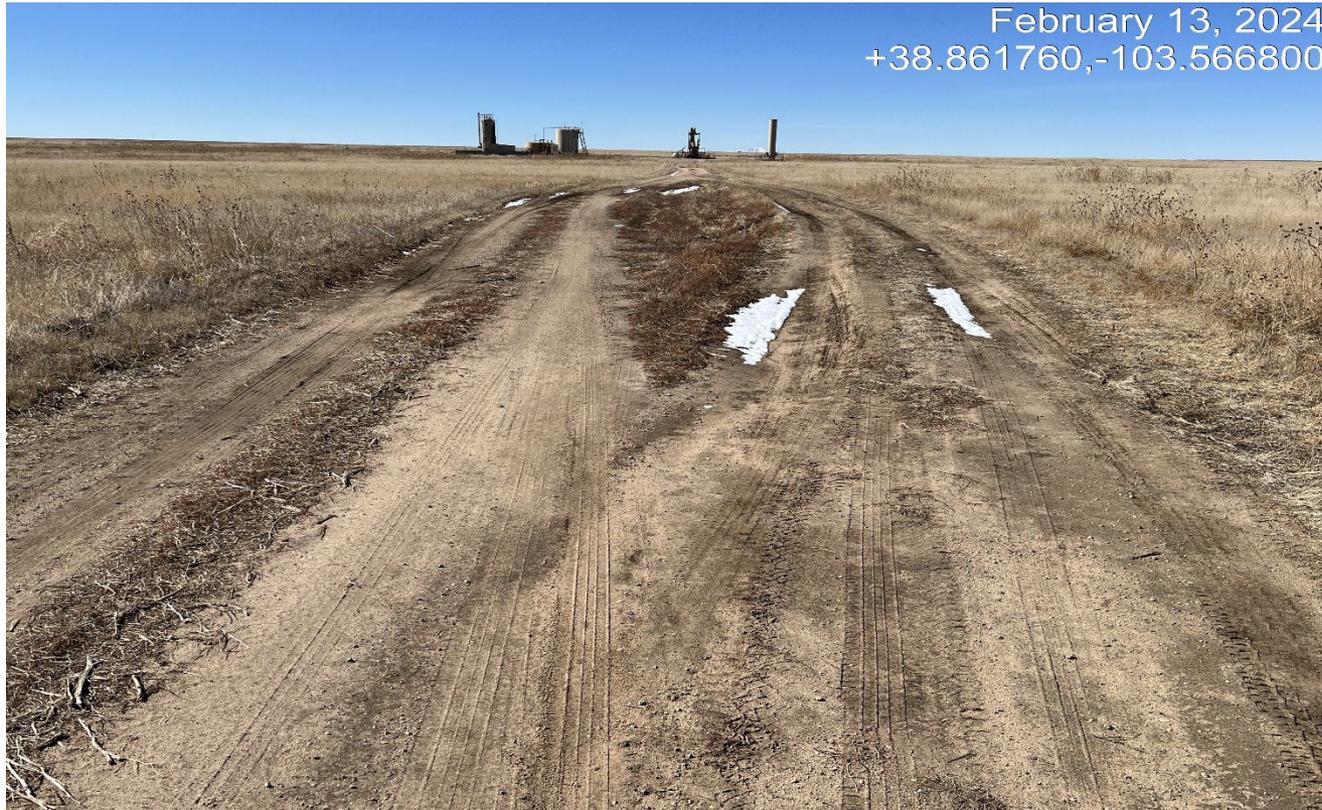
Photo 1. Facing west along the access road. Vehicles have widened the road at this area causing unnecessary disturbance to to lack of maintenance of the road. The road will need to be repaired and disturbance must be reclaimed..

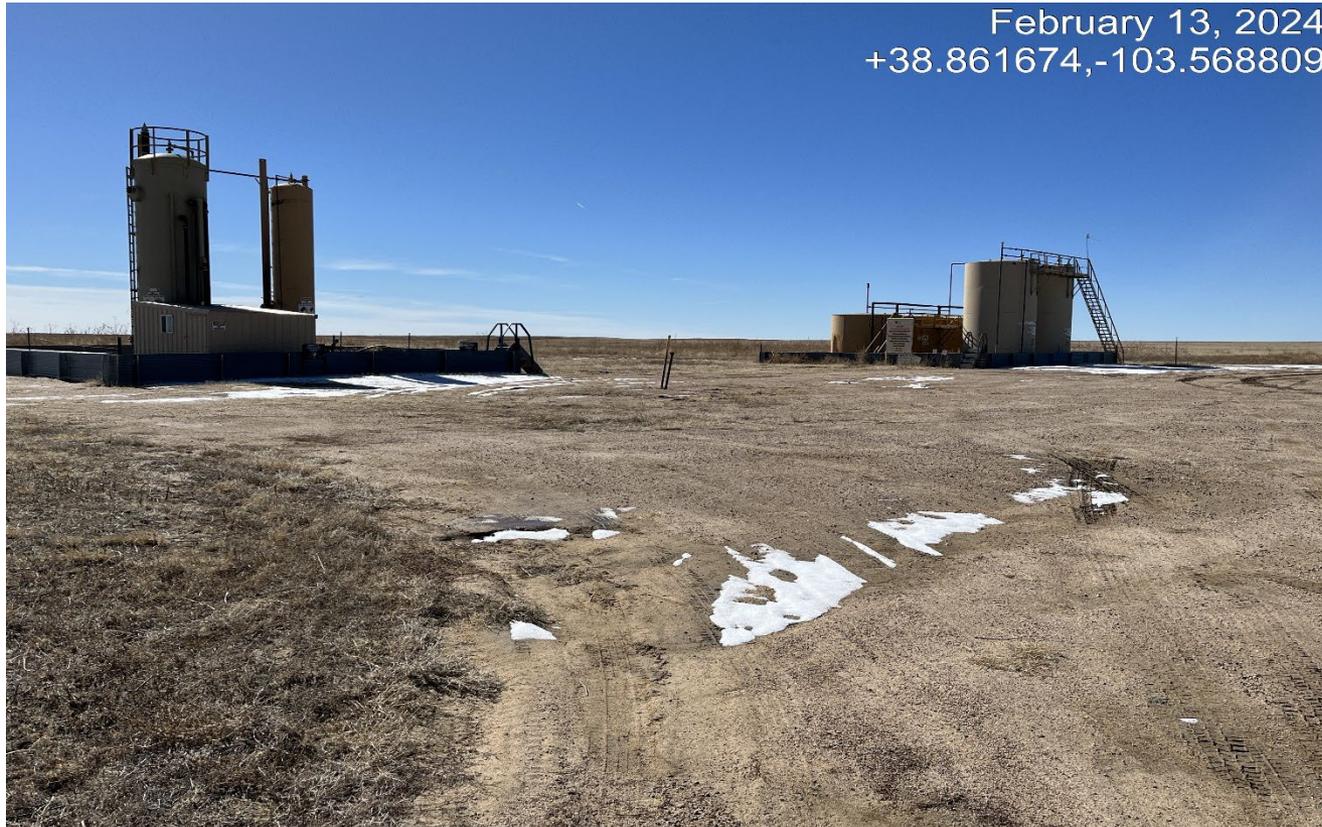
Photo 2. Facing southwest toward the onsite tank battery and vertical treaters.

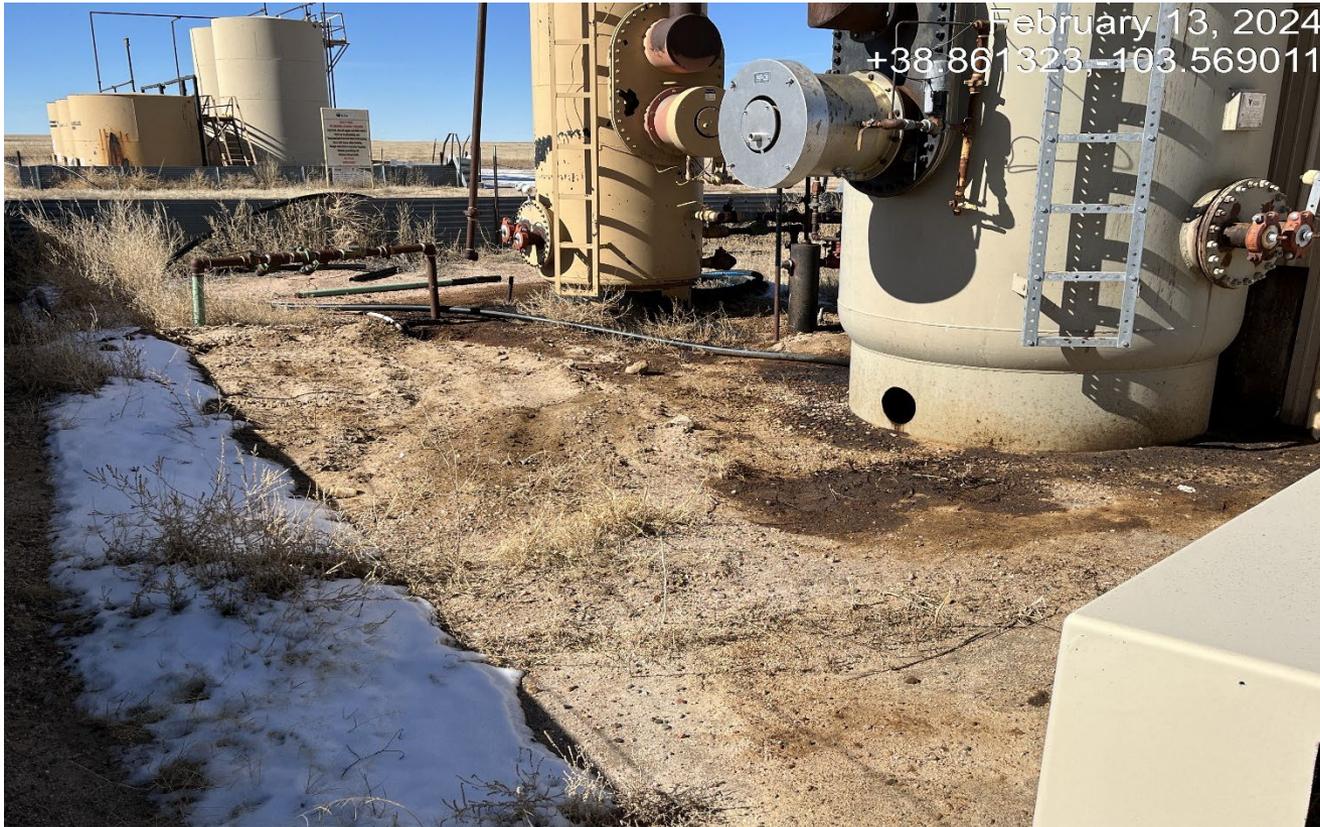
Photo 3. Facing toward the backside of the treater. There has been oil leaked out onto the ground that must be cleaned up.

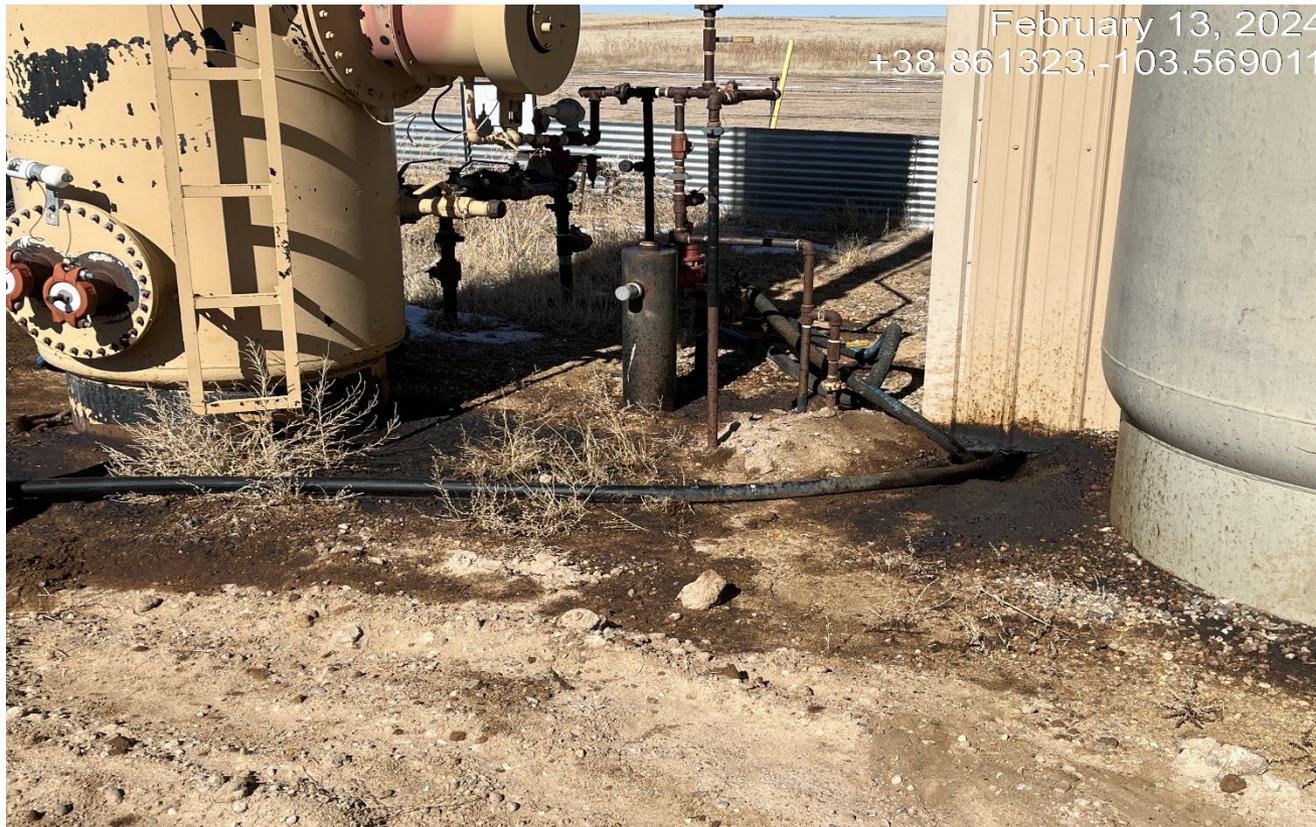
Photo 4. There are oil saturated soils around the treater that us be cleaned up.

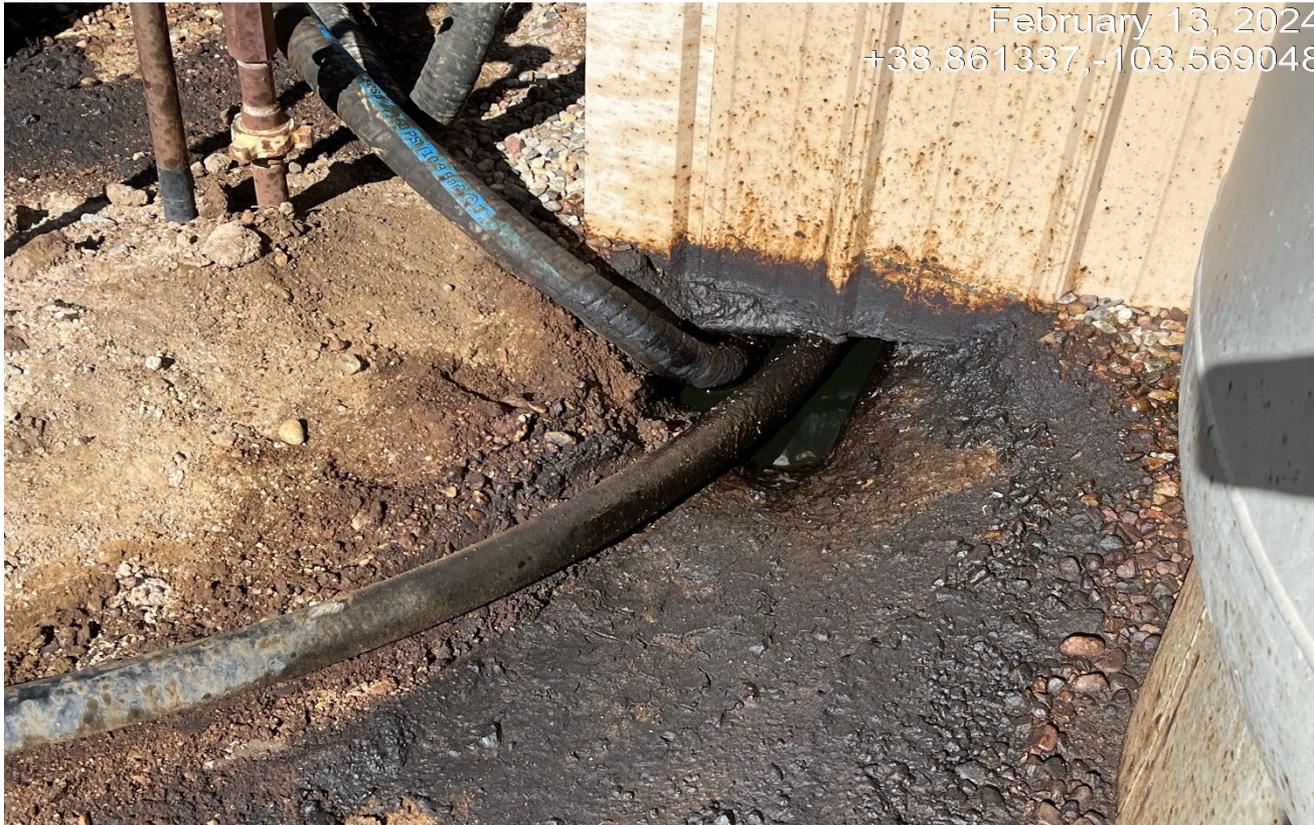
Photo 5. There is oil puddled up where the hoses go into the shed which indicates saturated soils and unknown amount of spill volume.

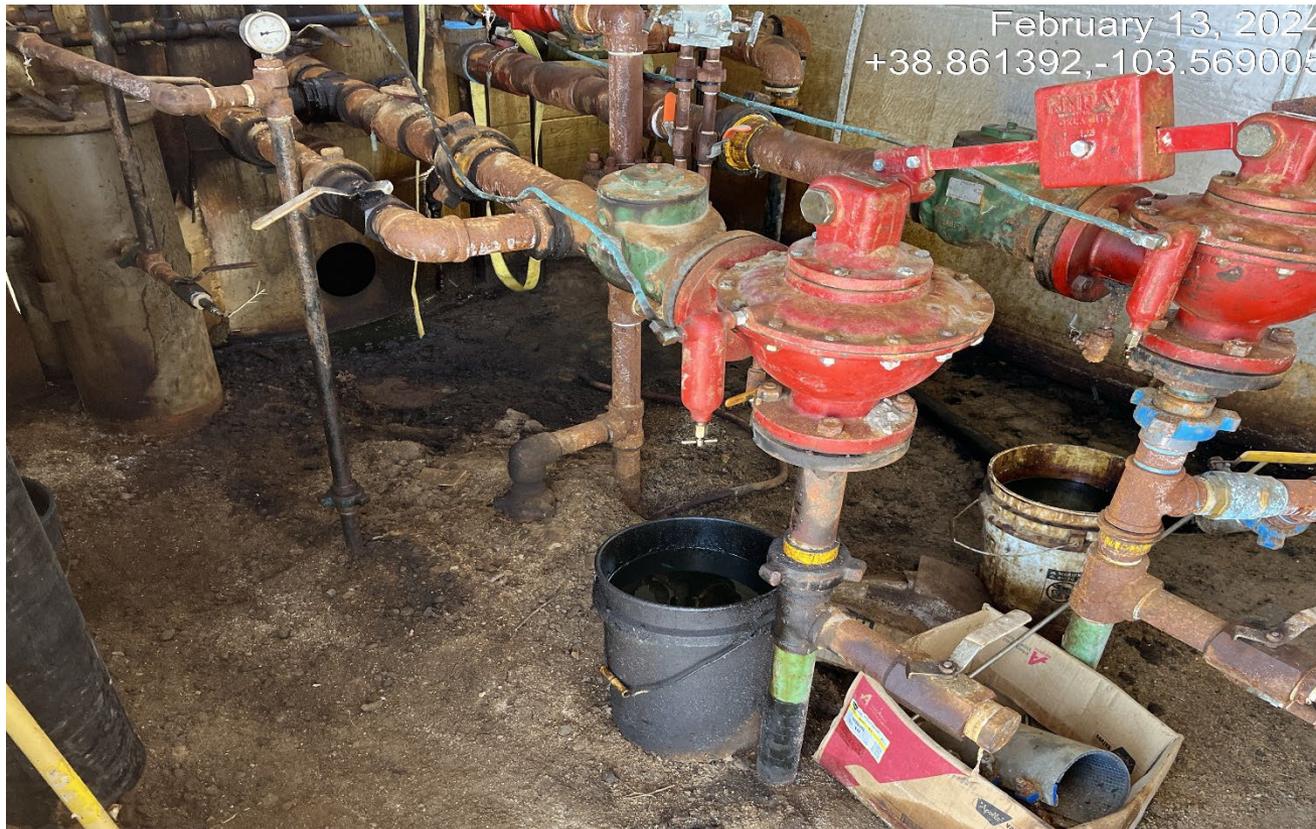
Photo 6. Inside the shed next to the treater. There is oil saturated soils inside the shed. There are full buckets of oil that appear to be collecting oil from leaking pipes.

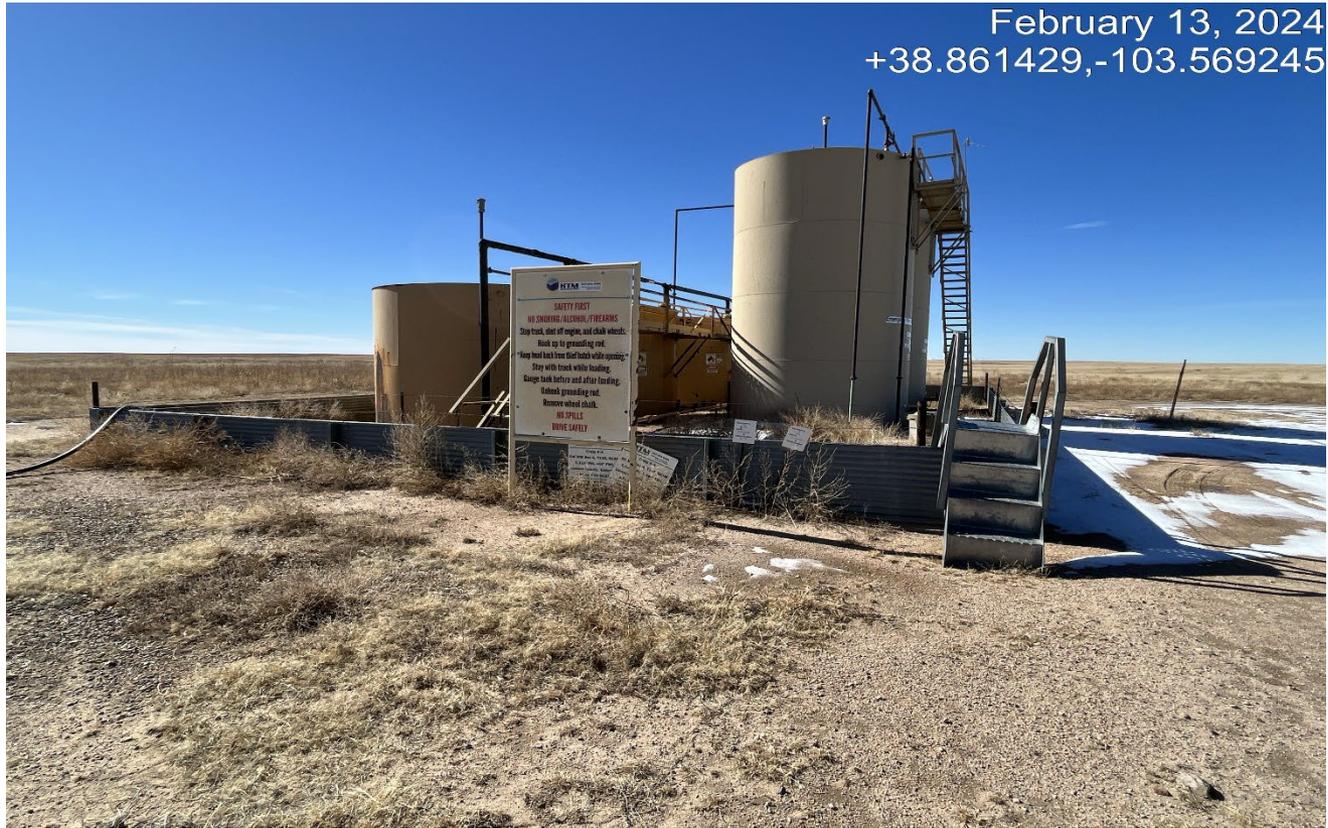
Photo 7. Facing toward the tank battery at the southwest side. There is some weed debris inside the containment that needs to be removed.

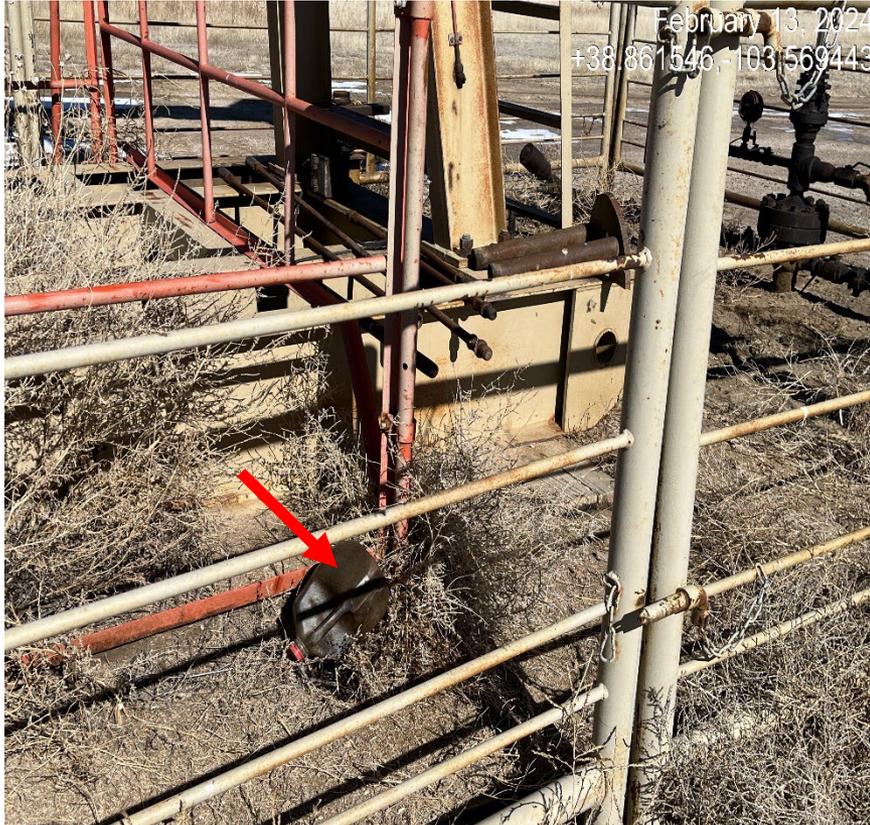
Photo 8. There is an oil filled milk jug that has tipped over and leaked oil onto the ground.

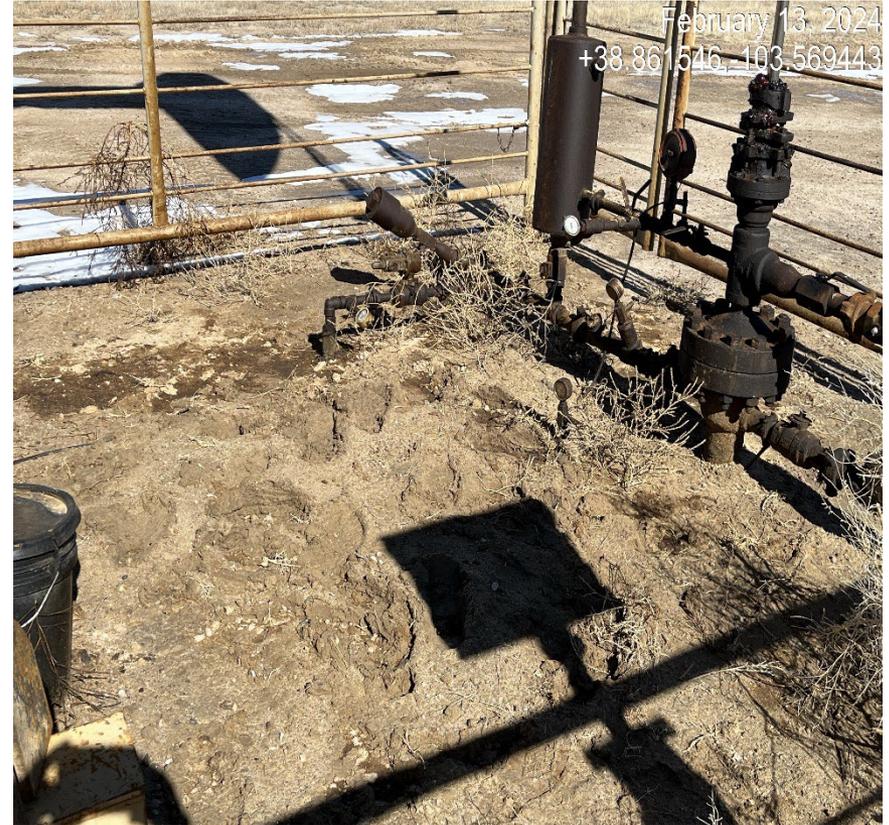
Photo 9. There is oily soils around the wellhead that need to be cleaned up.
