Final Reclamation Inspection

Operator: TIGGES OIL LLC - #88265

Location ID: 319016

Inspection Photos
Location Name: HARRINGTON 1-30
Location ID: 319016

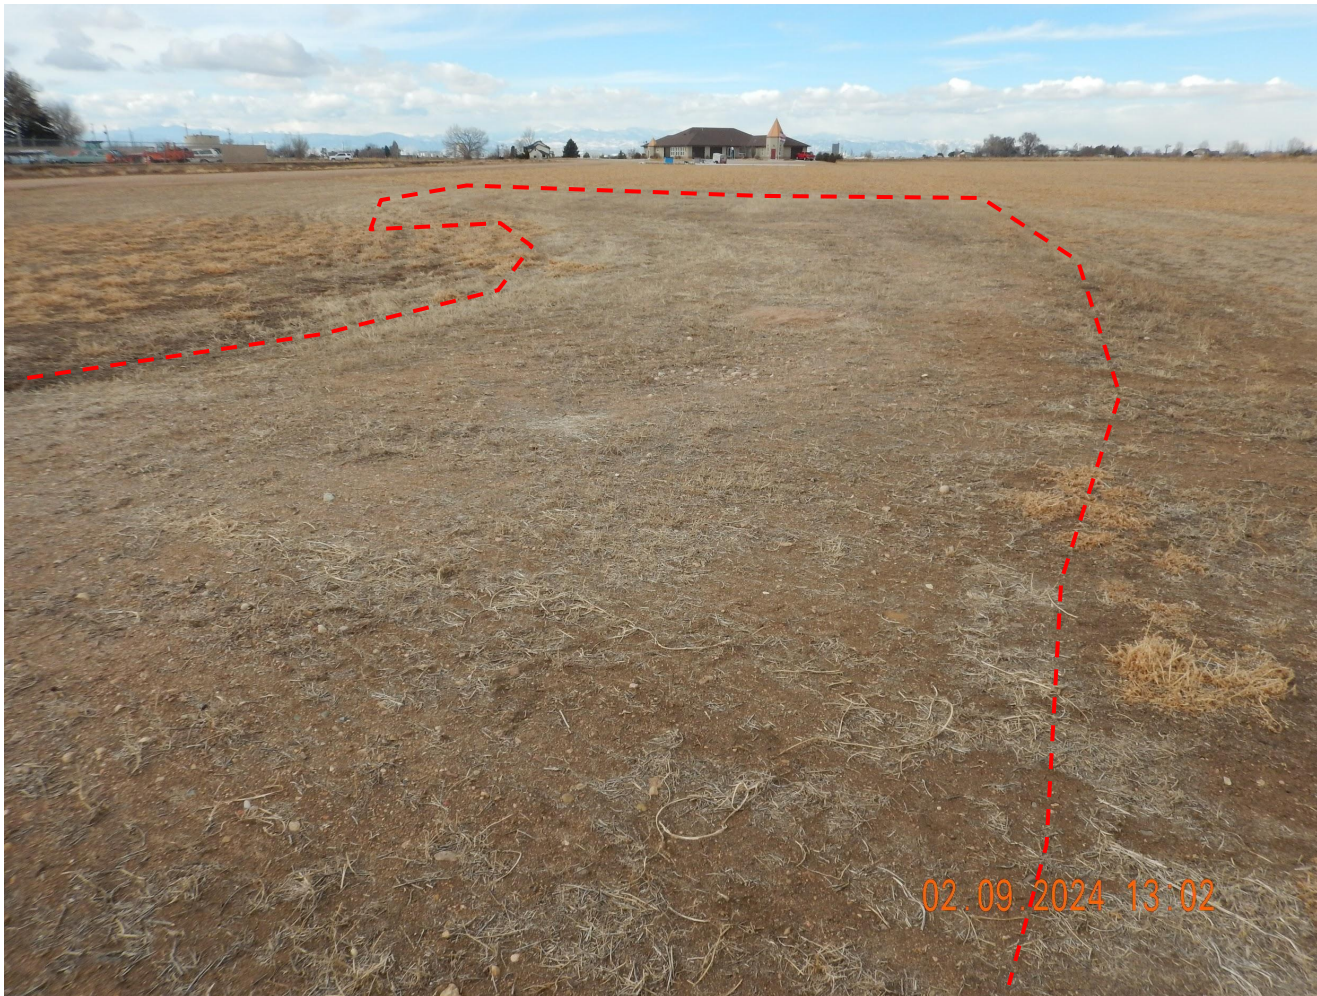
Photo 1. Photo taken from the eastern well location, facing West. Photo illustrates gravel remains, well location has not been contoured and there is no crop growth. Reference area crop is alfalfa.

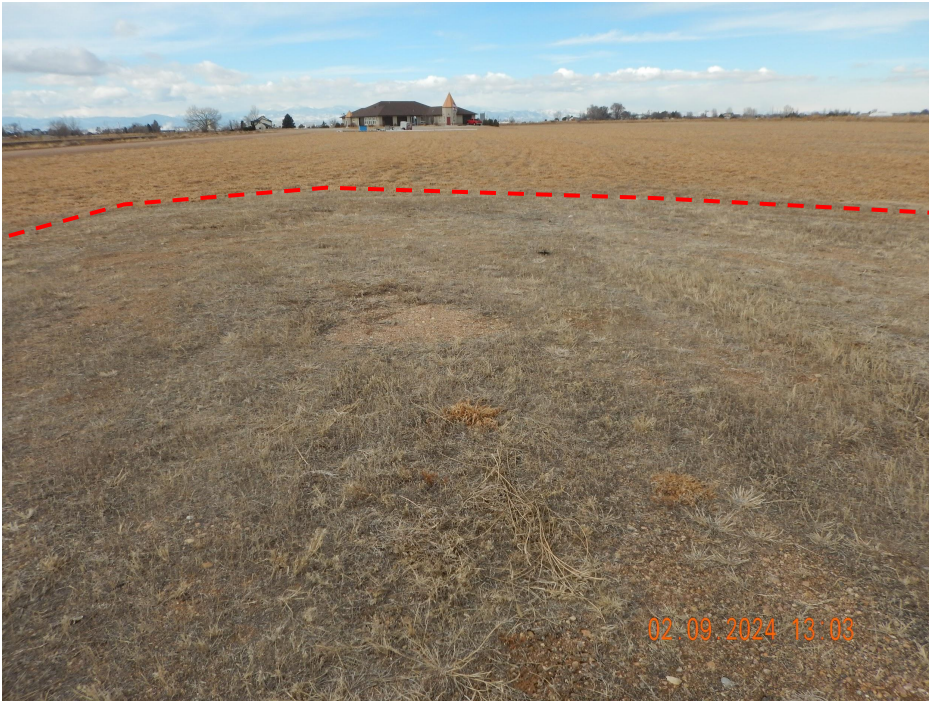
Photo 2. Photo taken from the central well location, facing West. See comments under Photo 1.

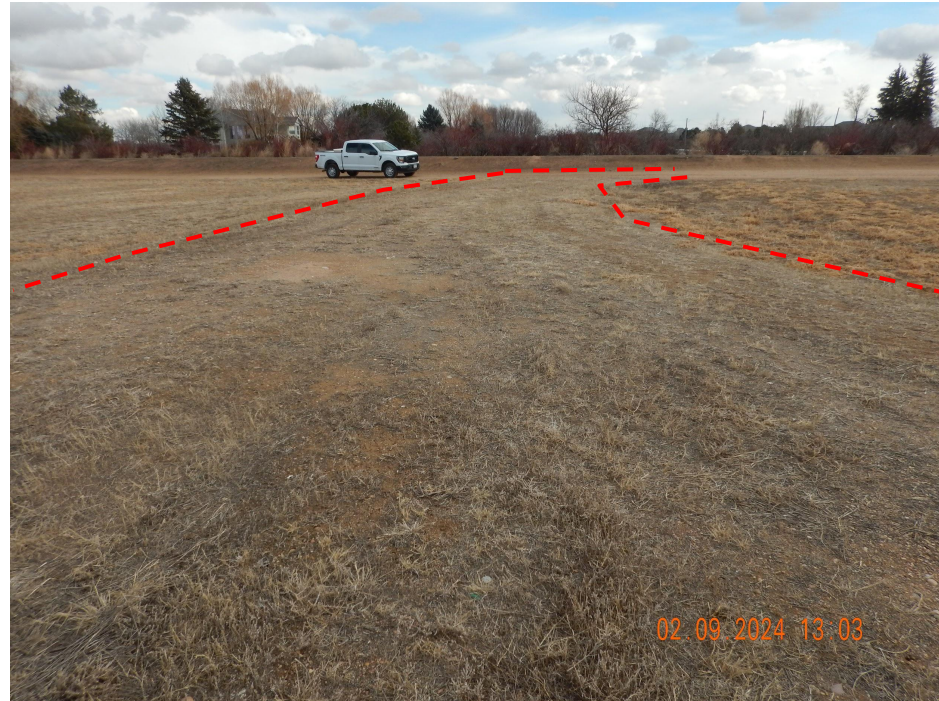
Photo 3. Photo taken from the central well location, facing East. See comments under Photo 1.

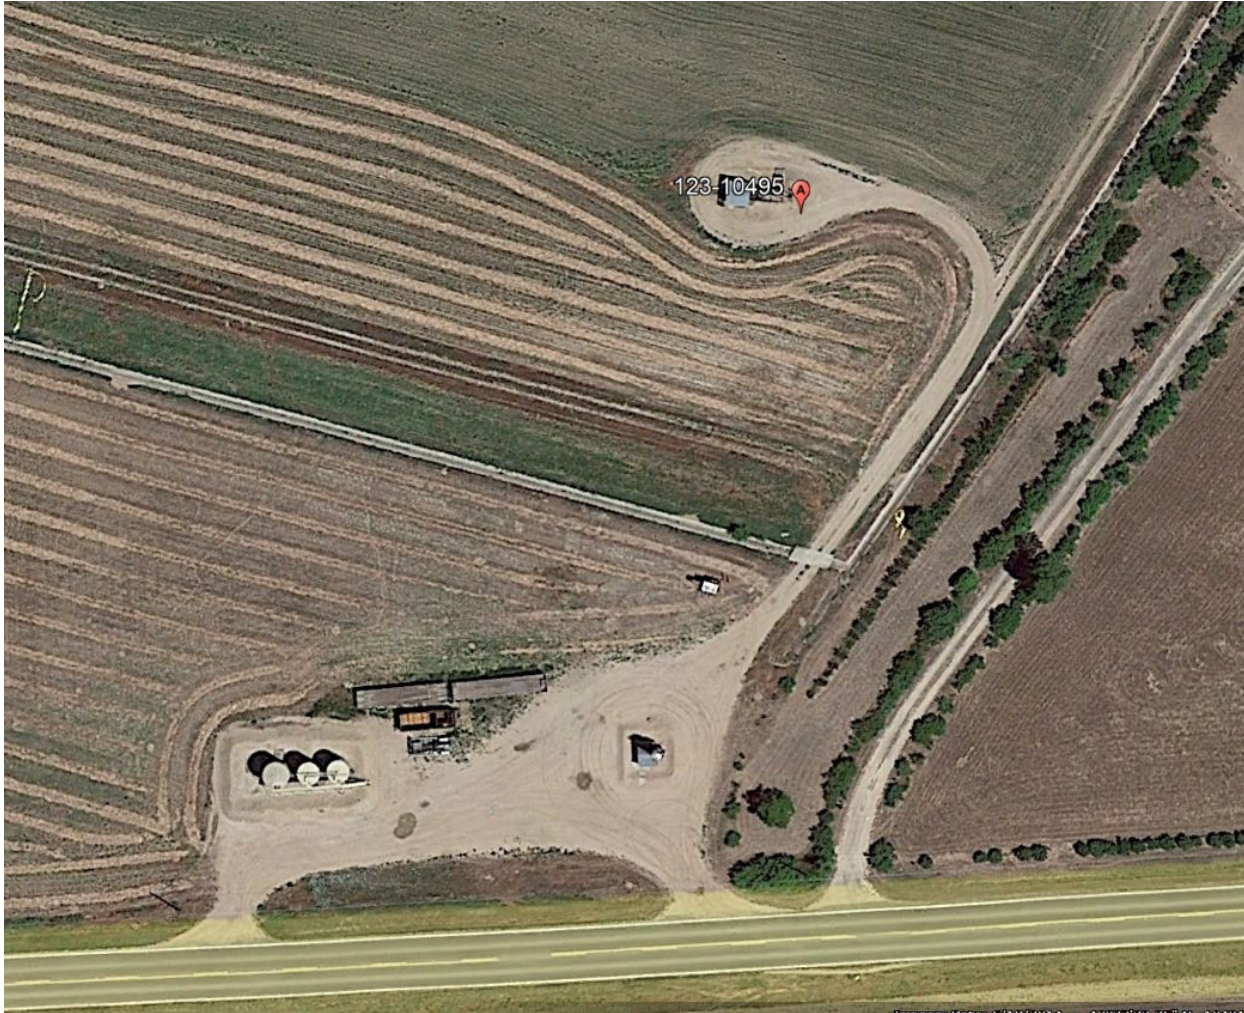
Photo 4. Google Earth aerial imagery taken 6/19/2014 illustrating the well location and tank battery location during active operations.

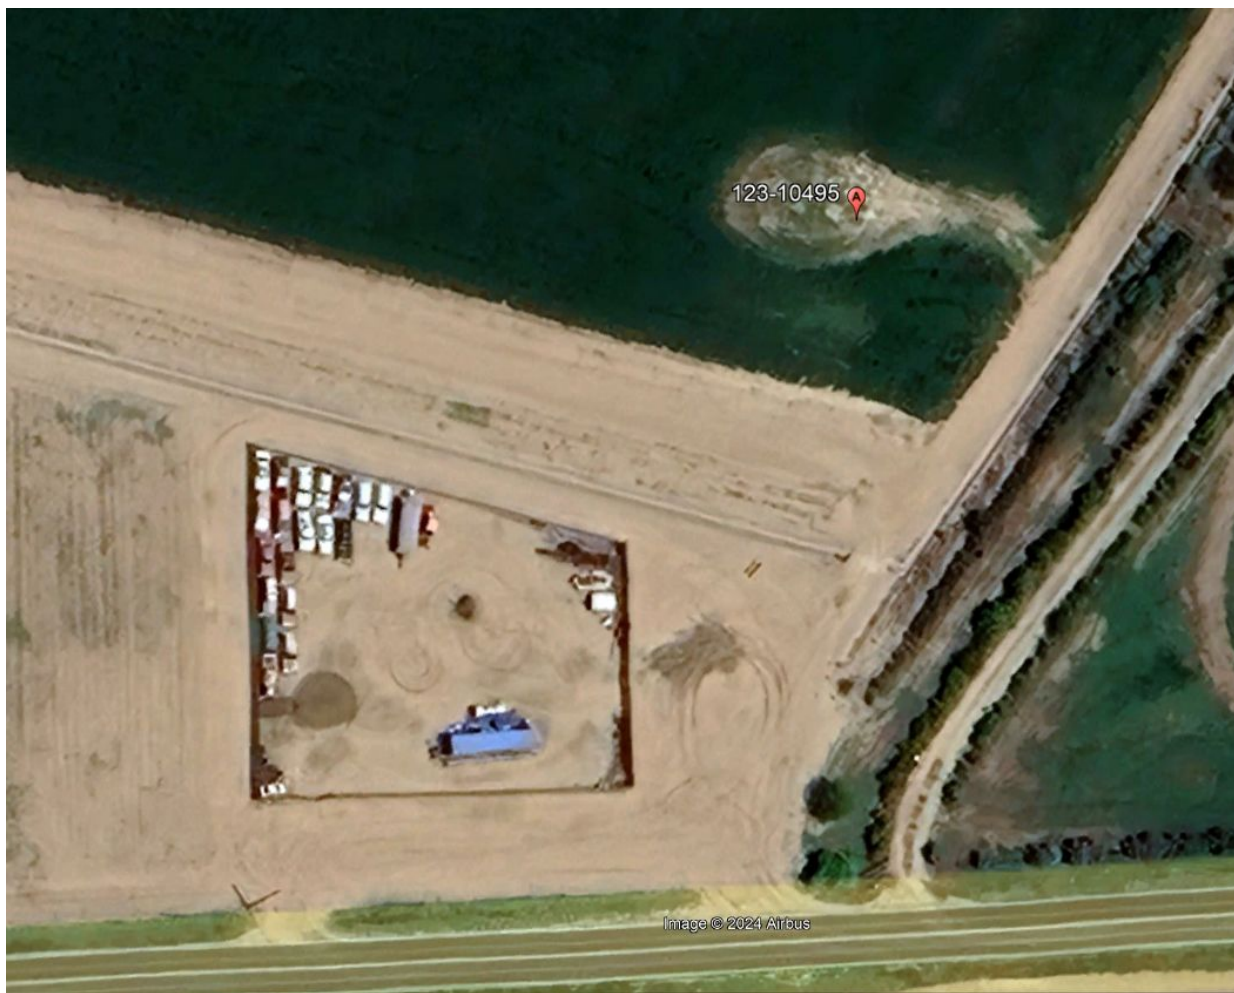
Photo 5. Google Earth aerial imagery taken 5/20/2023 illustrating the well location and tank battery location post plugging operations. Imagery illustrates the lack of crop growth at the well location. Note- surface owner has left the tank battery location graveled and stabilized, and has changed the land use for that area that was previously an agricultural field.
