Interim Reclamation and Stormwater Inspection

Operator: Noble Energy Inc. - 100322

Location ID: 323719

Inspection Photos
Location Name: Ocoma G25-10
Location ID: 323719

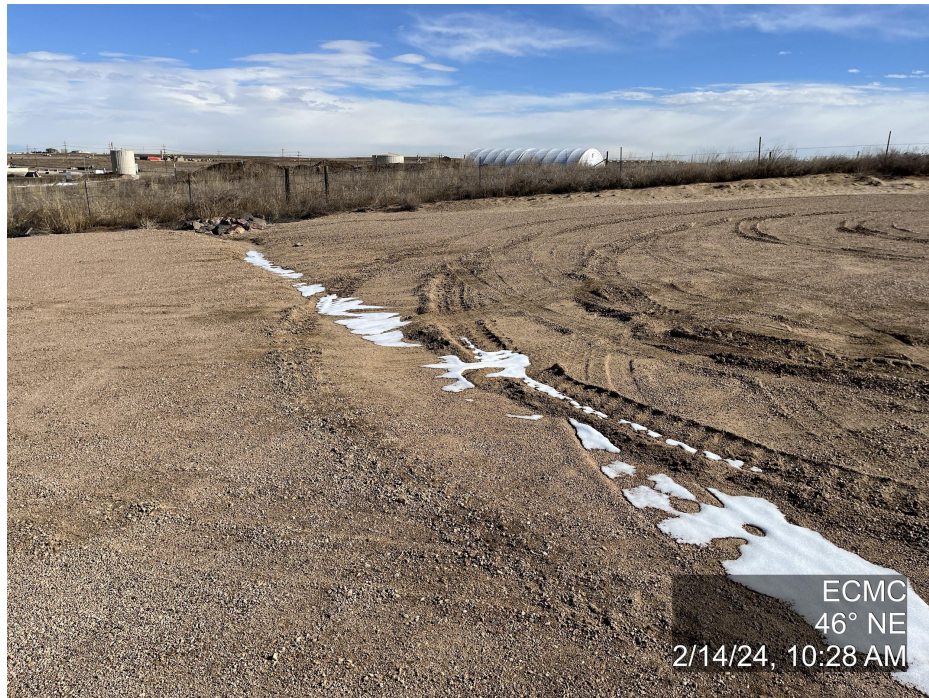
Photo 2. The photo was taken at the tank battery location facing Northeast. The photo illustrates the a diversion ditch running West to East along the center of the location.

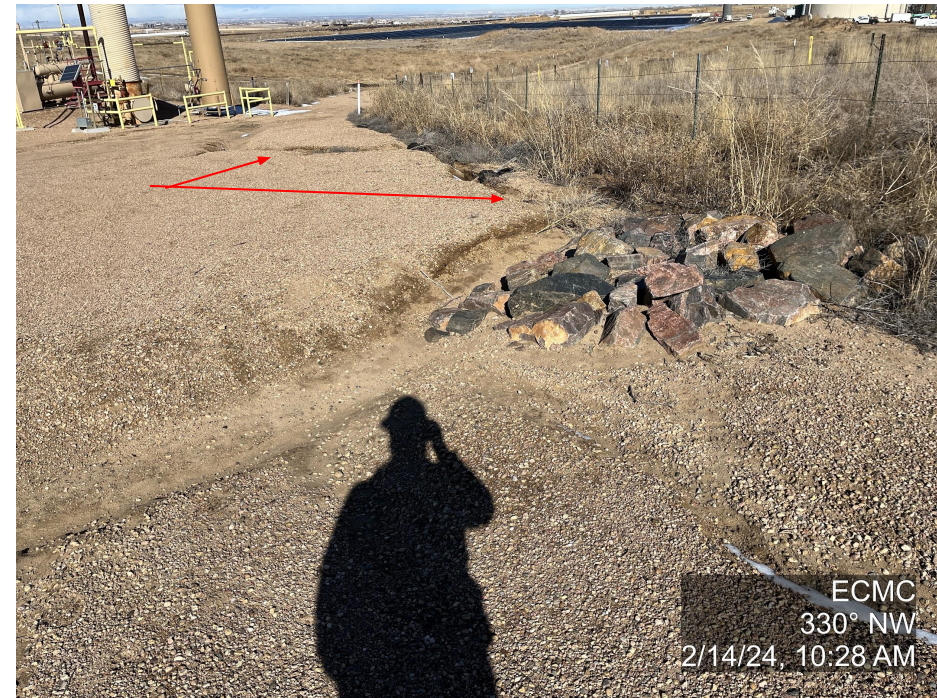
Photo 3. The photo was taken from the tank battery location facing Northwest. The photo illustrates where the ditch runs to a section of rip rap and shows erosion around the outer edge as well as rilling erosion running down the pad to the North.

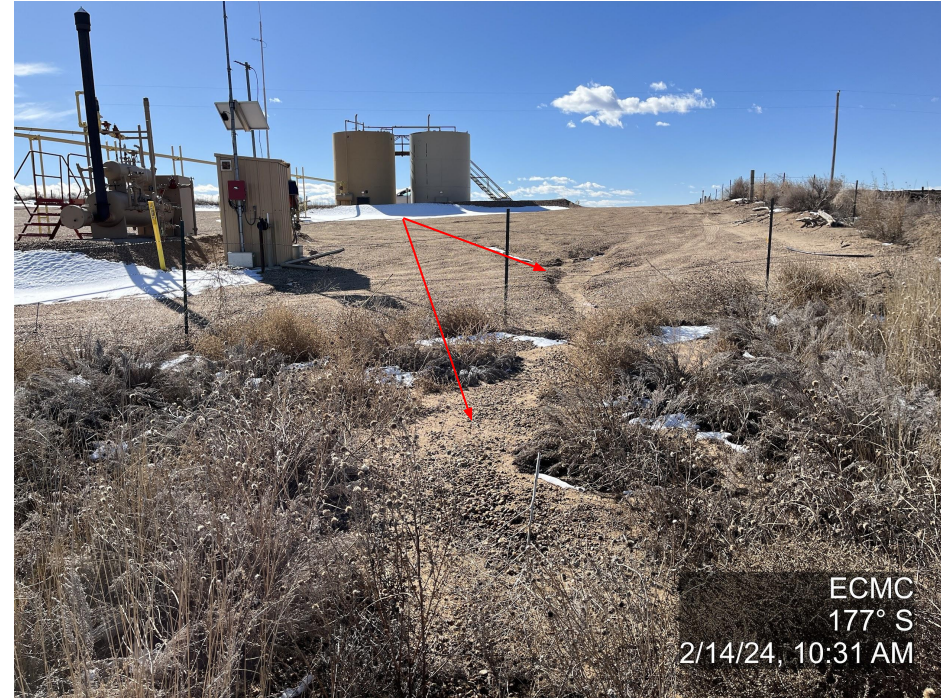
Photo 5. The photo was taken at the tank battery location facing South. The photo illustrates erosion on the West side of the facility flowing sediment beyond the disturbance boundary fence.
