# Interim Reclamation and Stormwater Inspection

Operator: PDC Energy Inc. - 69175

Location ID: 439315

Inspection Photos  
Location Name: Honebein 4N64W7K Pad  
Location ID: 439315

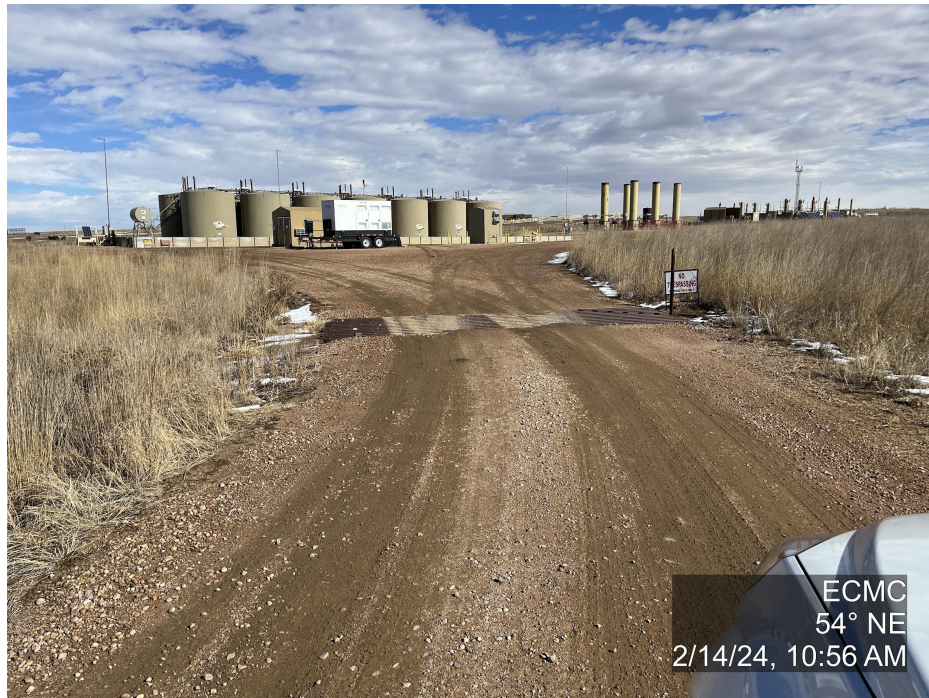
**Photo 1.** The photo was taken from the main access road at the entrance to the facility facing Northeast. The photo illustrates an overview of the location and cattle guard.

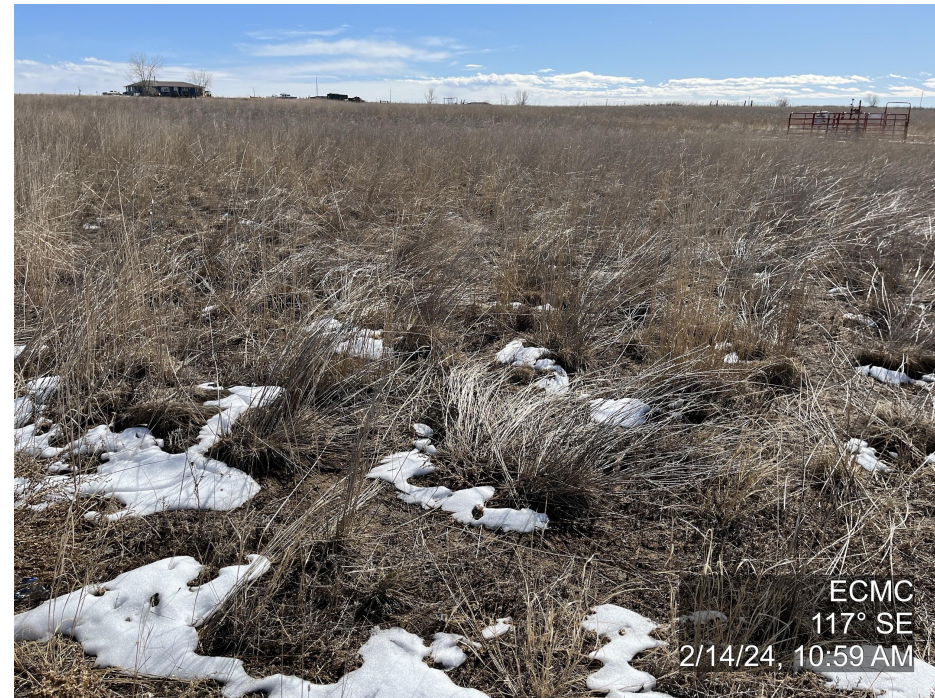
**Photo 2.** The photo was taken from the well location facing Southeast. The photo illustrates the interim areas are dominated by a wheatgrass species, sand dropseed, and curlycup gumweed.

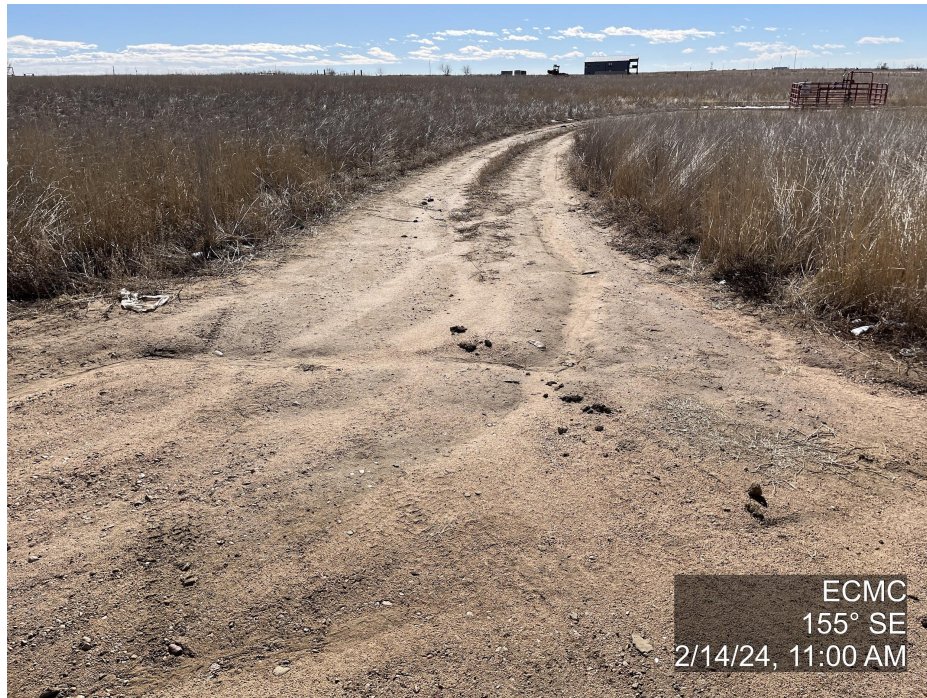
**Photo 3.** The photo was taken from the well location facing Southeast. The photo illustrates the small road between the wellheads and rest of the production facility. There is some erosional rilling visible here that appears to be fed by water flowing from the uphill portion of the location to the East.

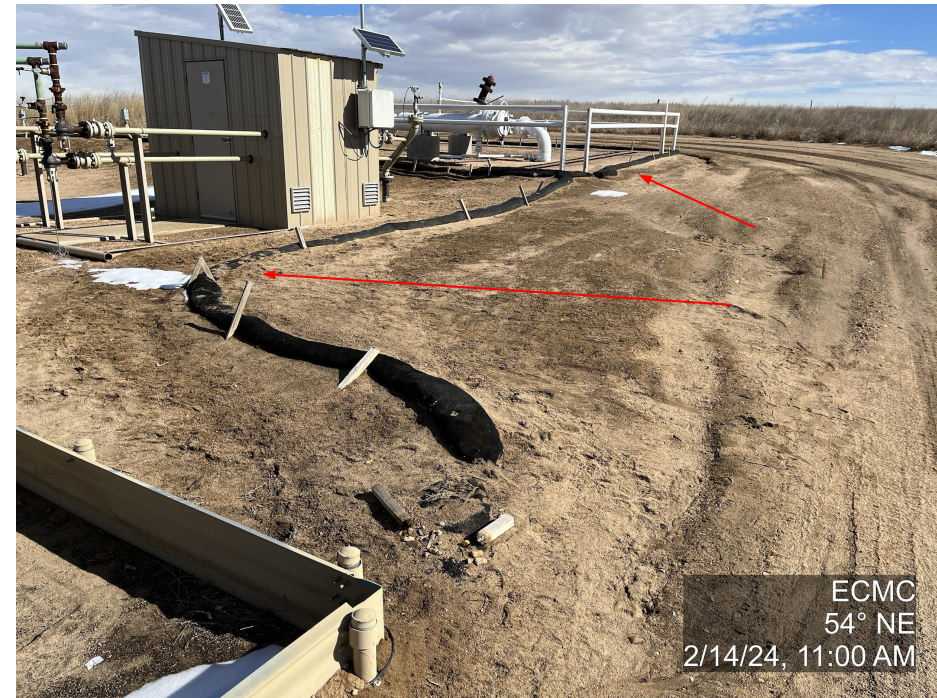
**Photo 4.** The photo was taken from the well location facing Northeast. The photo illustrates what appears to be the start of where water flows across the facility pad. There is rilling all along this area and the wattle surrounding the equipment is all sedimented in.

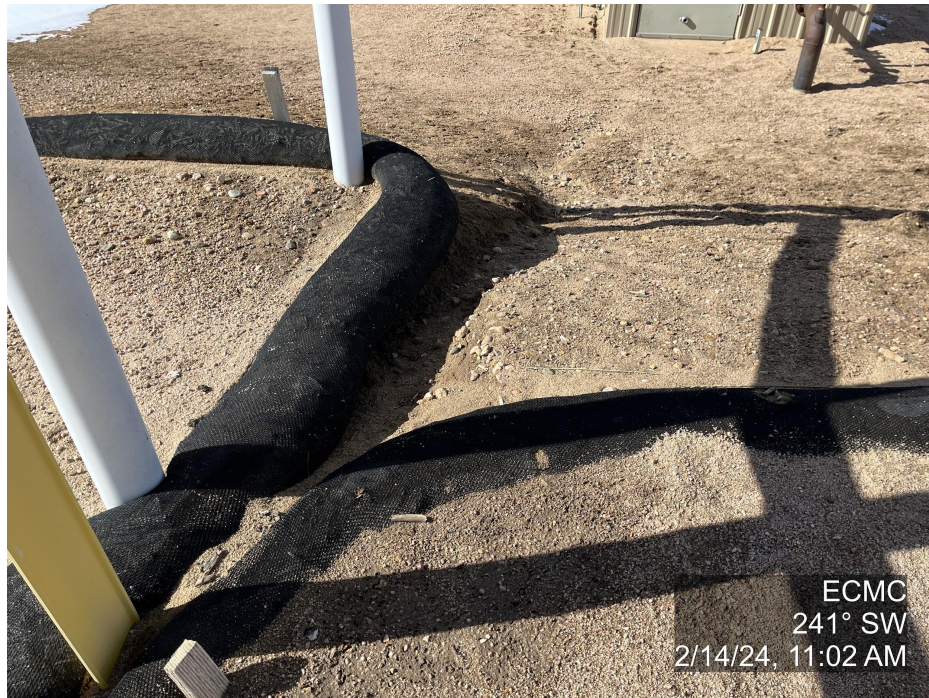
**Photo 5.** The photo was taken from the well location facing Southwest. The photo further illustrates the sedimentation of the wattle on the East side of the facility.

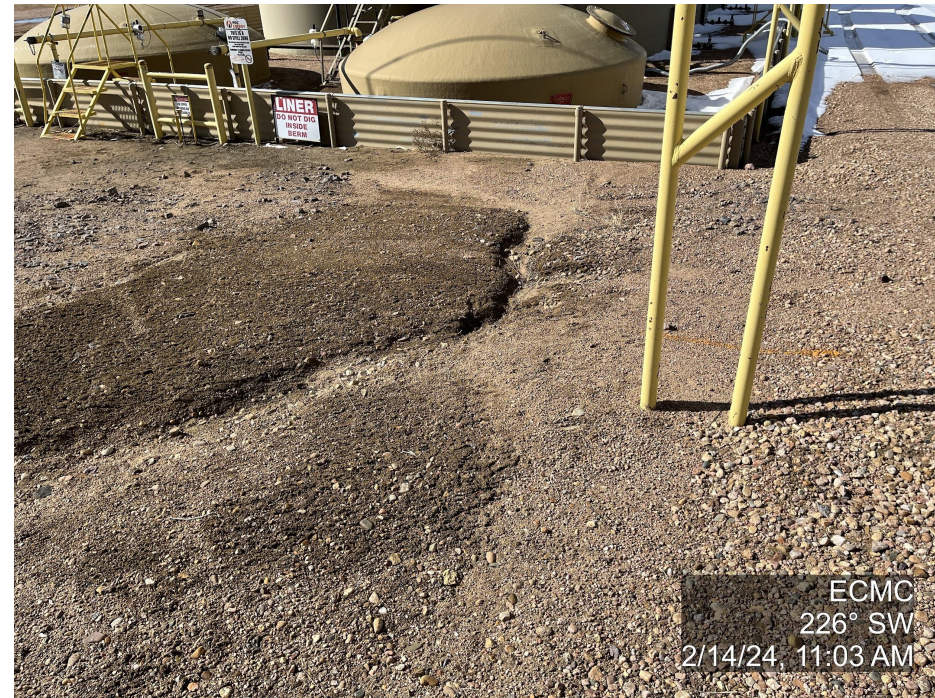
**Photo 6.** The photo was taken from the well location facing Southwest. The photo further illustrates water flow patterns across the pad.

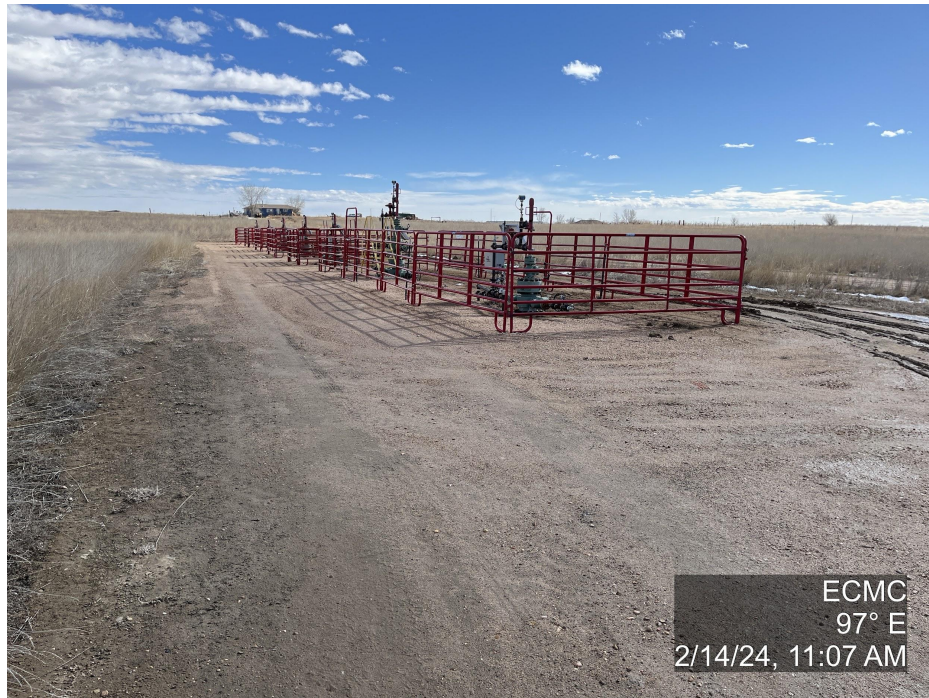
**Photo 7.** The photo was taken from the well location facing East. The photo illustrates the wellheads at the location.

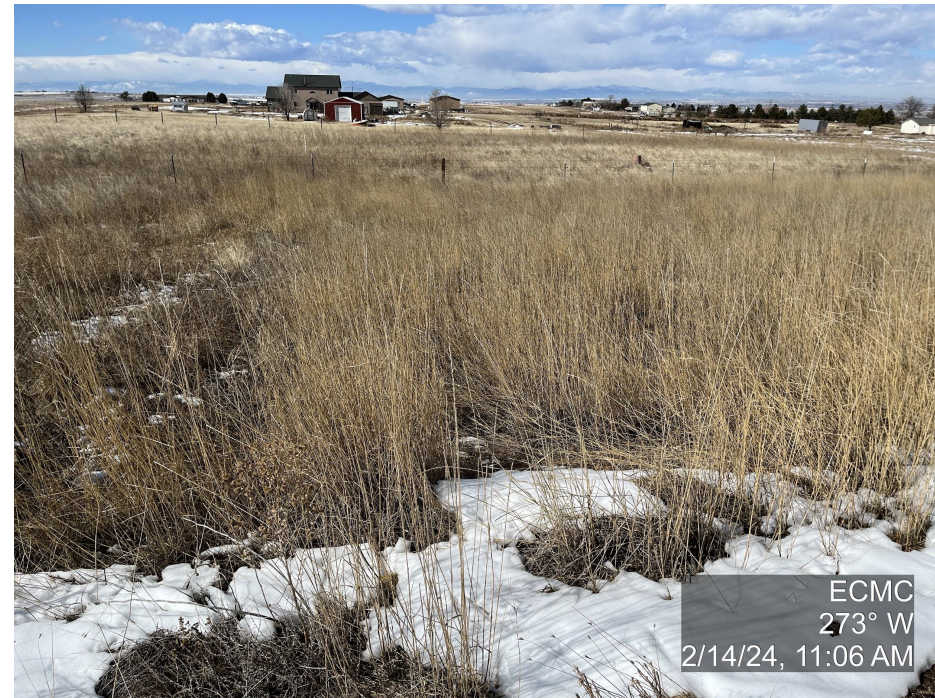
**Photo 8.** The photo was taken from the well location facing West. Refer to the comment for photo 2.
