**Operator: CIVITAS NORTH LLC**

**Location Name: Hunt 8-60 6C**

**Loc ID: 454166**

**Inspection: 709100215**

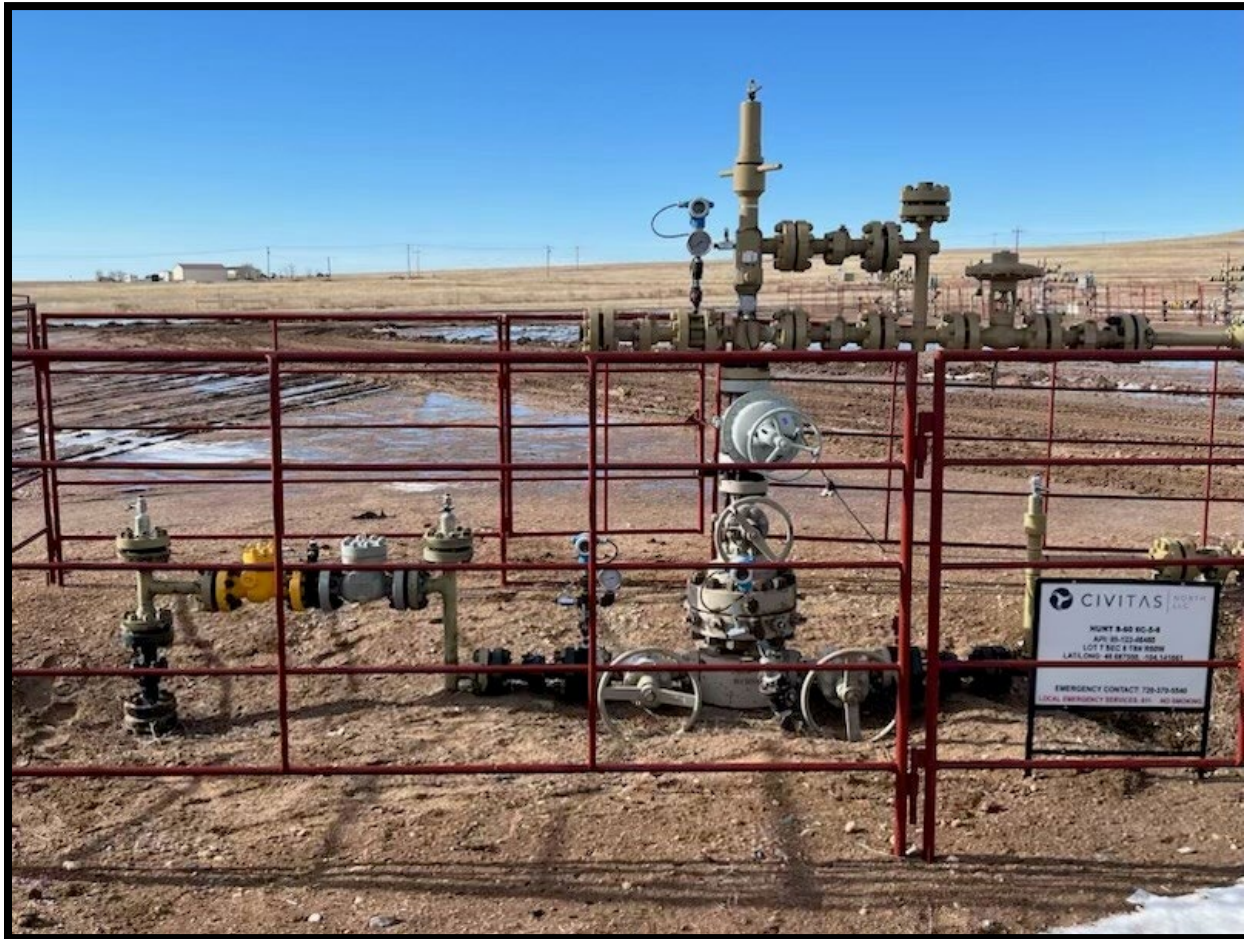
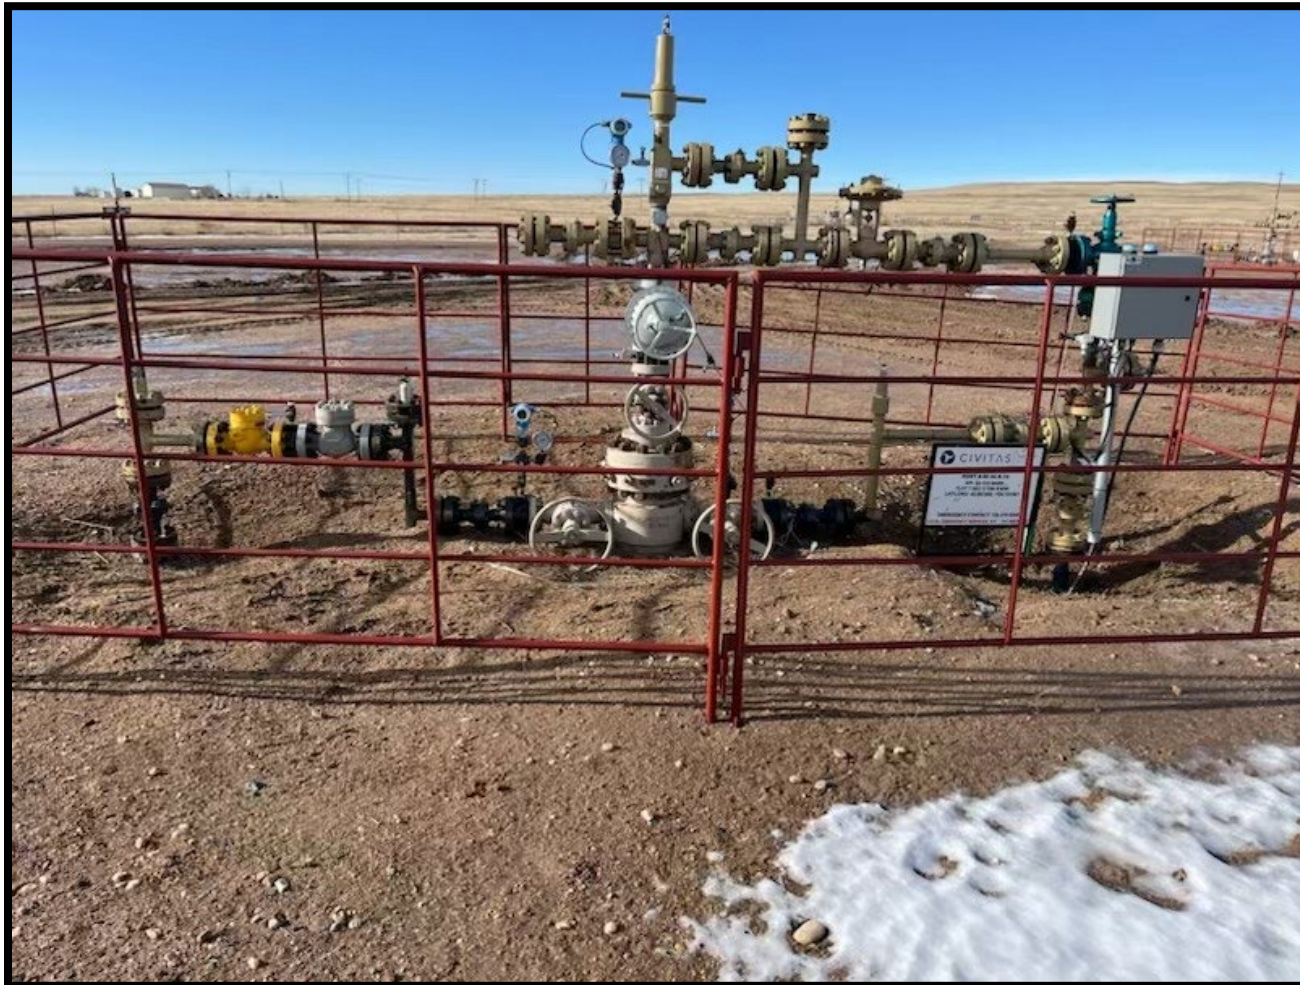
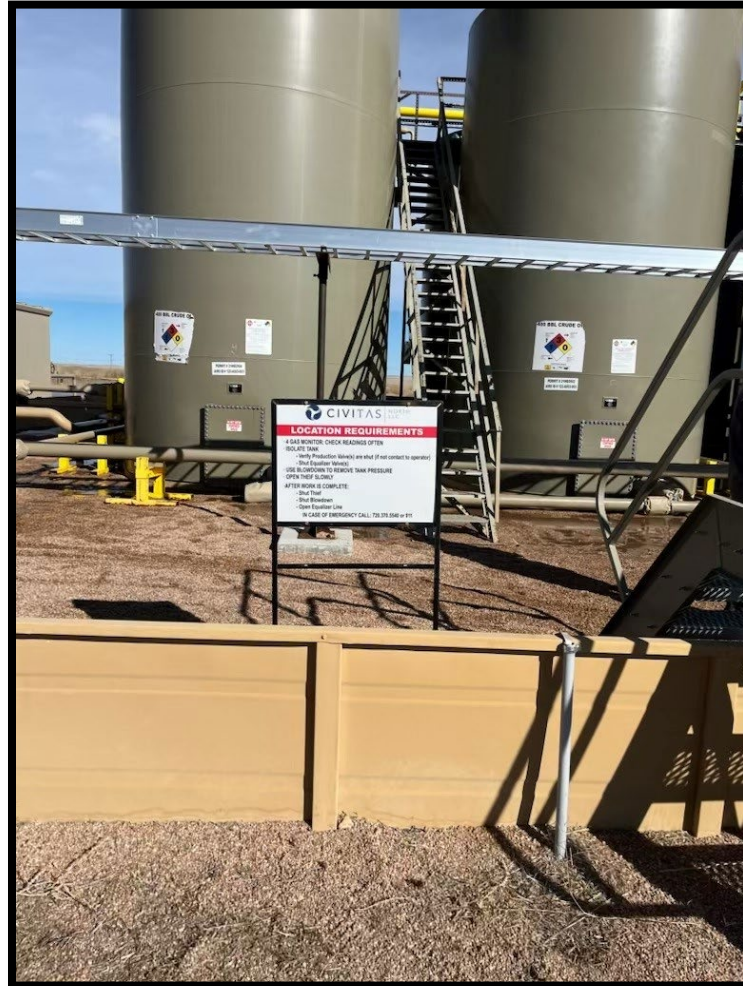
**CA:** Wellhead sign not properly installed. Comply with Rule 605.d.

**CA Resolution:** Operator has fixed and appropriately installed identified Wellhead signs to comply with Rule 605.d.

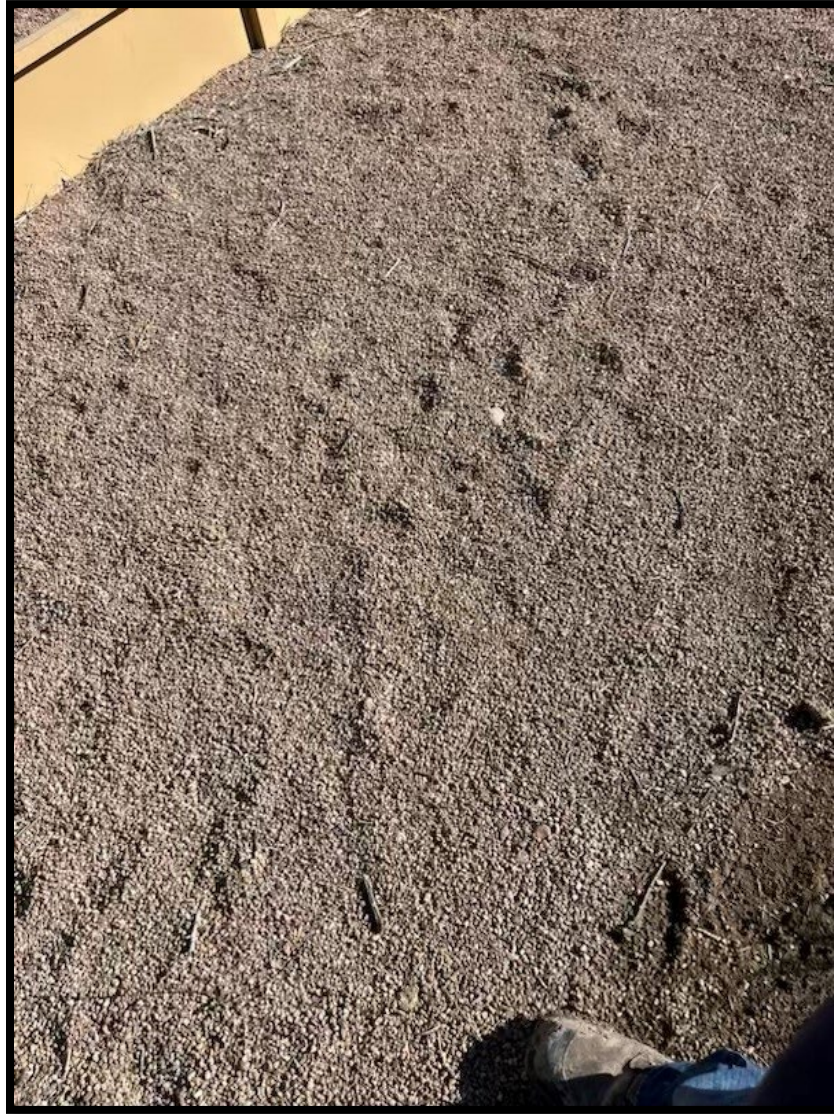
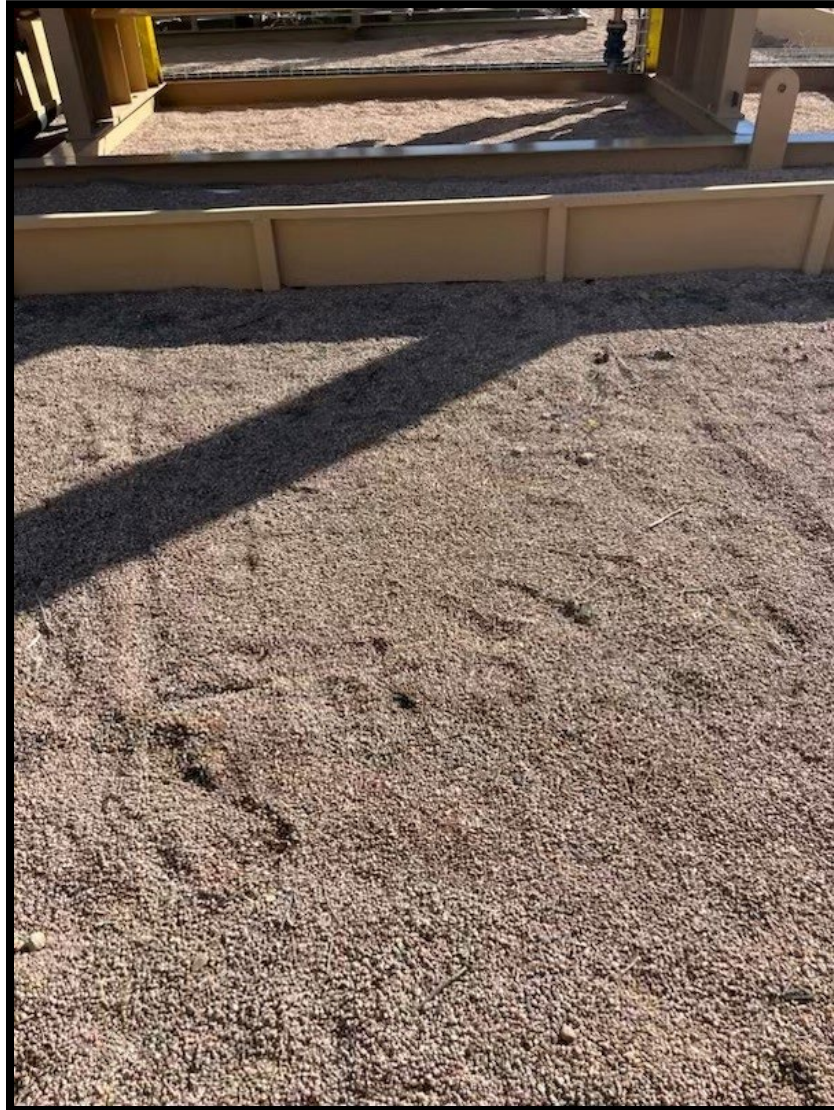
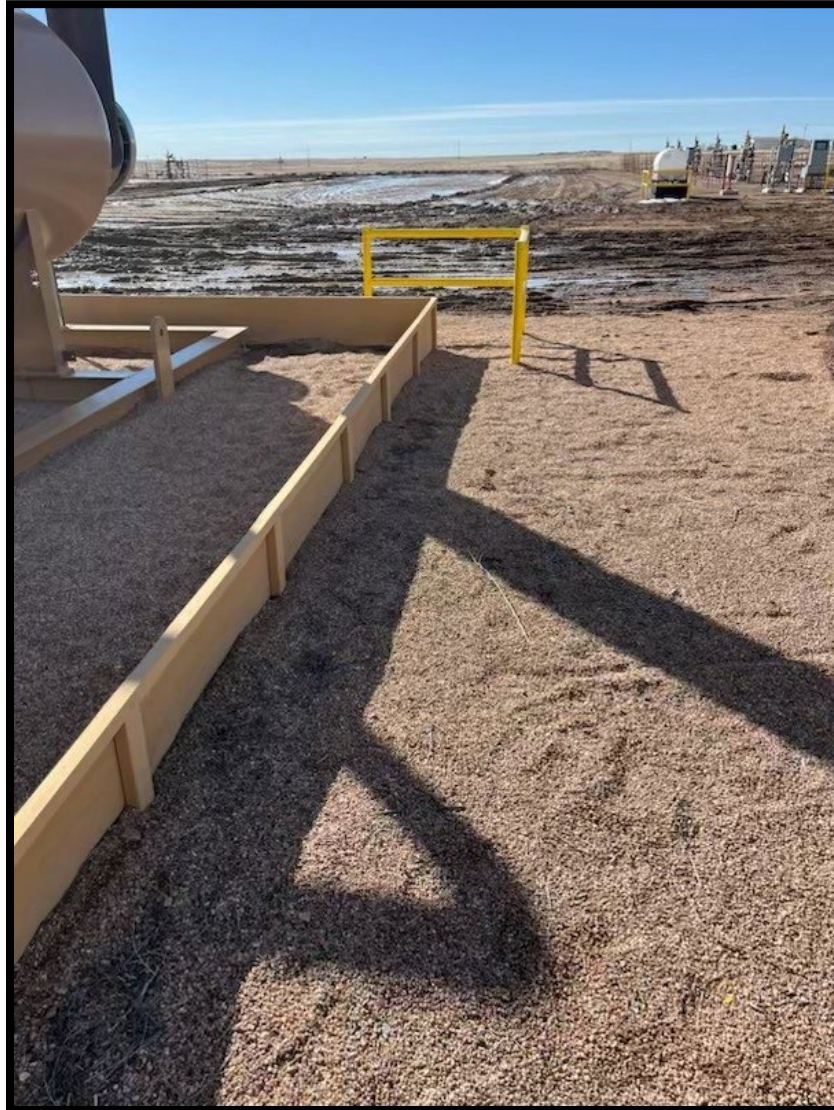
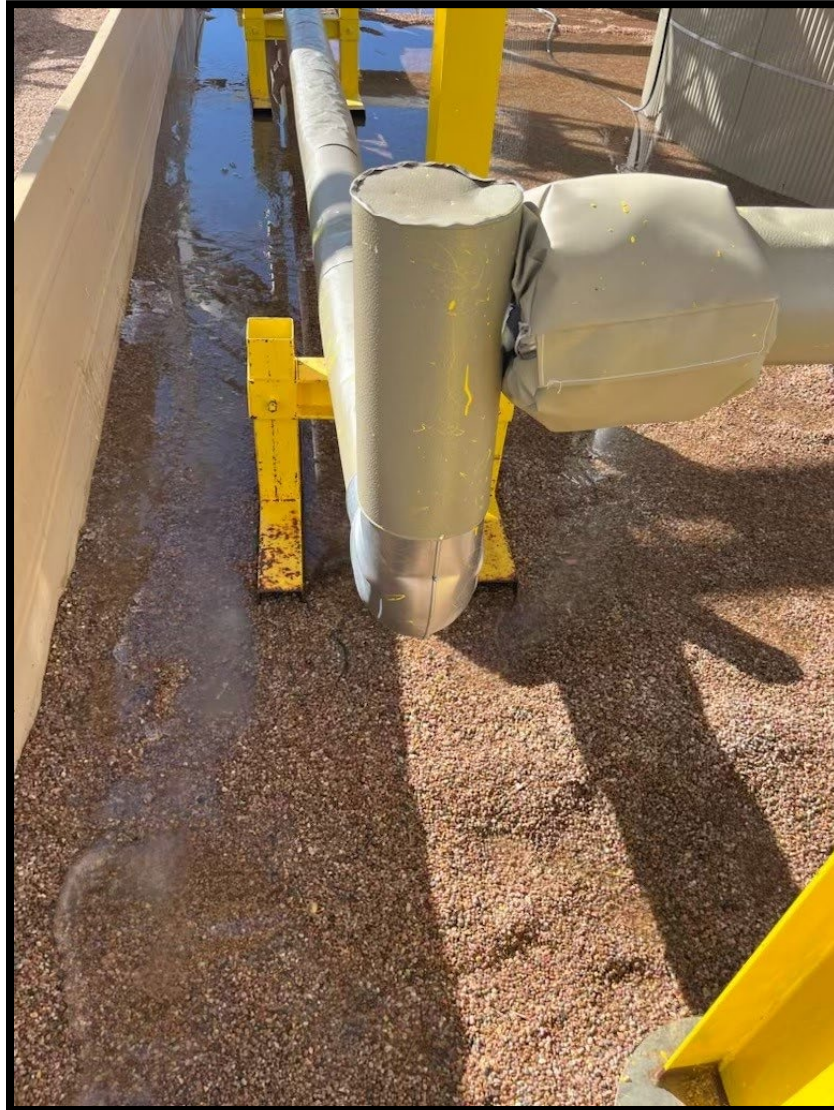
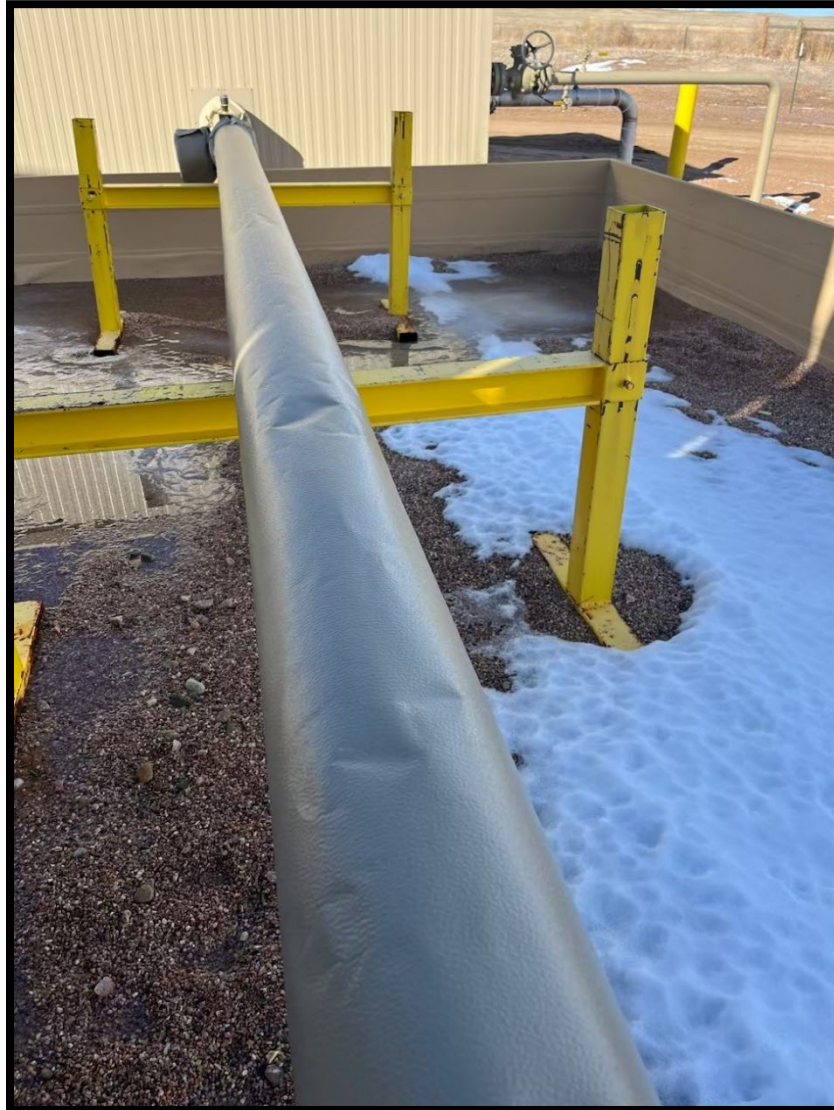
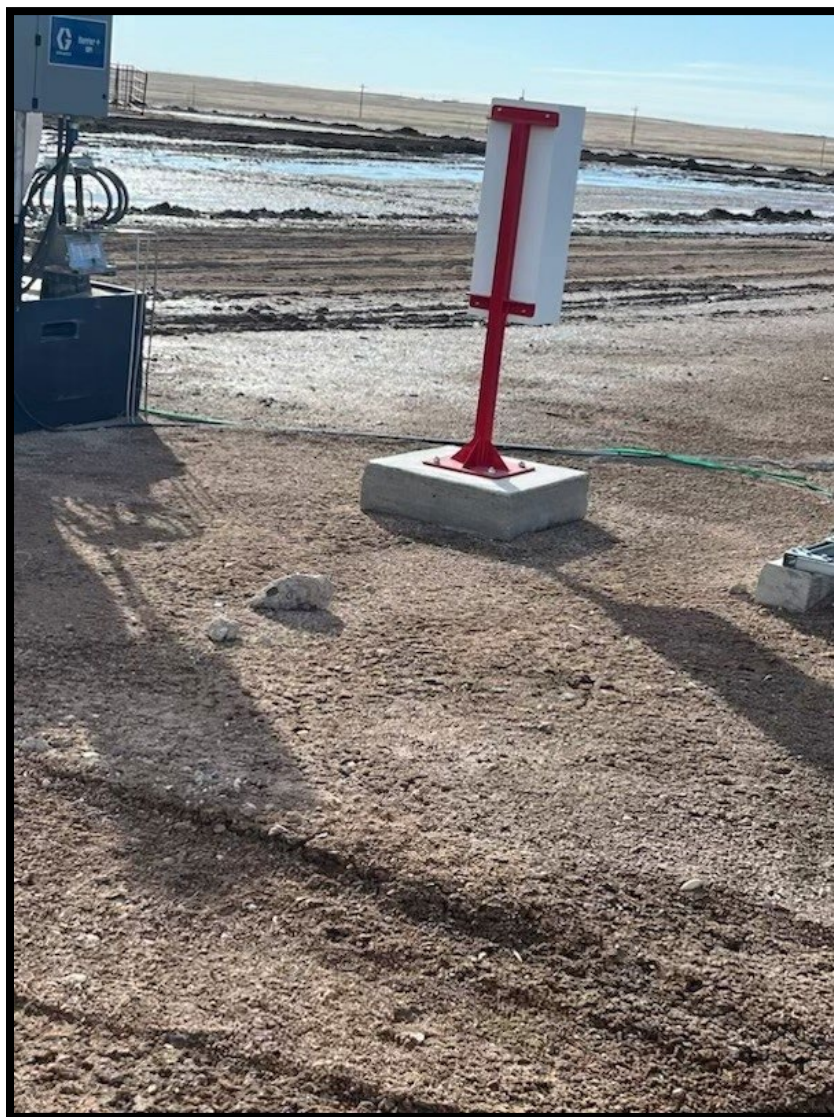
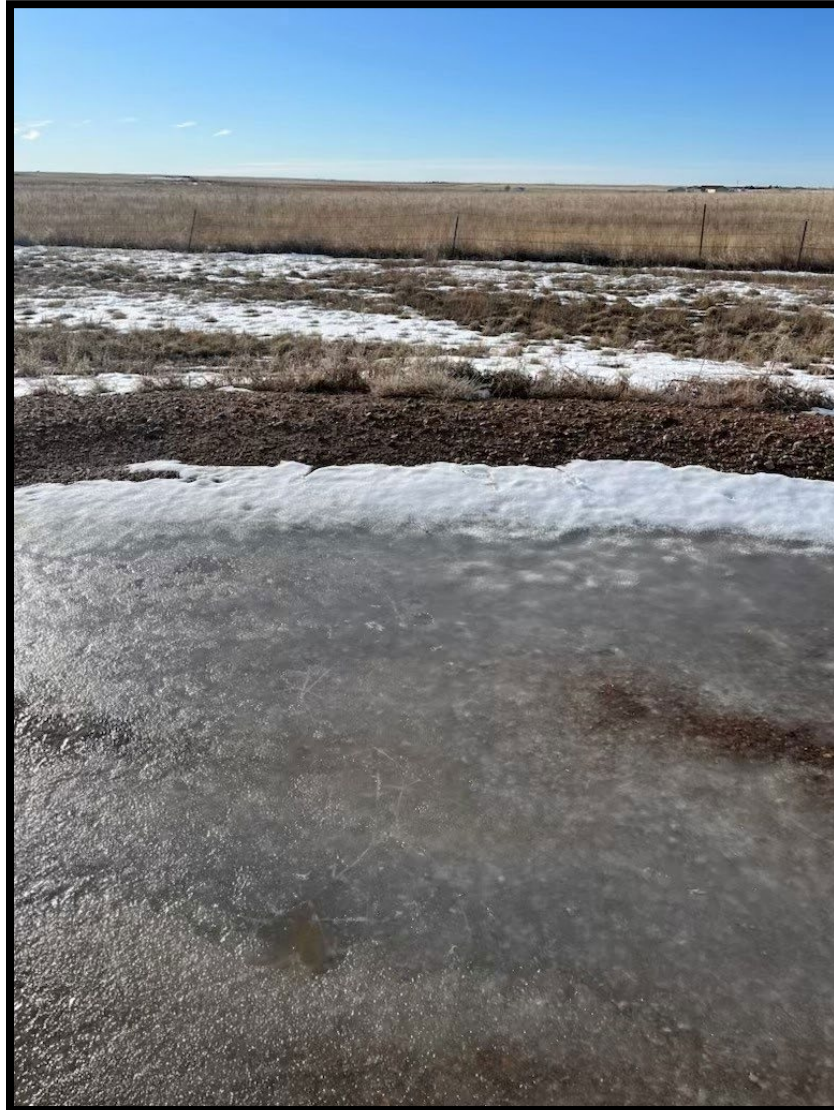
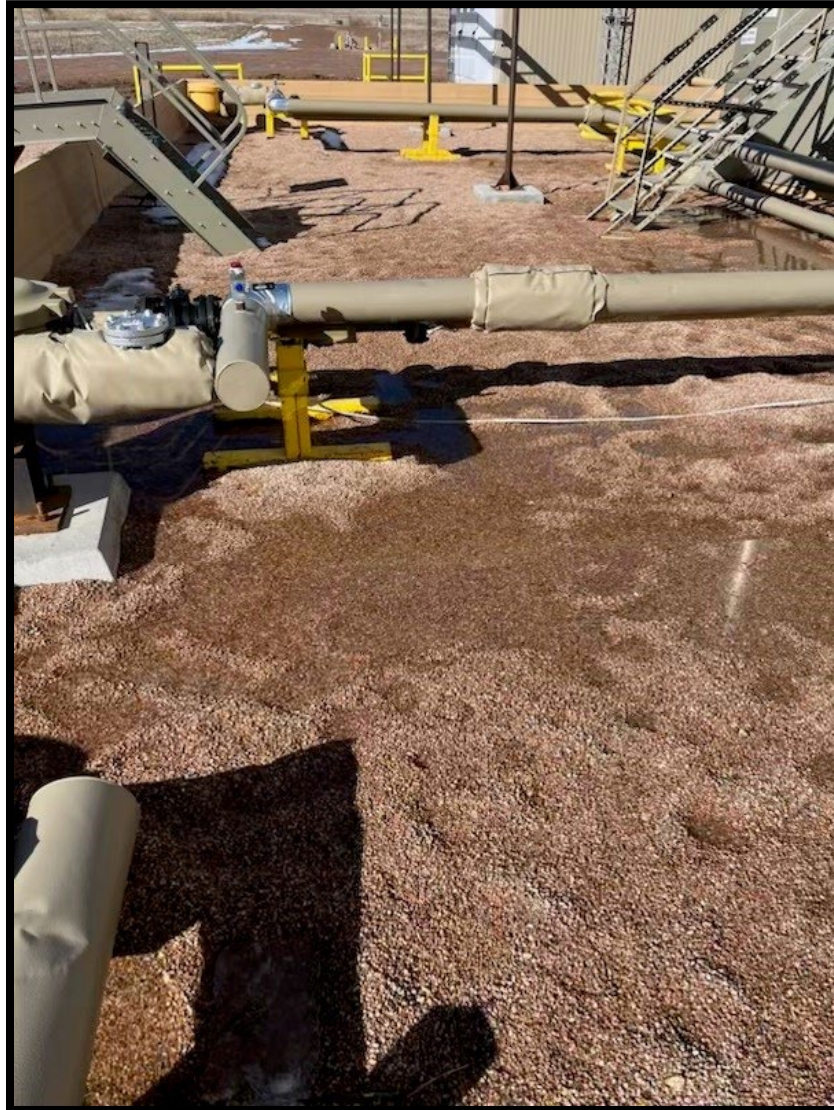
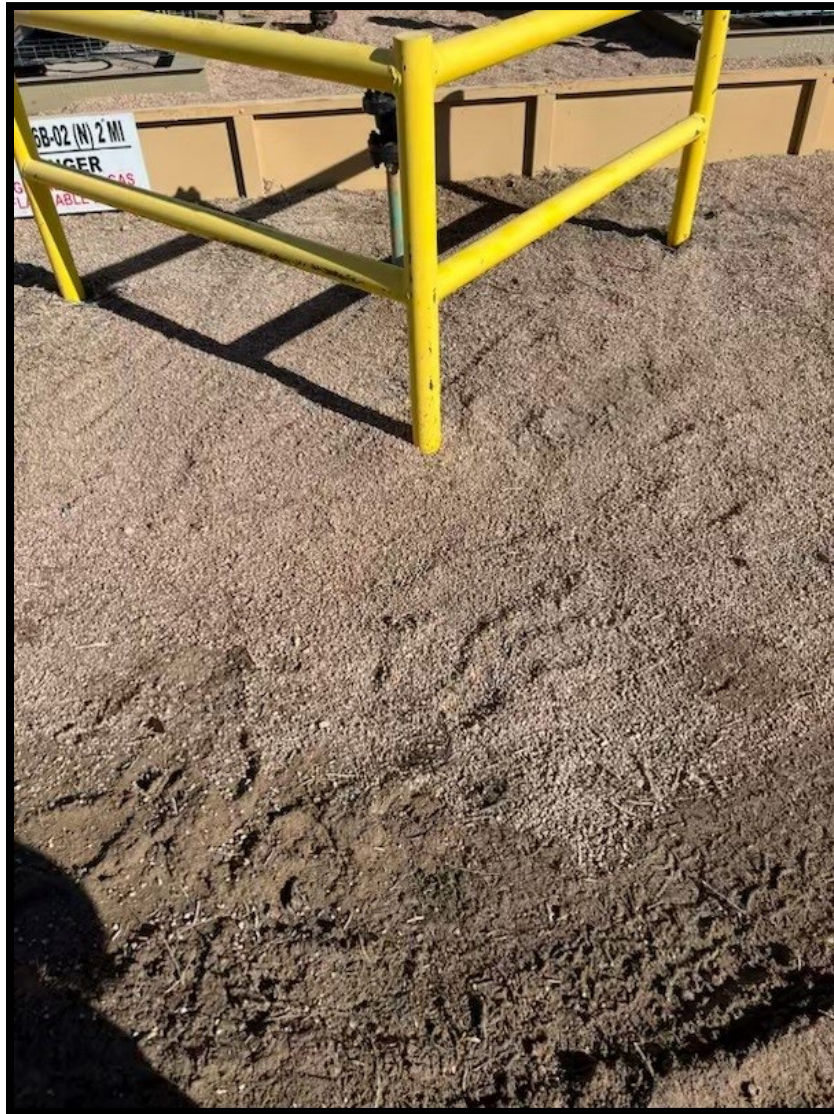
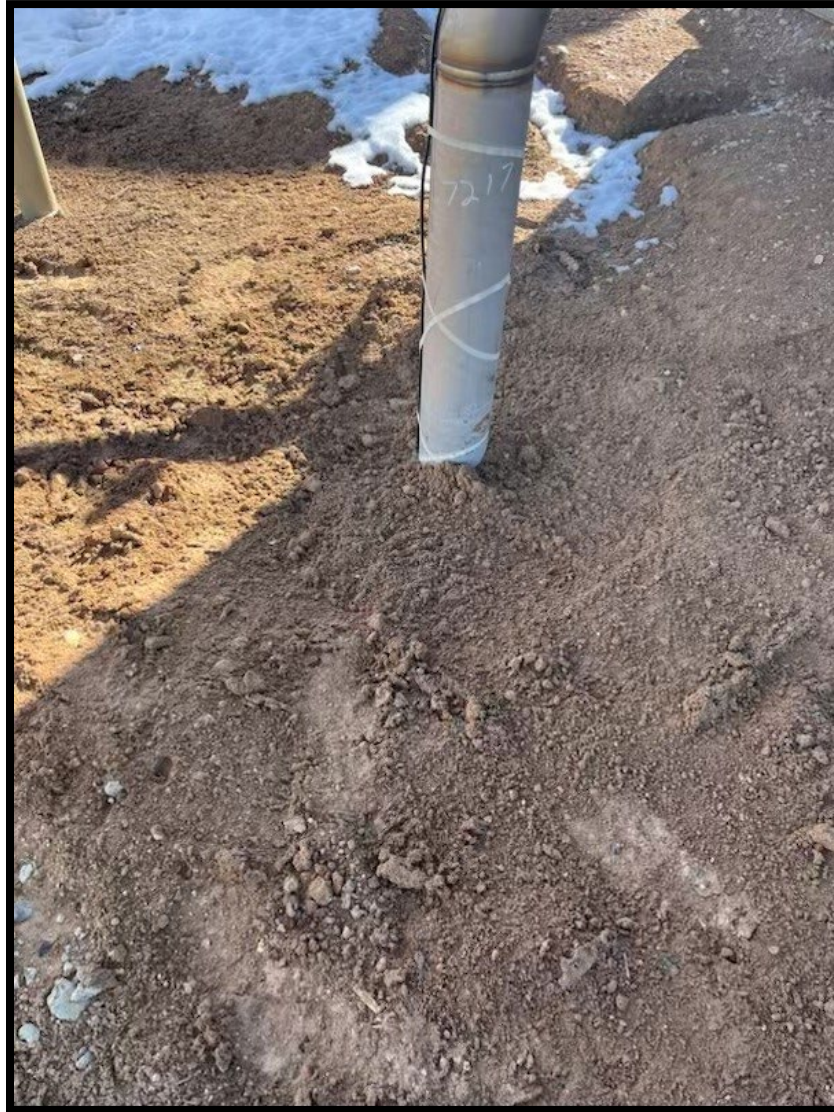
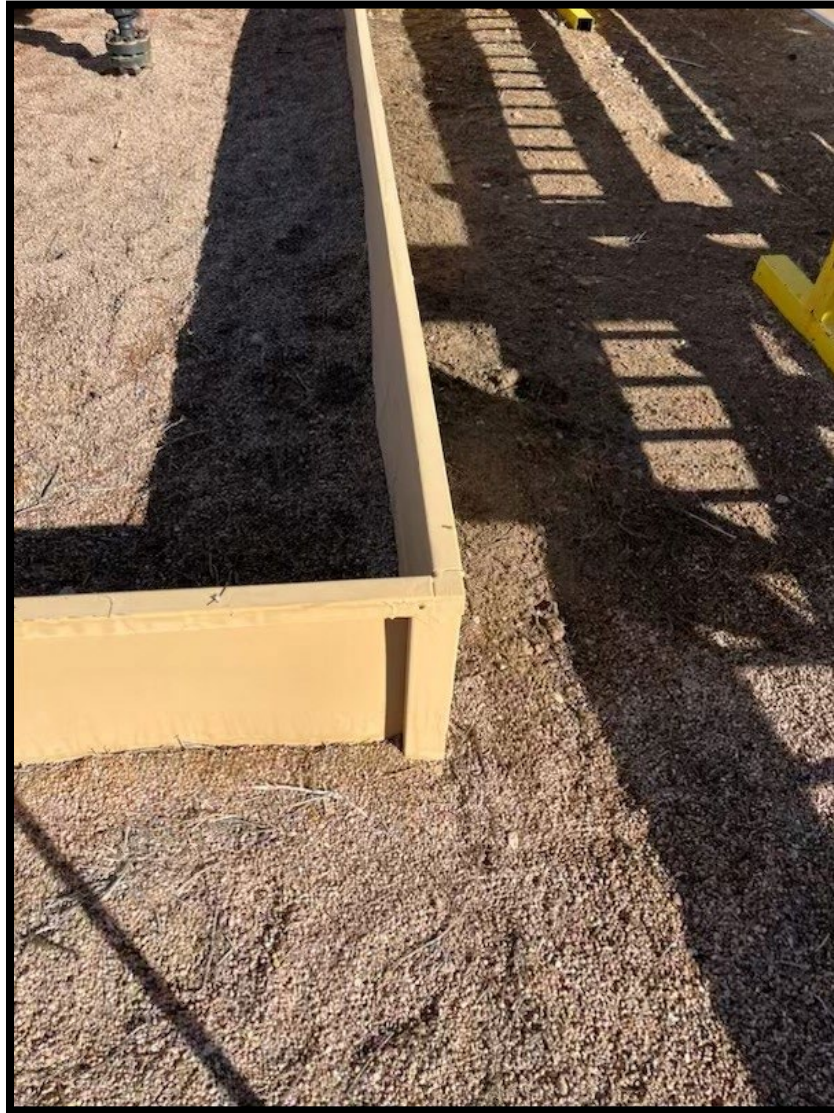
**CA:** Unused equipment (metal pipe, extra signs, spool of tubing, wiring, screws and nuts) observed on location. Comply with Rule 606

**CA:** Trash observed throughout location and among the wellheads. See photo documentation. Comply with Rule 606

**CA Resolution:** Operator has removed identified equipment from the location to comply with Rule 606.

**CA Resolution:** Operator has removed identified trash, debris, and tumbleweeds to comply with Rule 606.
