Inspection Photos

Loc: 483886

Operator: BNL (ENTERPRISE) INC

Inspection Date: 2/21/2024

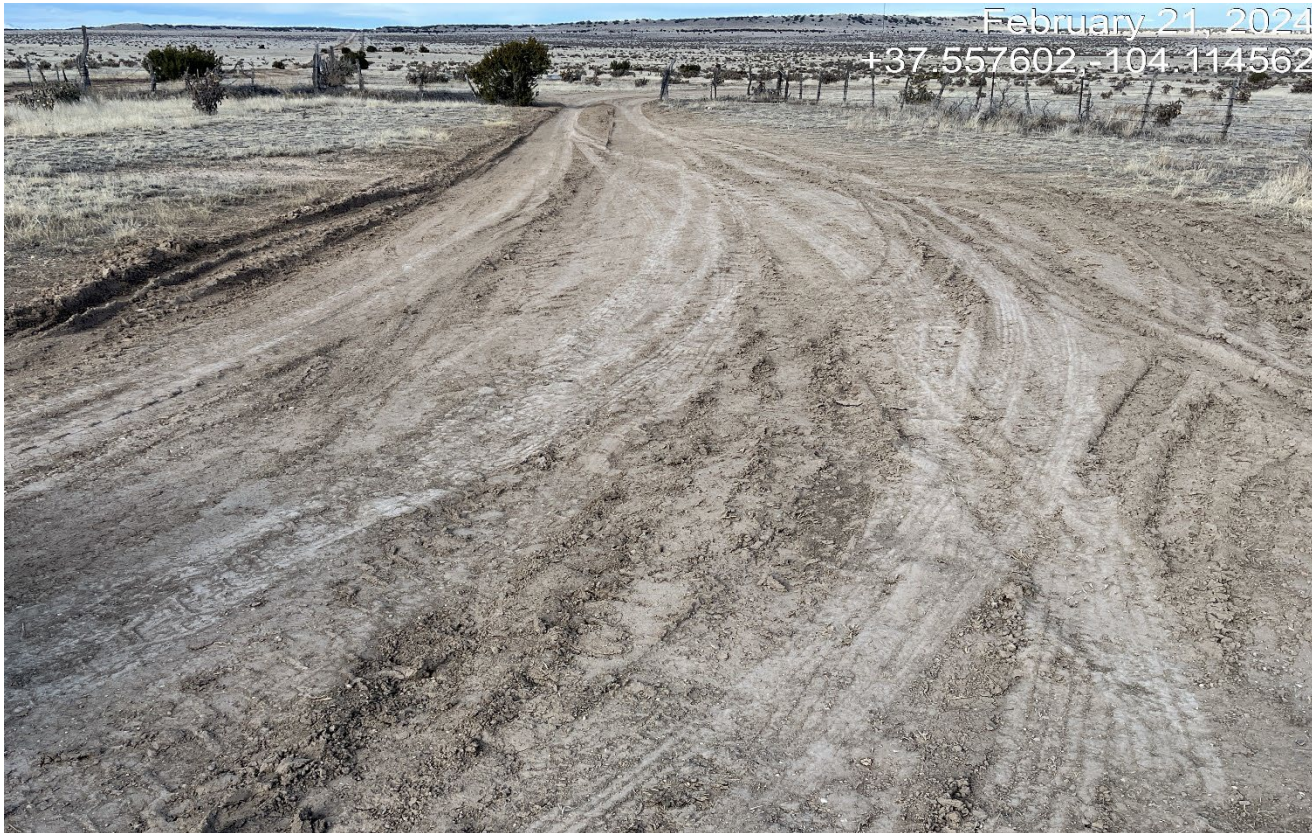
Photo 1. Facing northwest at the beginning of the access road. The road has been widened in this area from trucks onto the road..

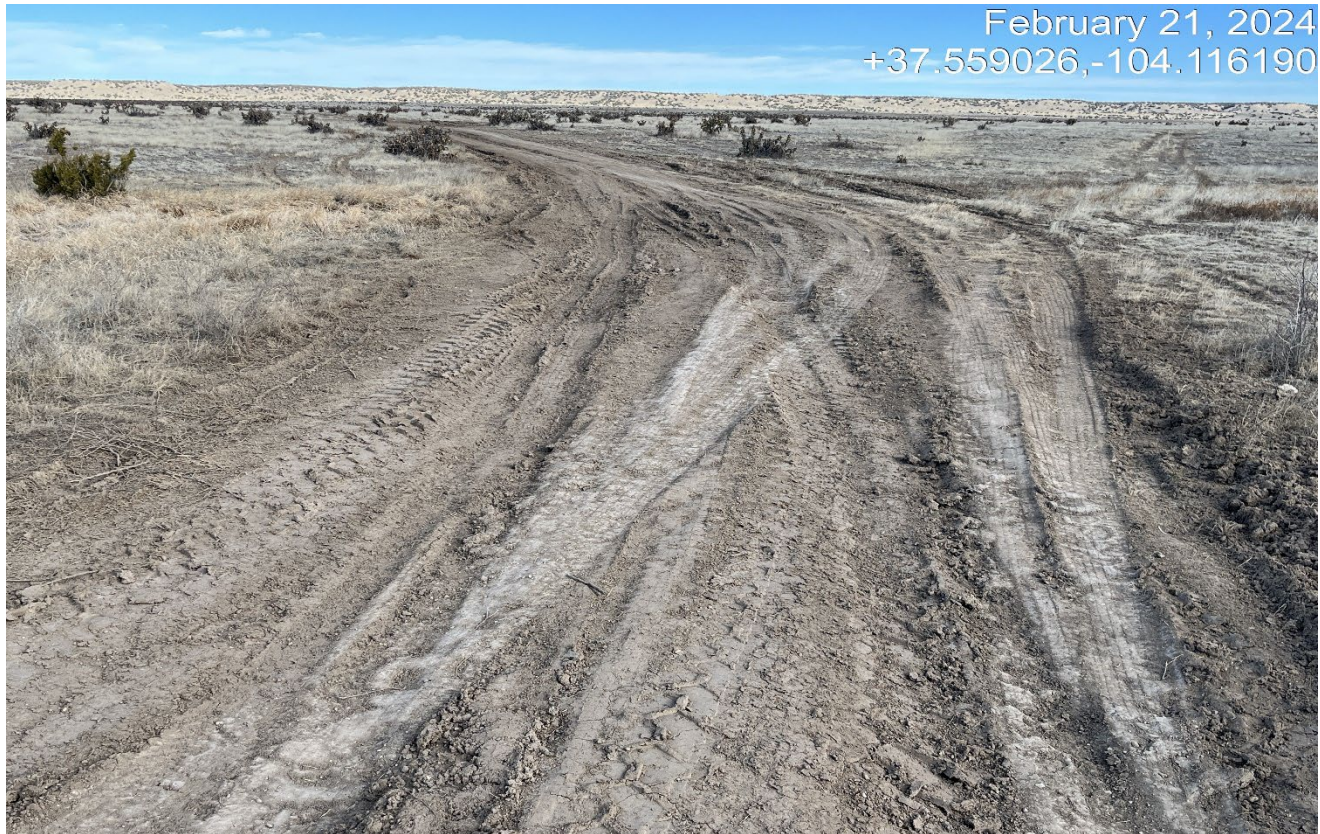
Photo 2. Facing north along the road. There is vehicle rutting that needs to be repaired and the road needs to be maintained to prevent widening and unnecessary disturbance.

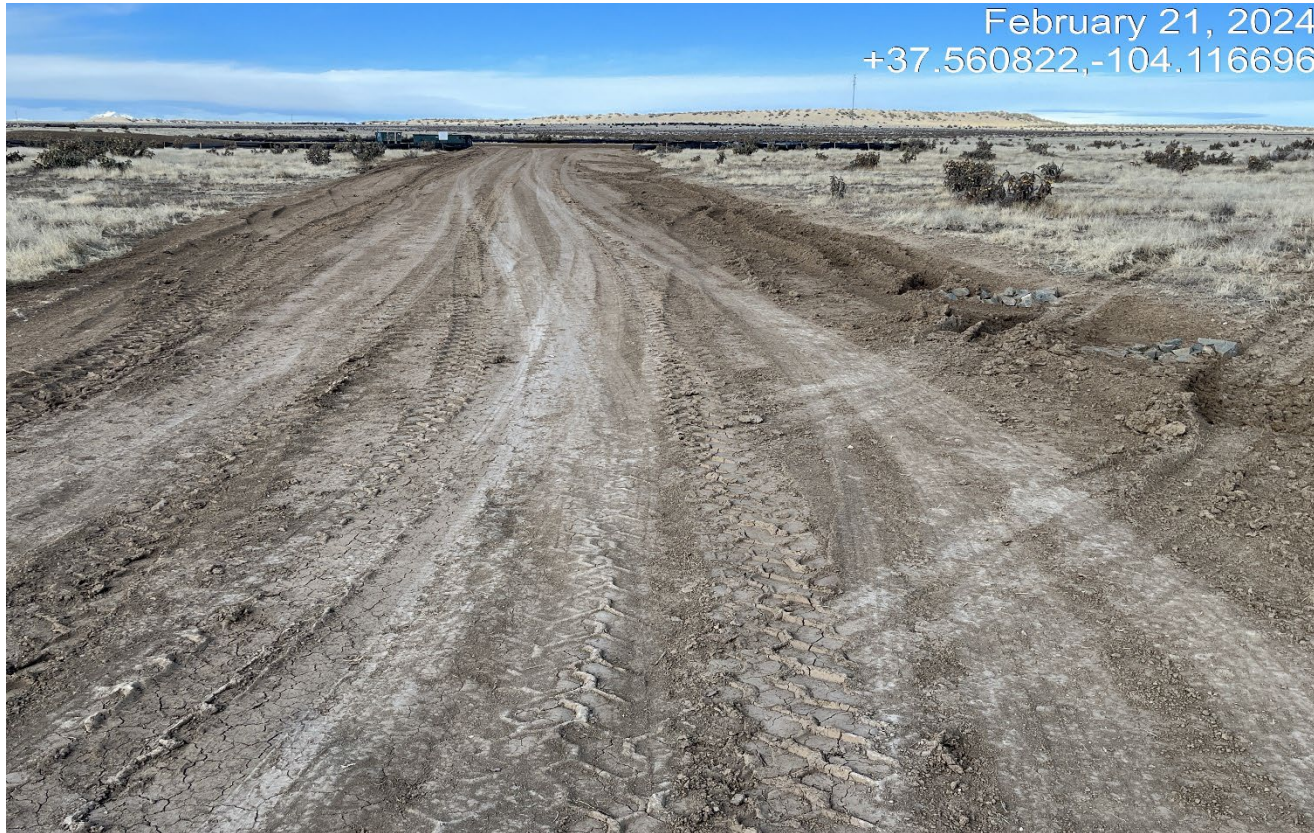
Photo 3. Facing west toward the access road. The side of the road needs to be seeded and stabilized and the road needs to be crowned and graveled if the well is developed. Disturbance needs to be better minimized.

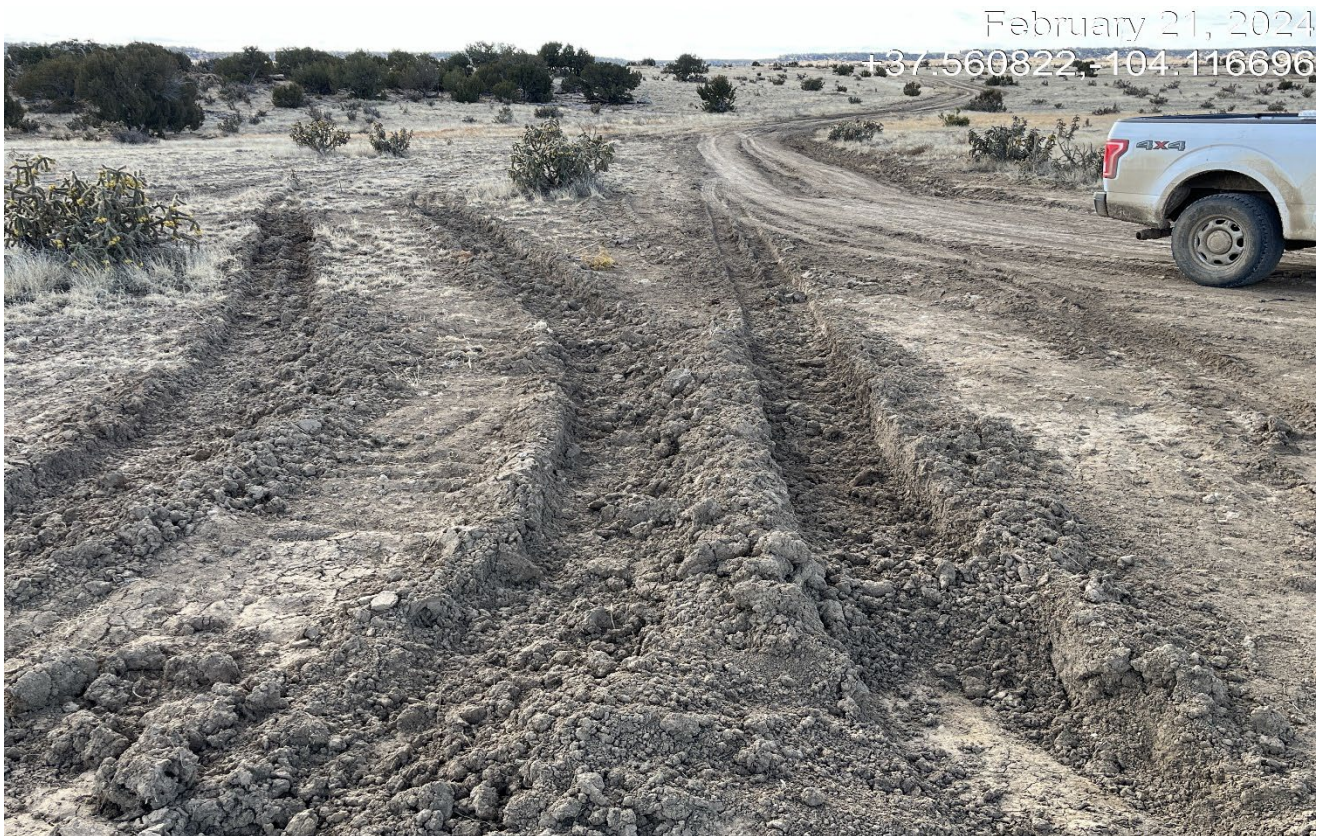
Photo 4. The vehicle ruts that went outside of the road will need to be raked and seeded..

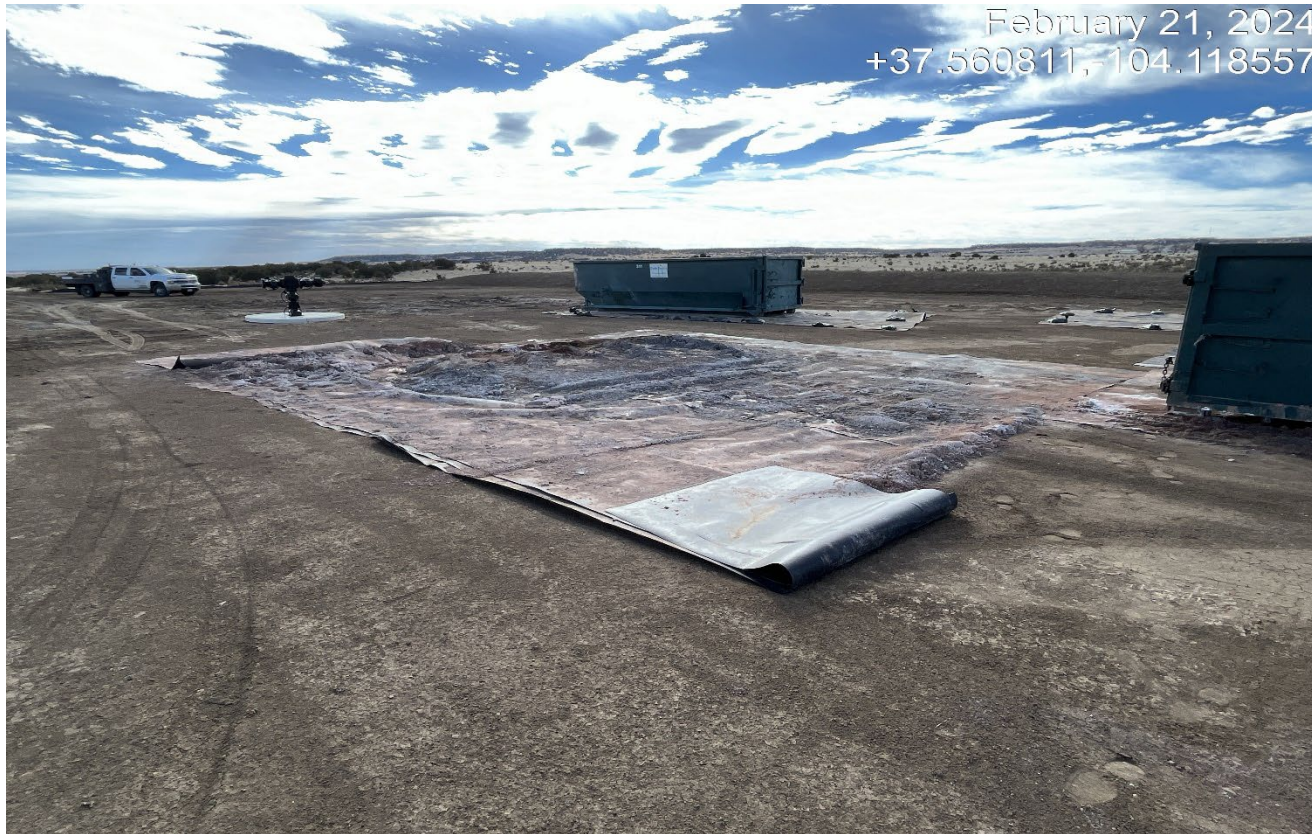
Photo 6. The drill cuttings are not properly stored with containment and have spread off the liner.

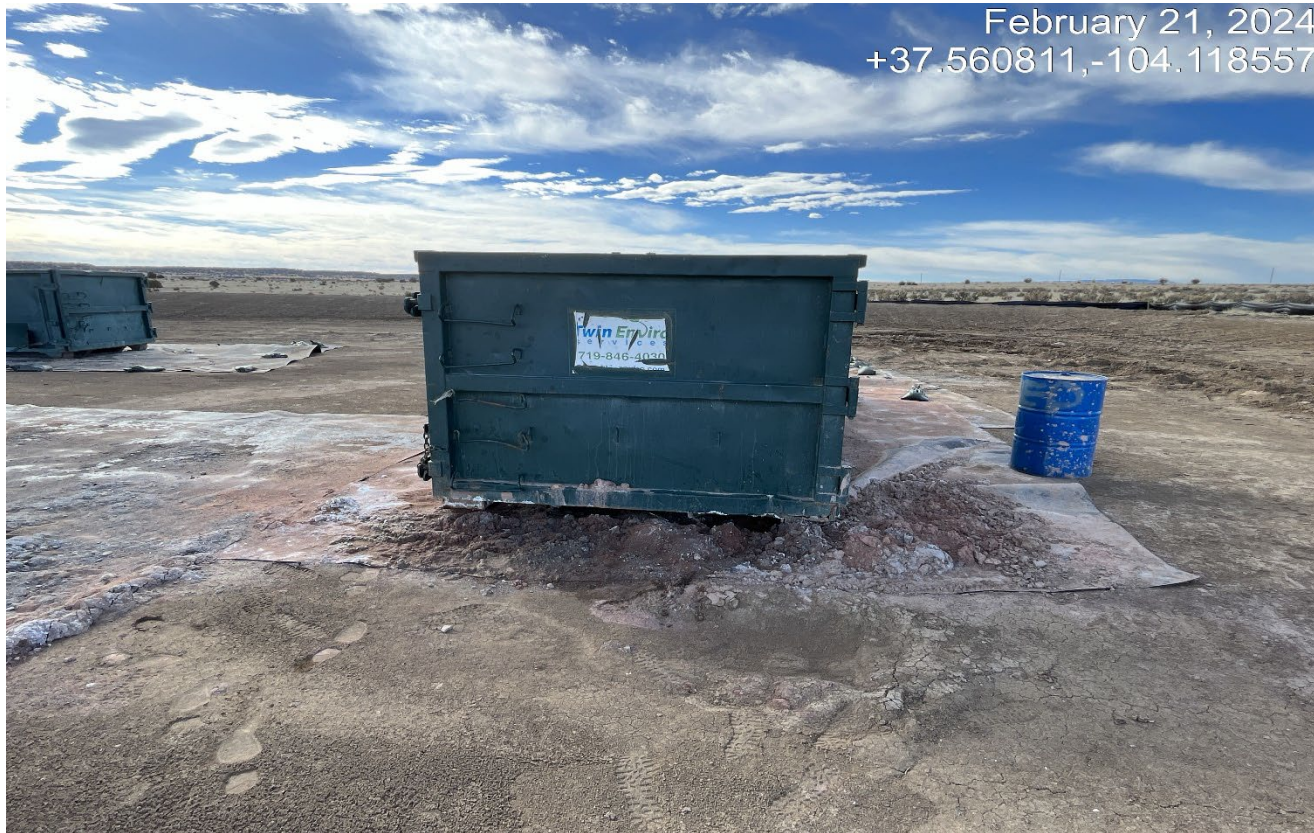
Photo 7. The containers are filled with drill cuttings and appear to be leaking out from the back gate. The drill cuttings are not properly stored with containment and have spread off the liner.

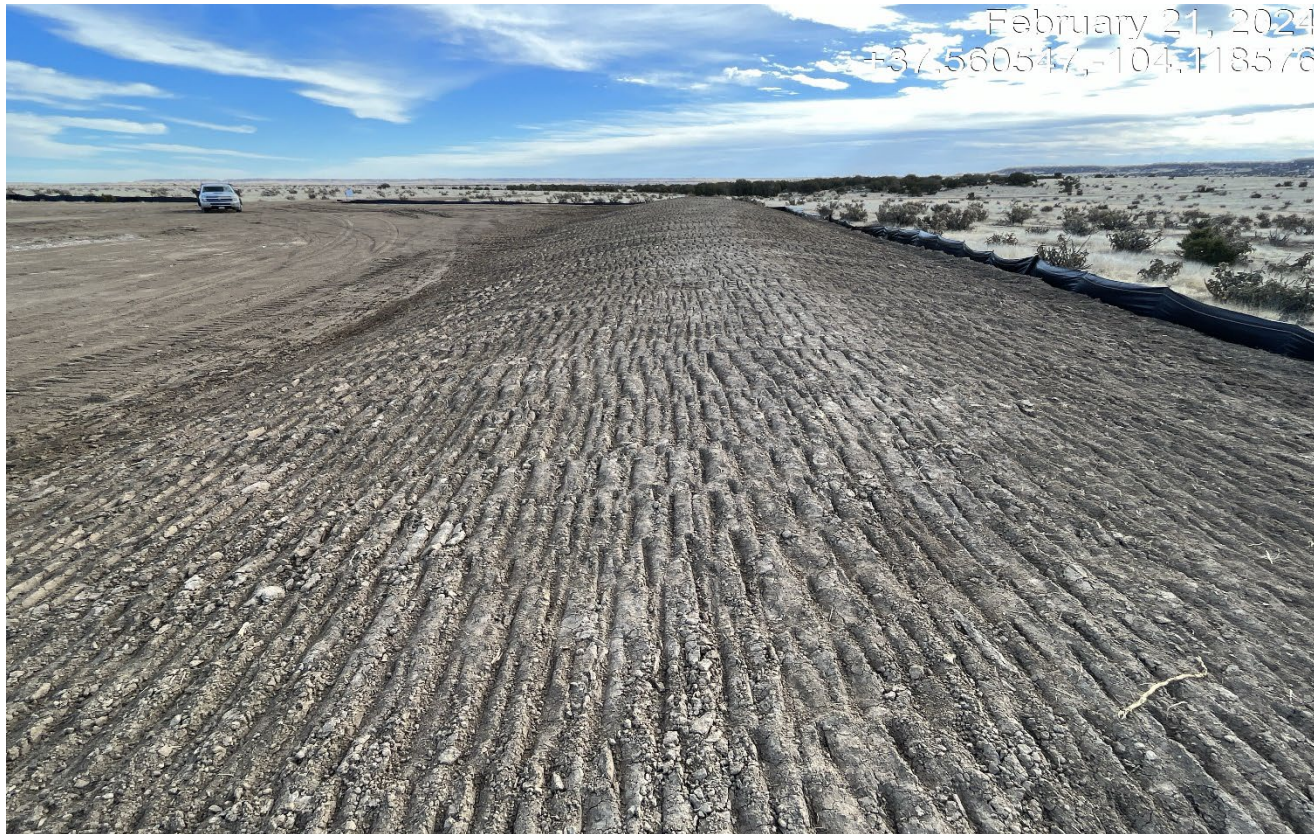
Photo 8. Facing toward the soil stock pile. The stock pile will need to be seeded before the growing season unless it will be re-spread for reclamation before that time.
