Interim Reclamation and Stormwater Inspection

Inspection Document #: 713900397

Location Name: Anschutz Equus Farms

#4-62-9_10 North

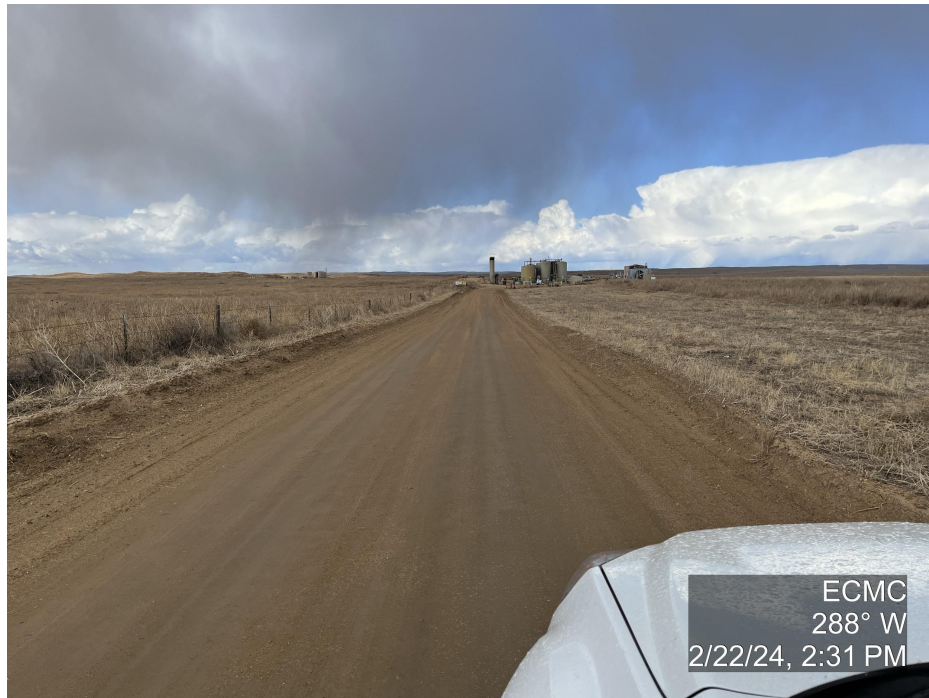
Photo 1. The photo was taken at the entrance to the facility along the access road facing West. The photo illustrates the access road has no stormwater issues at this time.

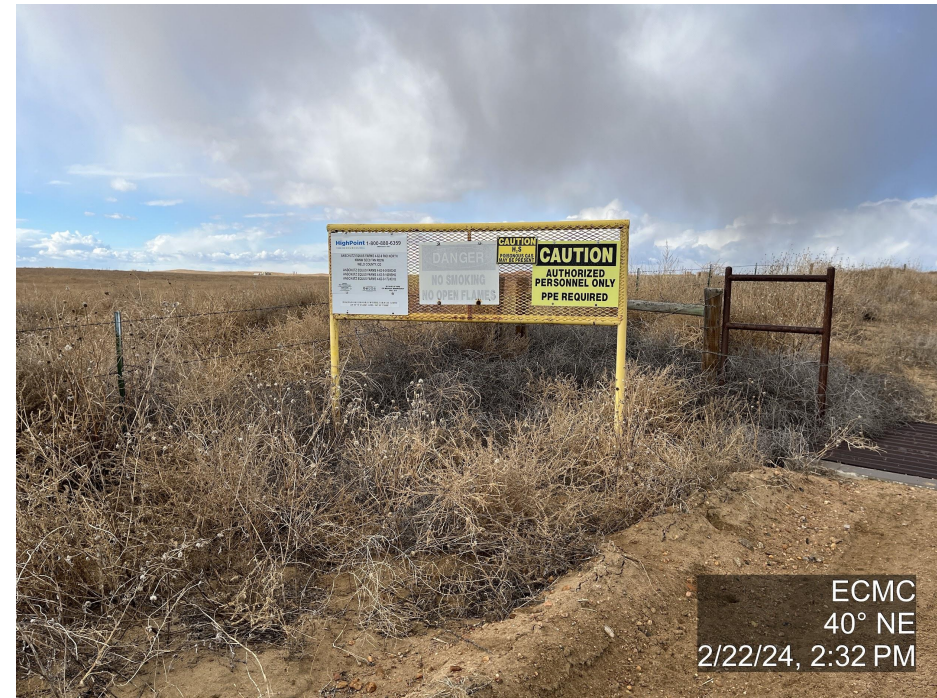
Photo 2. The photo was taken at the entrance to the facility facing Northeast. The photo illustrates the operator sign and warning signage.

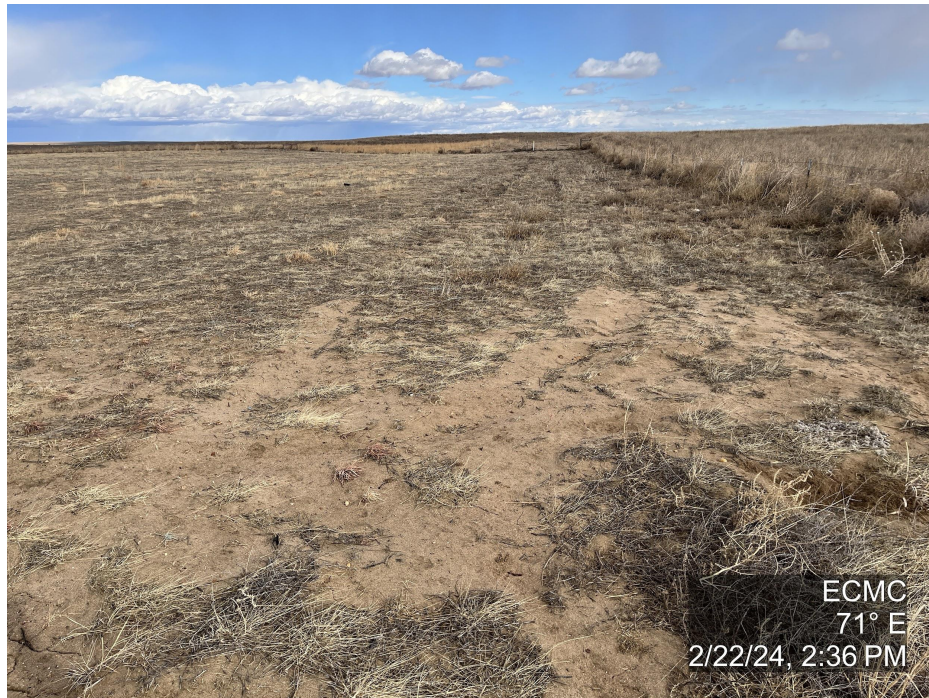
Photo 3. The photo was taken at the well location facing East. The photo illustrates interim areas are being managed actively by evidence of mowing.

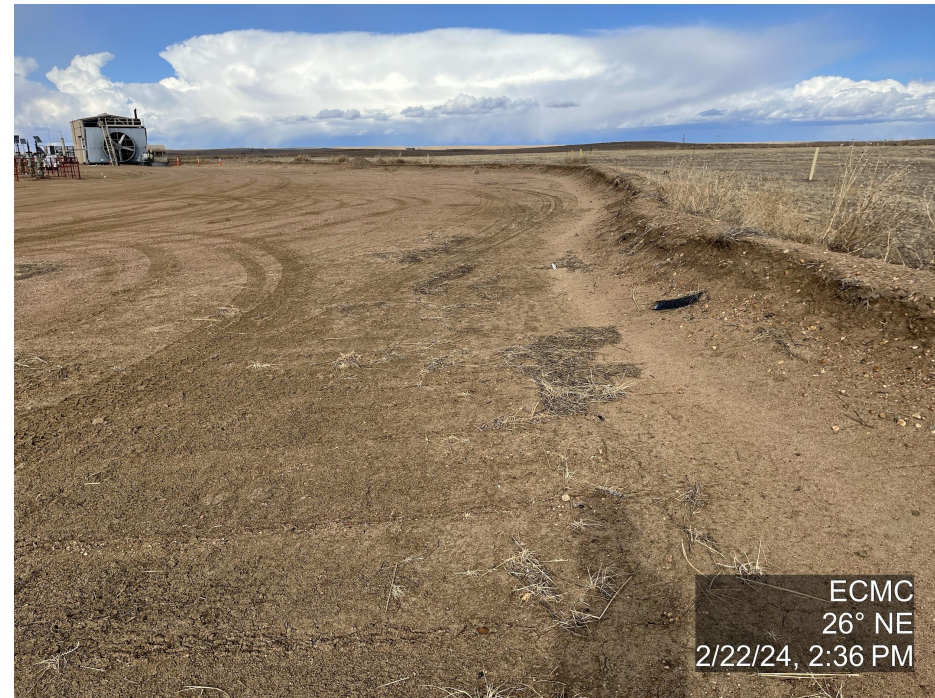
Photo 4. The photo was taken at the well location facing Northeast. The photo illustrates the boundary of the production pad being stabilized by a gravel berm.

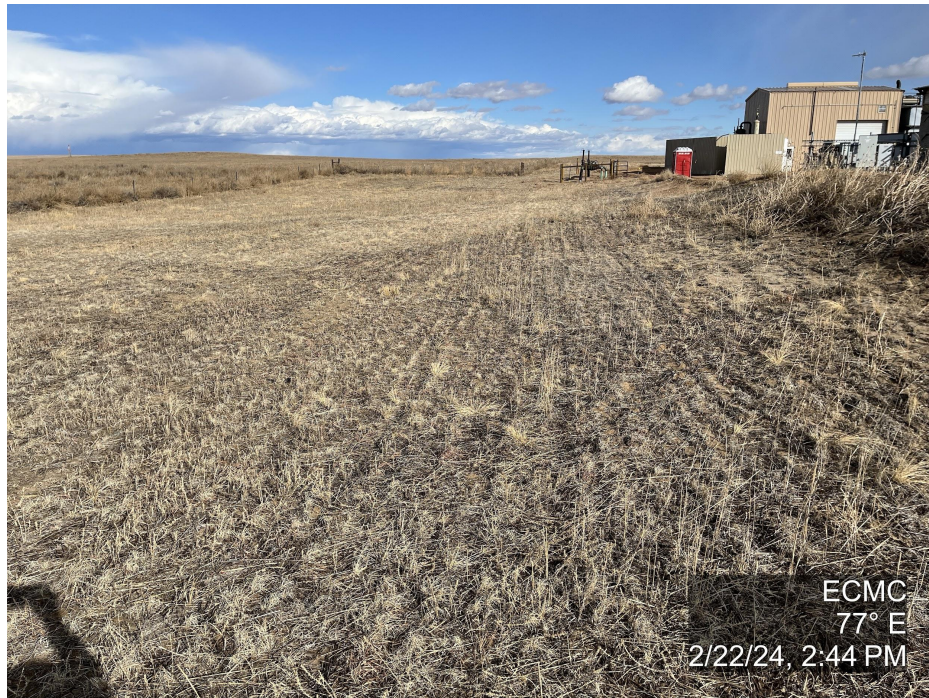
Photo 7. The photo was taken at the well location facing East..
Refer to the comment for photo 3.

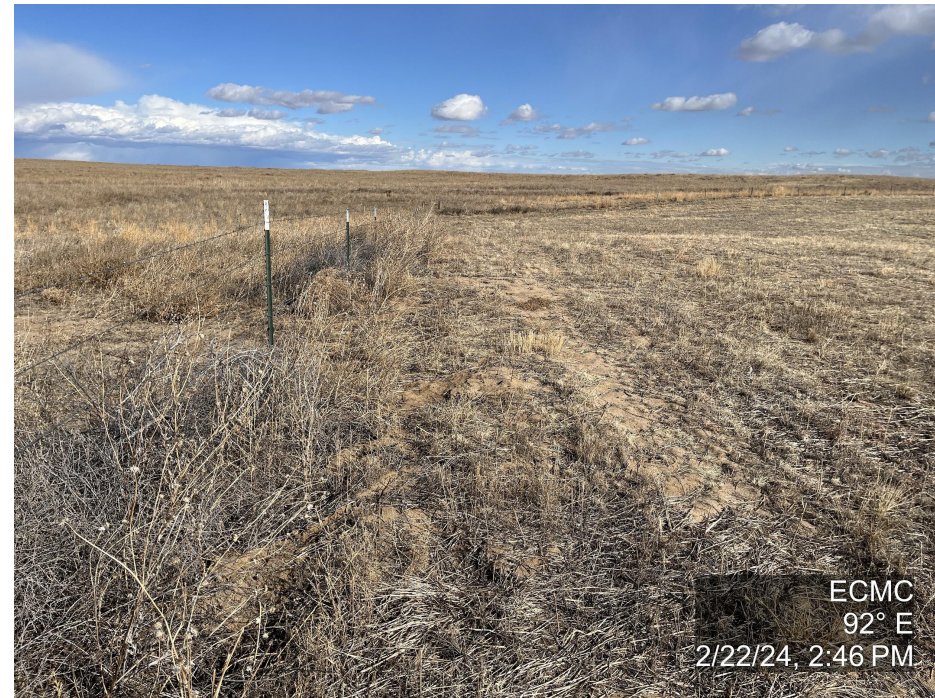
Photo 8. The photo was taken at the well location facing East.
Refer to the comment for photo 3.

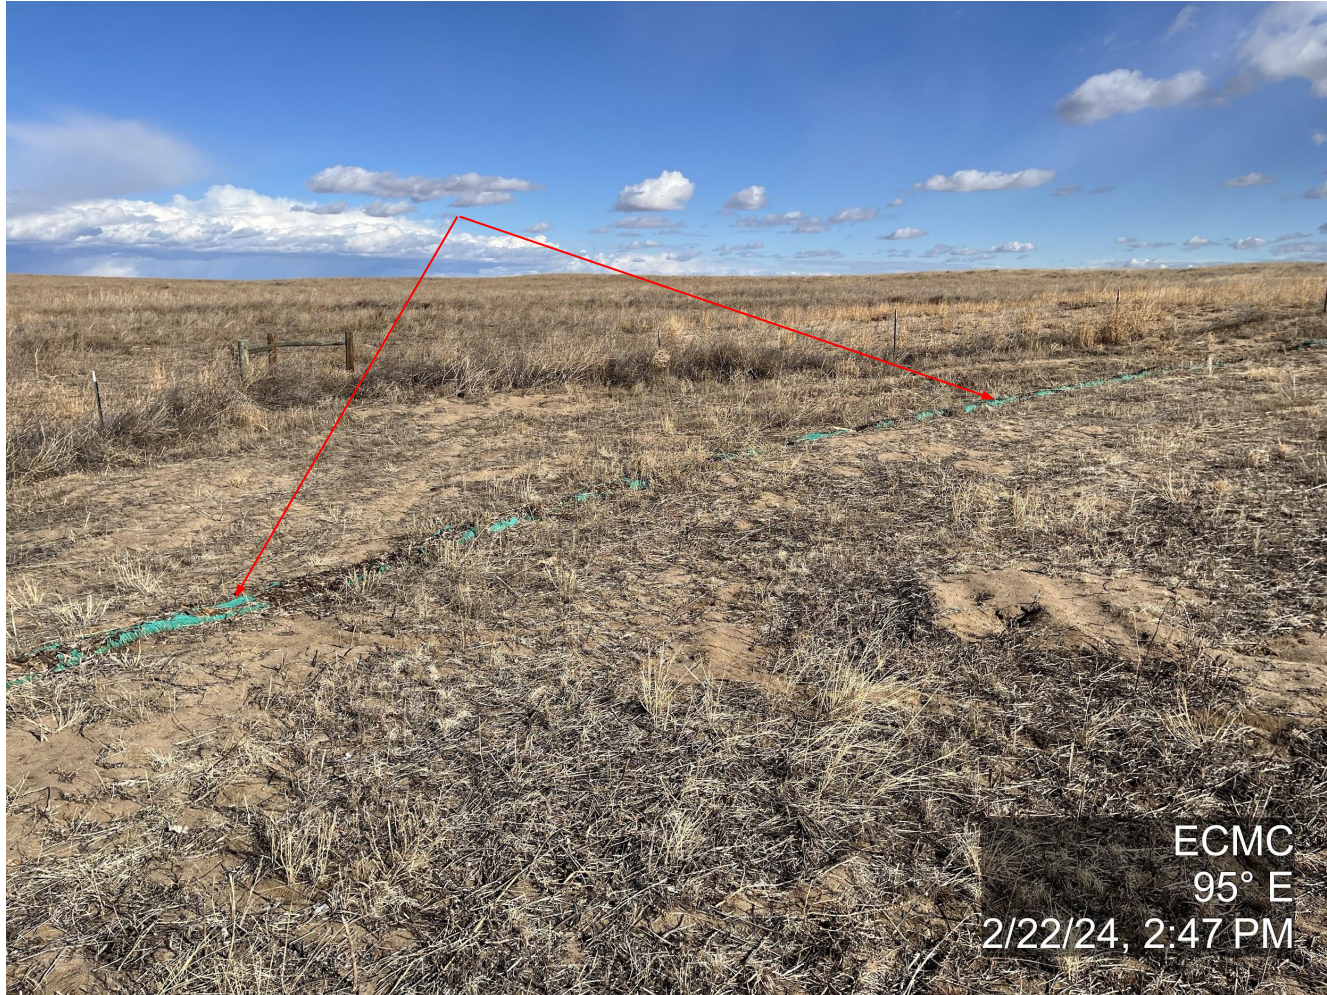
Photo 9. The photo was taken at the well location facing East. The photo illustrates degraded wattle in the Northeast corner of the facility that now is considered debris.
