**Operator: CRESTONE PEAK RESOURCES OPERATING LLC**

**Location Name: Sam 25H-M166**

**Loc ID: 453474**

**Inspection: 709400793**

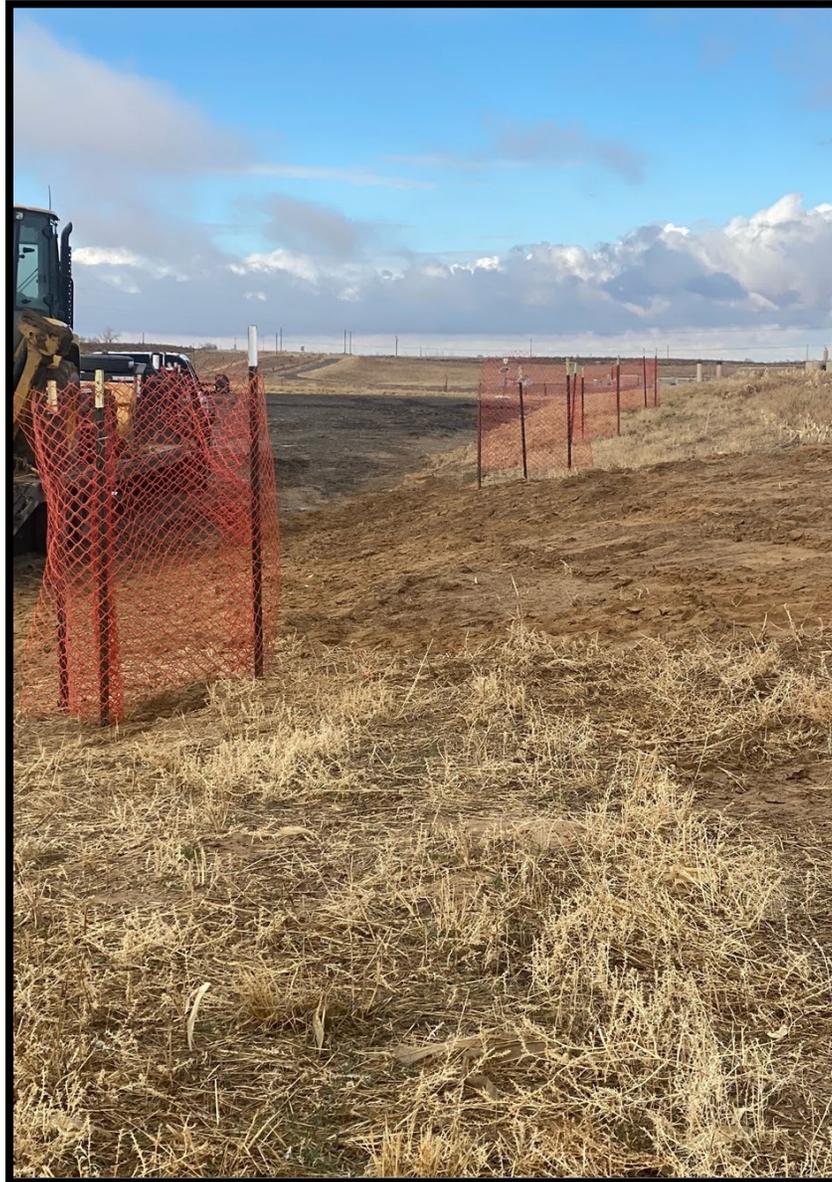
**Exhibit A**

**CA:** Lacking proper fencing around potholes on tank battery perimeter, causing danger or wildlife and human life. Comply with Rule 606.

**CA Resolution:** Operator has reported that fence around sample holes has been repaired to comply with Rule 606.
