**SITE-SPECIFIC QUALITY ASSURANCE
& QUALITY CONTROL AUDIT**

PERMIT CLOSURE REPORT – CROPLAND

Location ID 330432

Location Name Williams 18-16

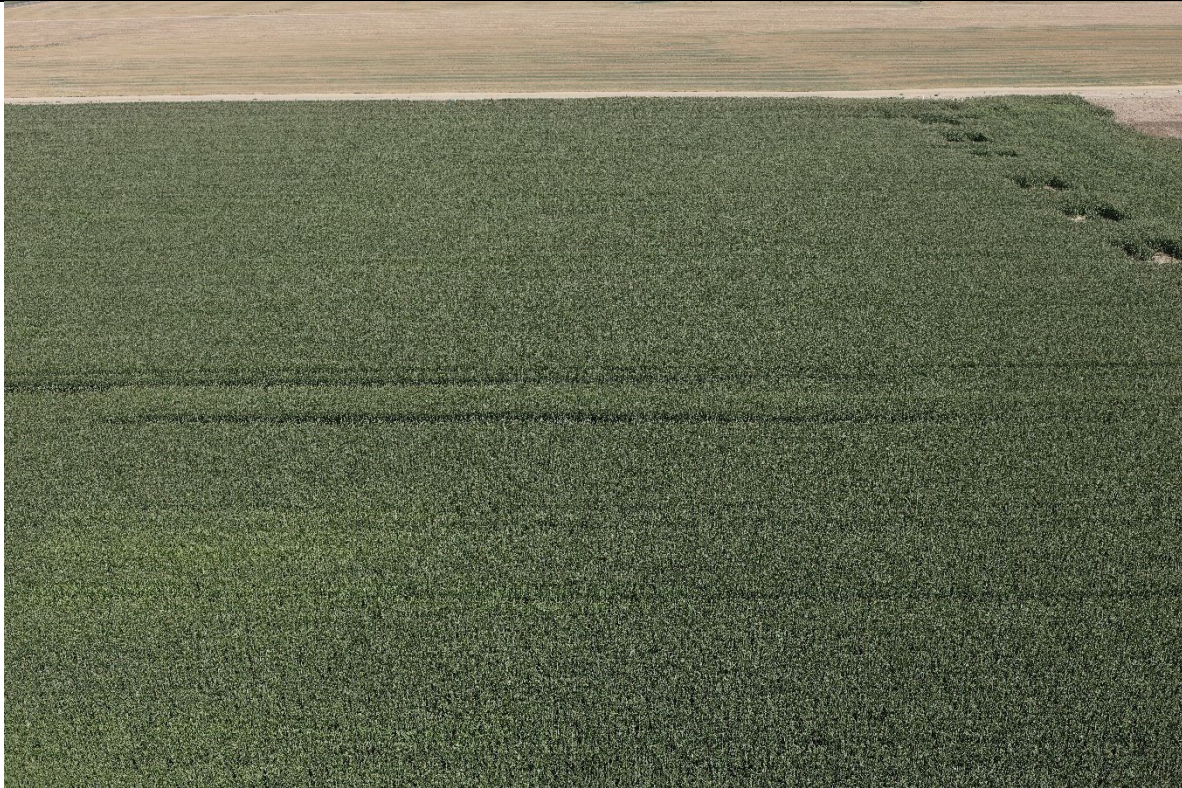
EAST – 40.133933 / -105.041011

In View – Well, Access Road, Flowline

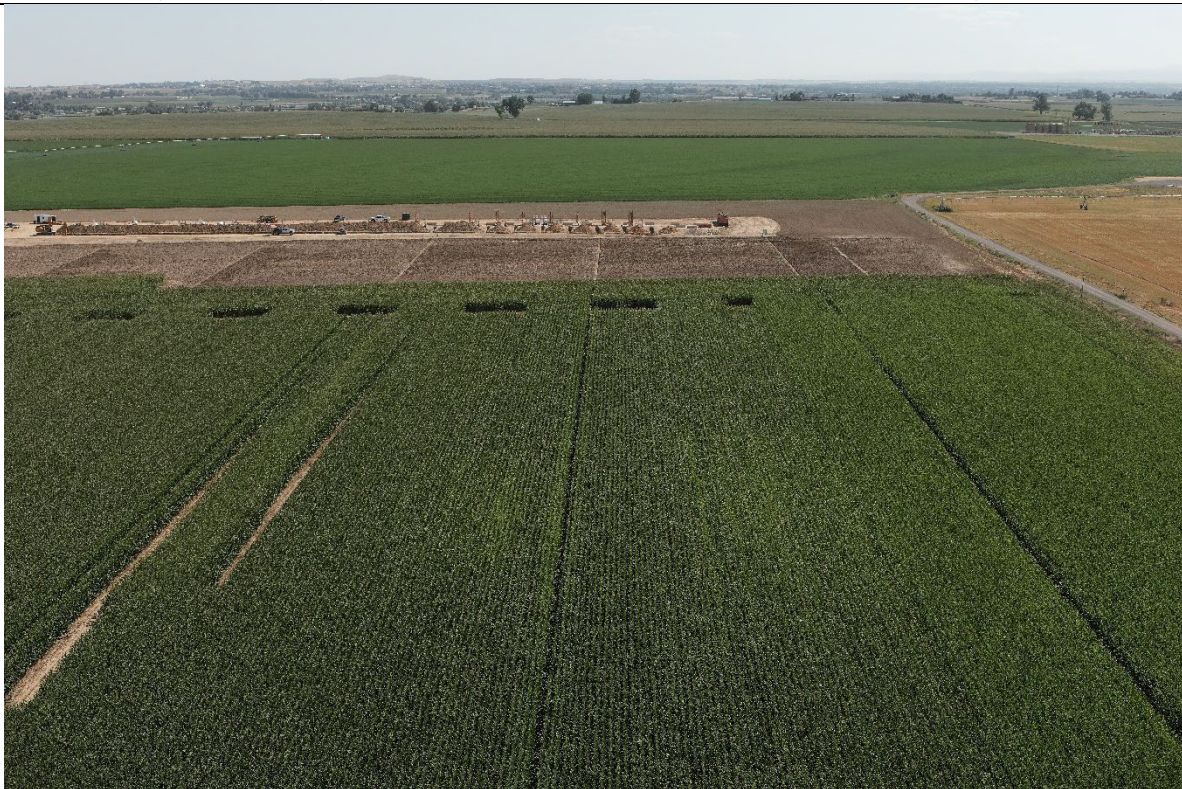
SOUTH – 40.135399 / -105.040214

In View – Well, Access Road, Flowline

*Active Facilities in photo associated with Loc ID [455340](#) Rinn Valley West.

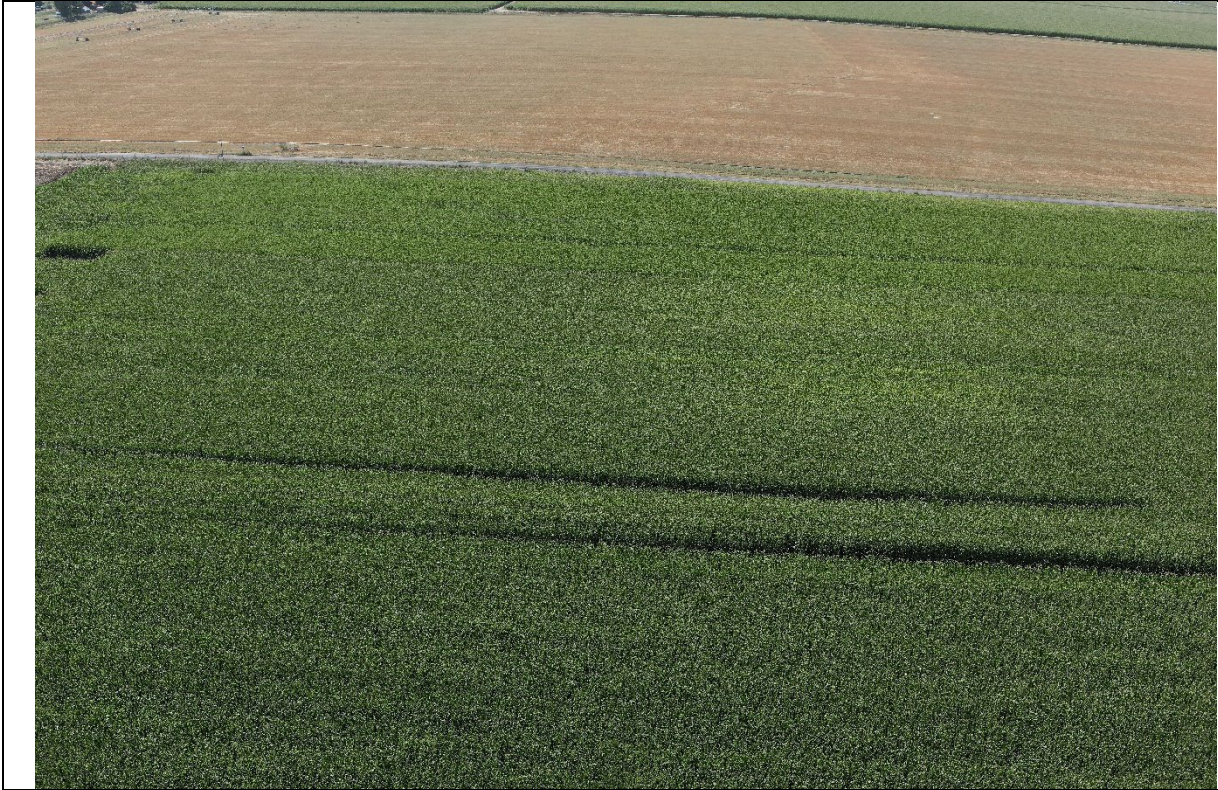
WEST – 40.134068 / -105.038571

In View – Well, Access Road, Flowline

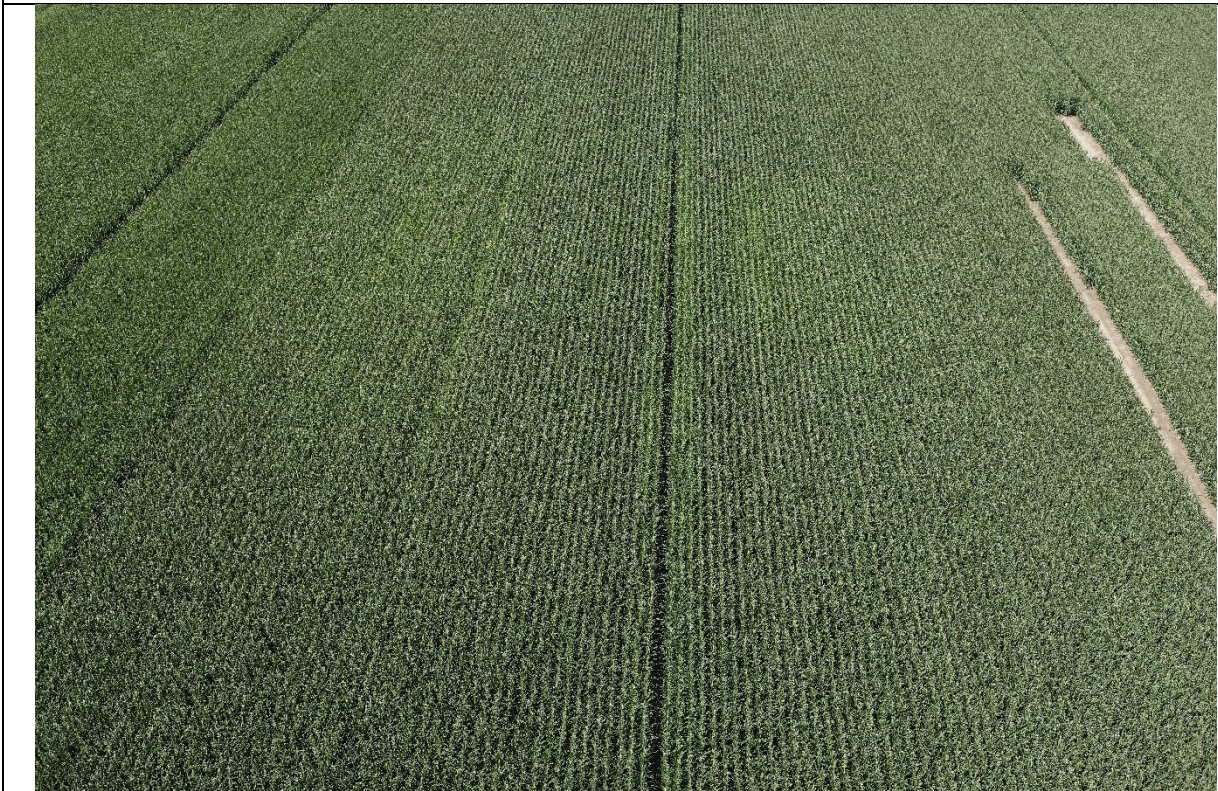
NORTH – 40.133424 / -105.040134

In View – Well, Access Road, Flowline

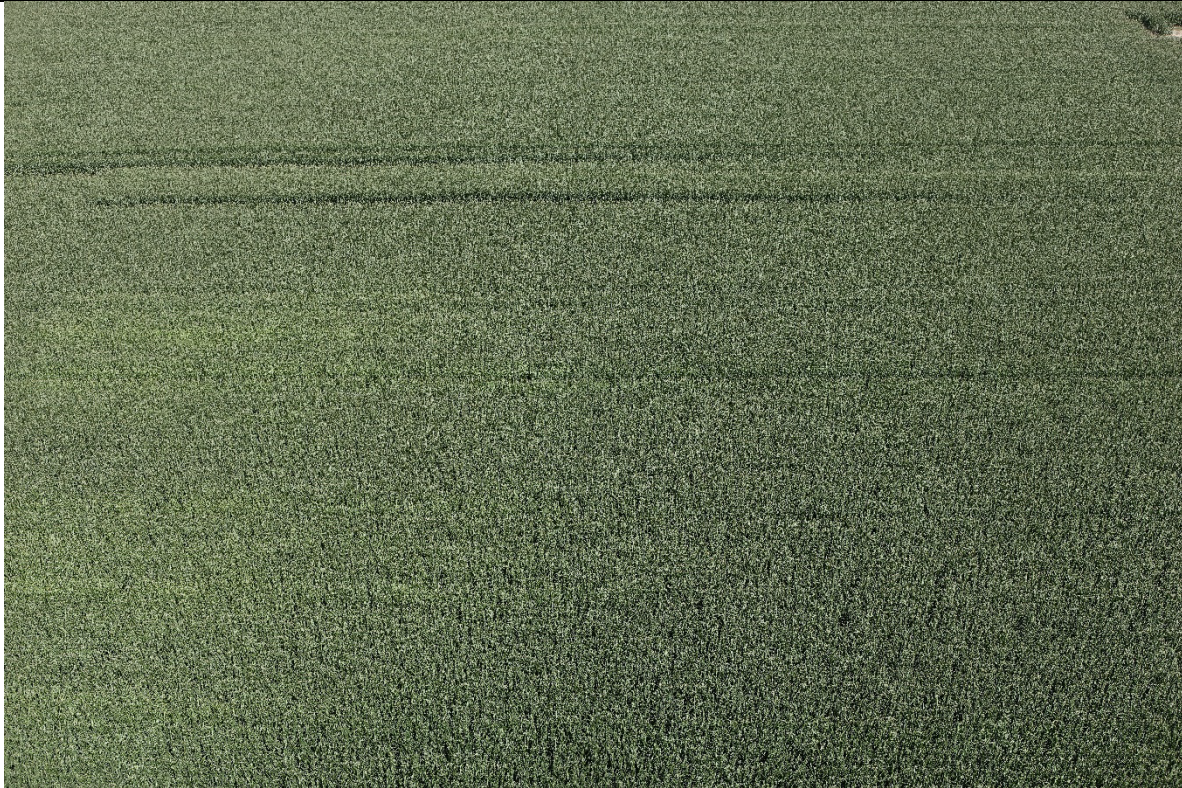
EAST – 40.133935 / -105.041010

In View – Well, Access Road, Flowline

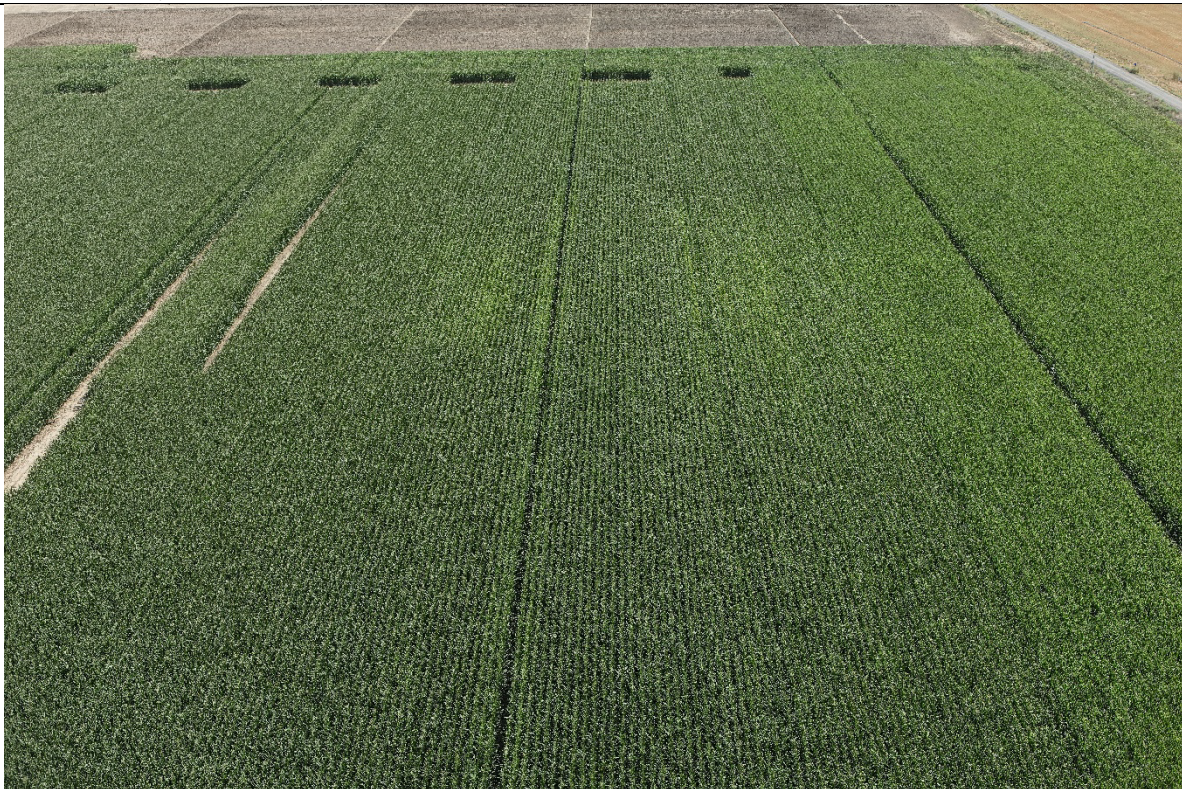
SOUTH – 40.135377 / -105.040218

In View – Well, Access Road, Flowline

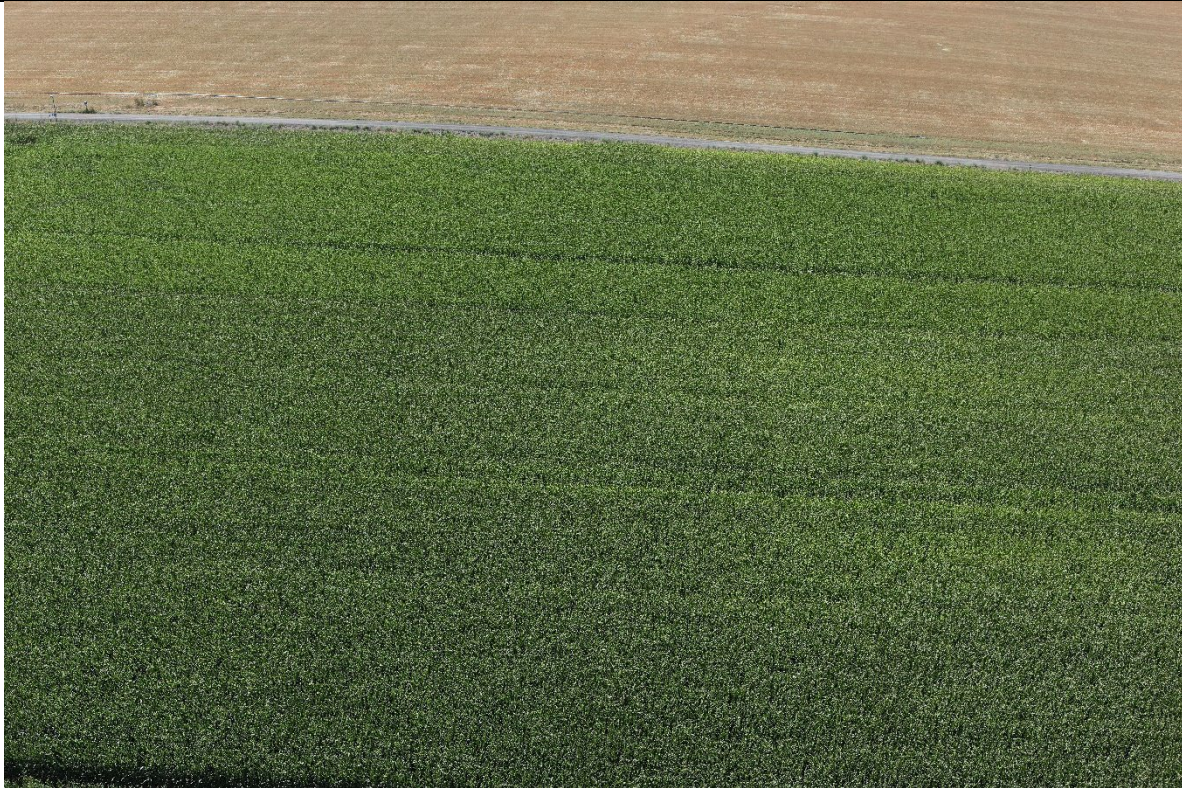
WEST – 40.134061 / -105.039191

In View – Well, Access Road, Flowline

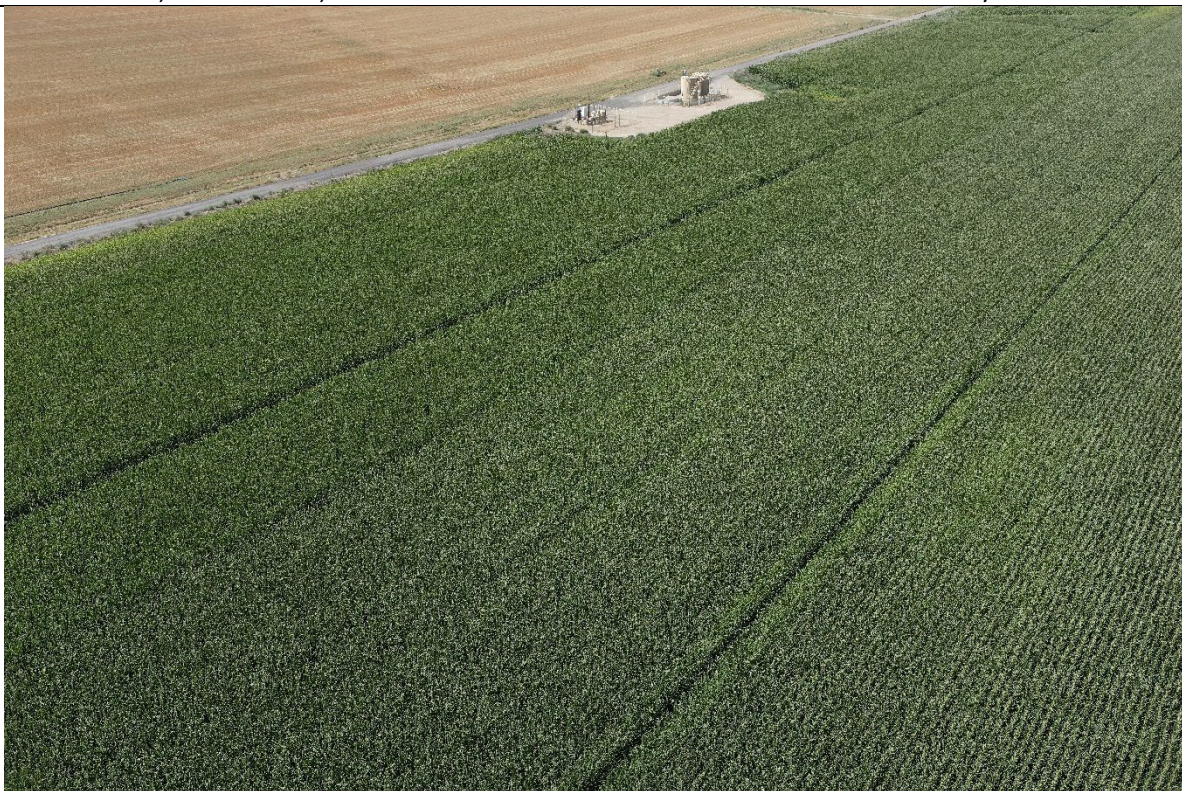
NORTHWEST – 40.133451 / -105.039831

In View – Well, Tank Battery, Access Road, Flowline

*Active Facilities in photo associated with Loc ID [458552](#) Williams 18-16.

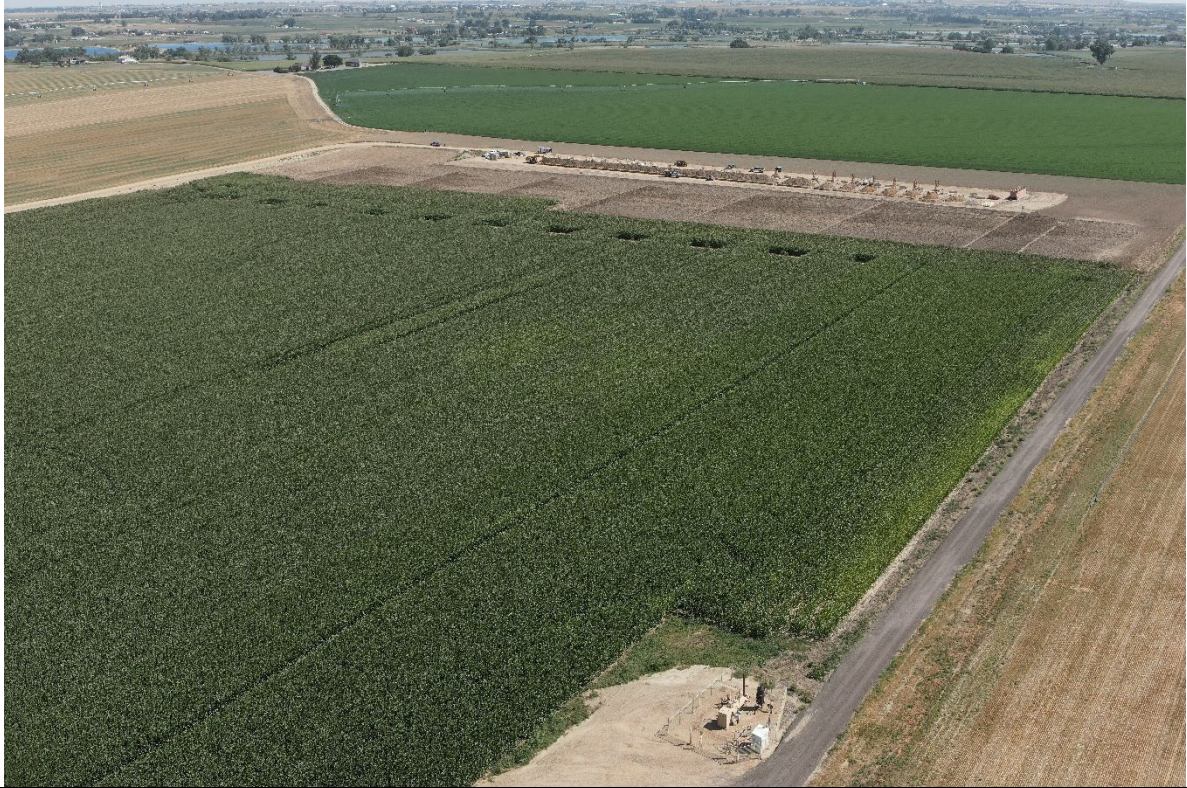
In View – Well, Tank Battery, Access Road, Flowline **SOUTHEAST** – 40.136105 / -105.041878
*Active Facilities in photo associated with Loc ID [455340](#) Rinn Valley West.

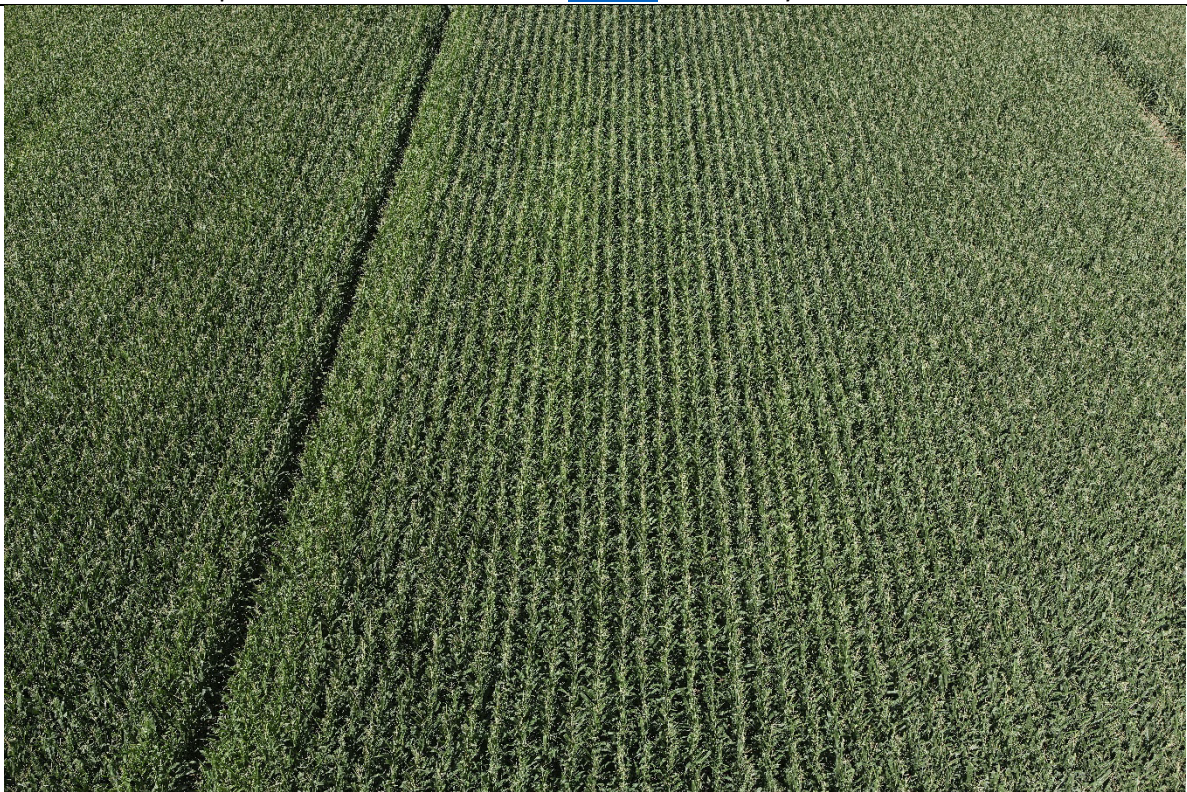
In View – Crop **OVERHEAD** – 40.133908 / -105.040031

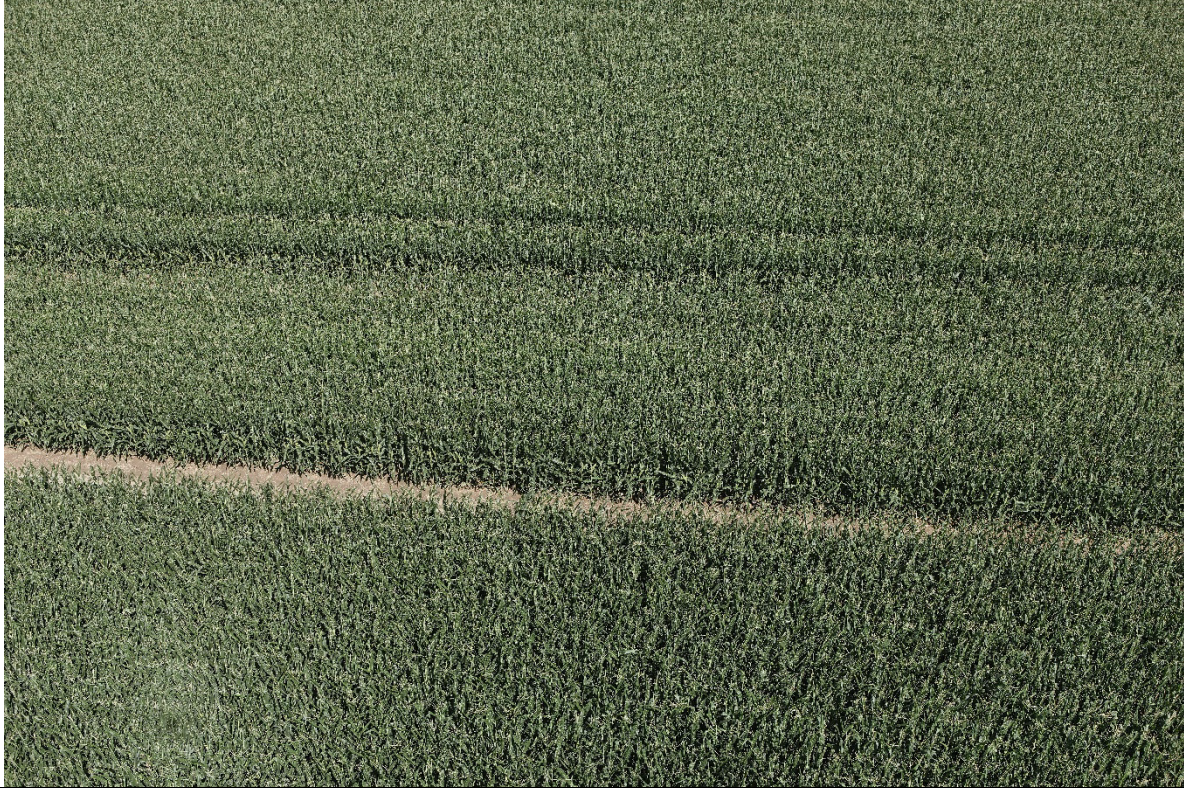
OVERHEAD – 40.133906 / -105.040027

In View – Crop

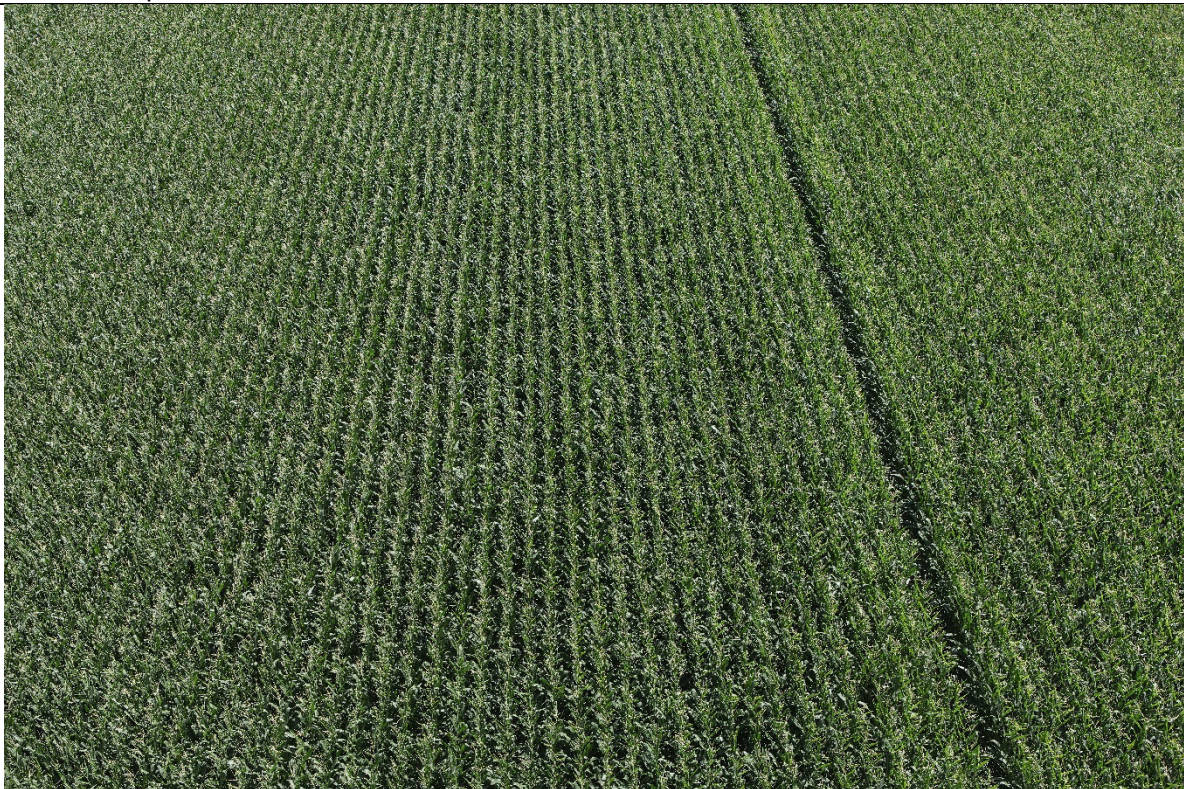
OVERHEAD – 40.133908 / -105.040032

In View – Crop

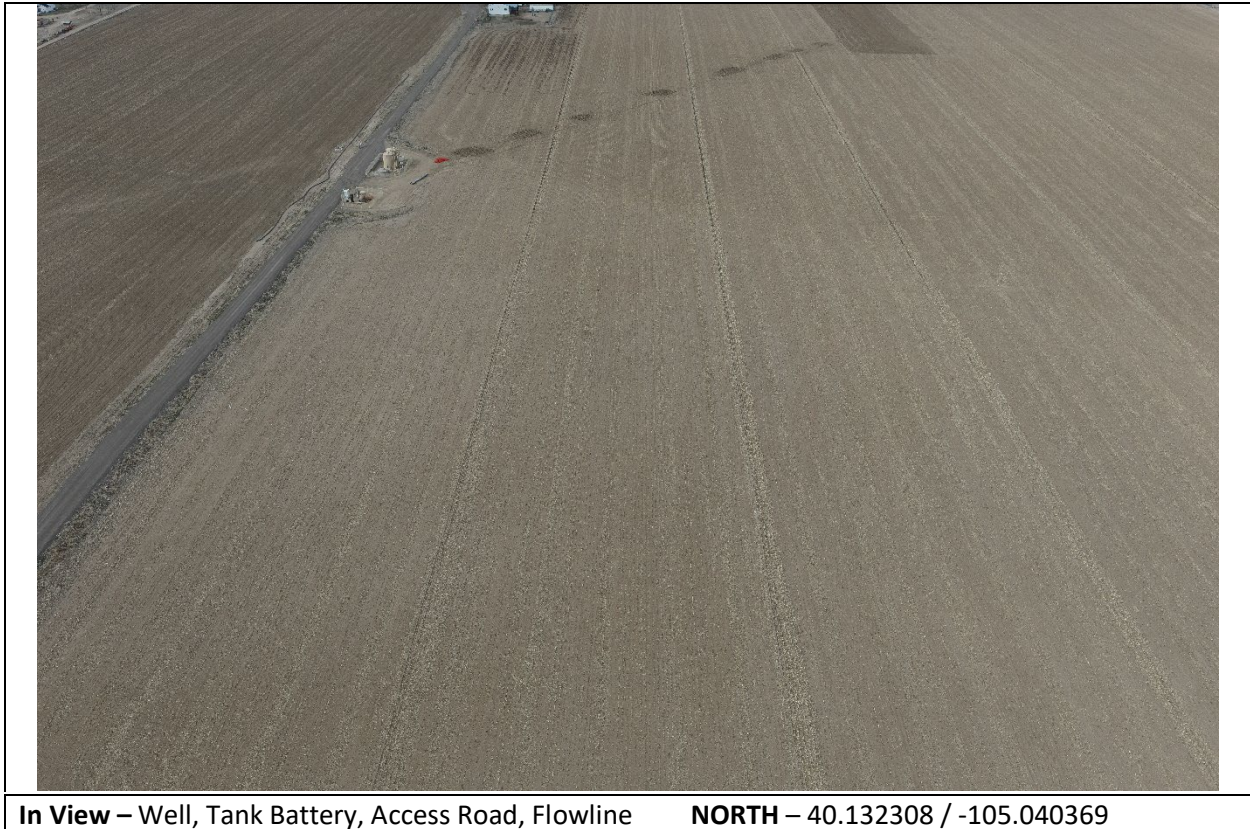
NORTH – 40.132308 / -105.040369

Cardinal directional photos of the site. Reference overview map. No Equipment at the Well.

In View – Well, Tank Battery, Access Road, Flowline

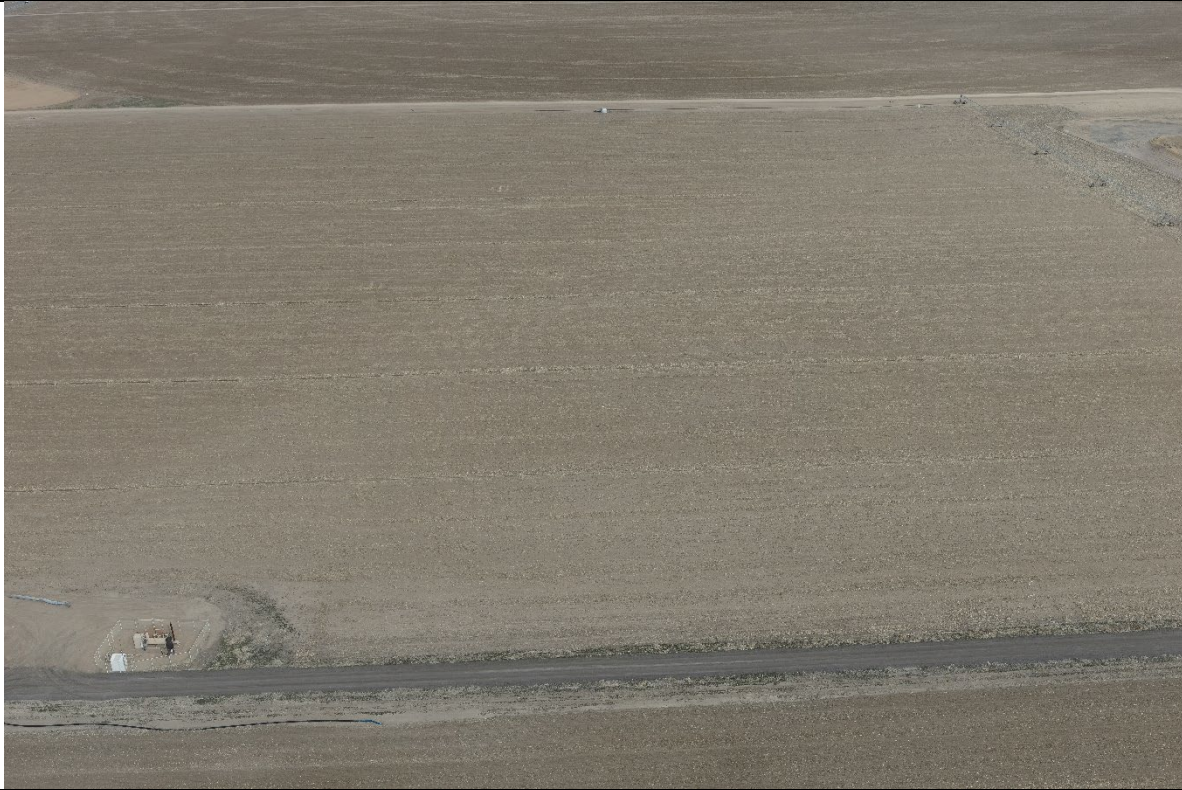
In View – Well, Tank Battery, Access Road, Flowline **EAST** – 40.134624 / -105.042964

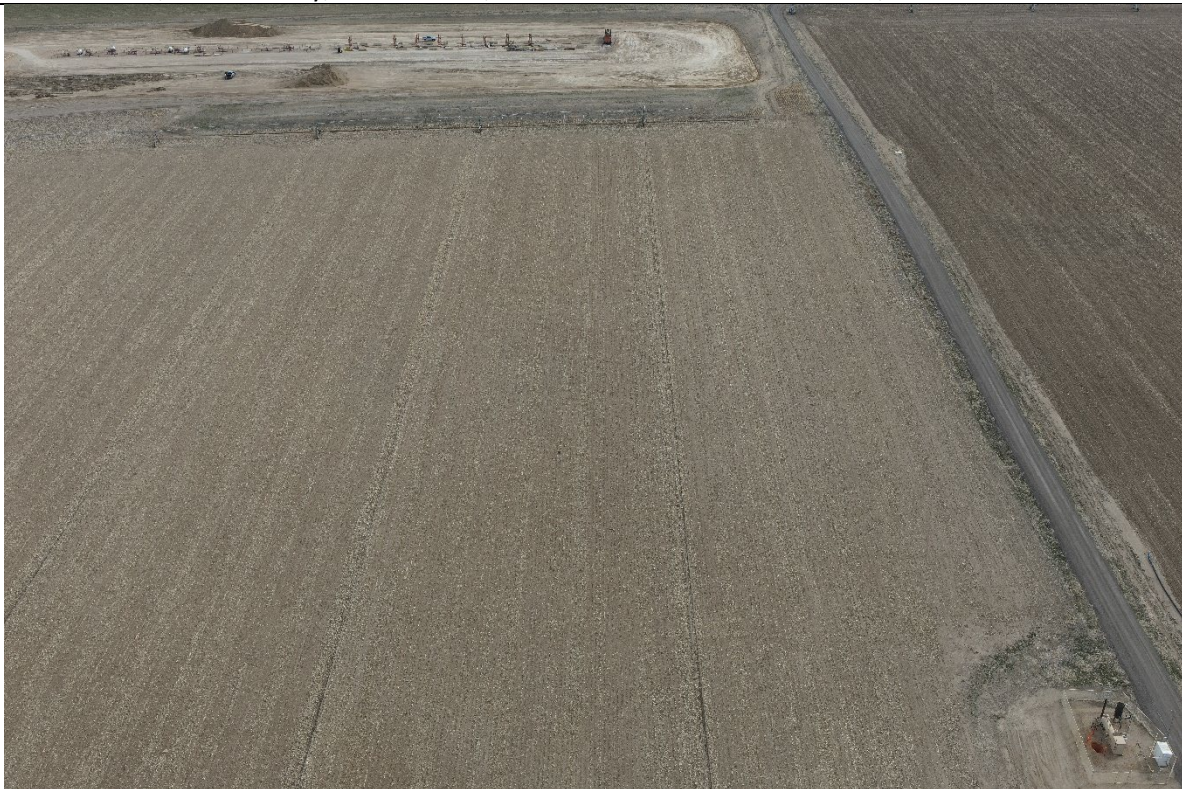
In View – Well, Tank Battery, Access Road, Flowline **SOUTH** – 40.136118 / -105.040593

*Active Facilities in photo associated with Loc ID [455340](#) Rinn Valley West.

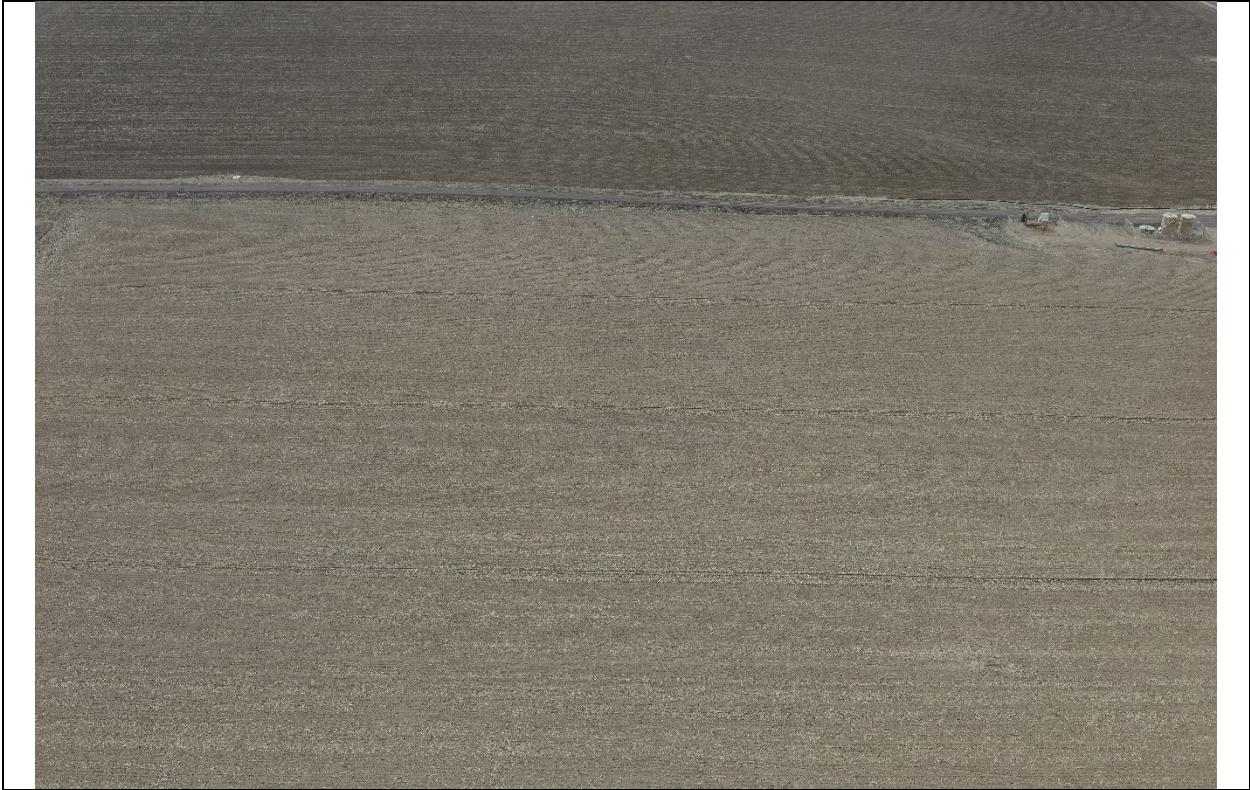
In View – Well, Tank Battery, Access Road, Flowline **WEST** – 40.134237 / -105.037934

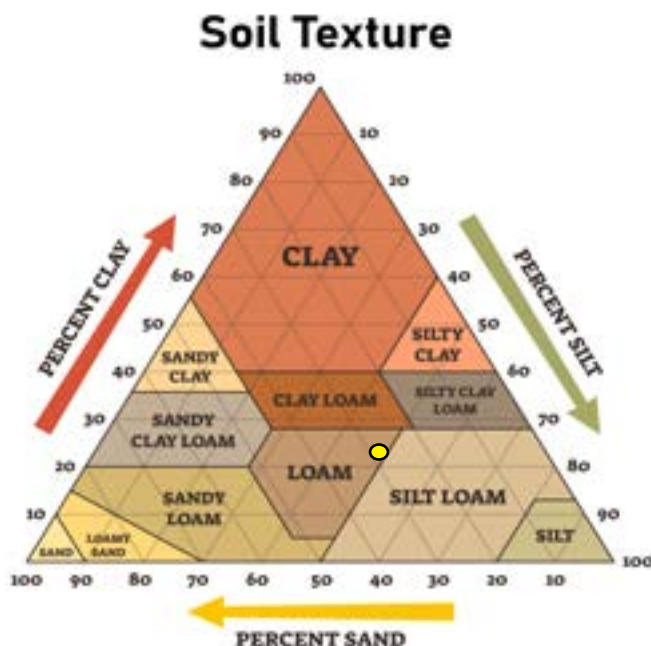
Soil Texture Triangle reflect the 0-10 in depth

Depth (in)	Physical			Chemical			
	Texture	Bulk Density	Partical Size Percent sand, silt, clay	pH	EC	SAR	OM%
0-10	Loam	1.30	29-49-21	7.9	0.0	0.0	1.11
10-20	Silt Loam	1.23	9-68-23	7.9	0.0	0.0	0.75
20-30	Silt Loam	1.23	9-68-23	7.9	0.0	0.0	0.75
30-40	Silt Loam	1.23	9-68-23	7.9	0.0	0.0	0.75
40-50	Silt Loam	1.23	9-68-23	7.9	0.0	0.0	0.75
50 +	Silt Loam	1.23	9-68-23	7.9	0.0	0.0	0.75

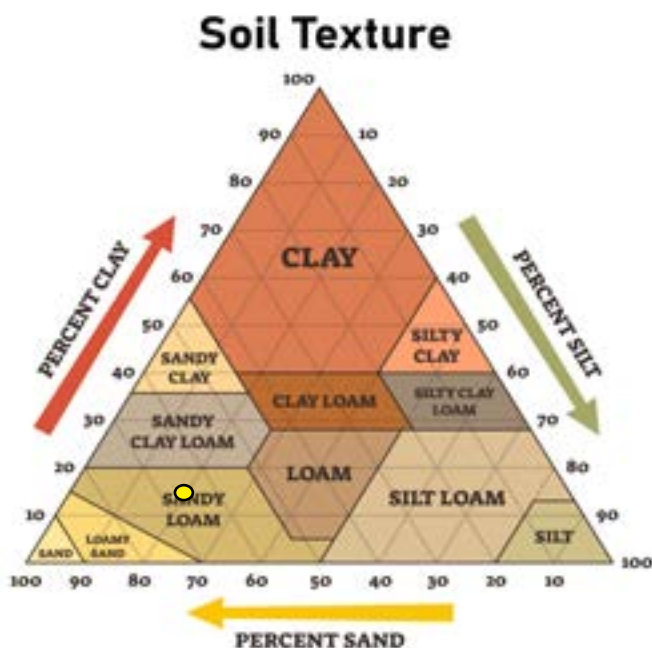
Soil Texture Triangle reflect the 0-10 in depth

Depth (in)	Physical			Chemical			
	Texture	Bulk Density	Partical Size Percent sand, silt, clay	pH	EC	SAR	OM%
0-10	Fine Sandy Loam	1.43	65-20-15	7.2	0.0	0.0	0.75
10-20	Sandy Clay Loam	1.23	56-17-27	7.2	0.0	0.0	0.75
20-30	Sandy Clay Loam	1.41	62-22-16	8.3	1.0	0.0	0.25
30-40	Fine Sandy Loam	1.50	64-26-10	8.5	1.0	0.0	0.25
40-50	Fine Sandy Loam	1.50	64-26-10	8.5	1.0	0.0	0.25
50 +	Fine Sandy Loam	1.50	64-26-10	8.5	1.0	0.0	0.25
