Operator: Highpoint Resources

Location Name: Anschutz Equus Farms 4-62-9_10 North

Loc ID: 433642

Inspection: 713900397

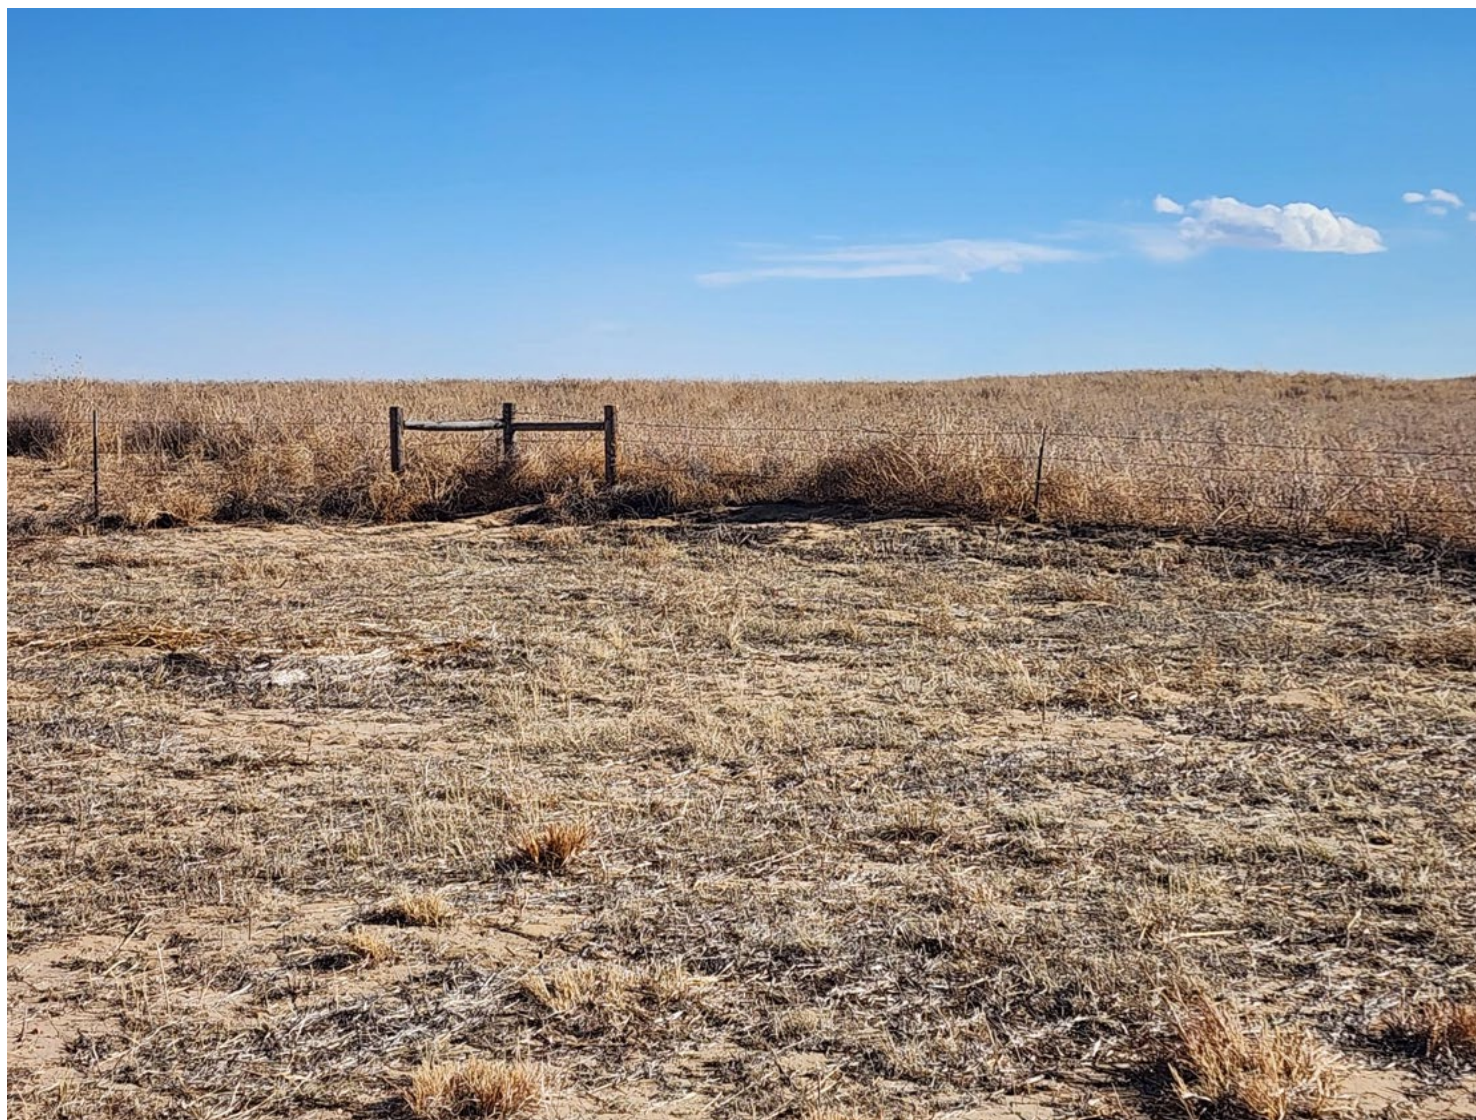
Exhibit A

CA: Wattle in the Northeast corner of the facility has degraded and is no longer functioning as a stormwater BMP and is now considered debris. Replace or remove the BMP per Rule 606.

CA Resolution: Wattle has been installed to comply with Rule 606.
