**SITE-SPECIFIC QUALITY ASSURANCE
& QUALITY CONTROL AUDIT**

PERMIT CLOSURE REPORT – CROPLAND

Location Name ROTHE-65N63W/31SWSW

5 Feb 2024

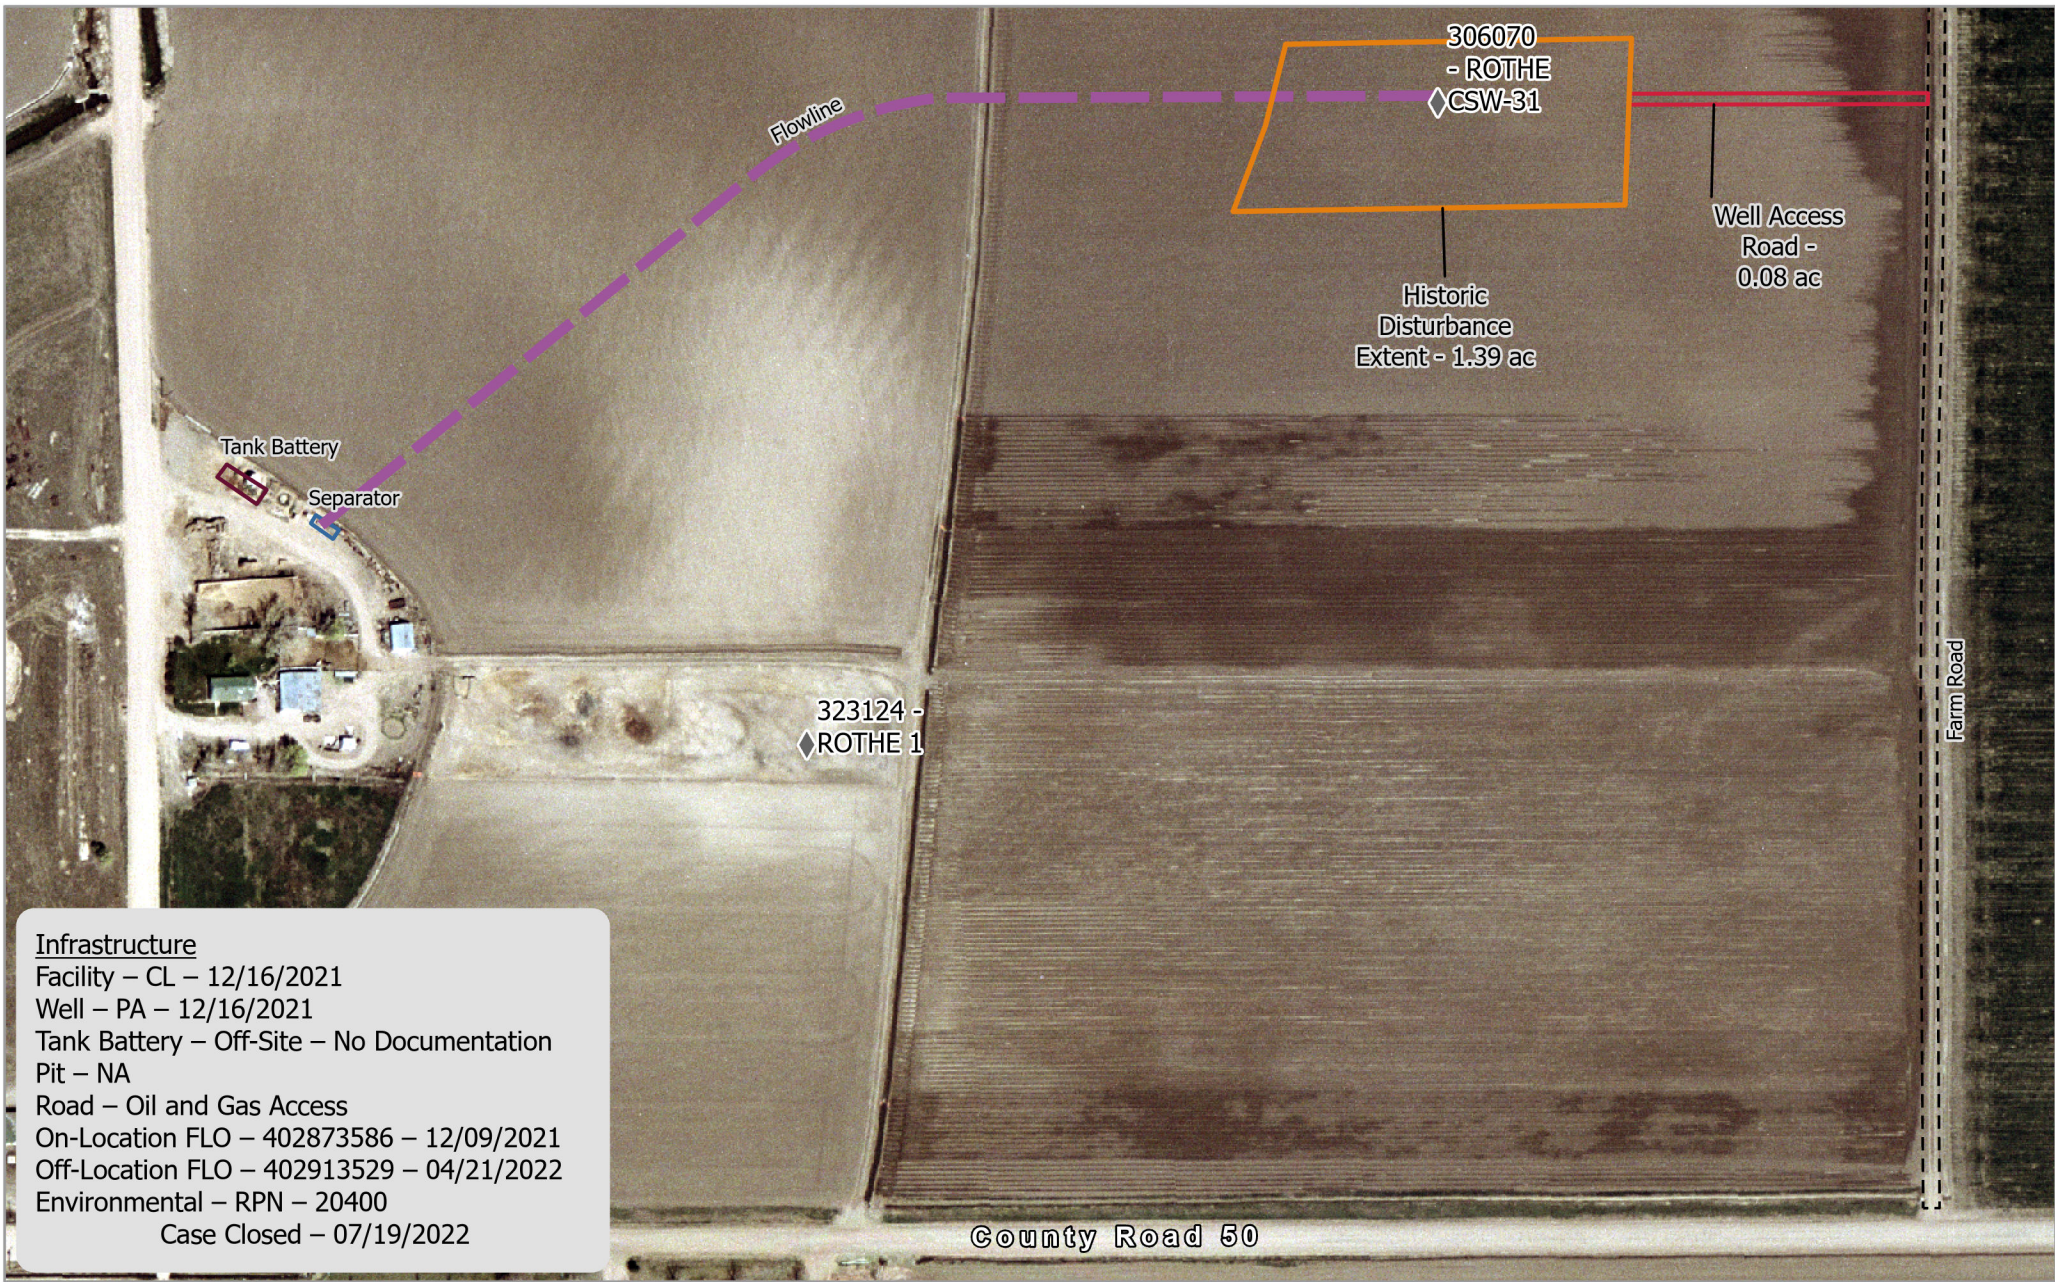
**CIV - 306070- ROTHE CSW-31
 Map Extent - Pre-Infrastructure
 Overview**

Imagery: DRCOG
 Imagery Date: 13 Apr 2004
 Map Date: 05 Feb 2024
 Datum: WGS 1984 UTM Zone 13N
 POC: Soil Sage

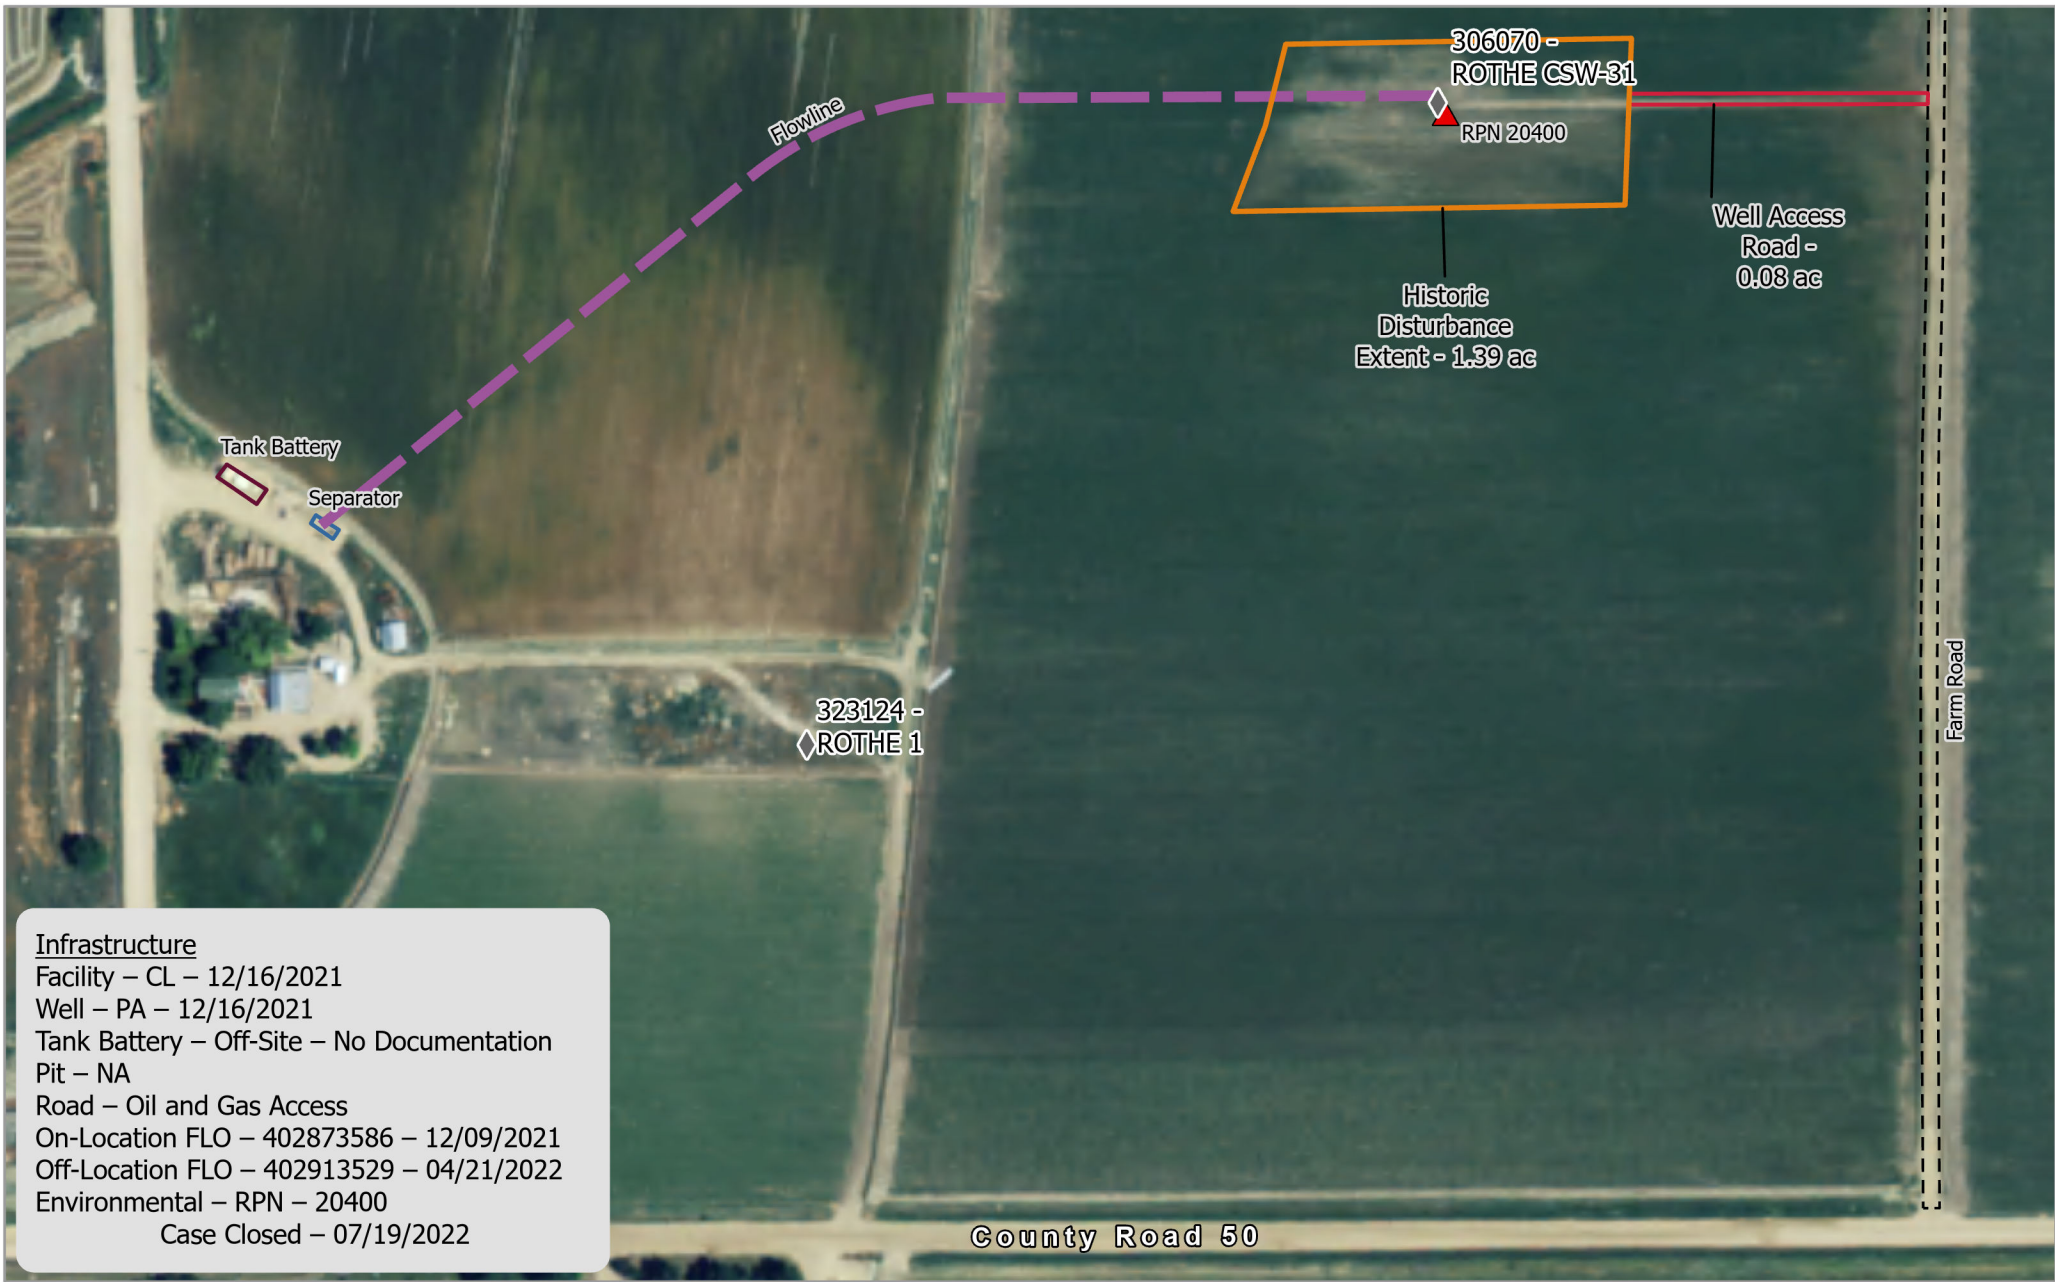
CIV - 306070- ROTHE CSW-31
Map Extent - Pre-Plugging Overview

Imagery: USDA NAIP
 Imagery Date: 2011
 Map Date: 05 Feb 2024
 Datum: WGS 1984 UTM Zone 13N
 POC: Soil Sage

Disturbance Extent: 1.47 Acres
 Scale: 1:2,300

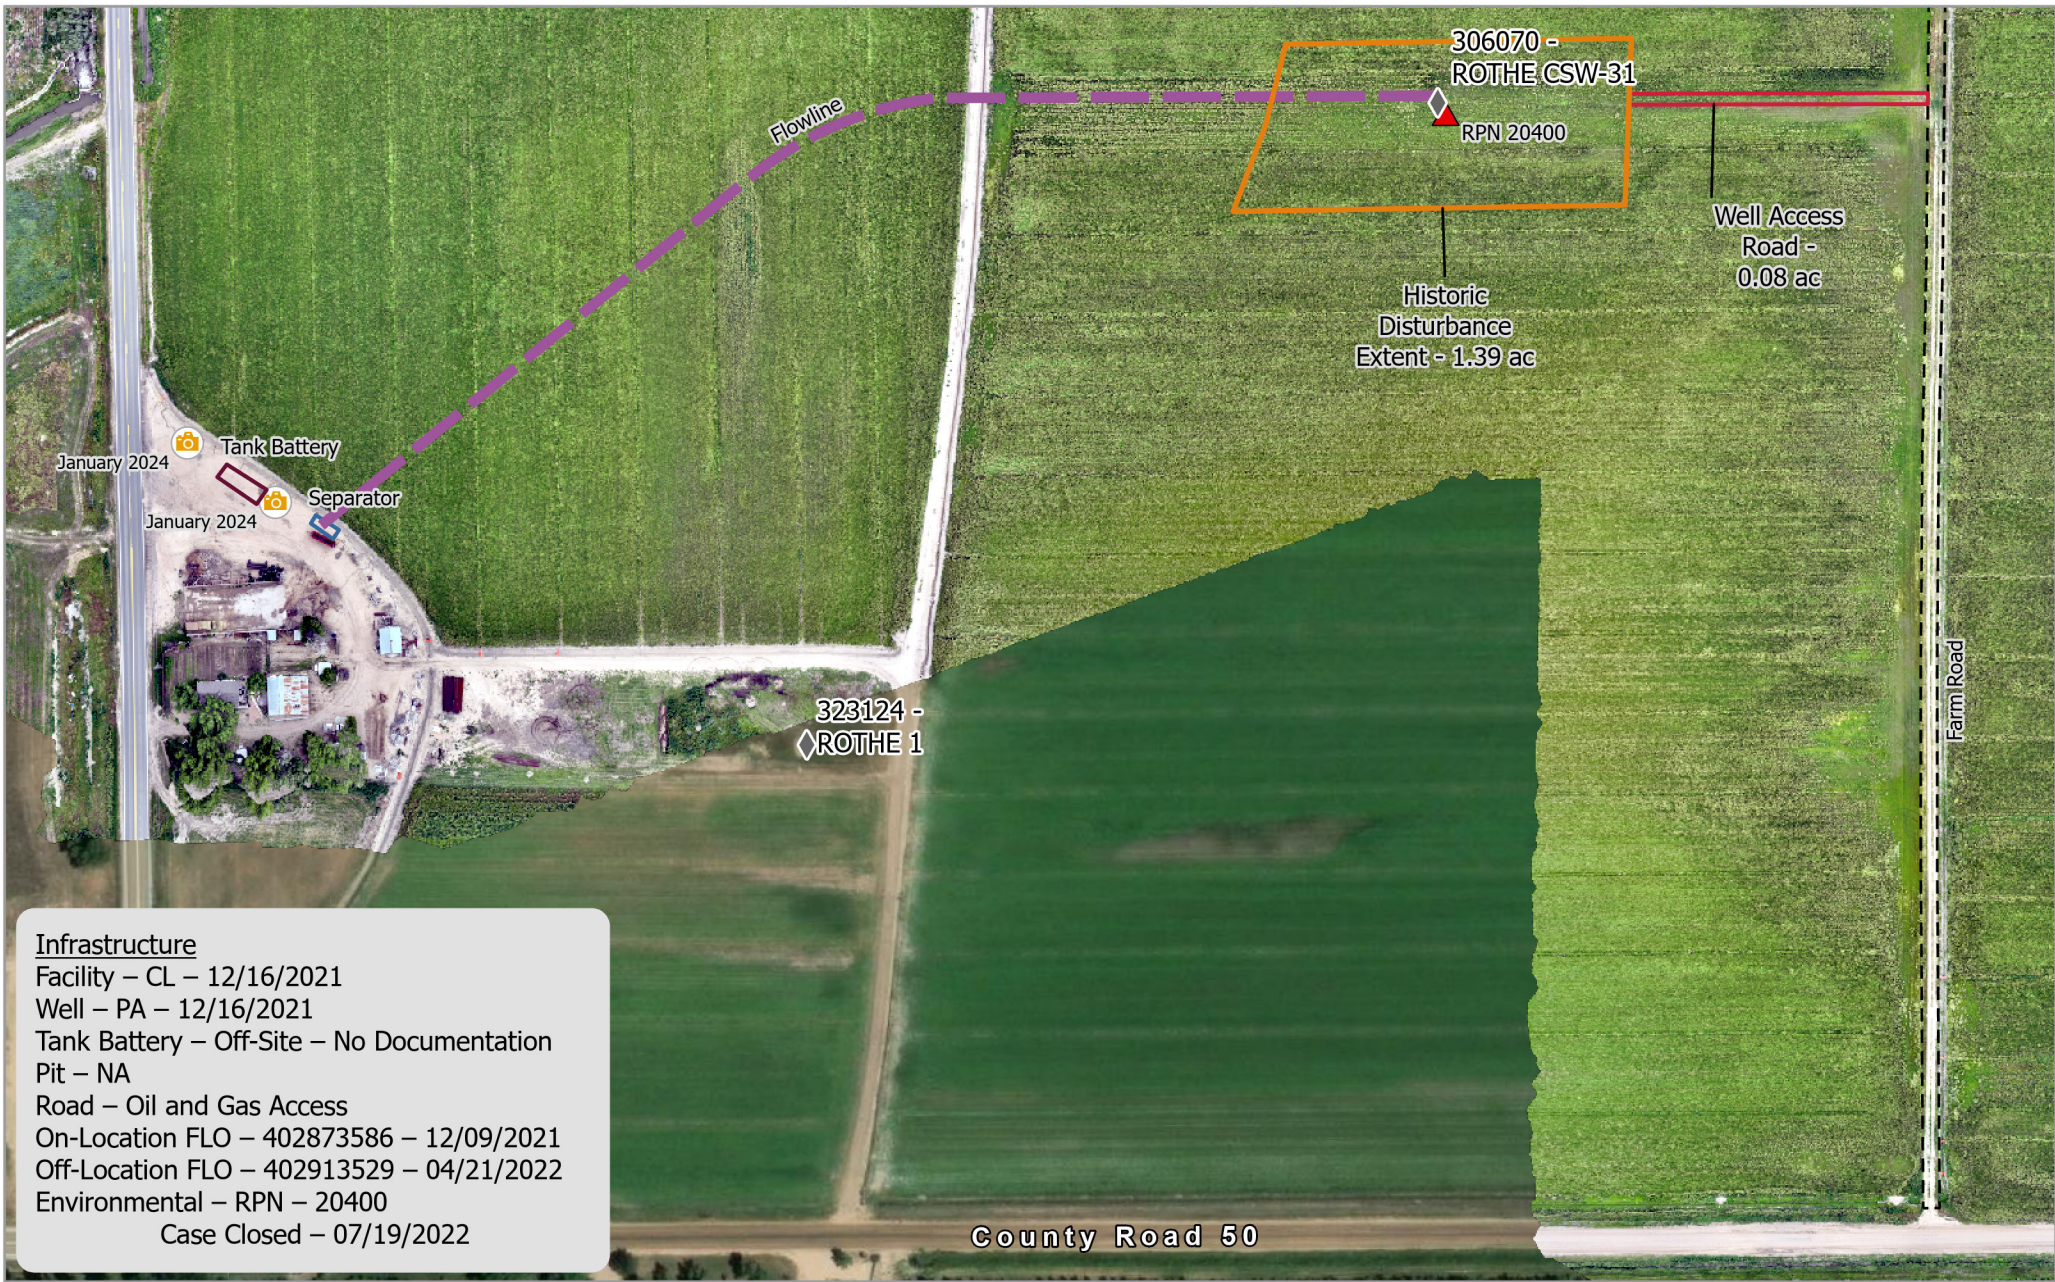
CIV - 306070- ROTHE CSW-31
Map Extent - Post-Plugging Overview

Imagery: RS Orthomosaic, Maxar
 Imagery Date: 22 Jun 2023, 1 Aug 2020
 Map Date: 05 Feb 2024
 Datum: WGS 1984 UTM Zone 13N
 POC: Soil Sage

Disturbance Extent: 1.47 Acres
 Scale: 1:2,300

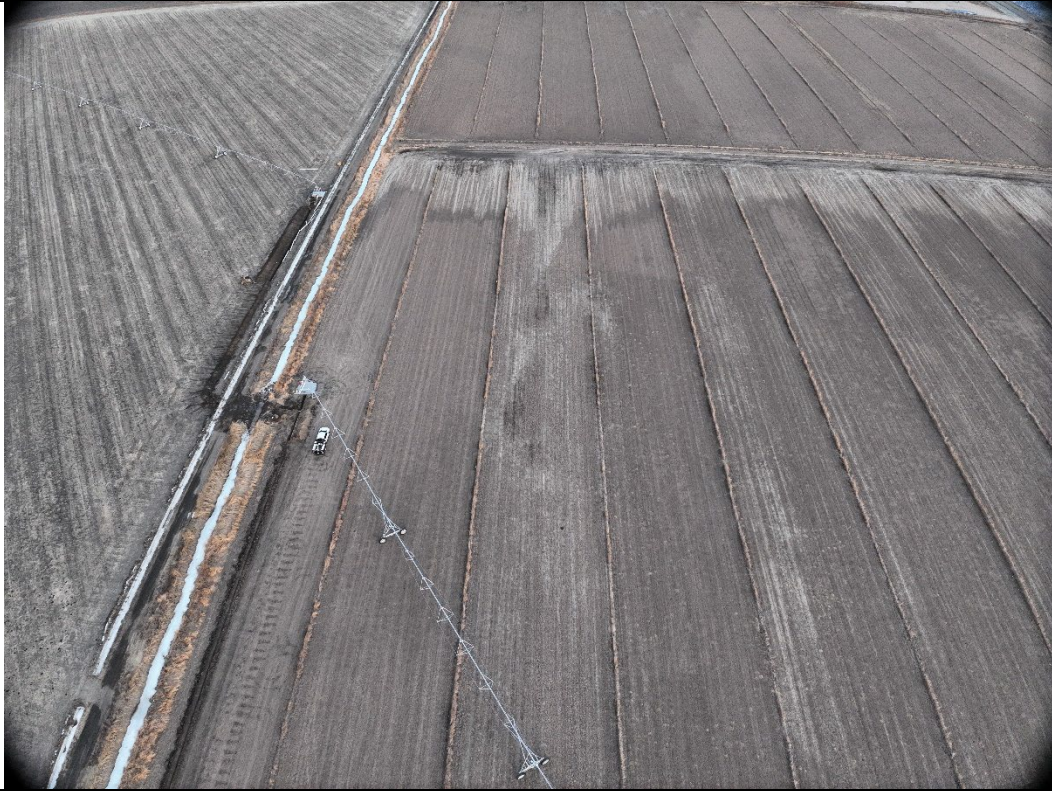
NORTH – 40.350768 / -104.483538

In View – Well, Access Road, Flowline

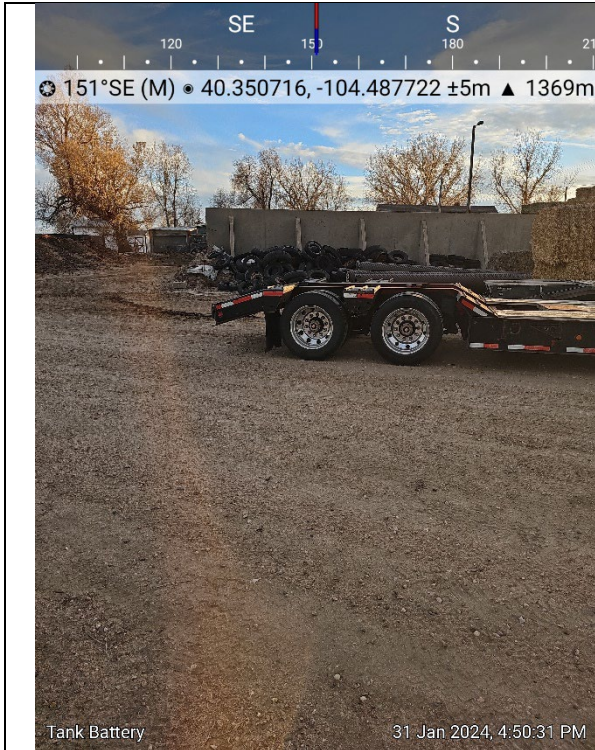
Looking South at Tank Battery location –
40.350716 / -104.487722

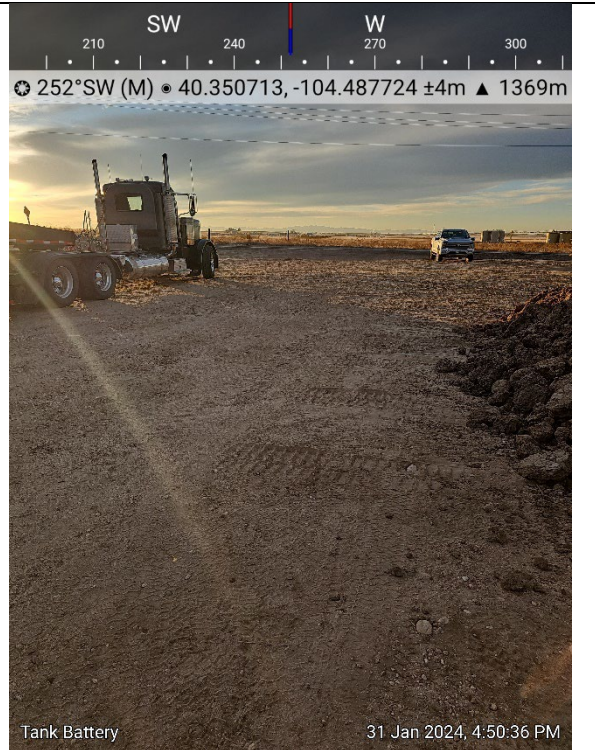
Looking West at Tank Battery location –
40.350713 / -104.487724

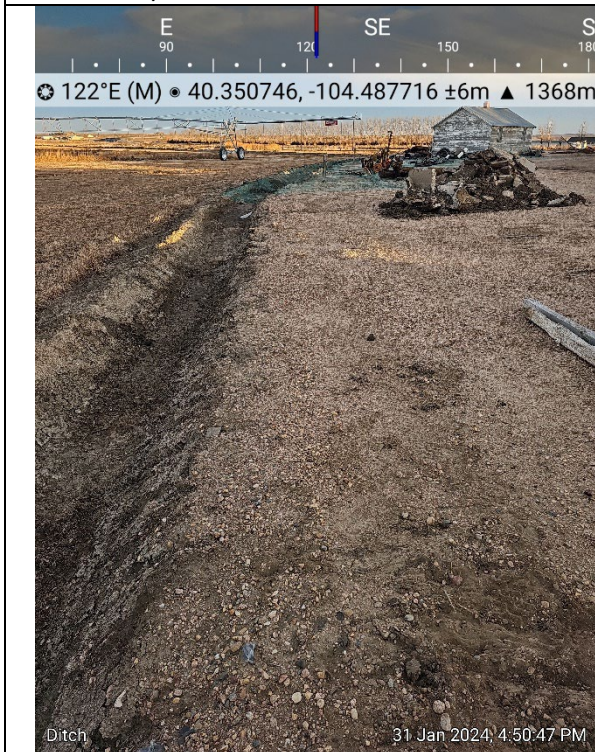
Ditch near Tank Battery Location –
40.350746 / -104.487716

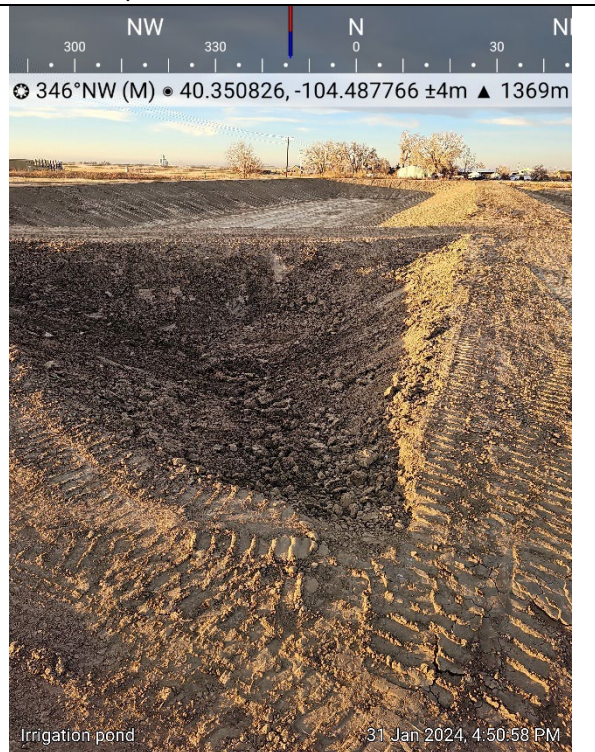
Looking North at Irrigation Pond North of Tank
Battery – 40.350826 / -104.487766

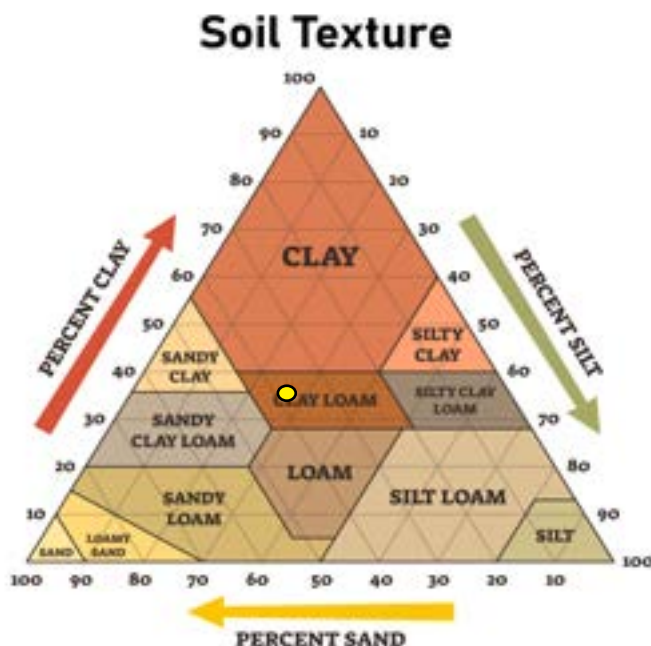
The location of the site is contained within one soil type, Nunn clay loam.

Soil Texture Triangle reflect the 0-10 in depth Erosion Potential (10 inches)
