# Inspection Photos

**Operator:** TEP ROCKY MOUNTAIN LLC #96850

**Location ID:** 335743

**Inspection Doc:** 696205645

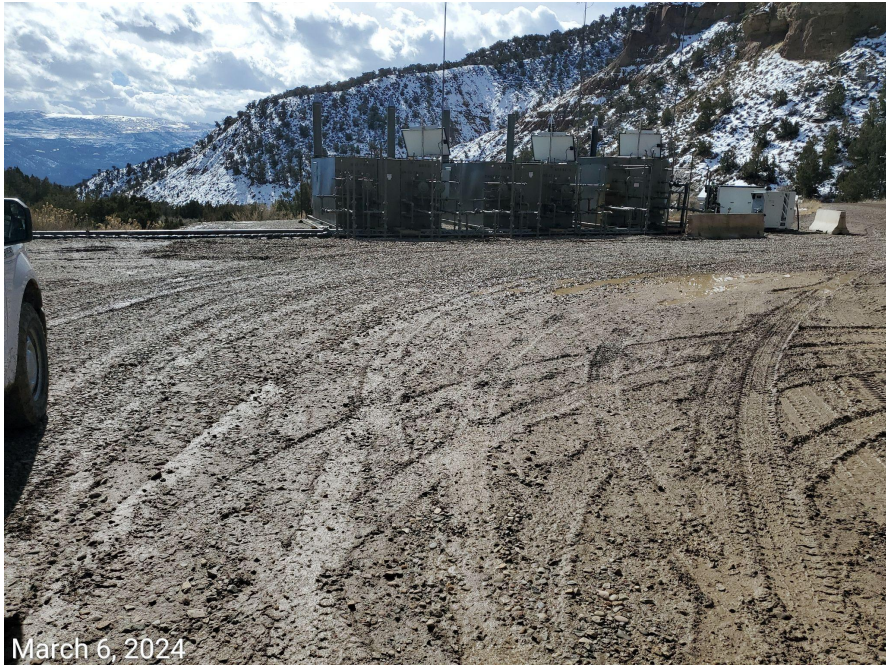
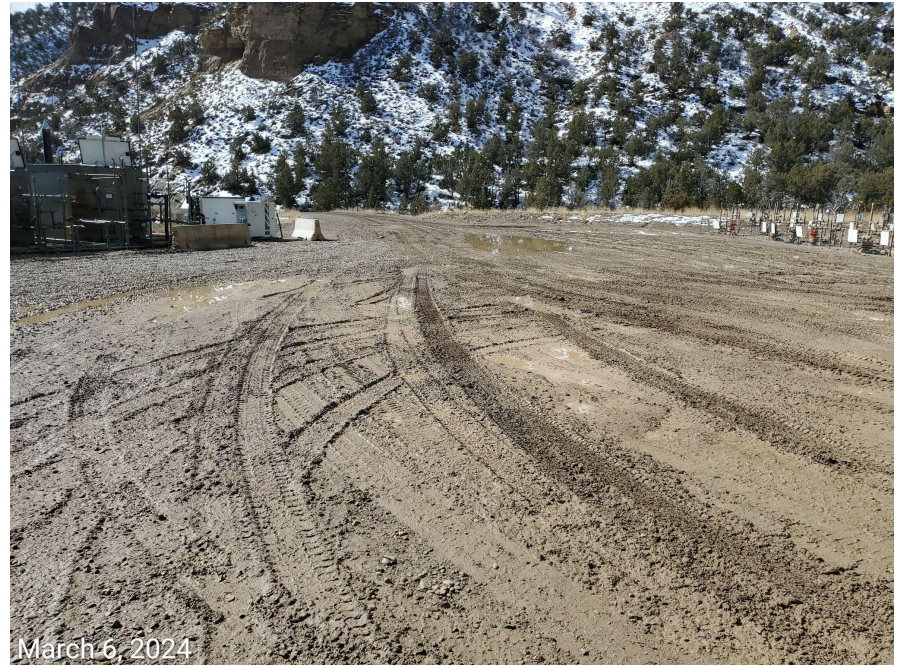
**Photo 1:** Photos 1-2 taken from the northeast end of the Location. Photos provides an overview of the Location from south, southwest, northwest to north.

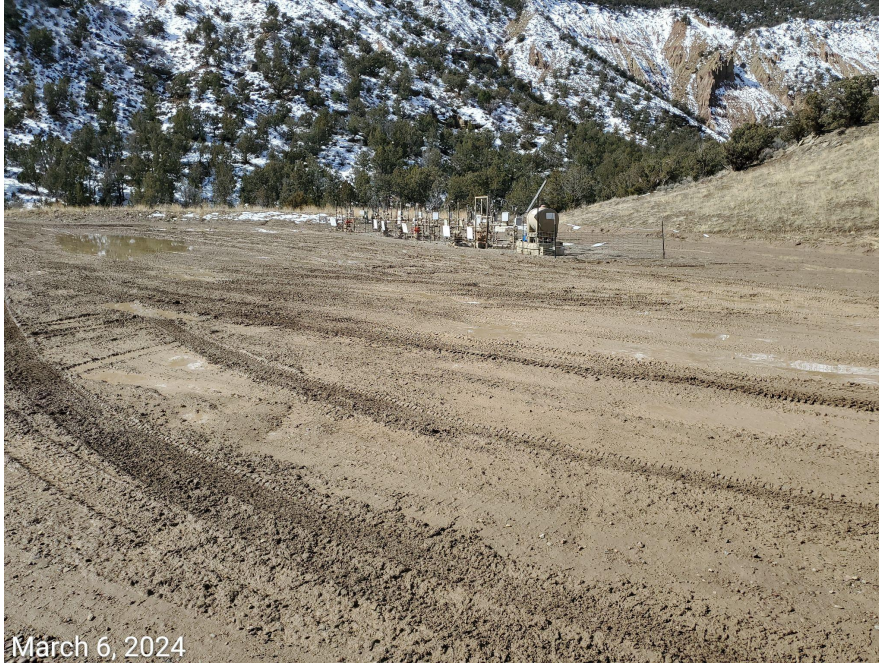
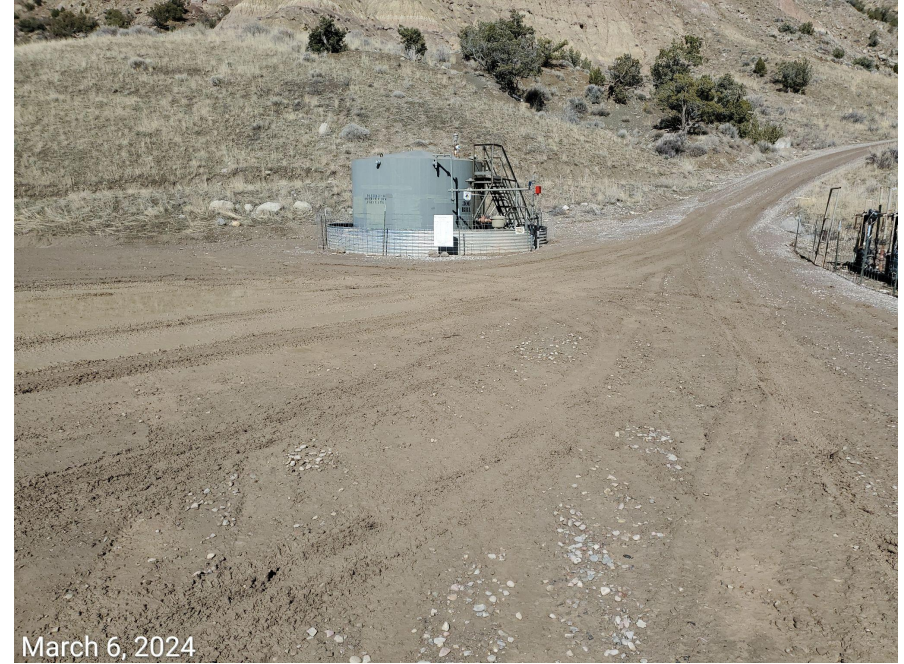
**Photo 2:** See comments under photo 1.

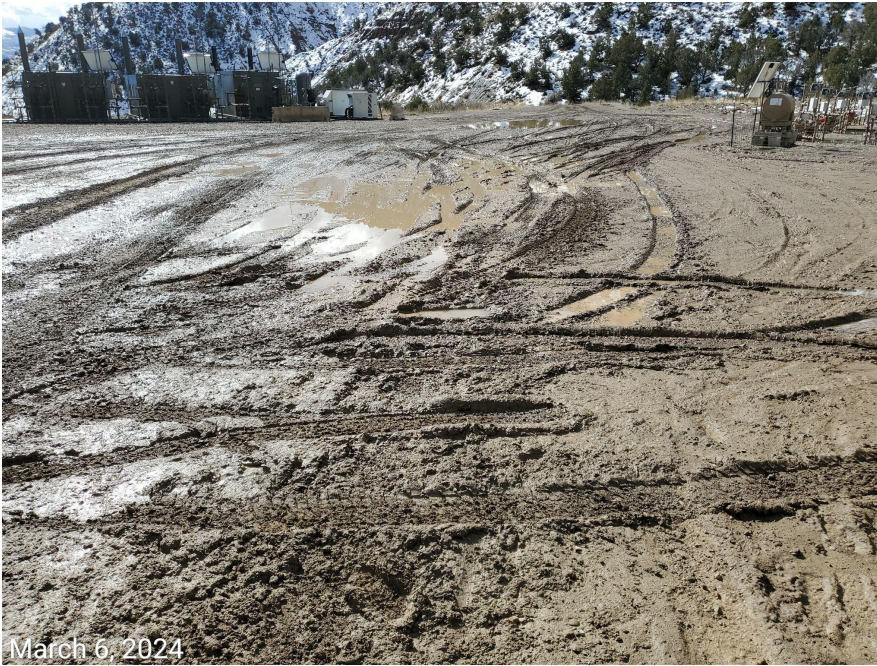
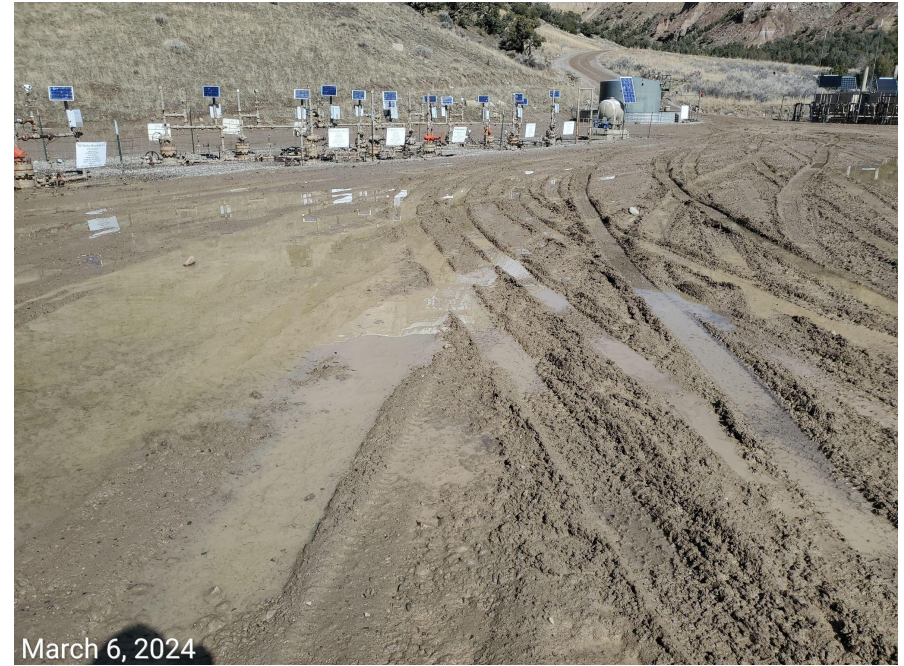
**Photo 3:** Photos taken from the working pad surface. Photos examples showing BMPs on the working pad surface have not been installed or maintained; Working pad surface lacks stabilization and tracking BMPs

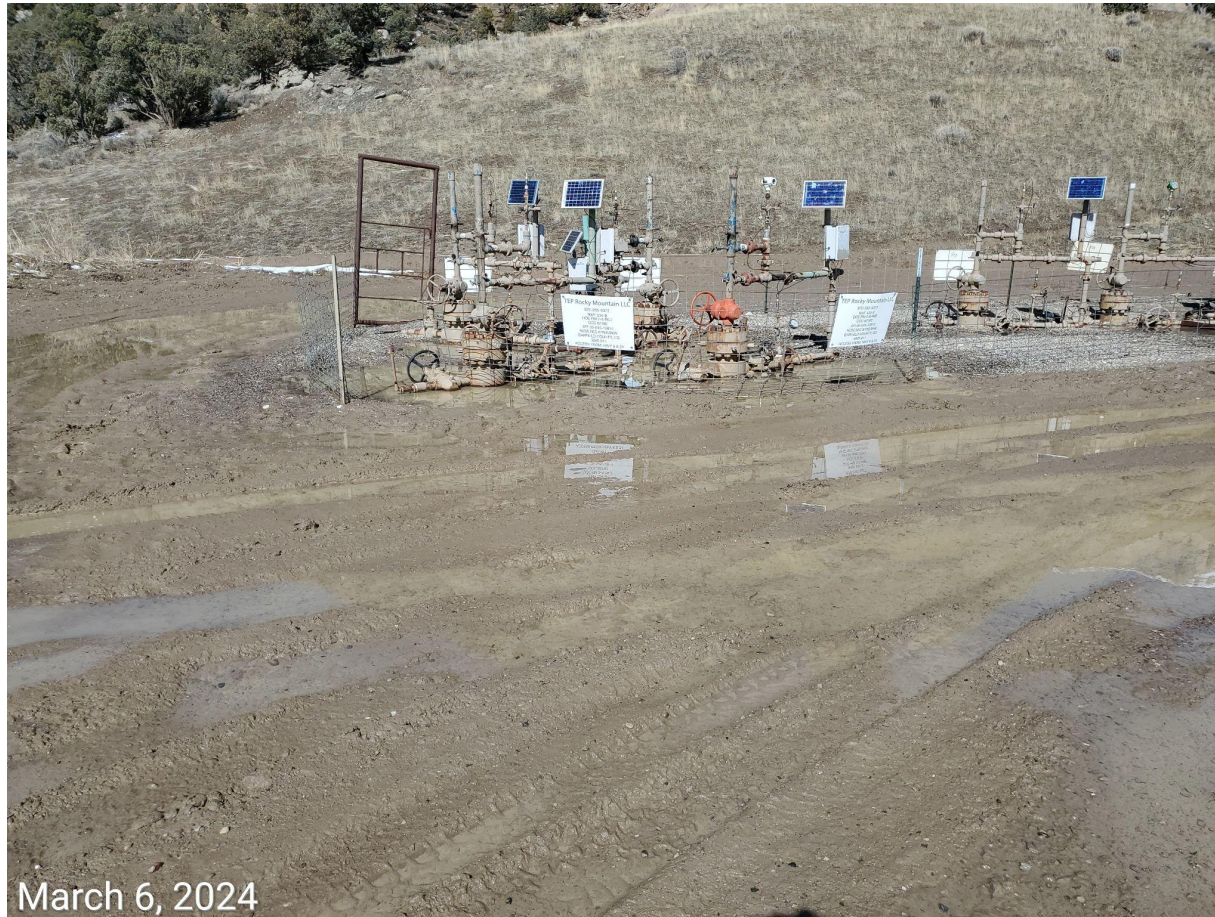
**Photo 4:** Photo example showing stormwater ponding on the WPS and facilitated in destabilization of the WPS, and has resulted in ponding around production equipment.

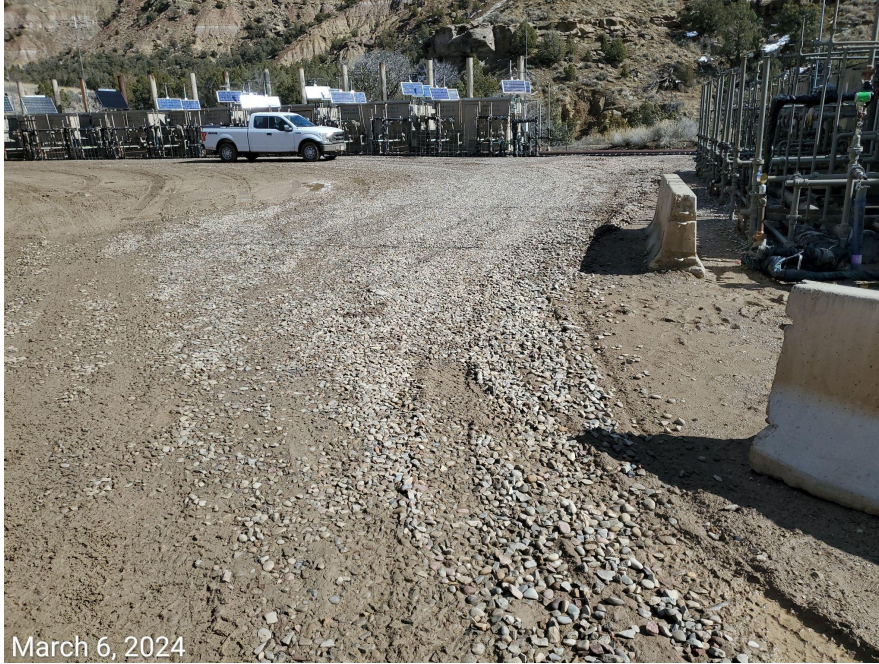
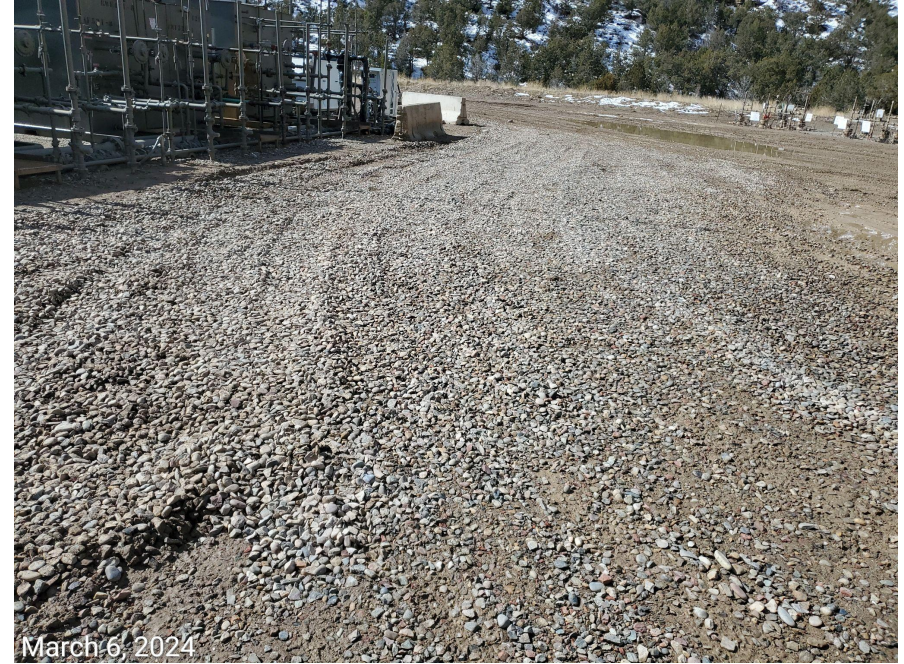
**Photo 5:** Photos examples showing areas of the working pad surface where additional work to stabilize the pad has been performed. BMPs and work to stabilize the remaining WPS, and to minimize erosion, degradation and sediment transport remain missing or insufficient.

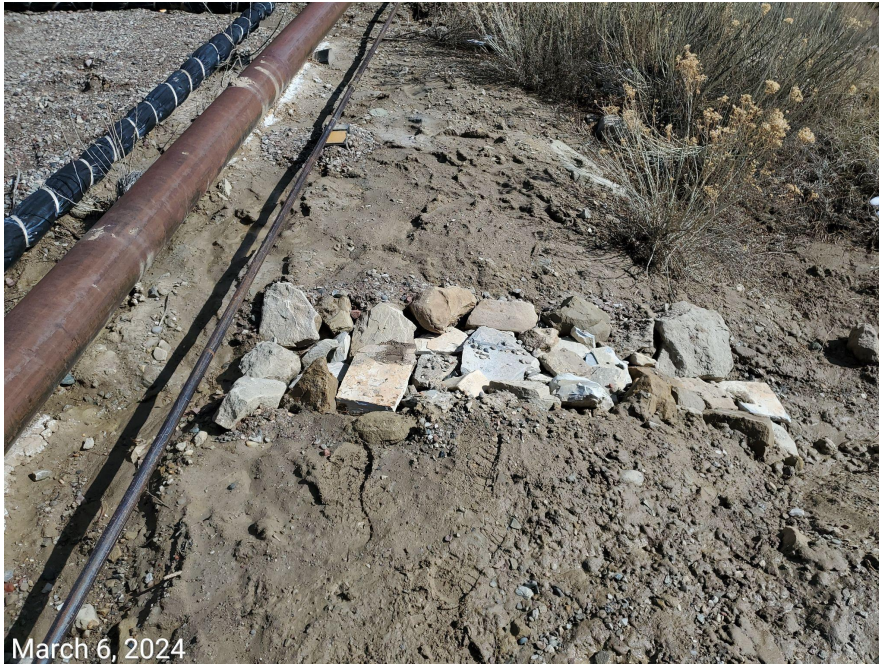
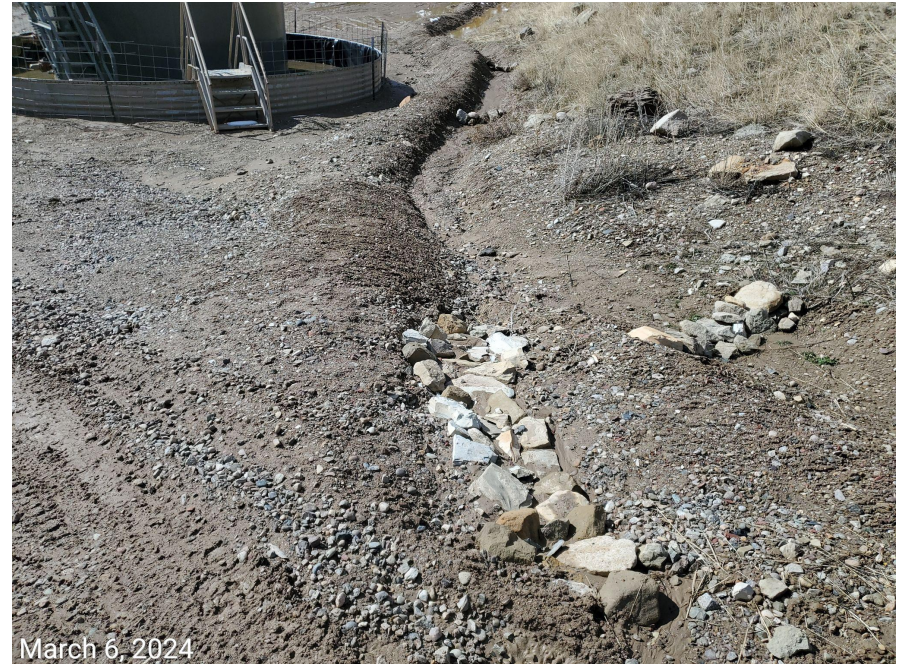
**Photo 6:** Additional BMPs to allow for proper stormwater discharge implemented on the east end of the Location, and access road to the north.

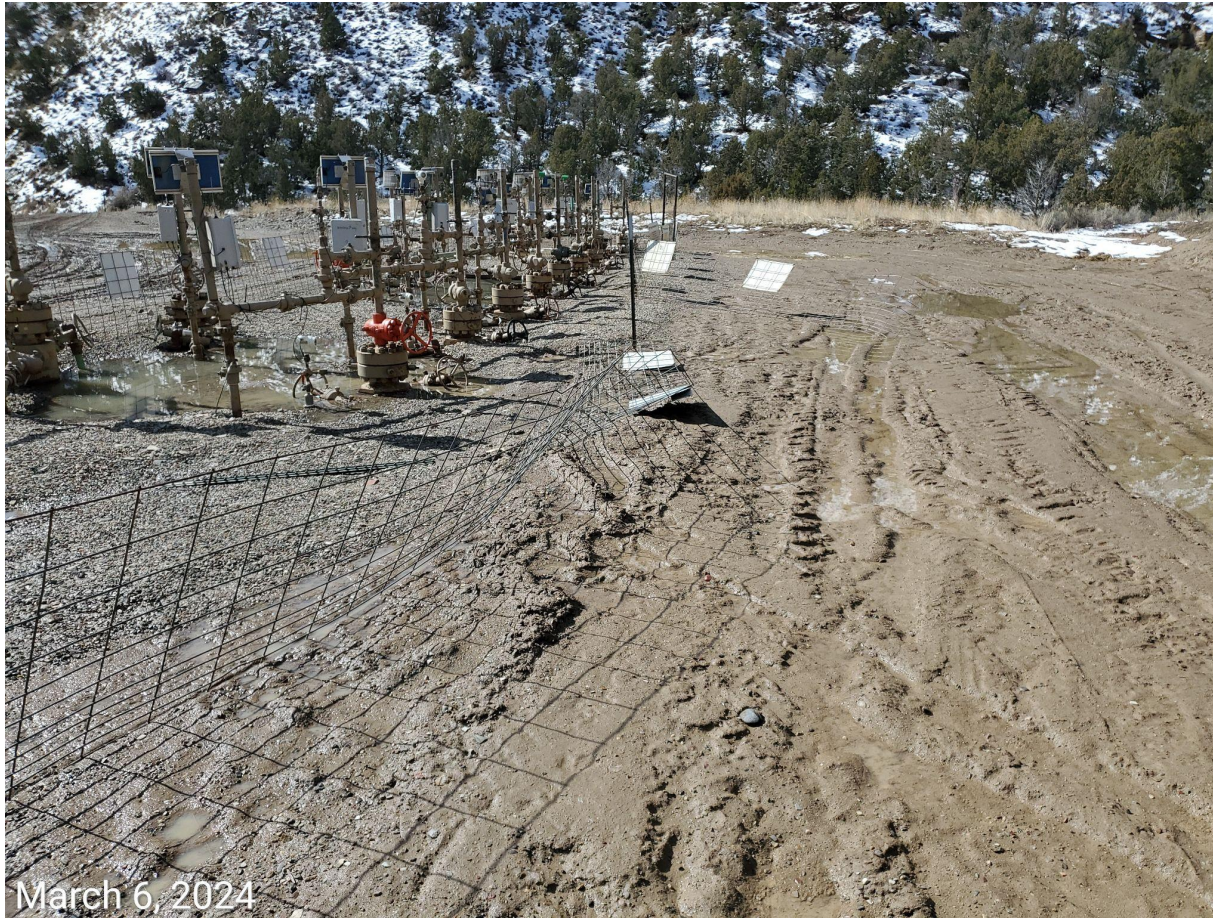
**Photo 7:** Fencing at wells in disrepair.
