Inspection Photos

Operator: TEP ROCKY MOUNTAIN LLC #96850

Location ID: 335742

Garfield County, CO

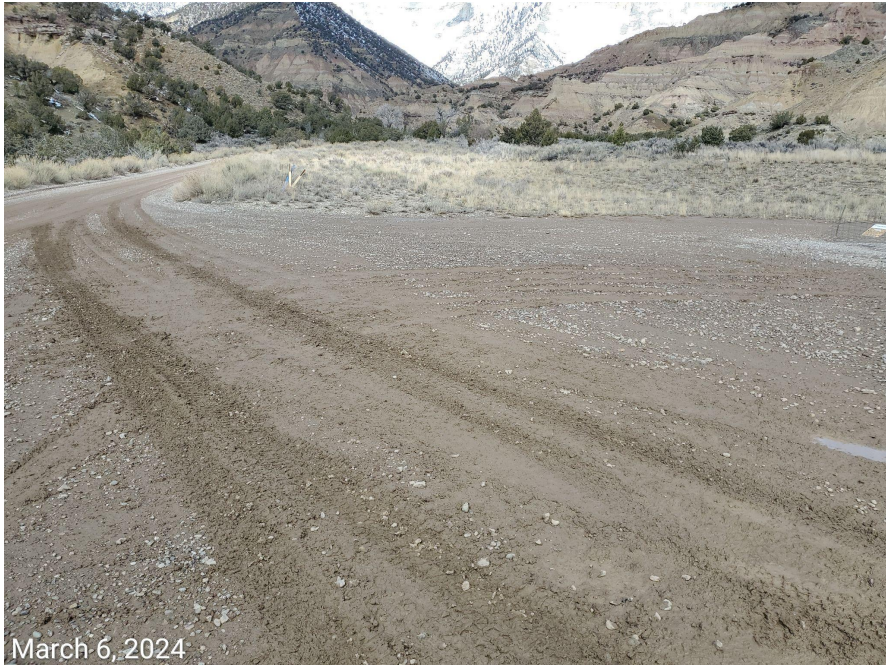
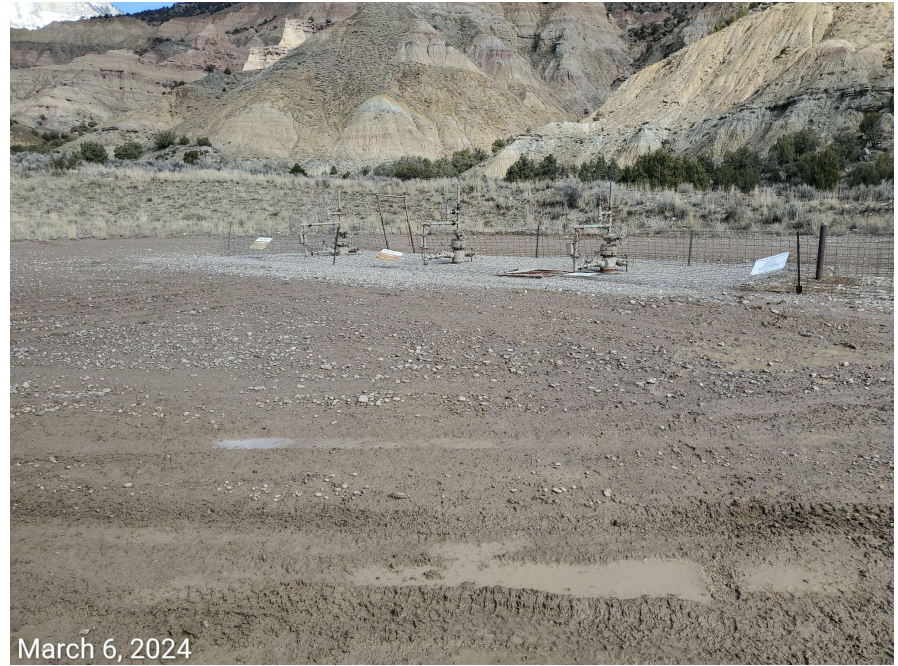
Photo 1: Photos 1-2 taken from the east end of the well pad. Photos provide an overview of the location from northwest, north, northeast to southeast.

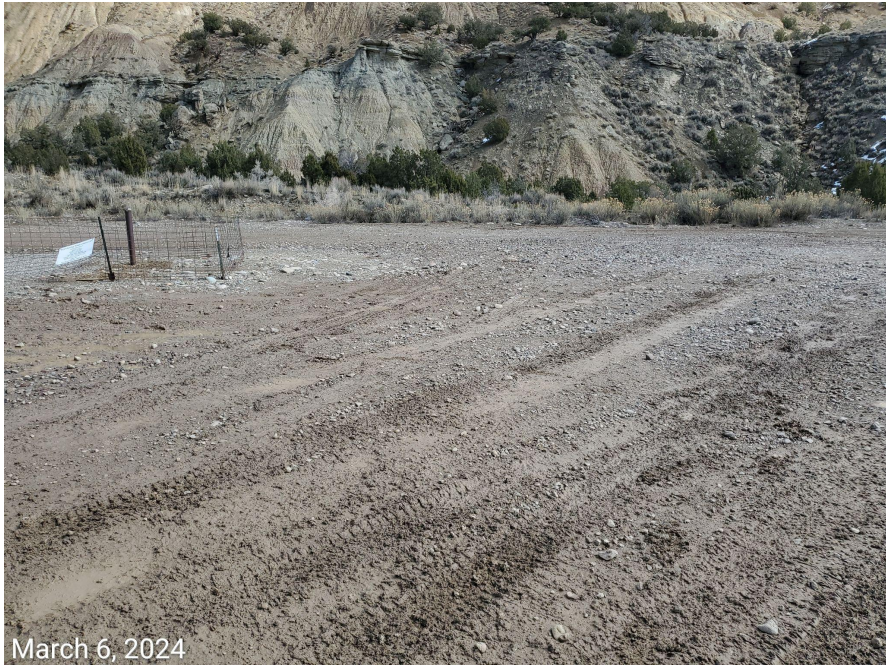
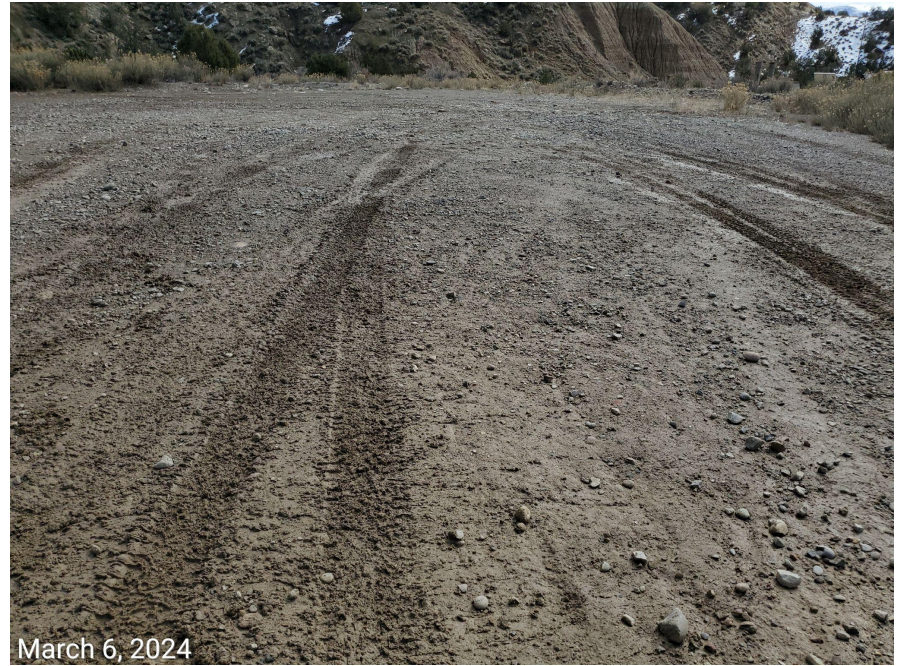
Photo 1: See comments under photo 1. Photo right also example showing areas of the southern well pad not reasonable needed for production.

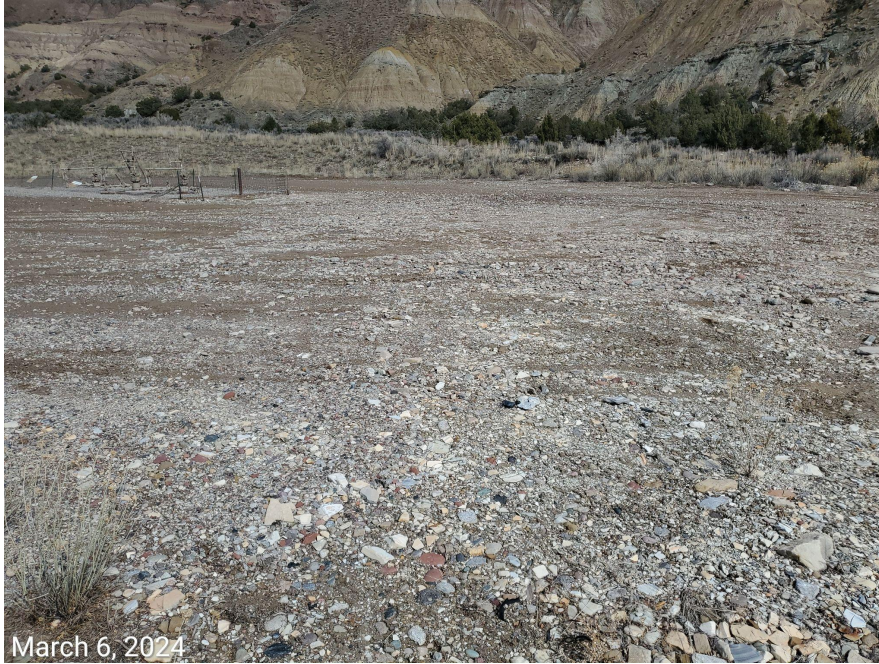
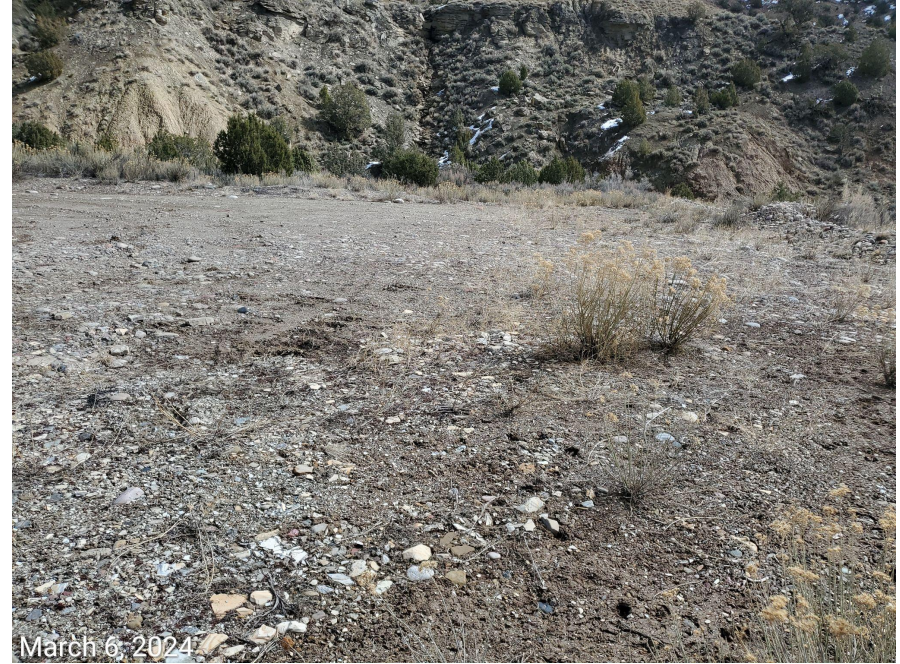
Photo 3: Photos taken from the southend of the well pad, facing northeast and east. Photos examples showing areas on the south end of the well pad Location not reasonably needed for production. Areas require reclamation pursuant to 1003 rules.

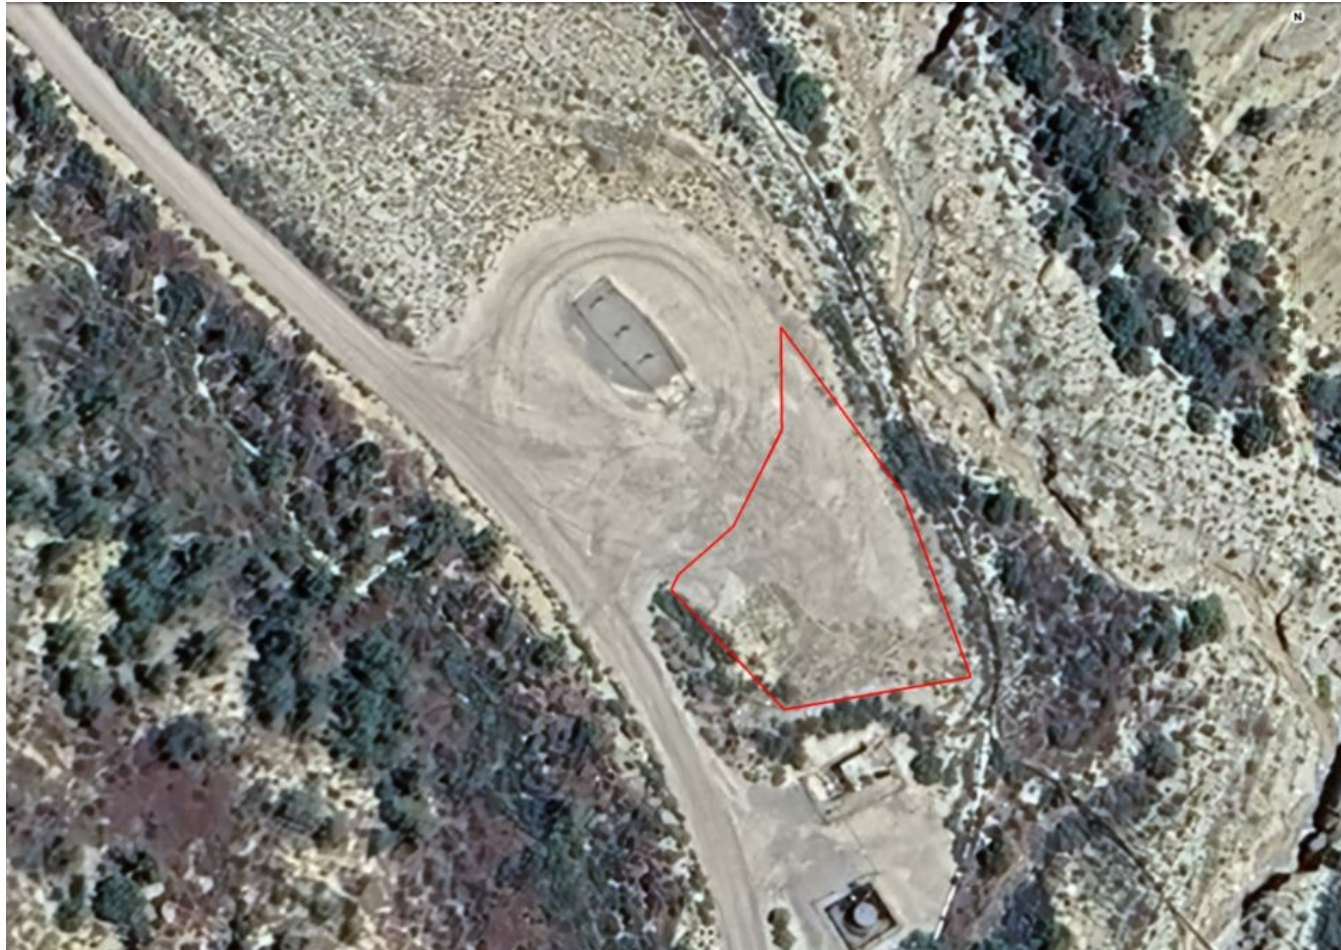
Photo 4: Google Earth aerial image. Red polygon represent approximate areas of the well pad not reasonable necessary for production activities.

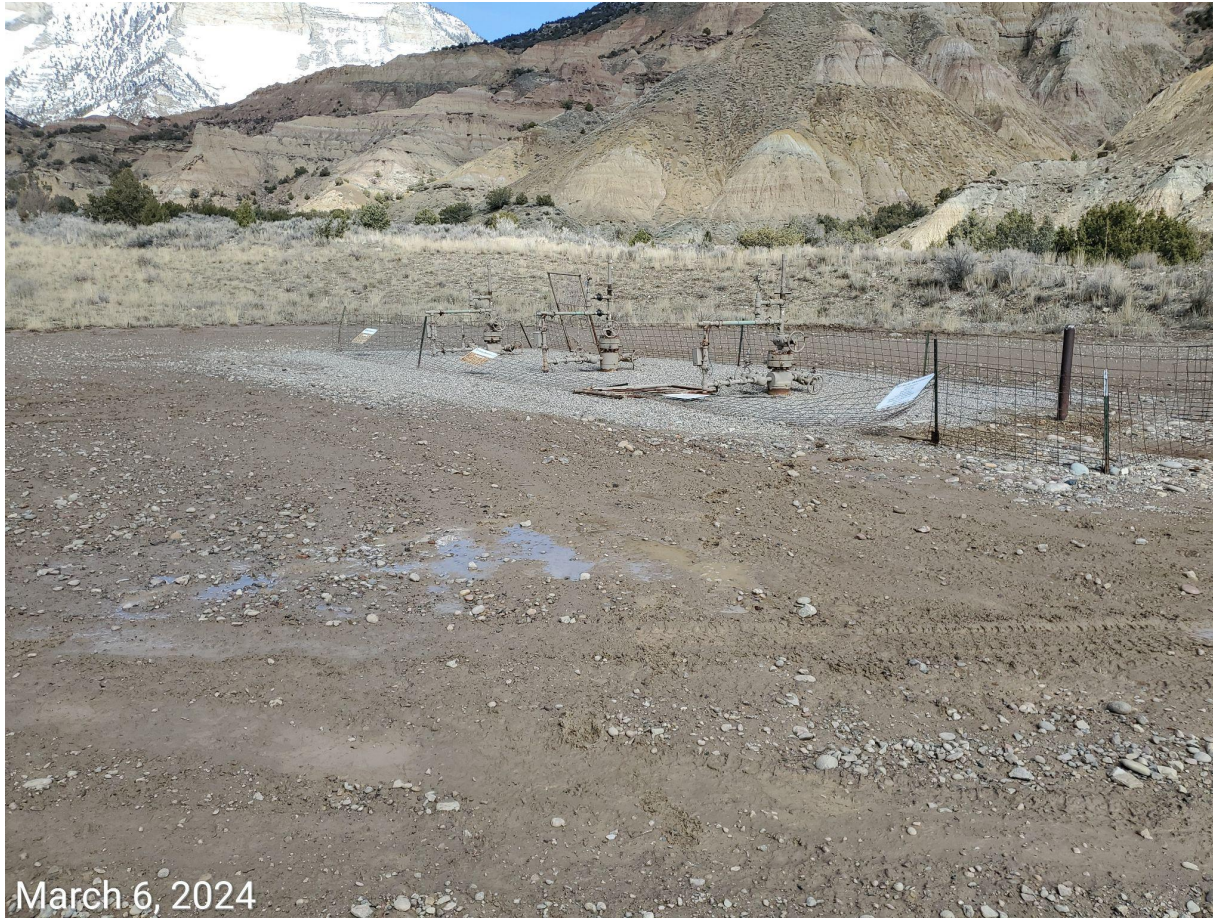
Photo 5: Photo shows fence at the wells is in disrepair.

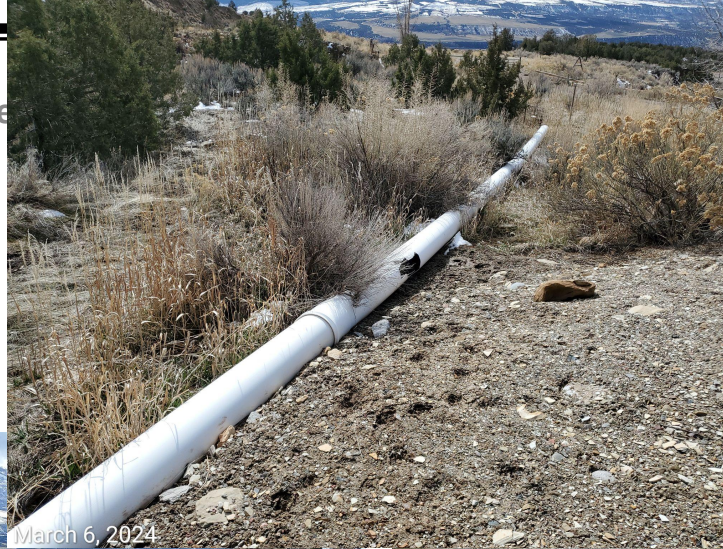
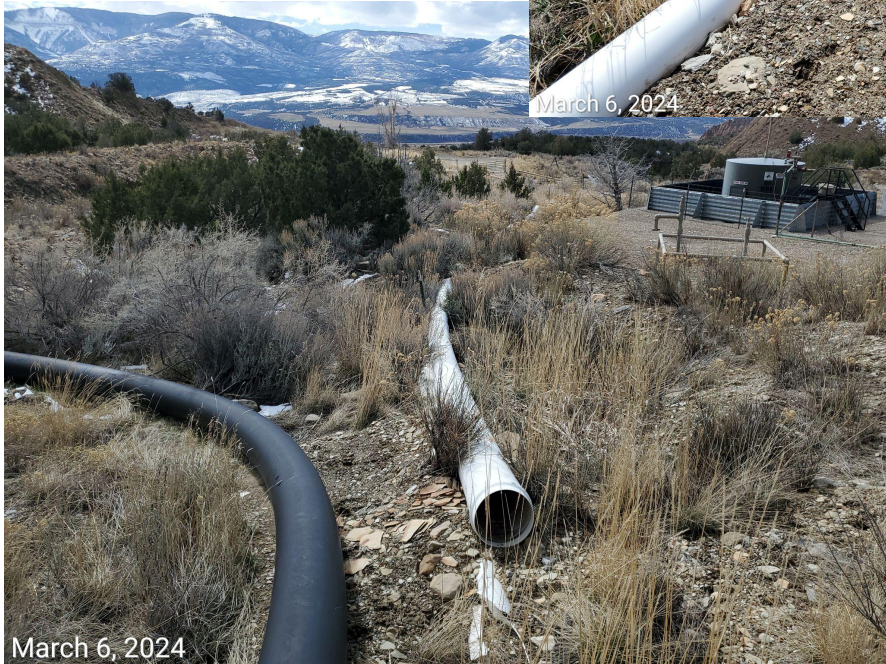
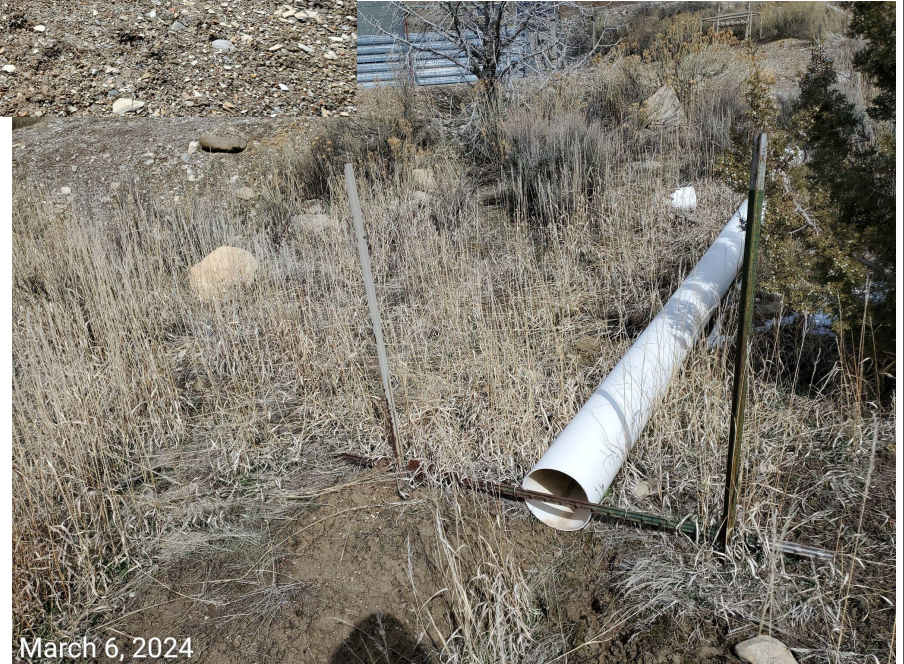
Photo 6: Photos taken from the east end of the Location. Photo shows unused pipe equipment; pipe disconnected and broken along sections.

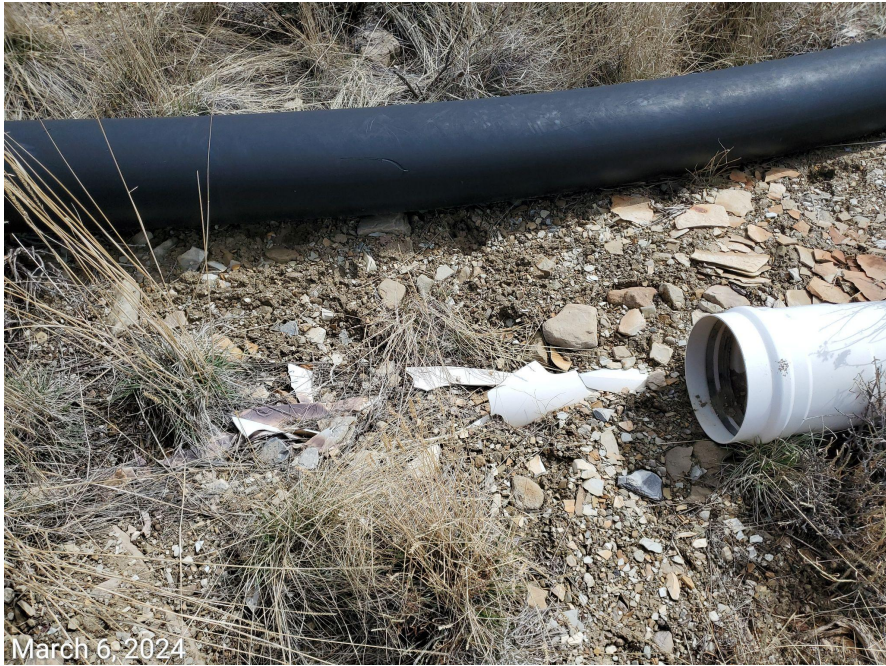
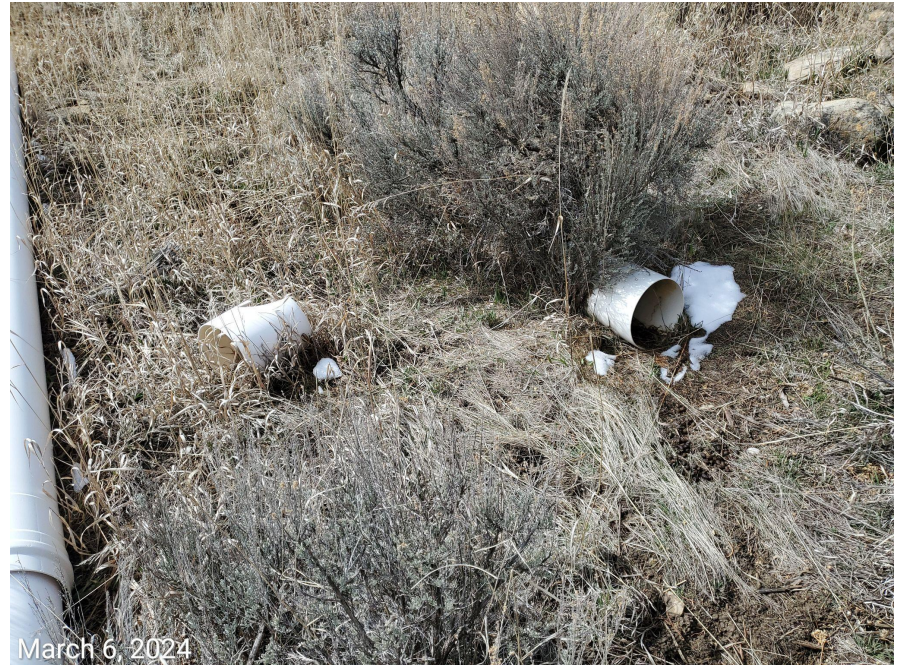
Photo 7: Photos taken from the east end of the Location. Photos examples showing various trash debris observed along unused pipe.

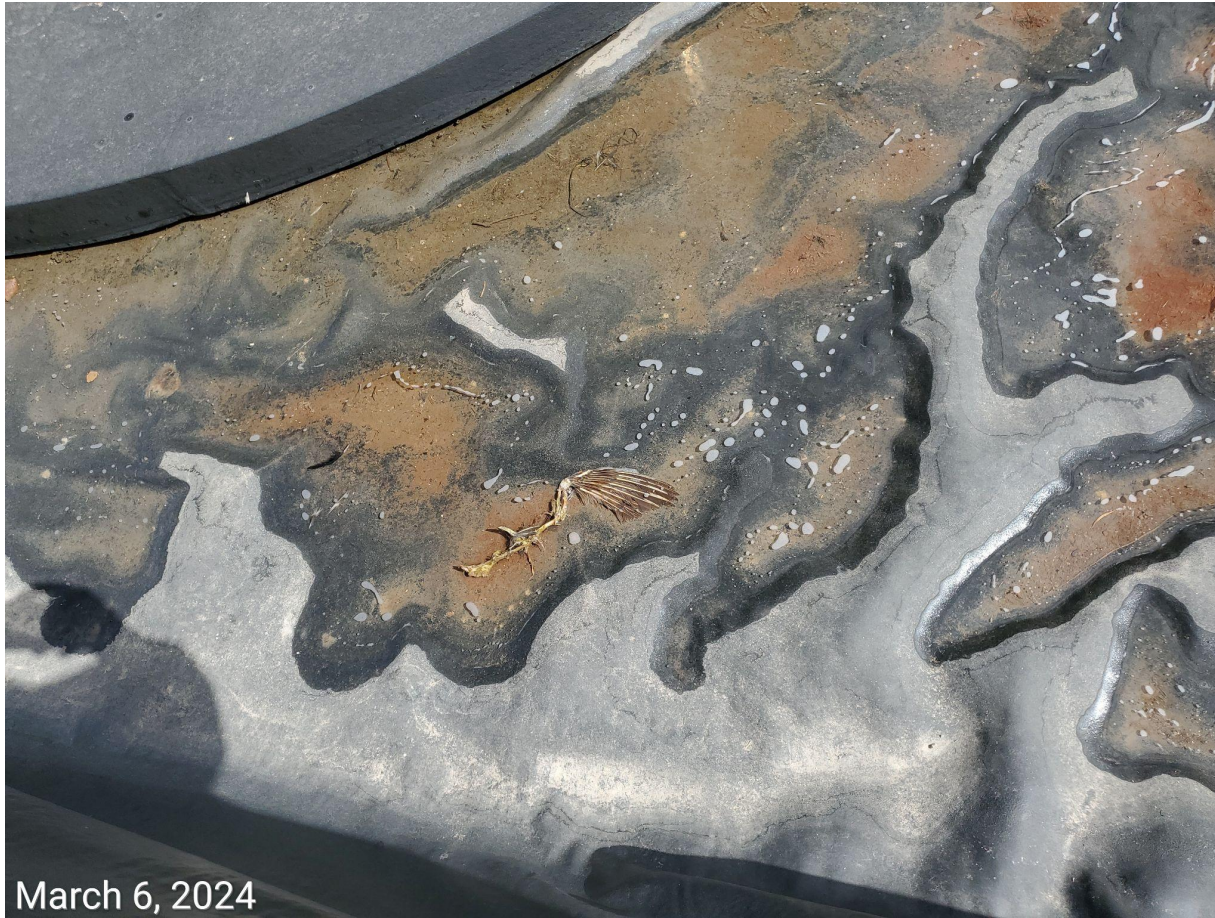
Photo 8: Wildlife mortality observed at the tank battery facility.
