# Inspection Photos

**Operator:** TEP ROCKY MOUNTAIN LLC #96850

**Location ID:** 335777

**Inspection Doc:** 696205655

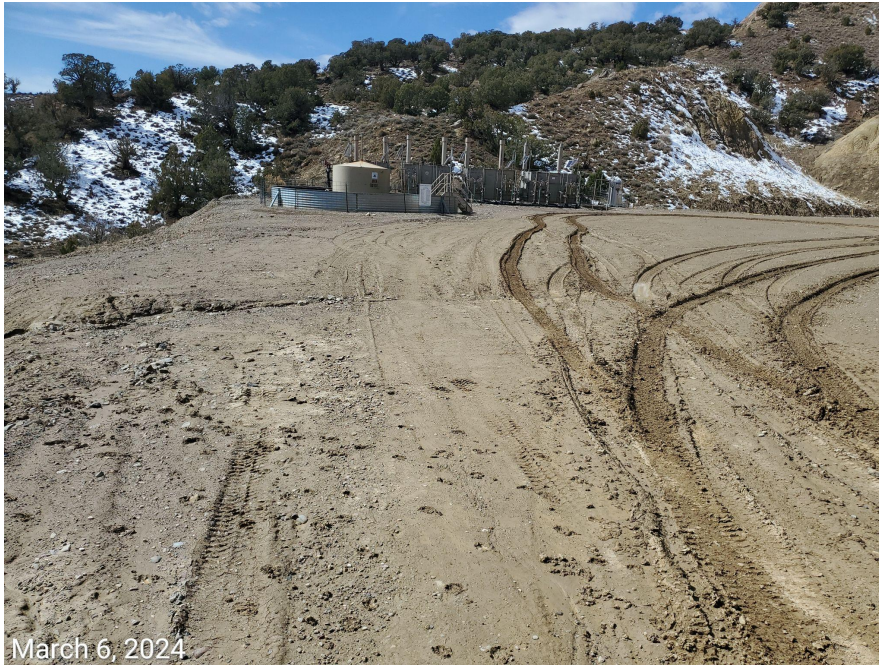
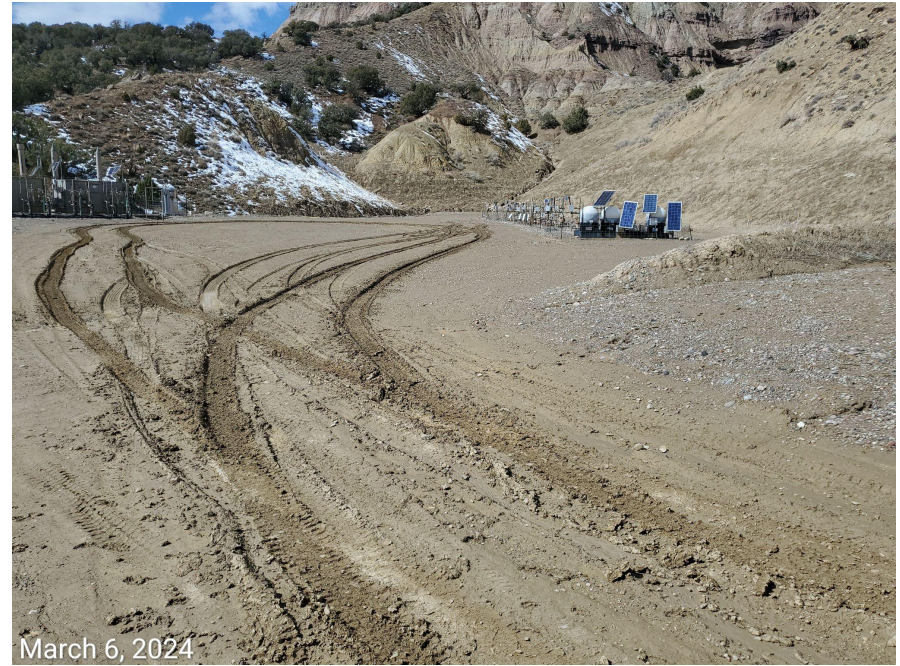
**Photo 1:** Photos taken from the Location entrance on the east end of the Location. Photos provide an overview of the Location from from southwest to west. Photos also show BMPs to stabilize the working pad, as well as to minimize erosion, degradation and sediment transport (tracking) remain missing or insufficient.

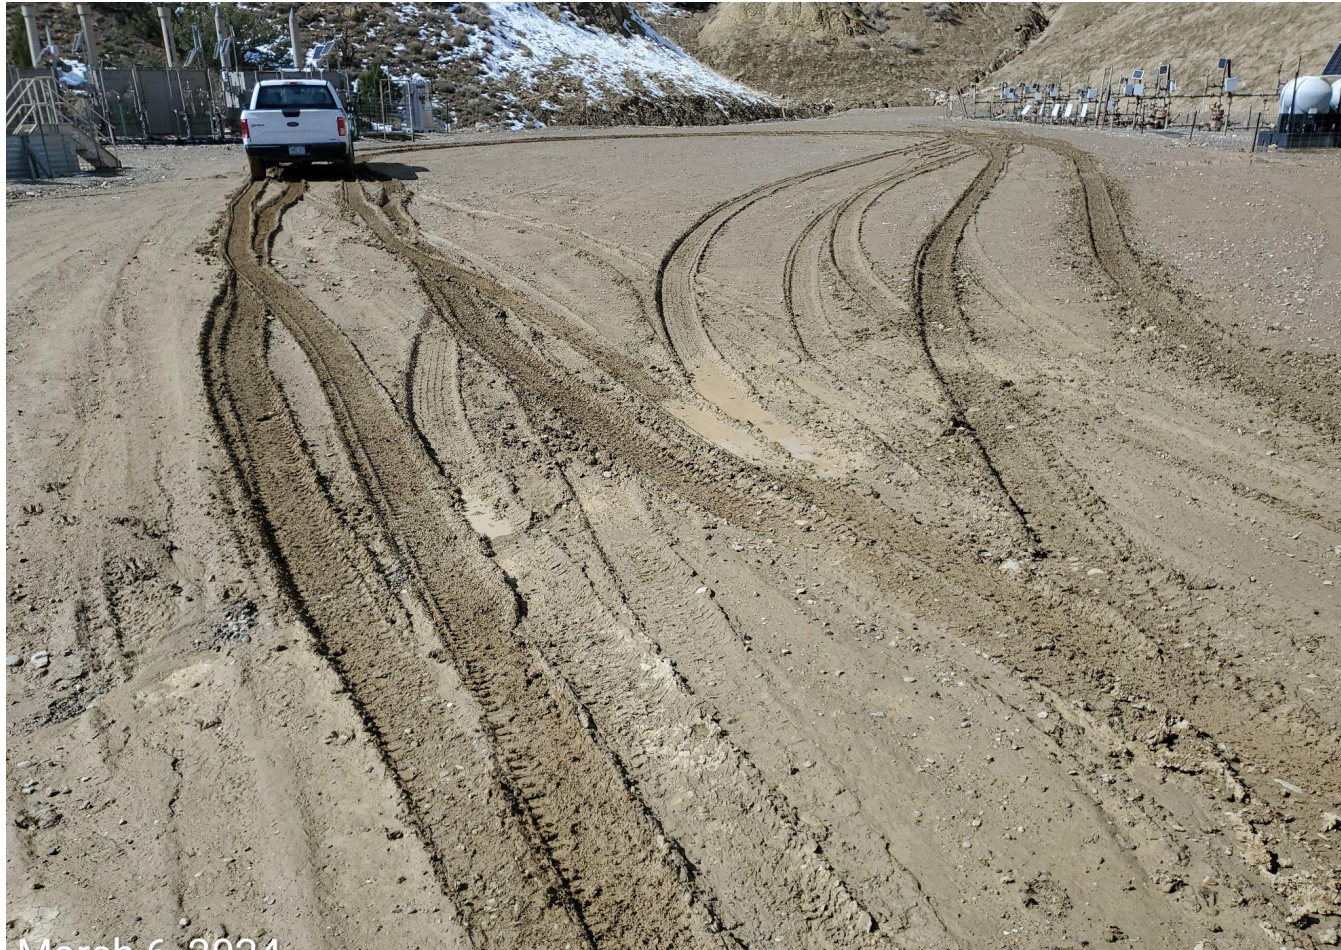
**Photo 2:** BMPs to stabilize the working pad, as well as to minimize erosion, degradation and sediment transport (tracking) remain missing or insufficient.

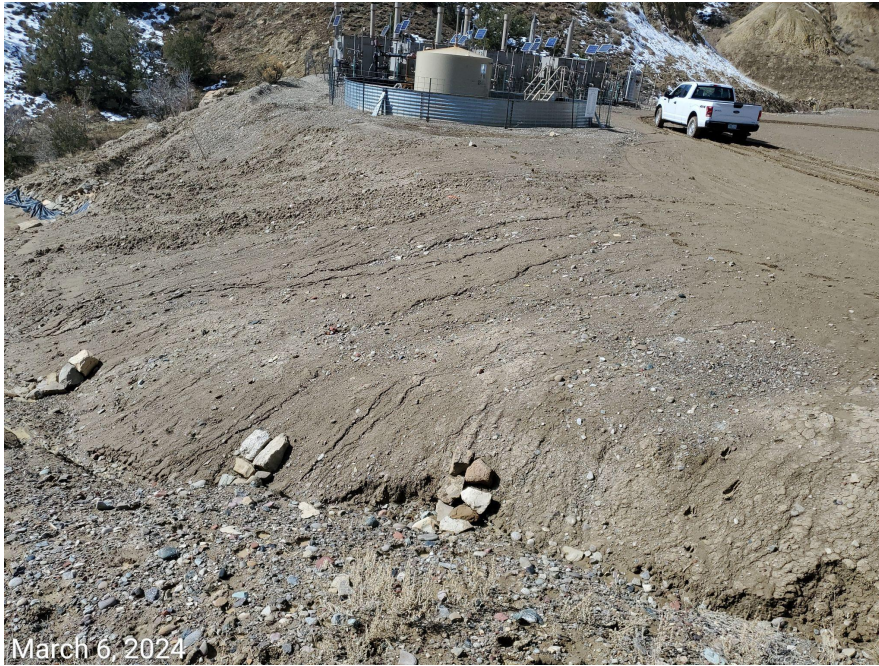
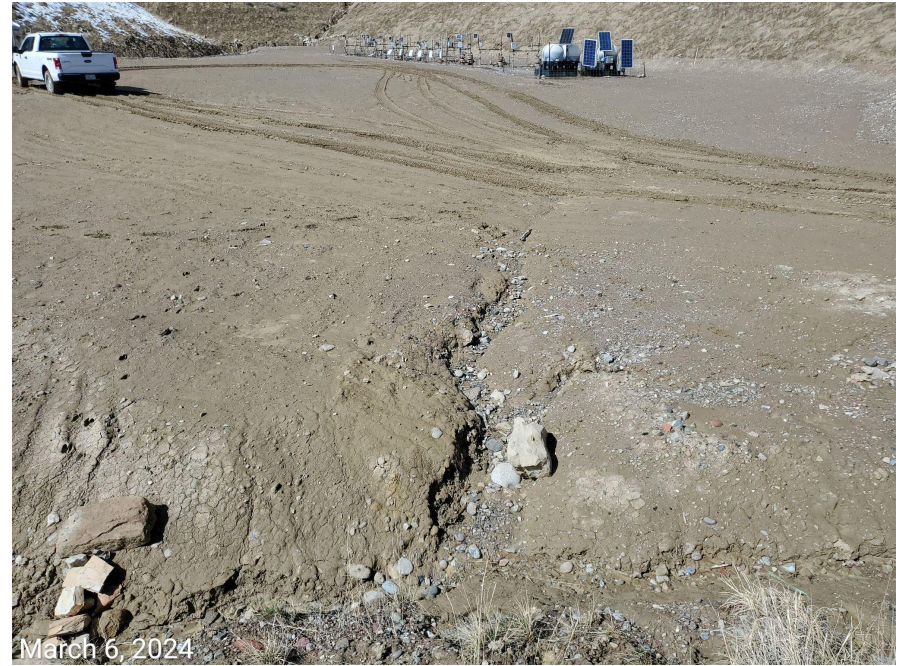
**Photo 3:** Photos taken from the southeast end of the Location, facing southwest and west. Photos show stormwater and erosion control BMPs to manage runoff in a manner that minimizes erosion and degradation at the east end of the Location remains missing or insufficient; erosion degradation has persisted.

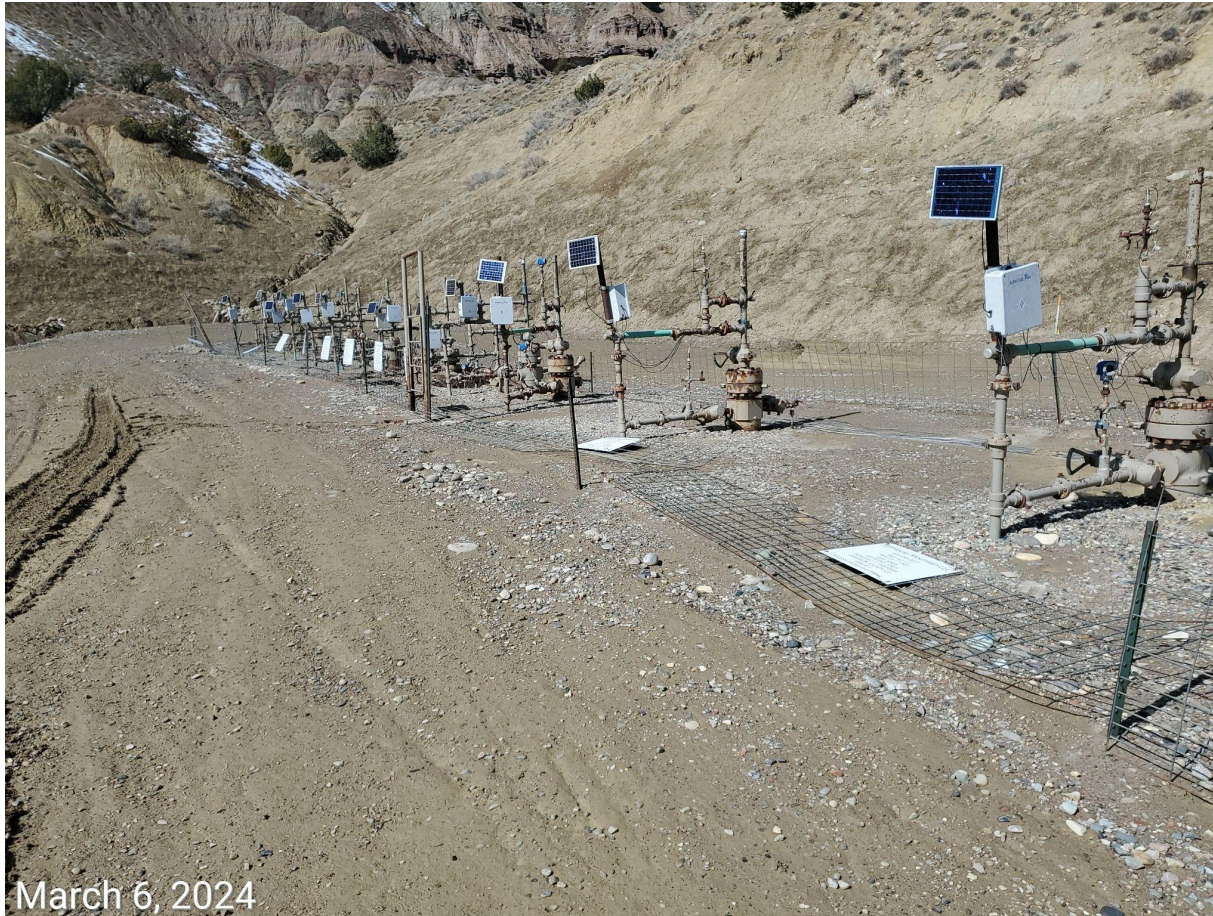
**Photo 4:** Photo shows fencing at the wells remains in disrepair.

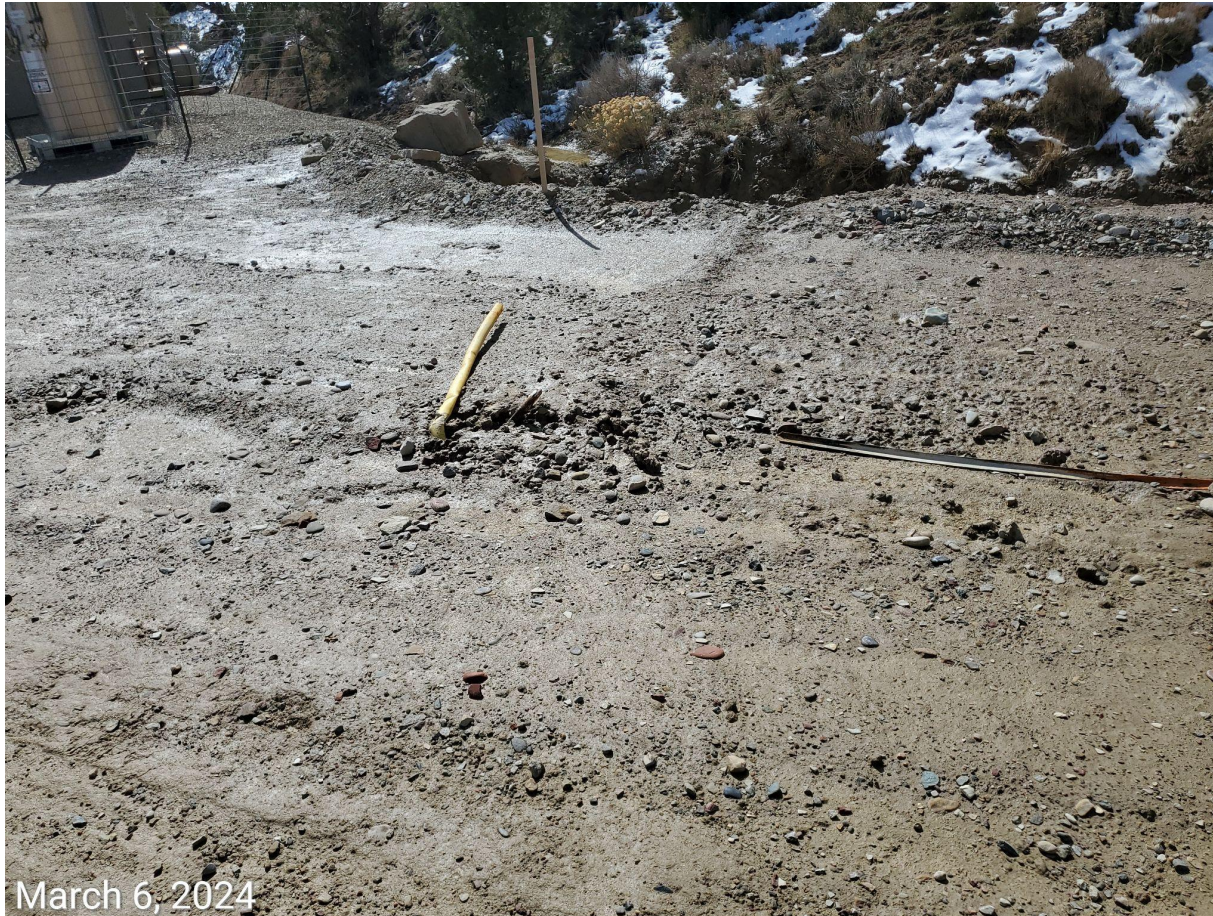
**Photo 5:** Marker at anchor on the southwest end of the Location in disrepair.
