Inspection Photos

Operator: TEP ROCKY MOUNTAIN LLC #96850

Location ID: 324180

Inspection Doc: 696205663

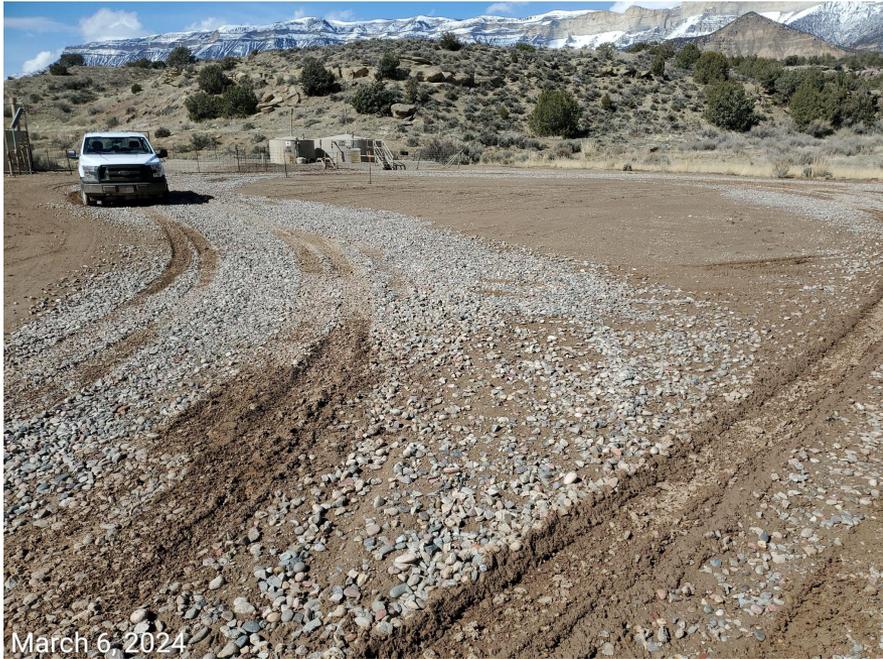
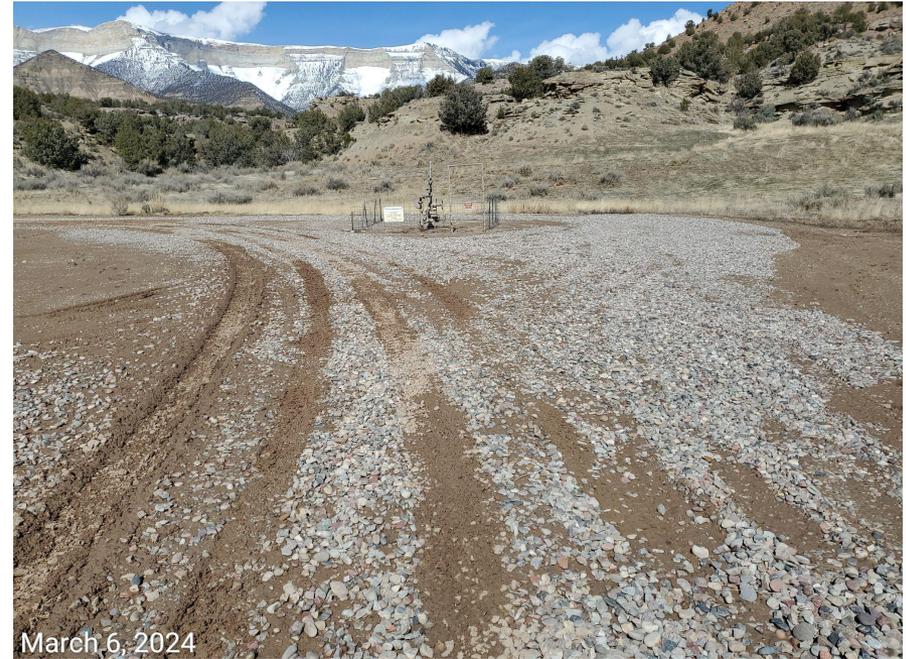
Photo 1: Photos 1-2 taken from the working pad surface of the Location. Photos examples showing work to stabilize the working pad surface, as well as to minimize tracking and sediment transport is insufficient. Operator appears to have only placed gravel material over select portions of the Location. BMP alone is inadequate as tracking and degradation issues are recurring; sediment has already filled in large areas of the pad that had been graveled.

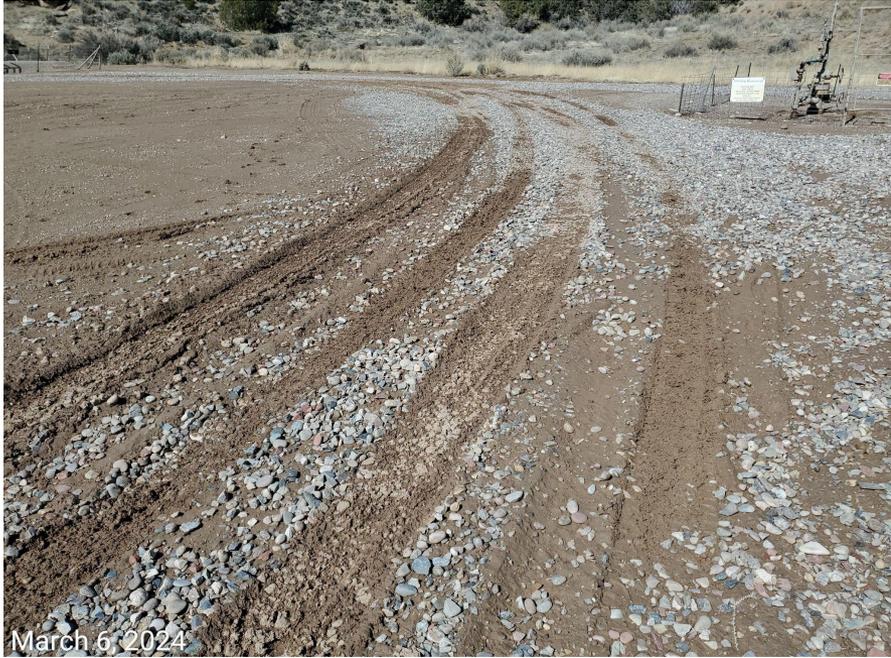
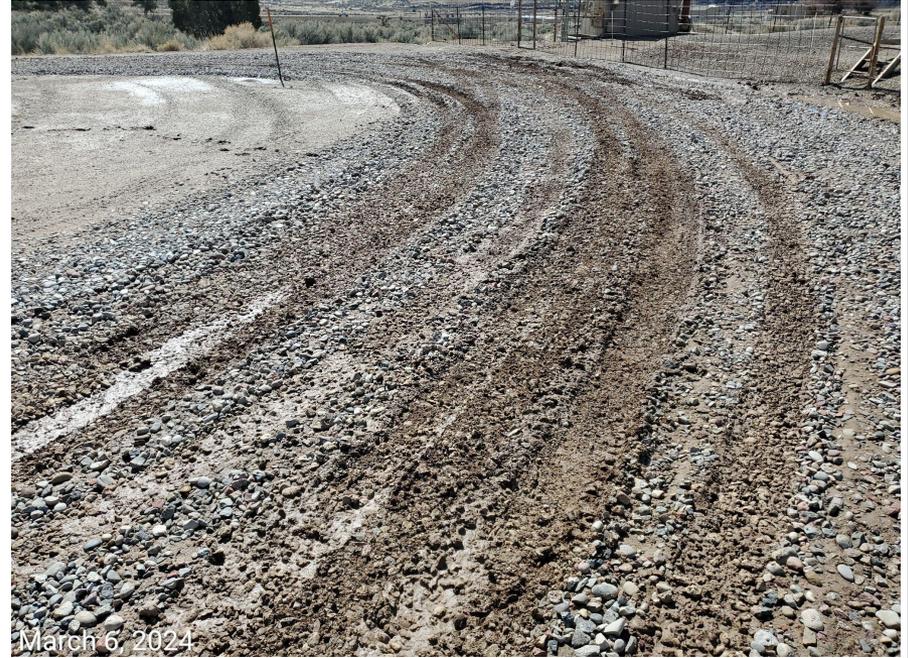
Photo 2: See comments under photo 1.

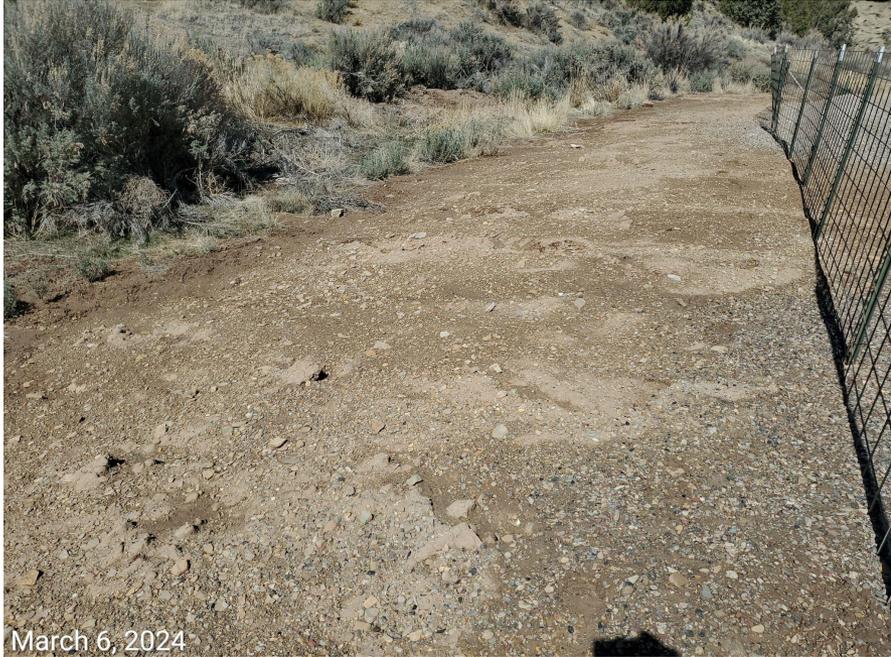
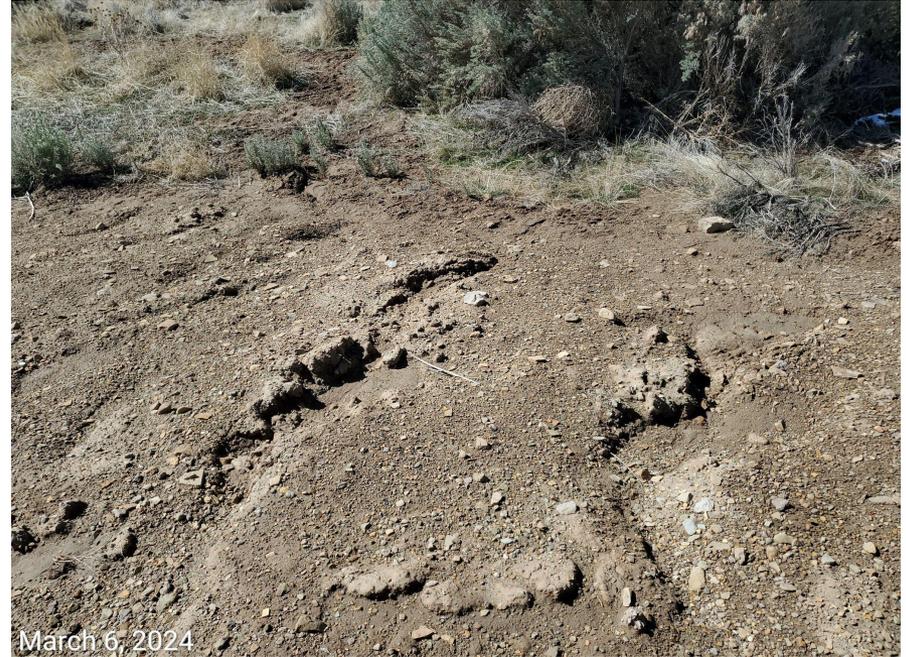
Photo 3: Photos taken from the west end of the Location. Photo shows stormwater and erosion control BMPs to manage runoff and minimize erosion, degradation and sediment transport remain missing or insufficient.
