# Final Reclamation Inspection

Operator: Benson Montin and Greer Drilling Corporation - 7650

Location ID: 325299

Location Name: DL Gould Flume Canyon 2

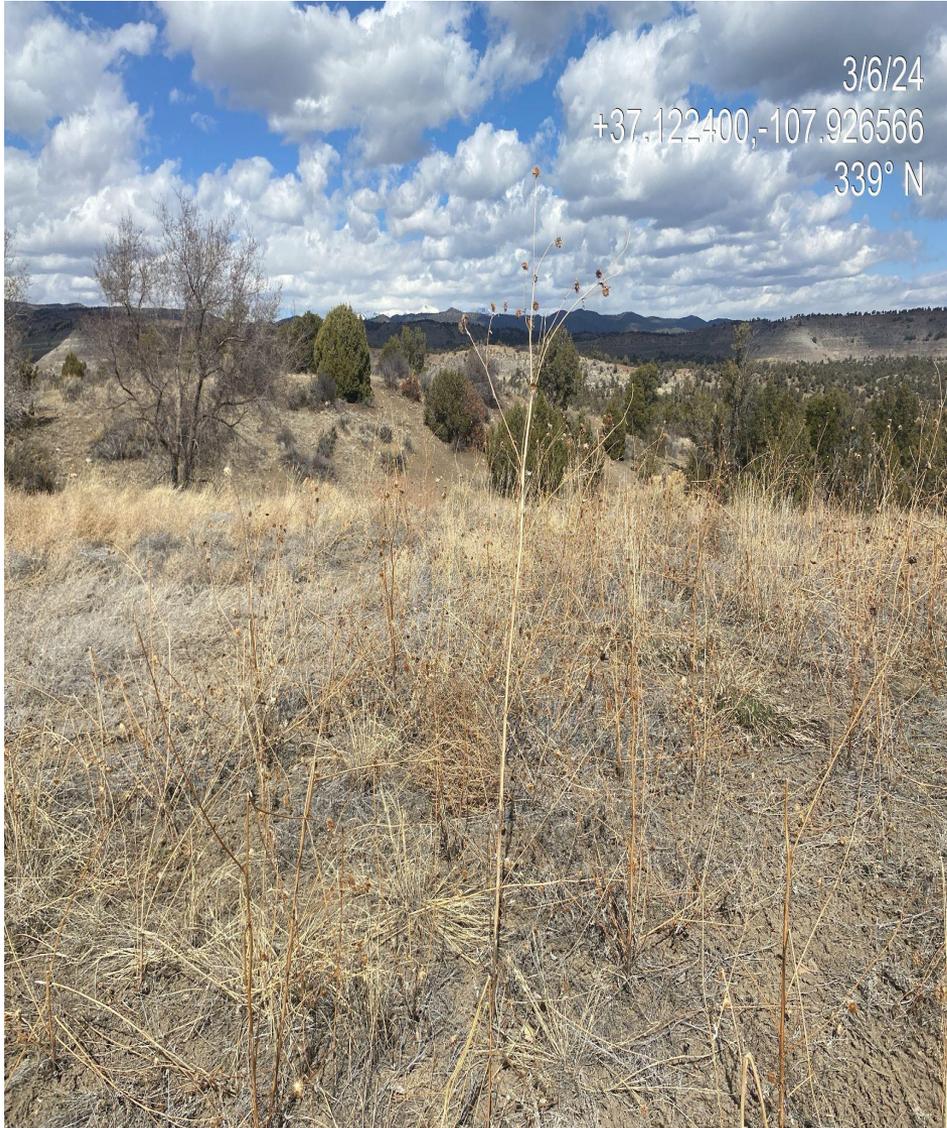
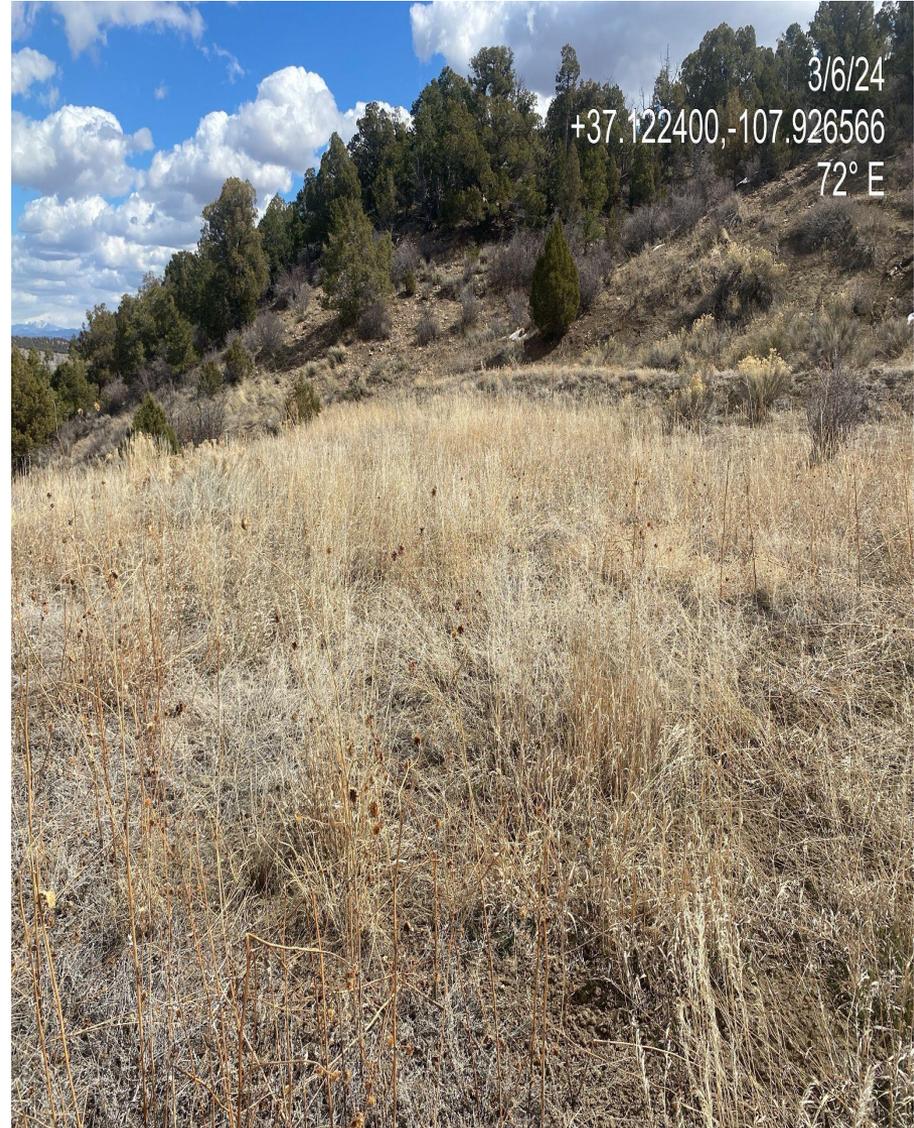
**Photo 2.** Cardinal photos taken from the center of the project area. Left photo facing north, right photo facing east.

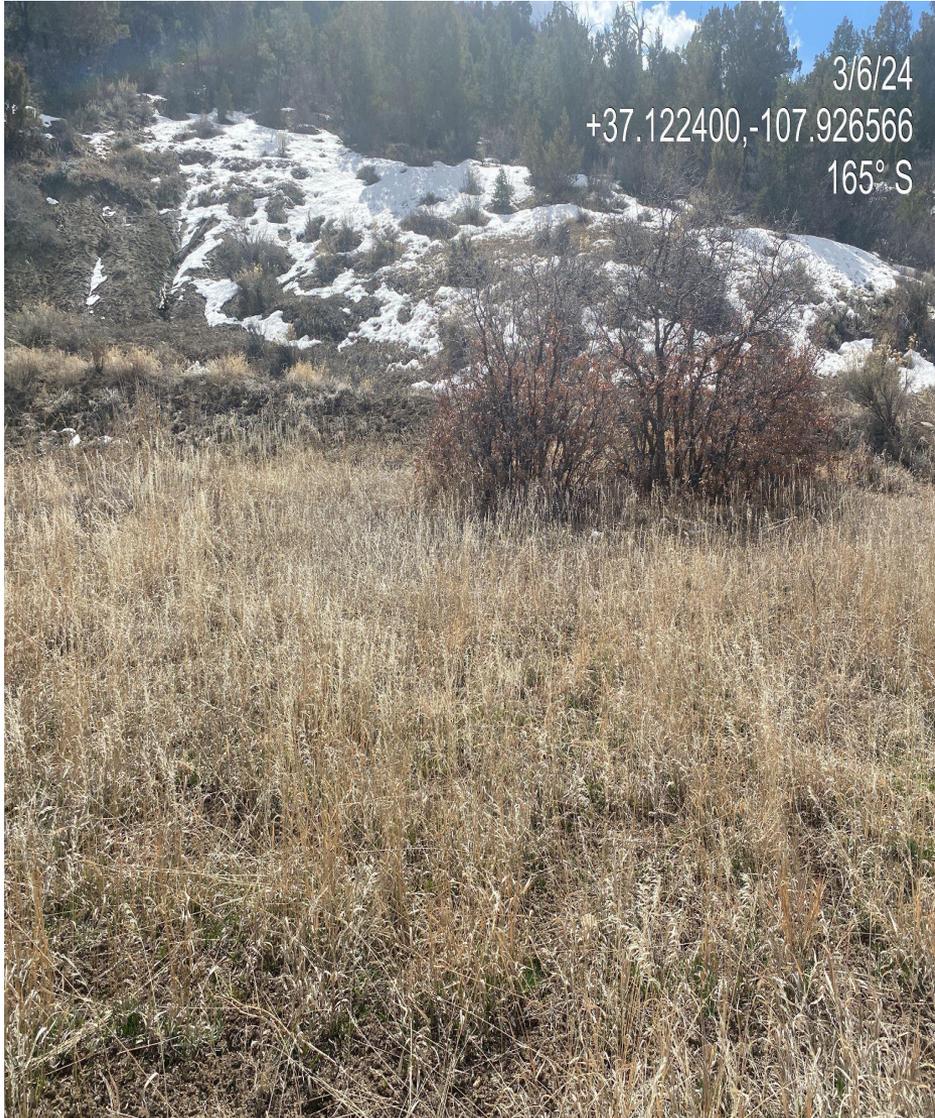
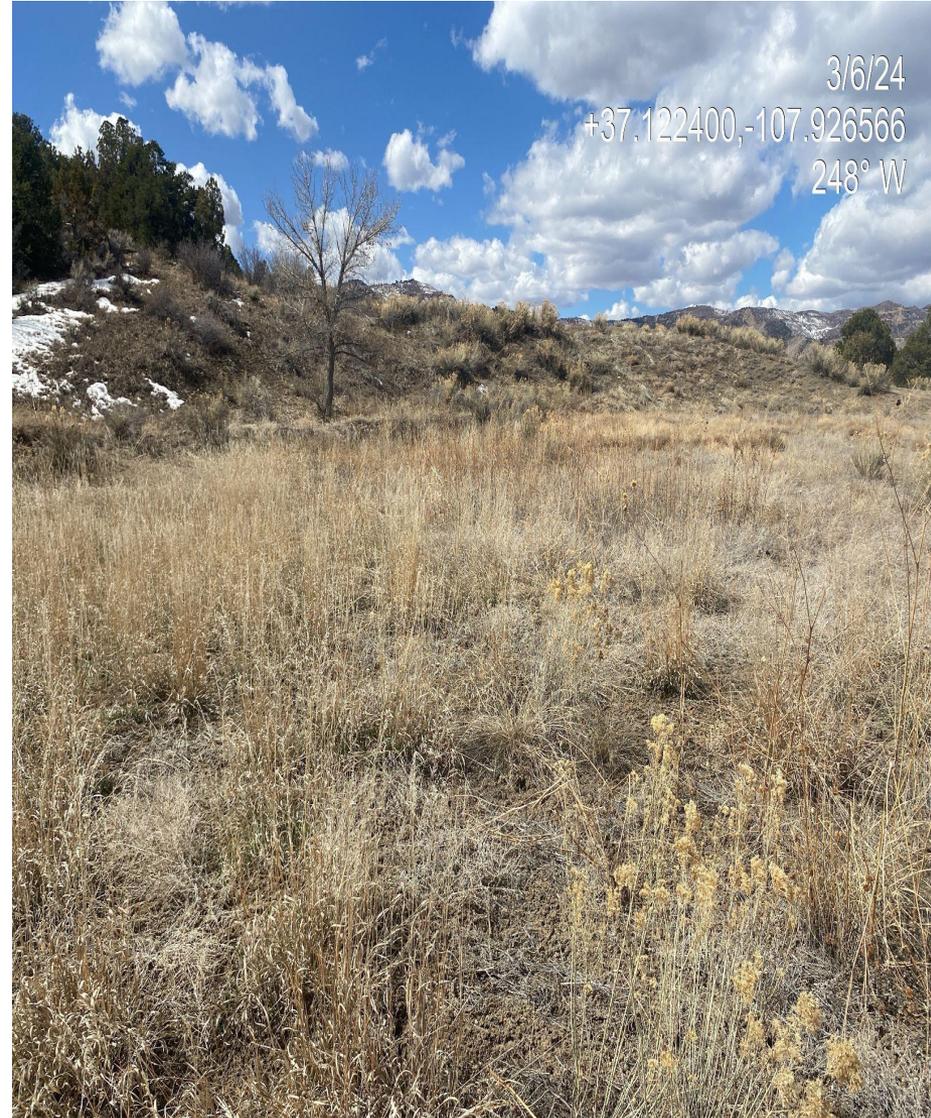
**Photo 3.** Cardinal photos taken from the center of the project area. Left photo facing south, right photo facing west. Note: Sparse vegetation at the well pad.

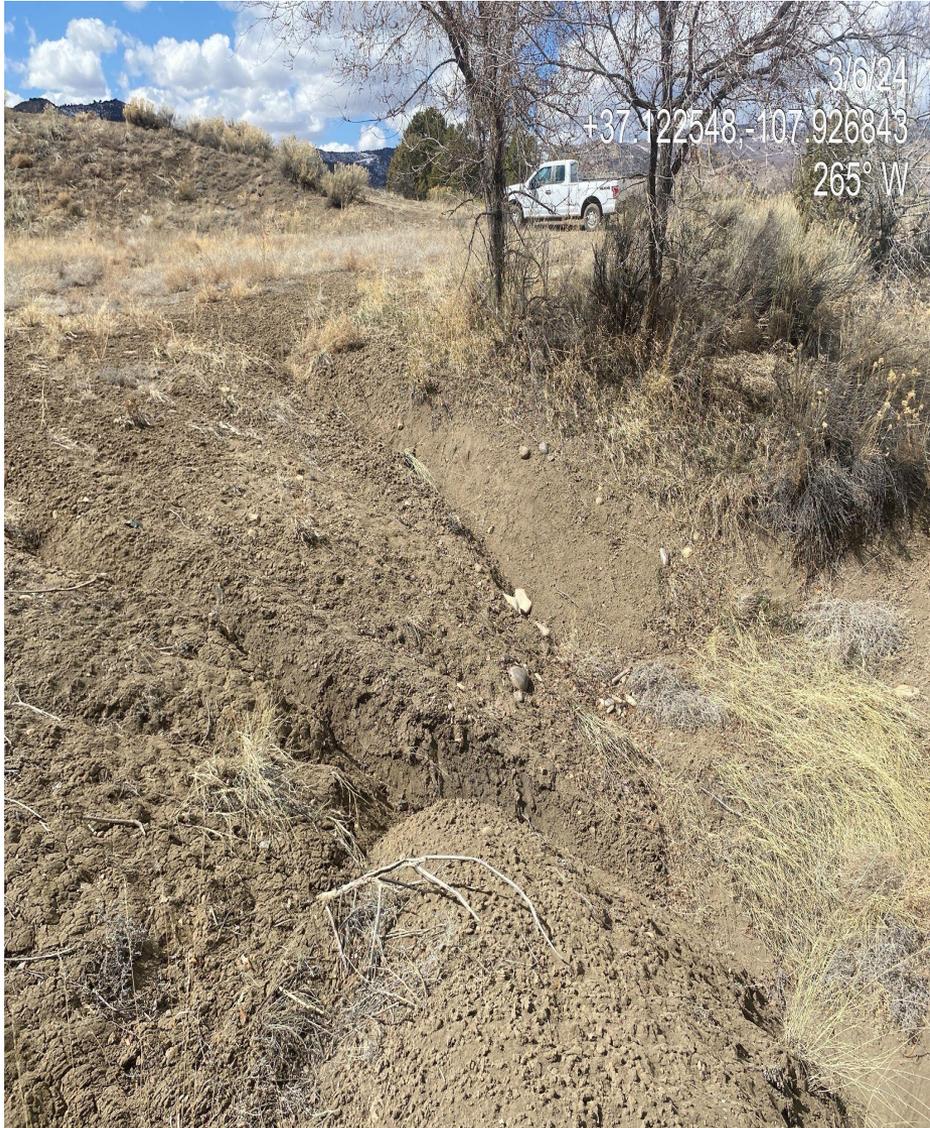
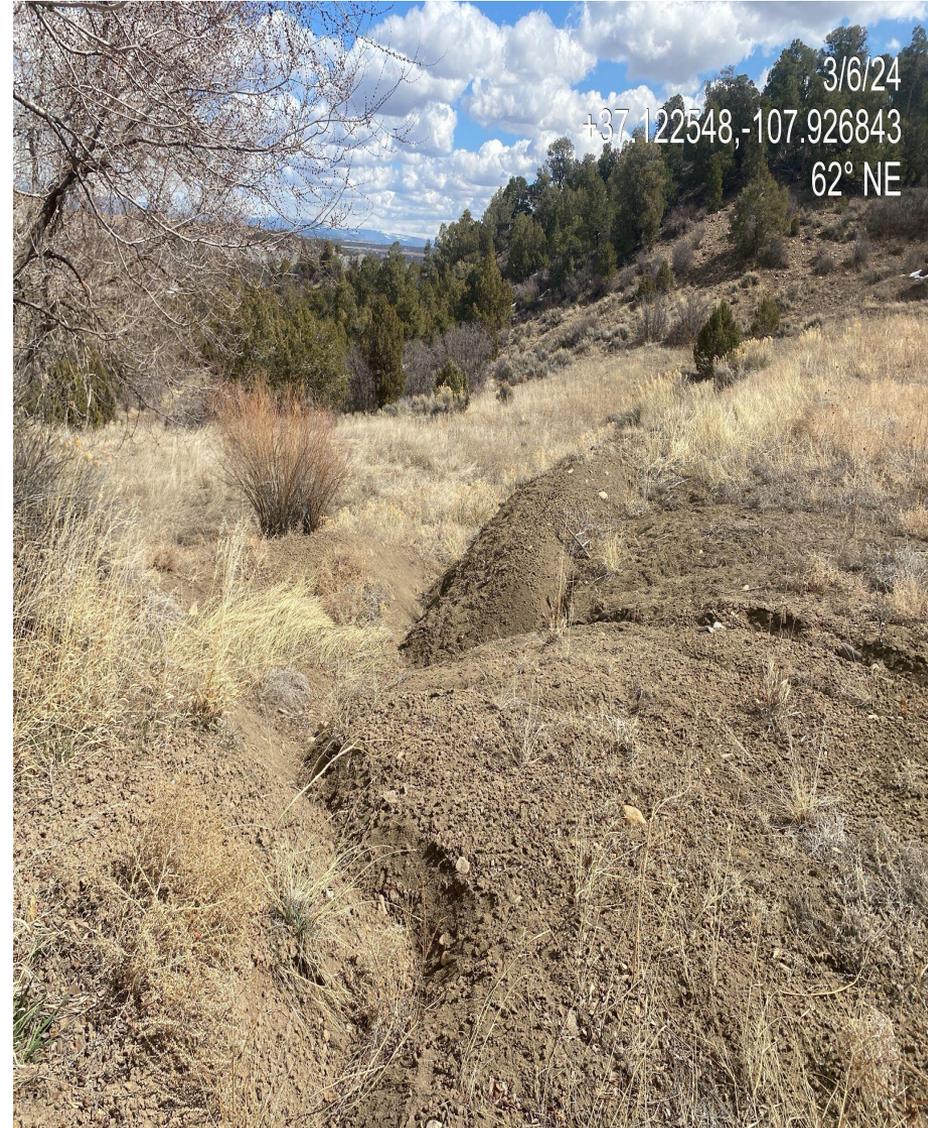
**Photo 4.** View of rill and gully erosion forming on the northwest portion of the disturbance.

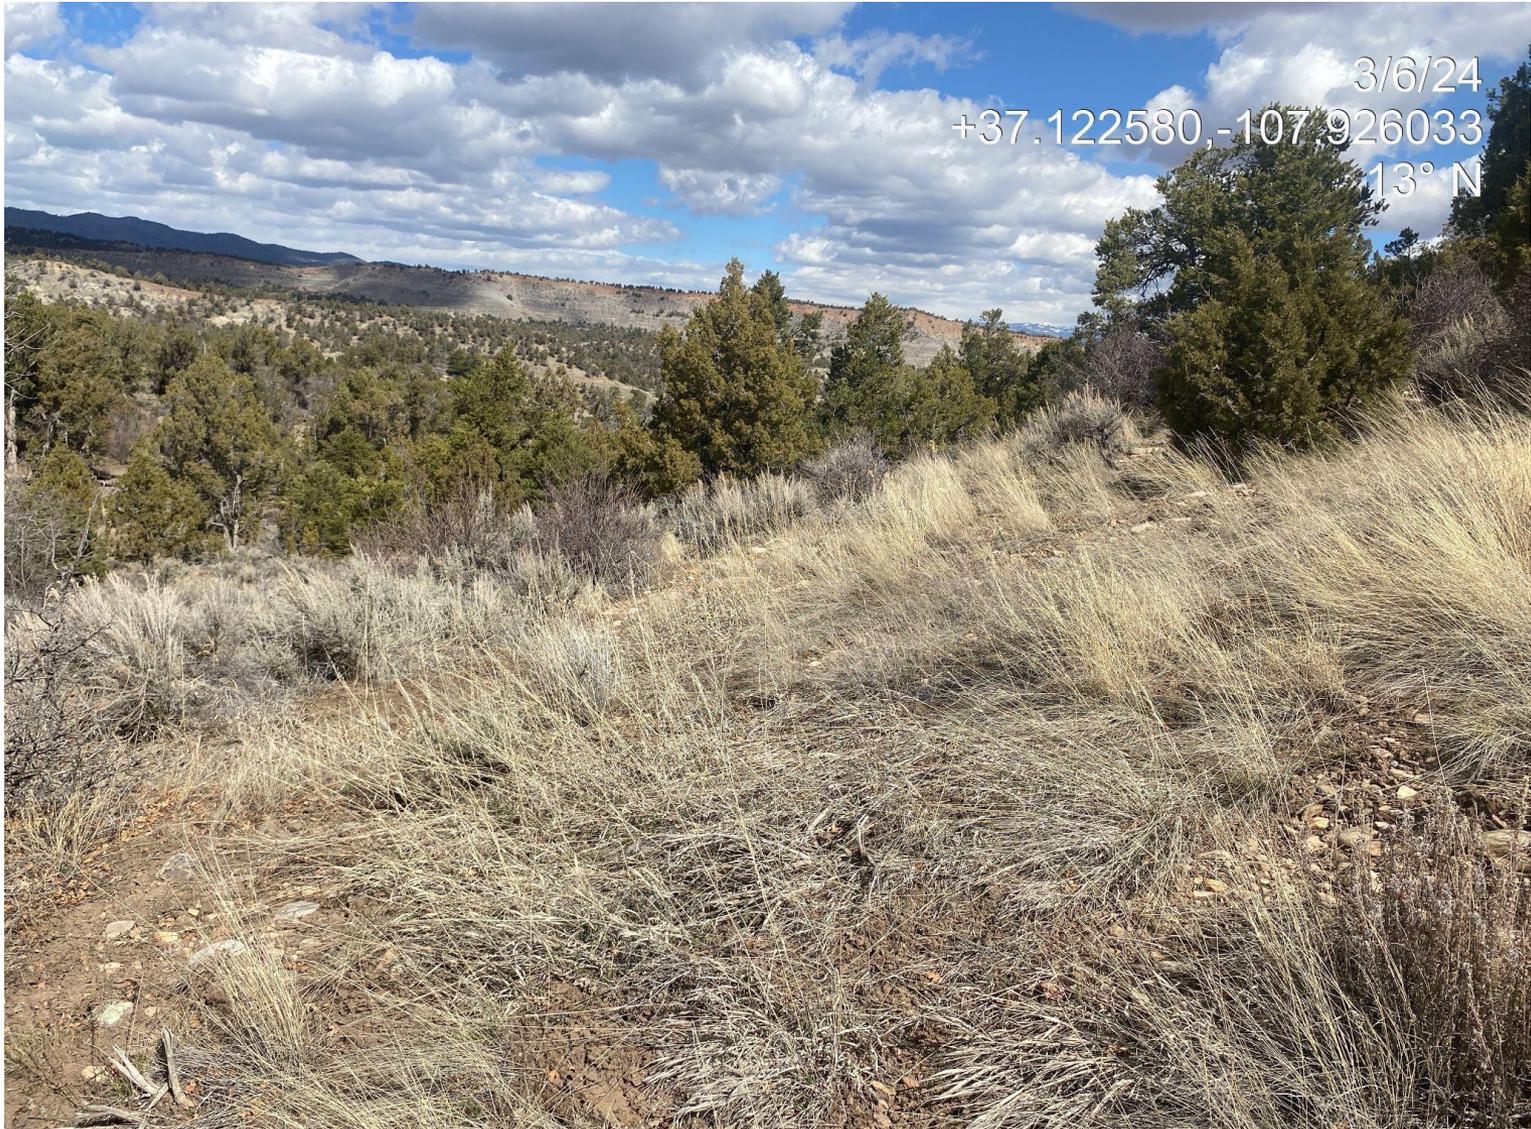
**Photo 5.** View of reference area comprised of smooth brome, rabbit brush, sagebrush and juniper.
