ATTACHMENT B

Photographic Log

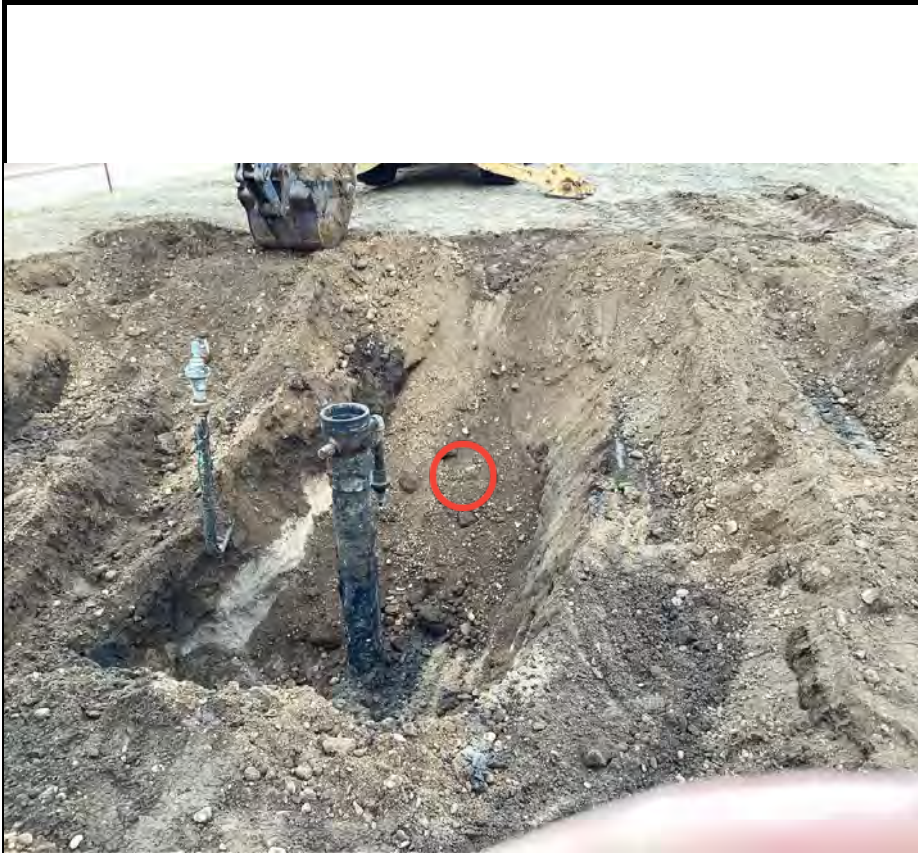
Equipment ID:		Equipment Type:	
Material:	Volume:	Contents:	
Notes/Conditions: WH01-S @ 4'

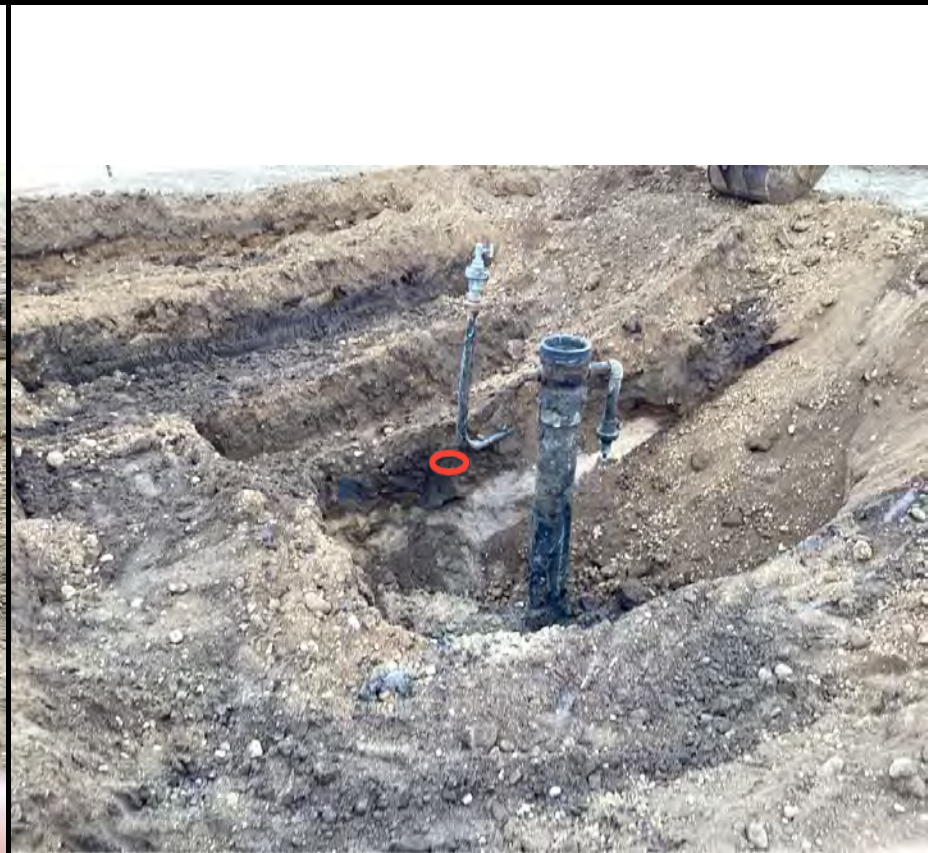
Equipment ID:		Equipment Type:	
Material:	Volume:	Contents:	
Notes/Conditions: WH01-E @ 4'

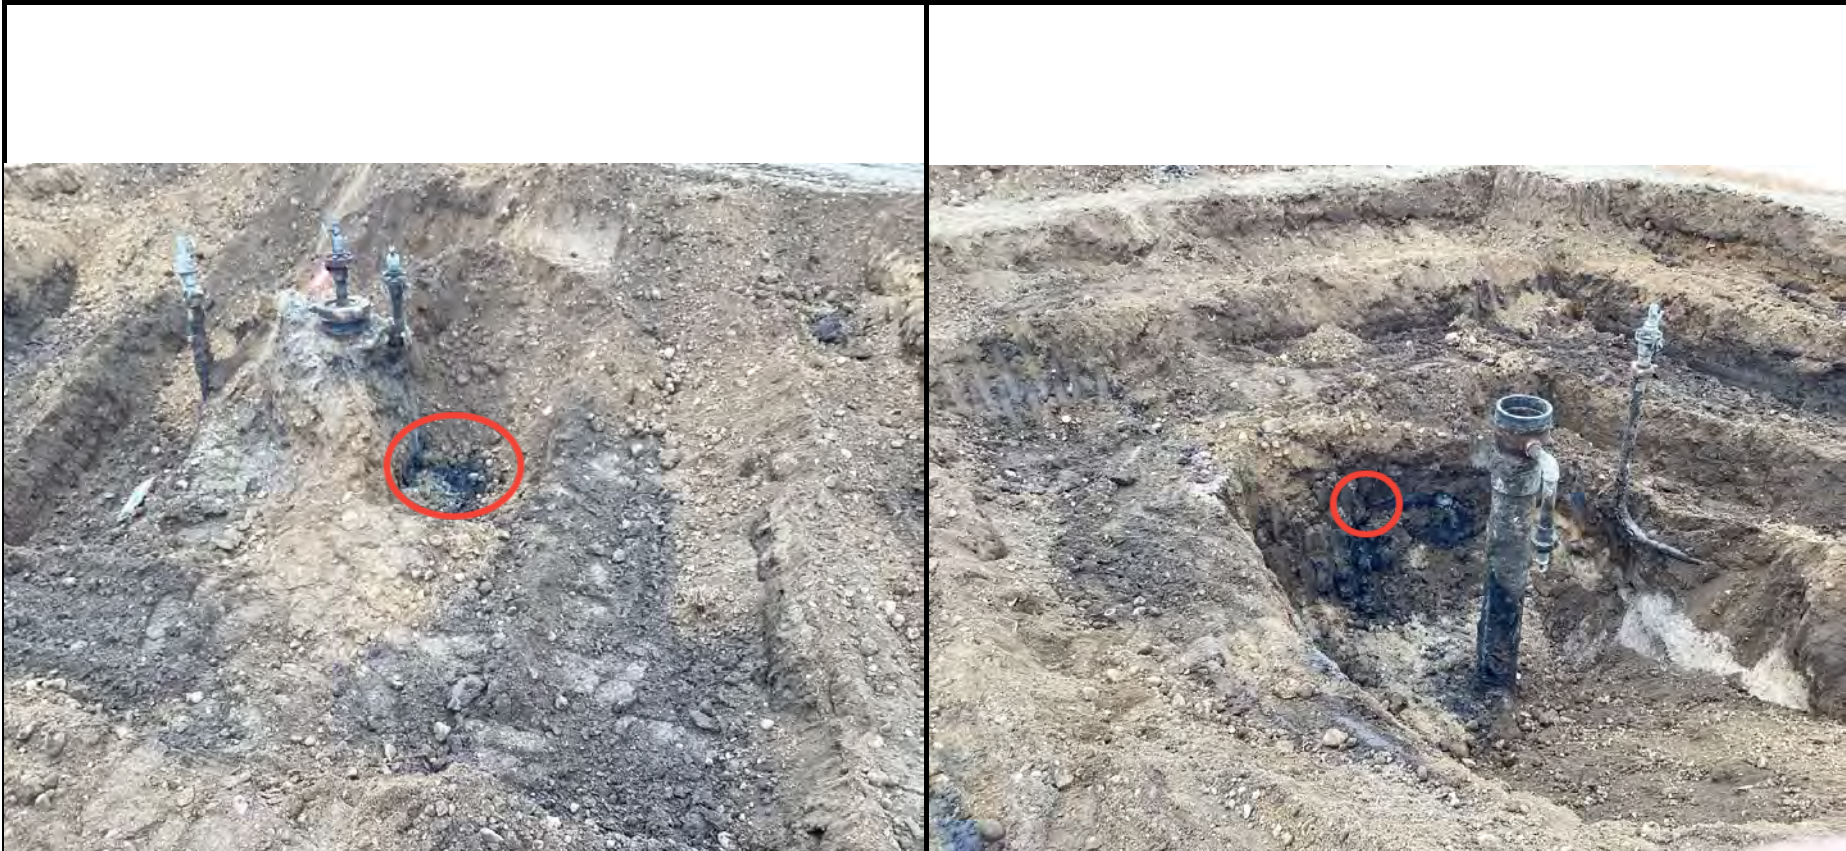
Equipment ID:		Equipment Type:		Equipment ID:		Equipment Type:	
Material:	Volume:	Contents:		Material:	Volume:	Contents:	
Notes/Conditions: WC01 @ 4'				Notes/Conditions: WH01-N @ 4'
