Storm Water Management and Erosion control
Location Name: TEP ROCKY MOUNTAIN LLC STRANAHAN 41C-27 Pad
Location ID: 335437

**Location Overview: Location is within High
Priority/Density/Black Bear Habitat areas & in close proximity
to NSO Habitat area.**

Section/Township/Range: 27 6S92W

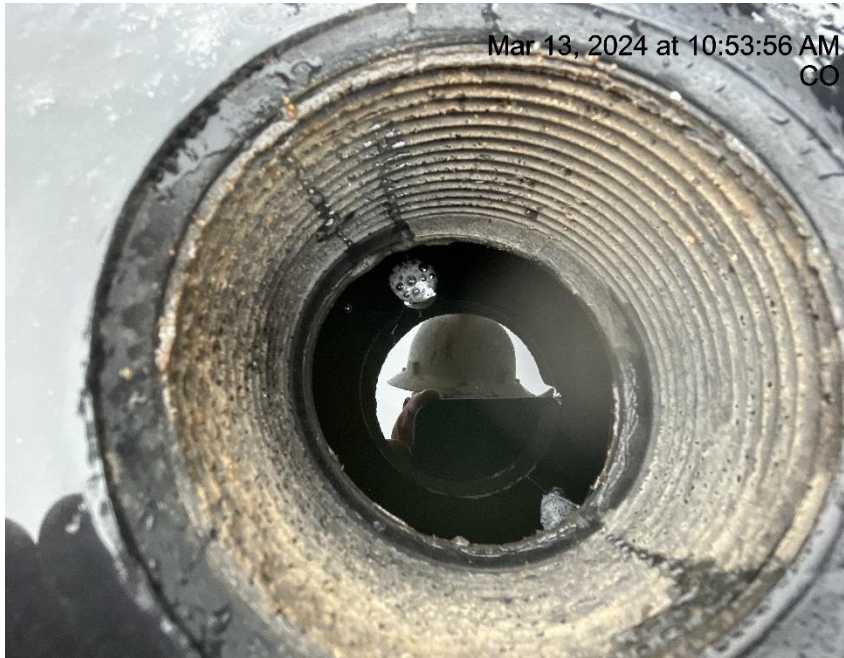
Photo # 9692 Chemical tank containment full of fluid/Failure to maintain chemical BMP/BMP insufficient to contain possible spill.

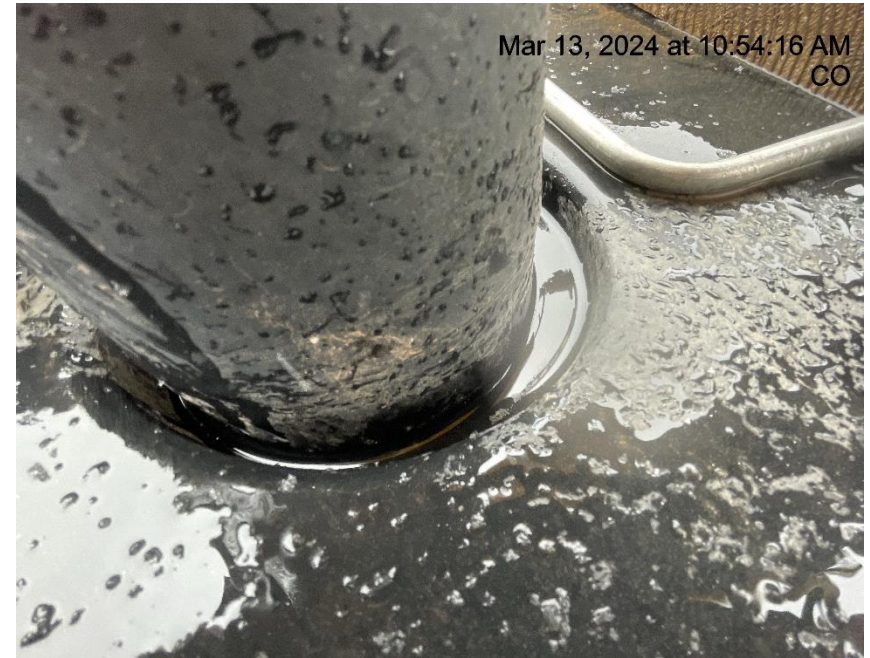
Photo # 9693 Chemical tank containment full of fluid/Failure to maintain chemical BMP/BMP insufficient to contain possible spill.

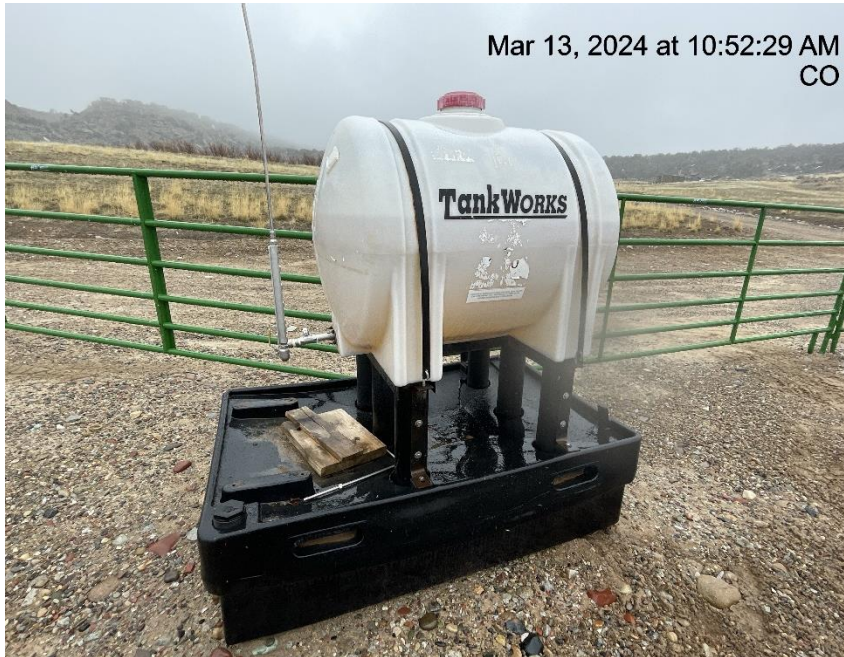
Photo # 9694 Chemical tank & containment are also unused equipment
