Final Reclamation and Stormwater Inspection

Location ID: 376781

Inspection Document #: 709400861

Inspection Photos
Location Name: Downing B 1
Location ID: 376781

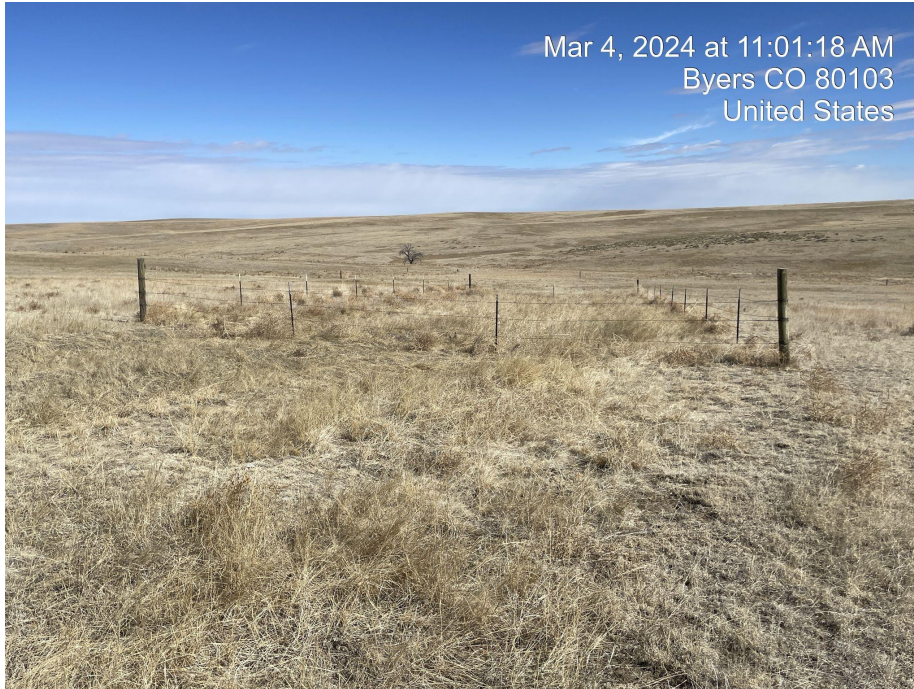
Photo 1. Photo taken facing northeast of perimeter fence of reclaimed access road. The access road meet final reclamation standards of 80% native vegetation, weed management will need to continue.

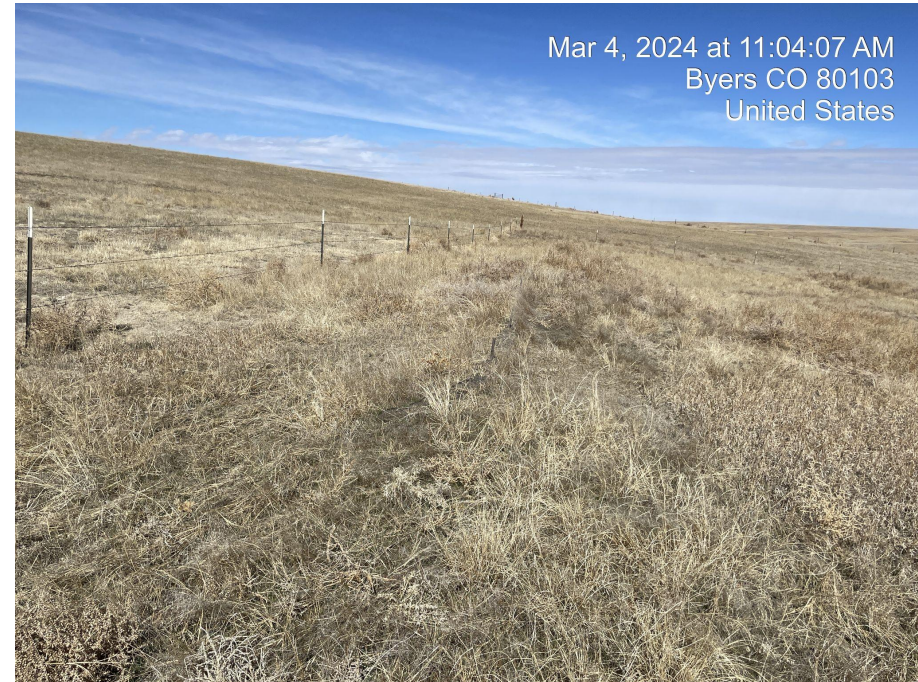
Photo 2. Photo taken facing northeast of reclaimed access road. The access road meet final reclamation standards of 80% native vegetation, weed management will need to continue.

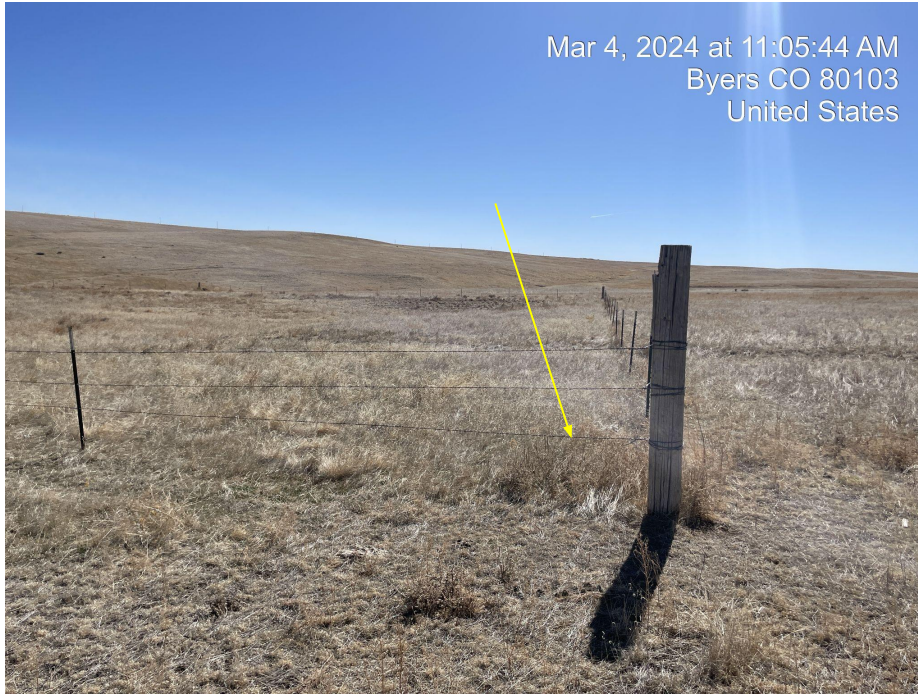
Photo 3. Photo taken facing east of reclaimed pad perimeter fence, vegetation and weeds (russian thistle & kochia). Weeds indicated by yellow arrow.

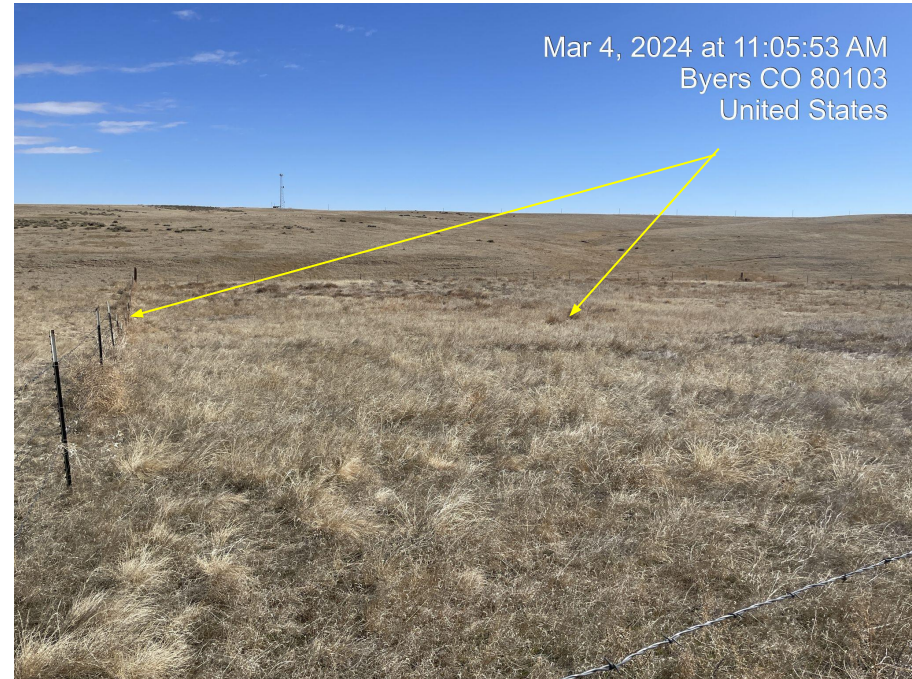
Photo 4. Photo taken facing north of reclaimed pad area of vegetation and weeds (russian thistle & kochia). Weeds indicated by yellow arrow.

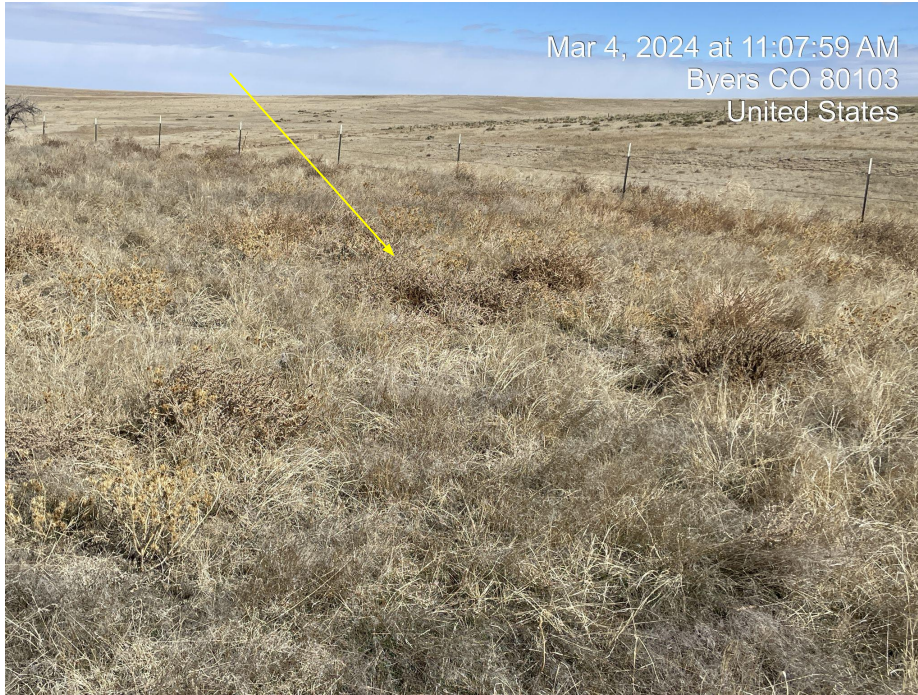
Photo 5. Photo taken facing southeast of reclamation area of vegetation and weeds (russian thistle, bull thistle & kochia). Weeds indicated by yellow arrow.

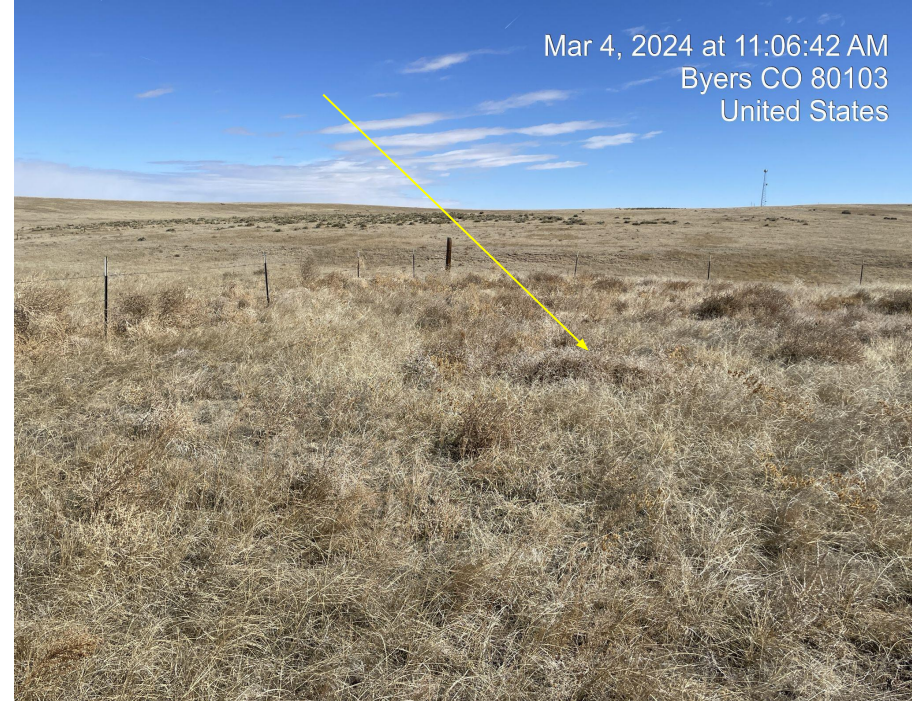
Photo 6. Photo taken facing southwest of pad reclamation area of vegetation and weeds (russian thistle & kochia). Weeds indicated by yellow arrow.

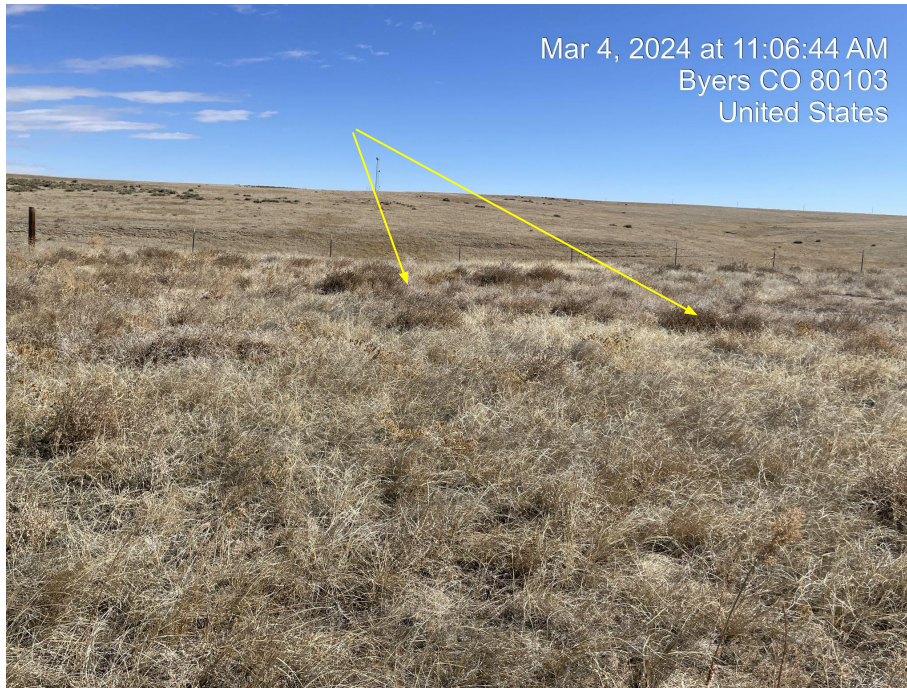
Photo 7. Photo taken facing west of pad reclamation area of vegetation and weeds (russian thistle, bull thistle & kochia). Weeds indicated by yellow arrow.

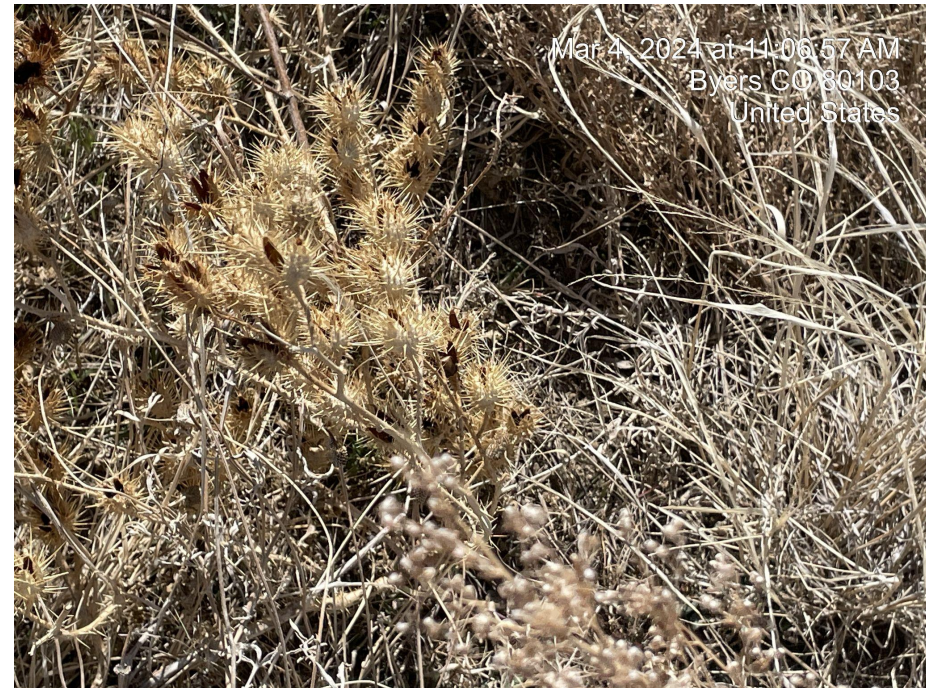
Photo 8. Photo taken facing northeast of close up of weeds (bull thistle).

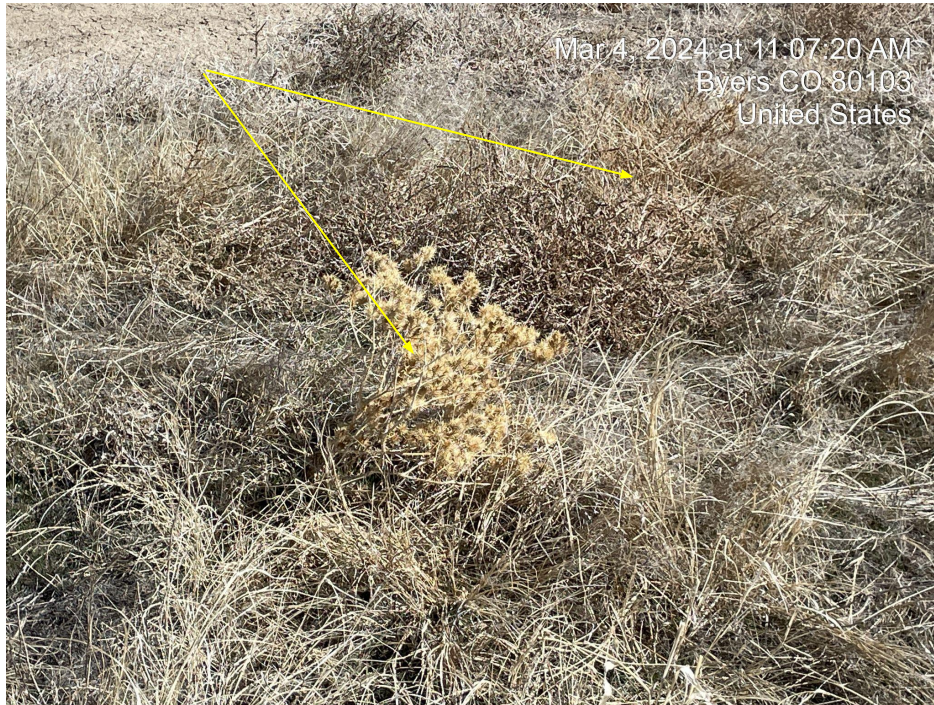
Photo 9. Photo taken facing east of pad reclamation area of vegetation and weeds (russian thistle, bull thistle & kochia). Weeds indicated by yellow arrow.

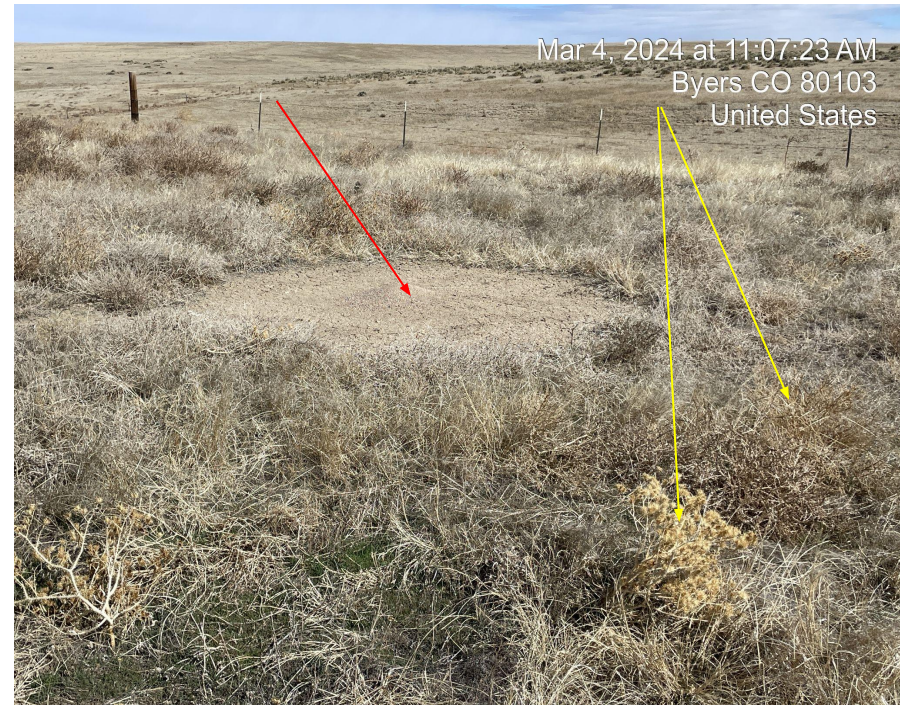
Photo 10. Photo taken facing west of pad reclamation area of bare soil, vegetation and weeds (russian thistle, bull thistle & kochia). Weeds indicated by yellow arrow, Red arrow indicates bare soil.

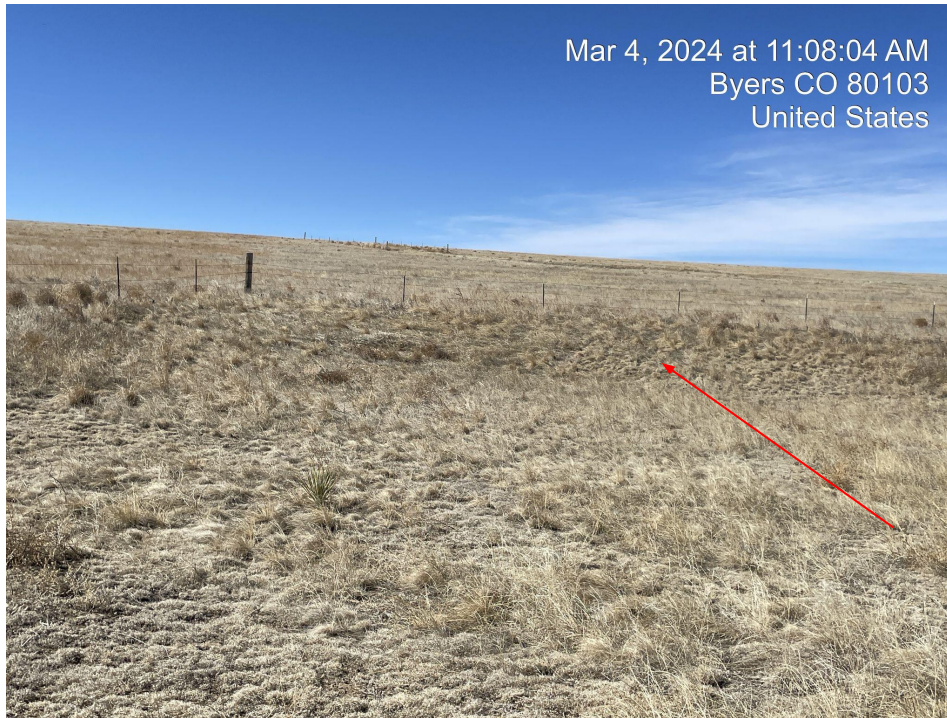
Photo 11. Photo taken facing southwest of pad reclamation area of vegetation and weeds (russian thistle & kochia) and cut slope not recontoured to native landscape (indicated by red arrow).

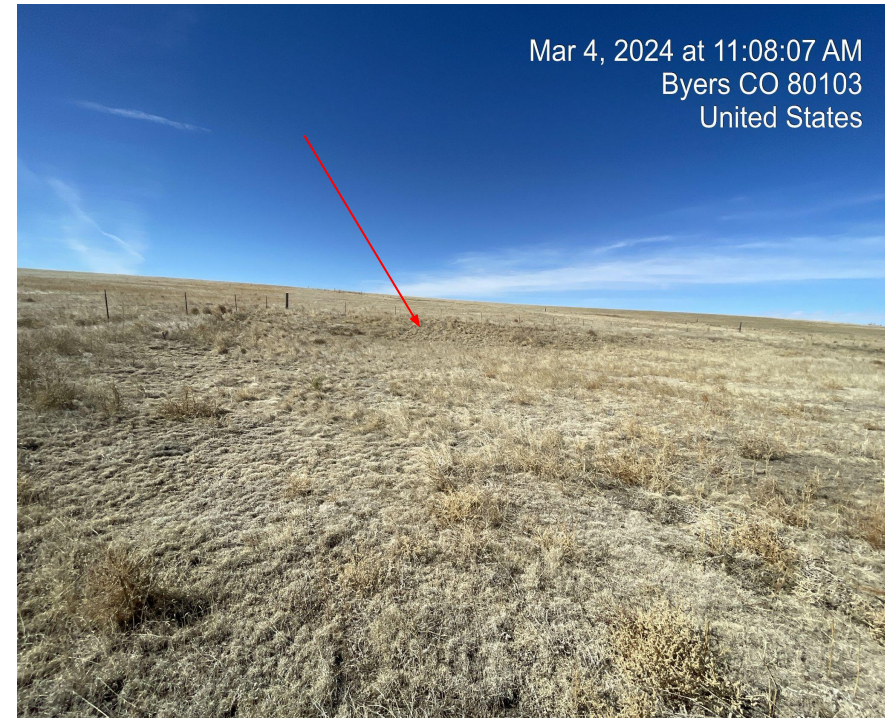
Photo 12. Photo taken facing southwest of pad reclamation area of vegetation and weeds (russian thistle & kochia) and cut slope not recontoured to native landscape (indicated by red arrow).

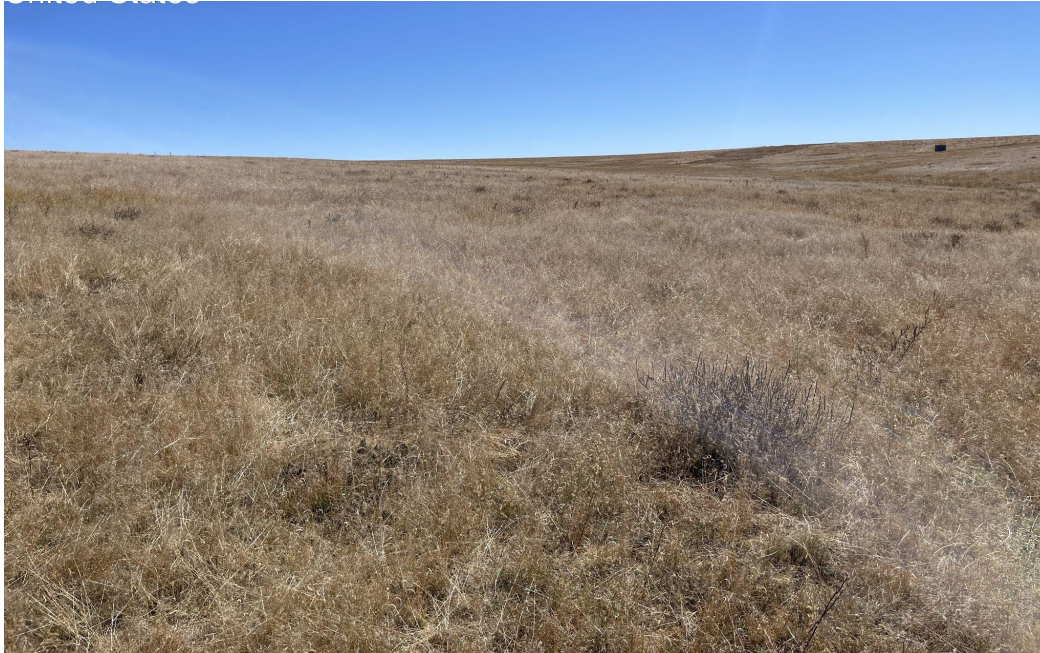
Photo 13. Photo taken facing southwest of native vegetation for reference.

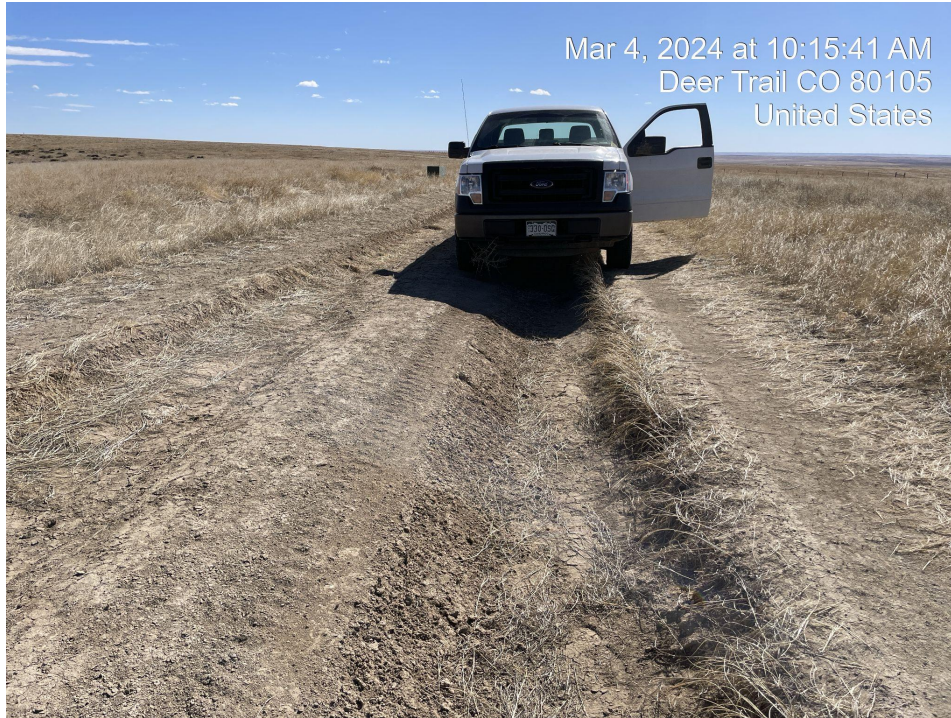
Photo 14. Photo taken facing south of rutted access road.

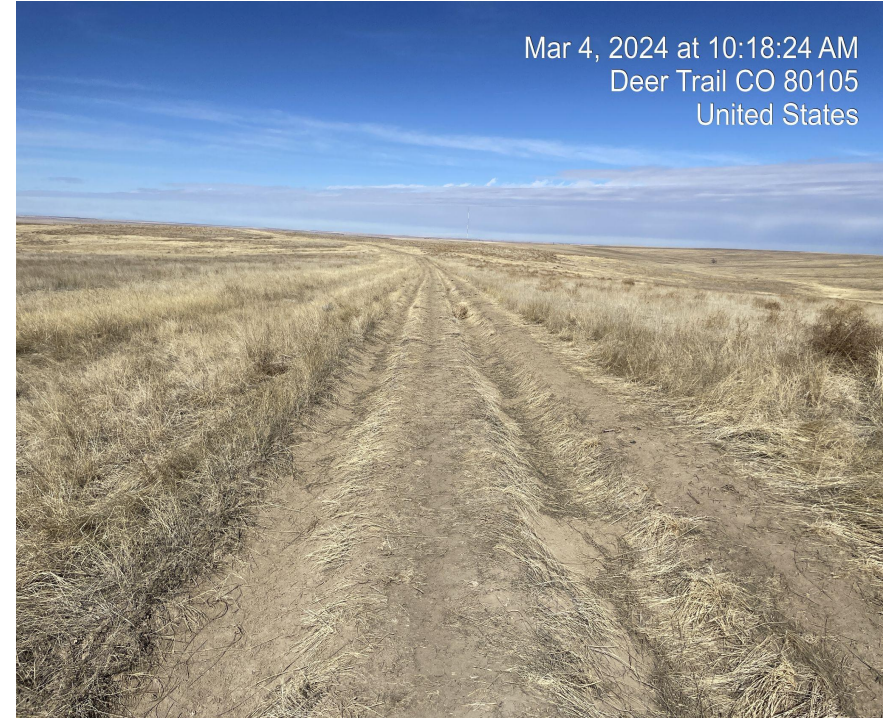
Photo 15. Photo taken facing northwest of rutted access road.
