# Final Reclamation and Stormwater Inspection

Operator: Oilfield Salvage & Service Co- #65550

Location ID: 311709

Inspection Photos  
Location Name: Noonan Ranch 10  
Location ID: 311709

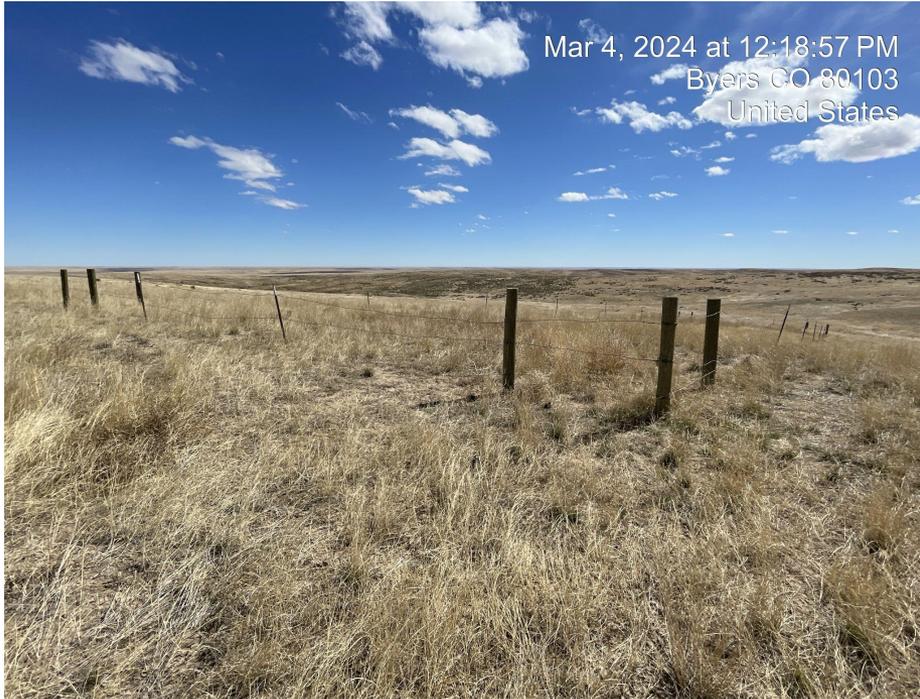
**Photo 1.** Photo taken facing southeast of reclaimed area.

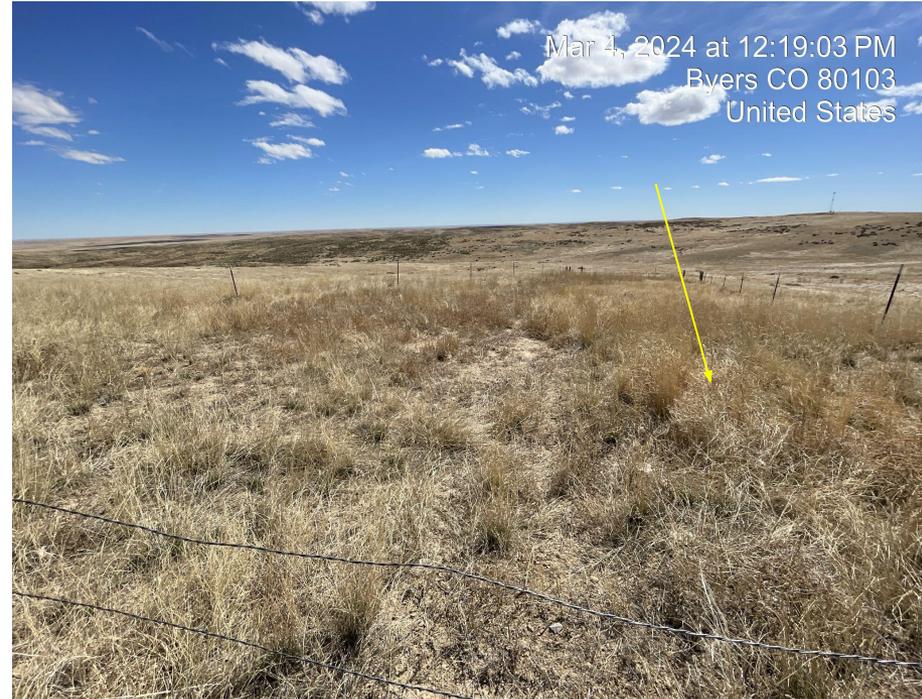
**Photo 2.** Photo taken facing south of pad reclamation area of vegetation and weeds (russian thistle & kochia). Weeds indicated by yellow arrow.

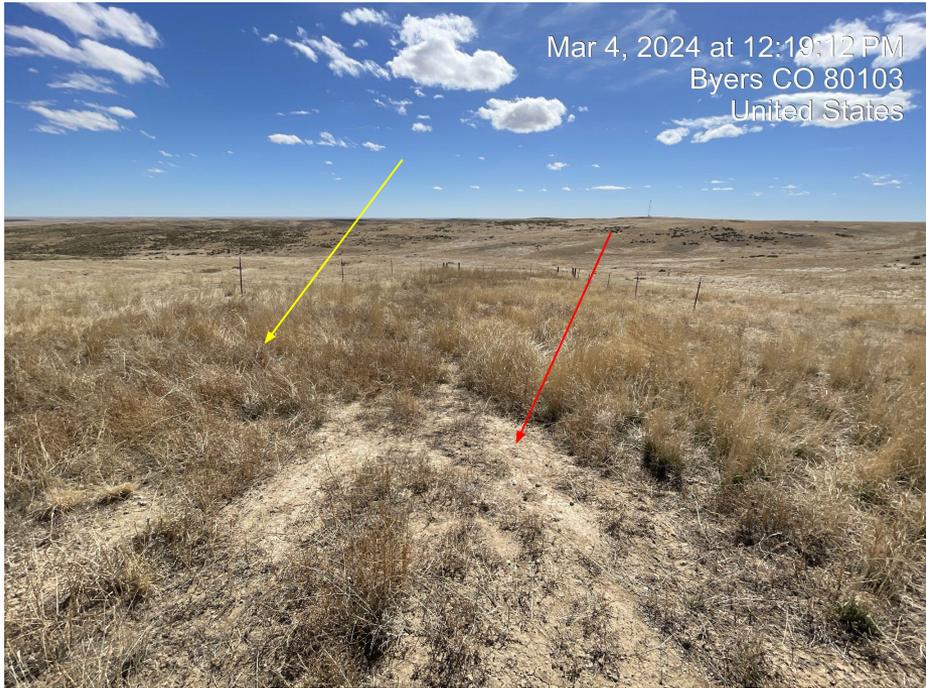
**Photo 3.** Photo taken facing south of reclamation area of vegetation, weeds (russian thistle & kochia) and bare soil. Weeds indicated by yellow arrow, bare soil indicated by red arrow.

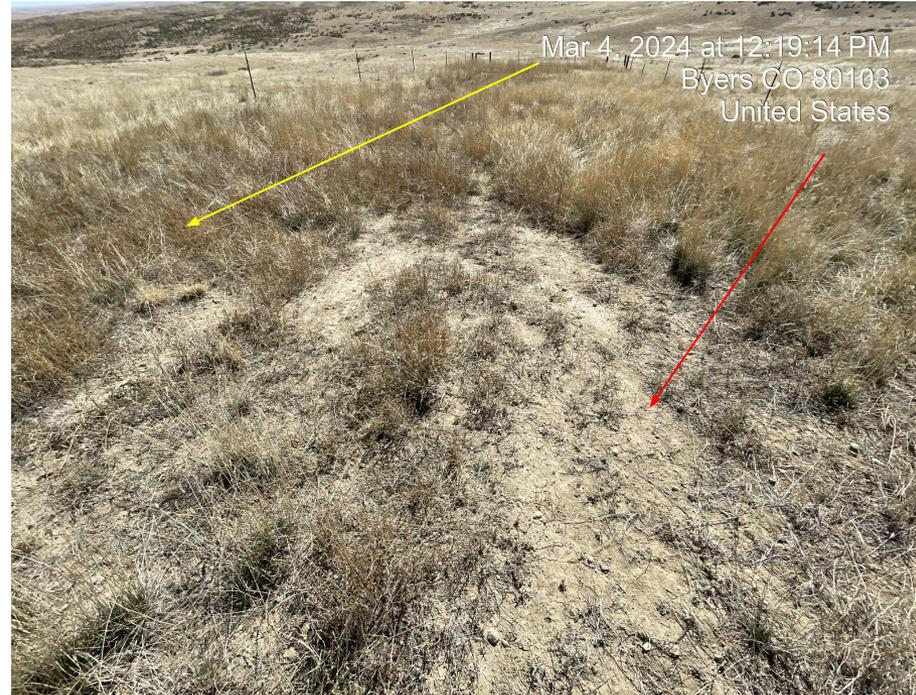
**Photo 4.** Photo taken facing south of reclamation area of vegetation, weeds (russian thistle & kochia) and bare soil. Weeds indicated by yellow arrow, bare soil indicated by red arrow.

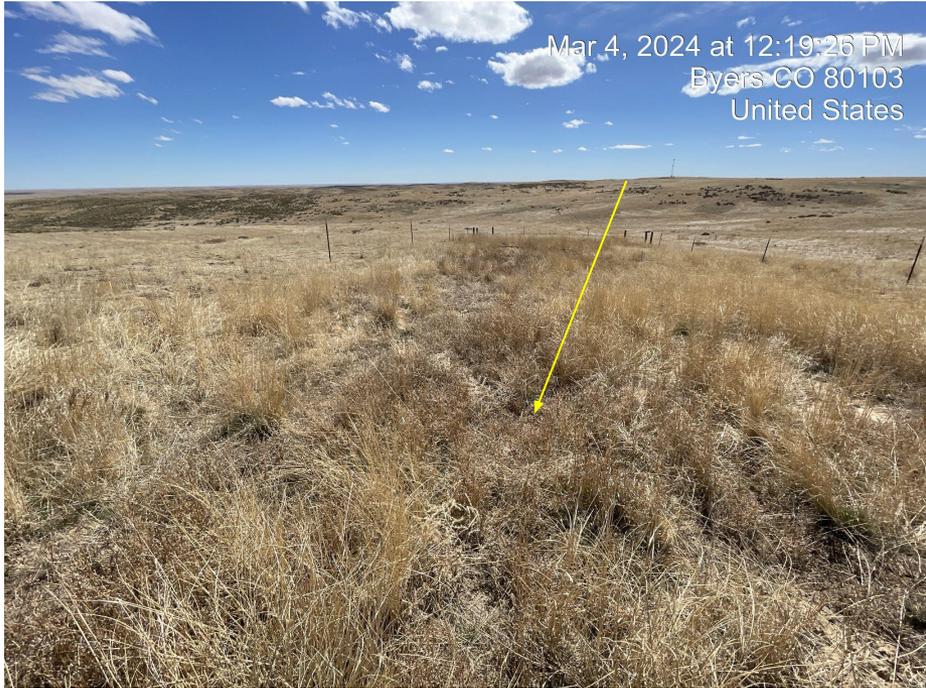
**Photo 5.** Photo taken facing southeast of reclamation area of vegetation and weeds (russian thistle & kochia). Weeds indicated by yellow arrow.

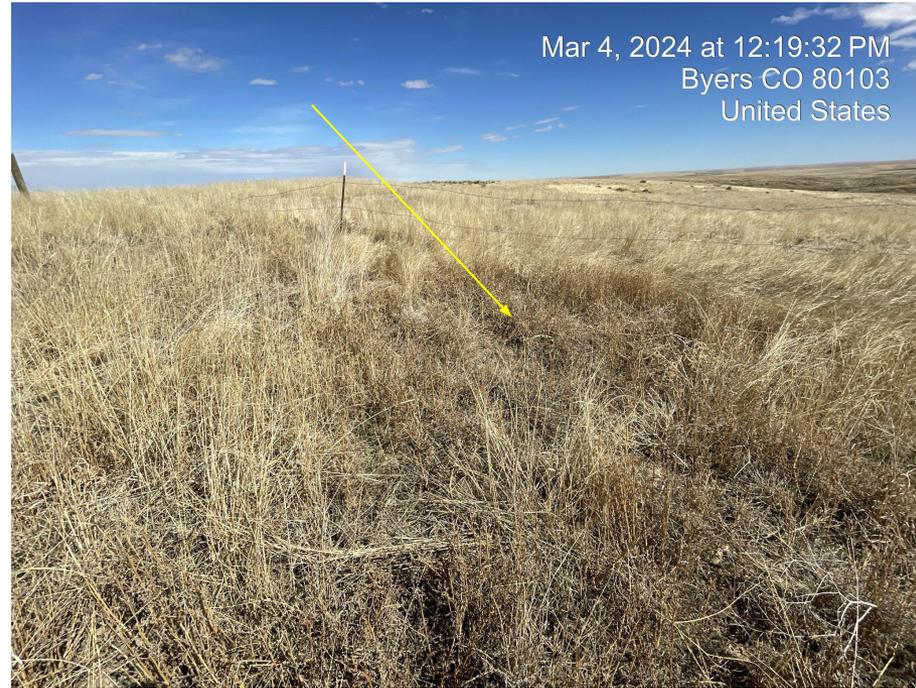
**Photo 6.** Photo taken facing northeast of reclamation area of vegetation and weeds (russian thistle & kochia). Weeds indicated by yellow arrow.

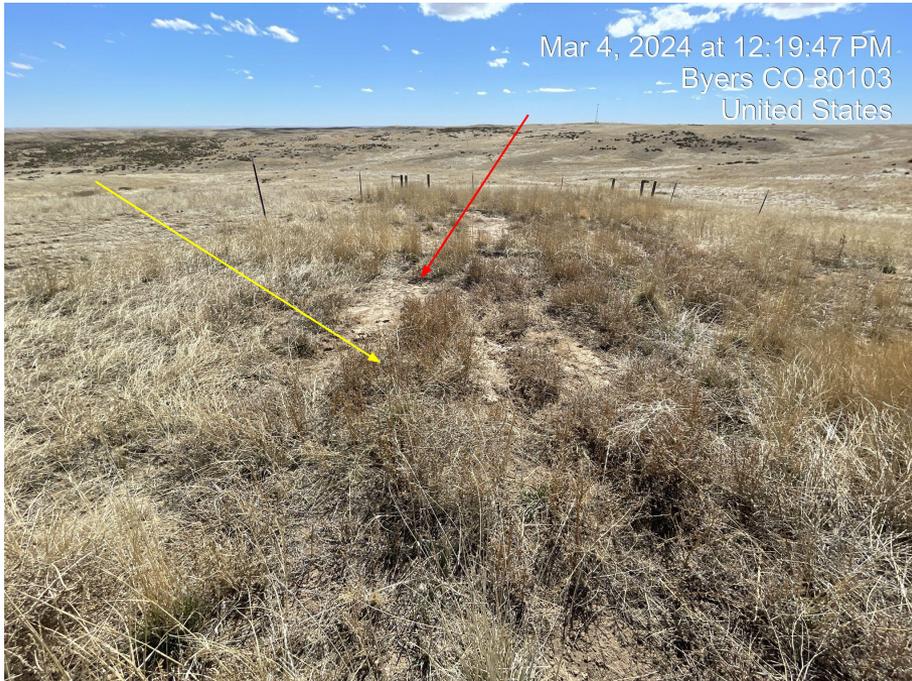
**Photo 7.** Photo taken facing southwest of reclamation area of vegetation, weeds (russian thistle & kochia) and bare soil. Weeds indicated by yellow arrow, bare soil indicated by red arrow.

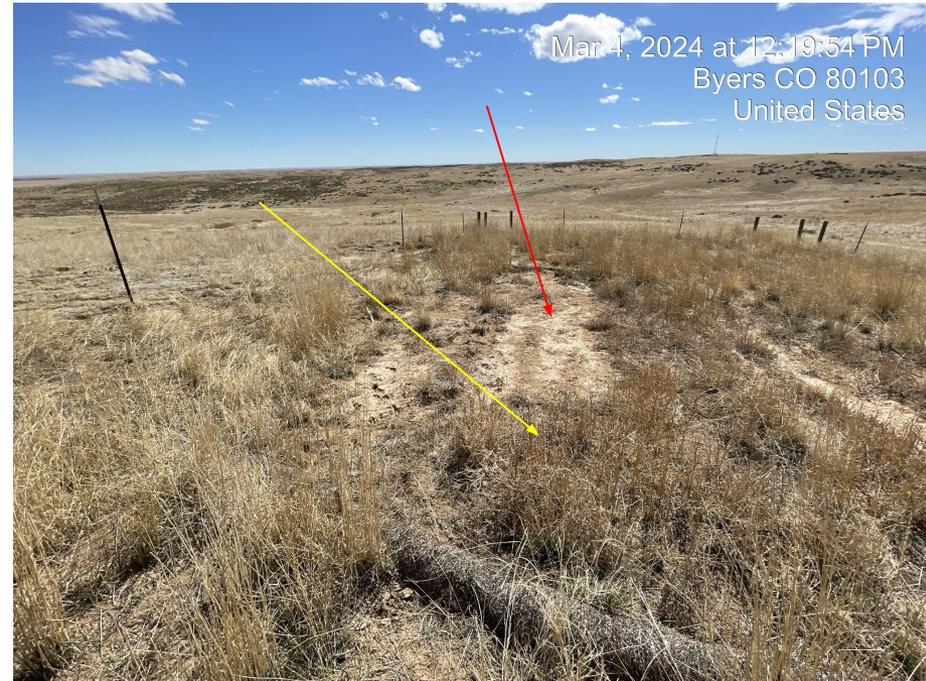
**Photo 8.** Photo taken facing southwest of pad reclamation area of vegetation, weeds (russian thistle & kochia) and bare soil. Weeds indicated by yellow arrow, bare soil indicated by red arrow.

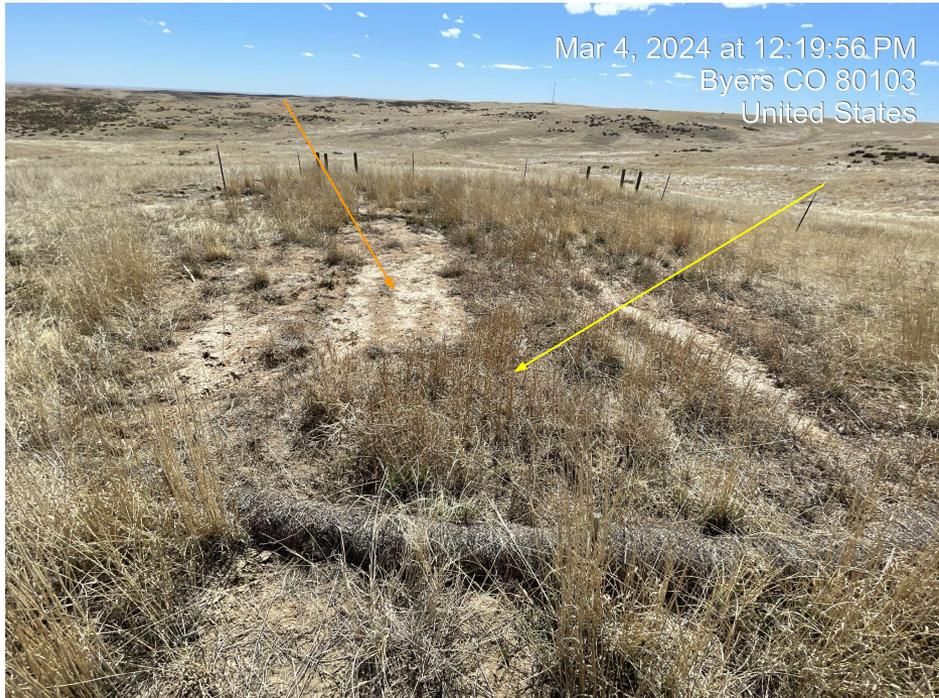
**Photo 9.** Photo taken facing south of reclamation area of vegetation, weeds (russian thistle & kochia) and bare soil. Weeds indicated by yellow arrow, bare soil indicated by red arrow.

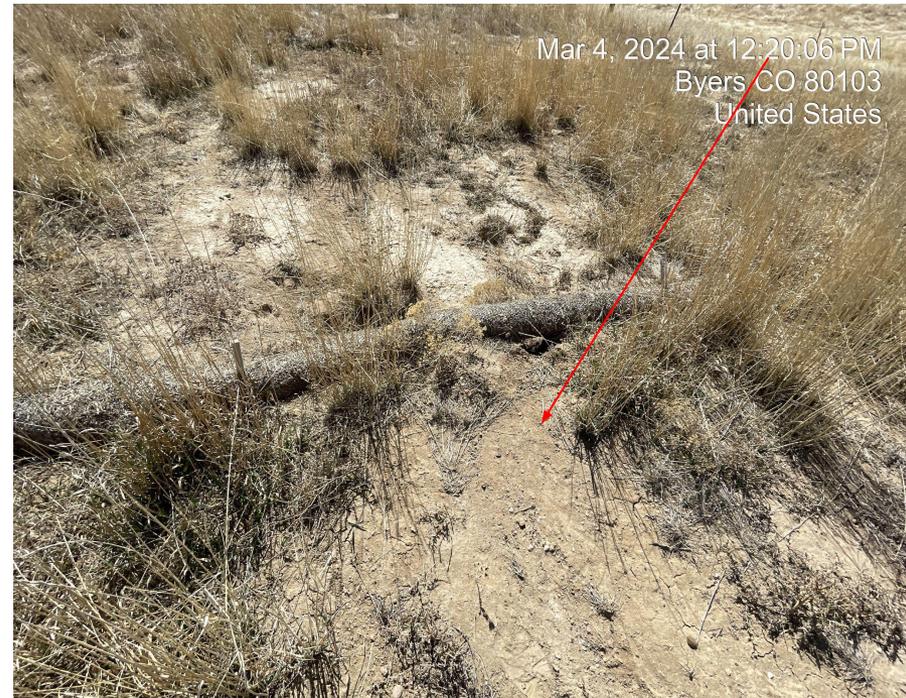
**Photo 10.** Photo taken facing south of reclamation area of vegetation, bare soil and stormwater erosion under BMP. Bare soil indicated by red arrow.

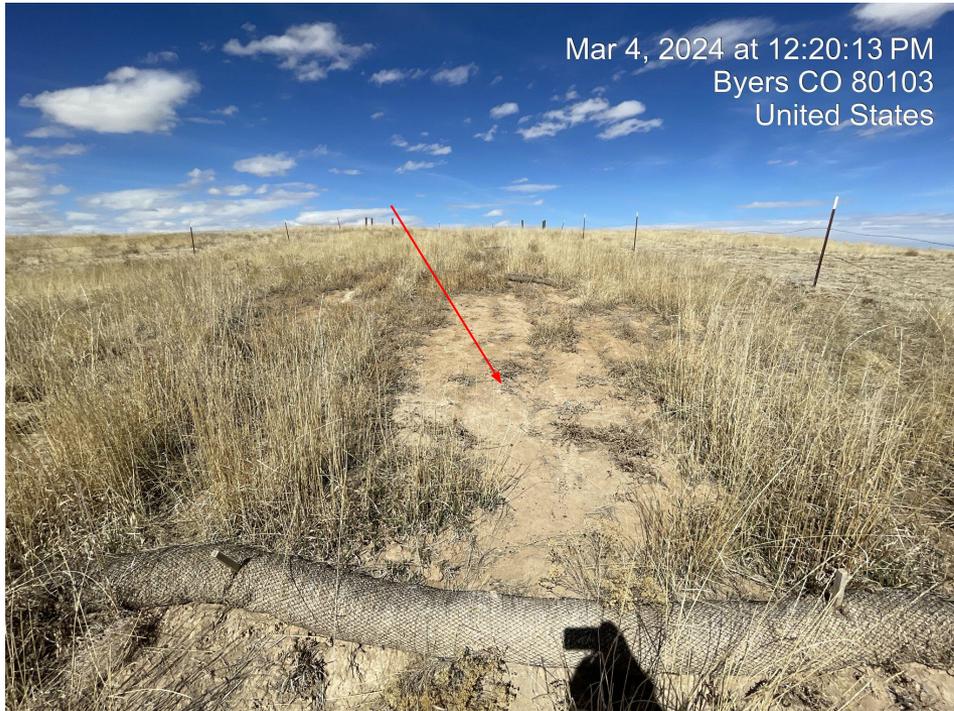
**Photo 11.** Photo taken facing north of pad reclamation area of vegetation and bare soil. Bare soil indicated by red arrow.

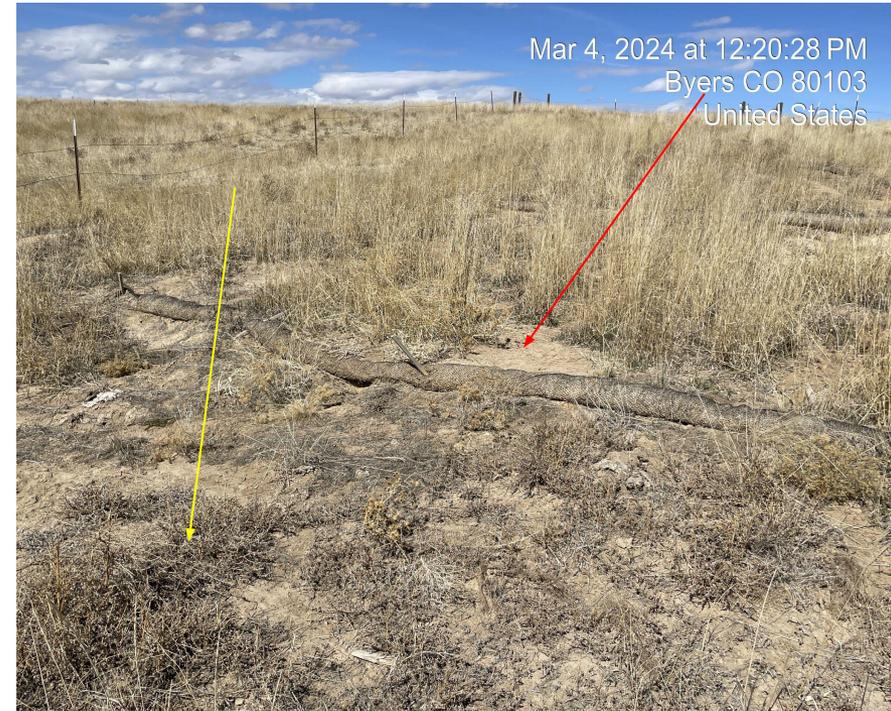
**Photo 12.** Photo taken facing north of pad reclamation area of vegetation and weeds (russian thistle & kochia) and bare soil. Weeds indicated by yellow arrow, bare soil indicated by red arrow.

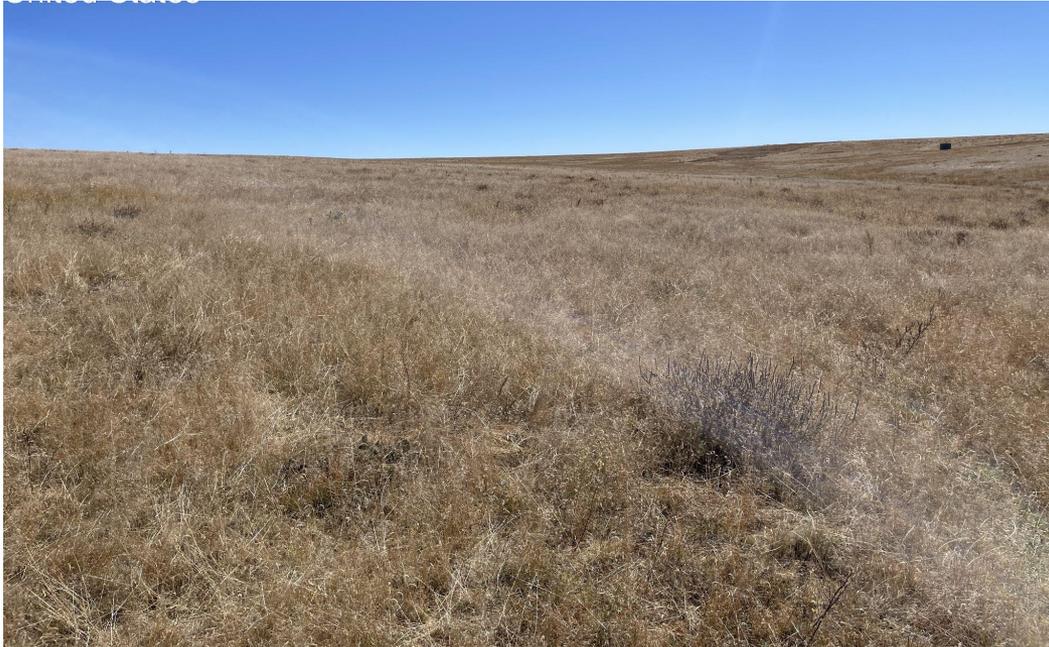
**Photo 13.** Photo taken facing southwest of native vegetation for reference.

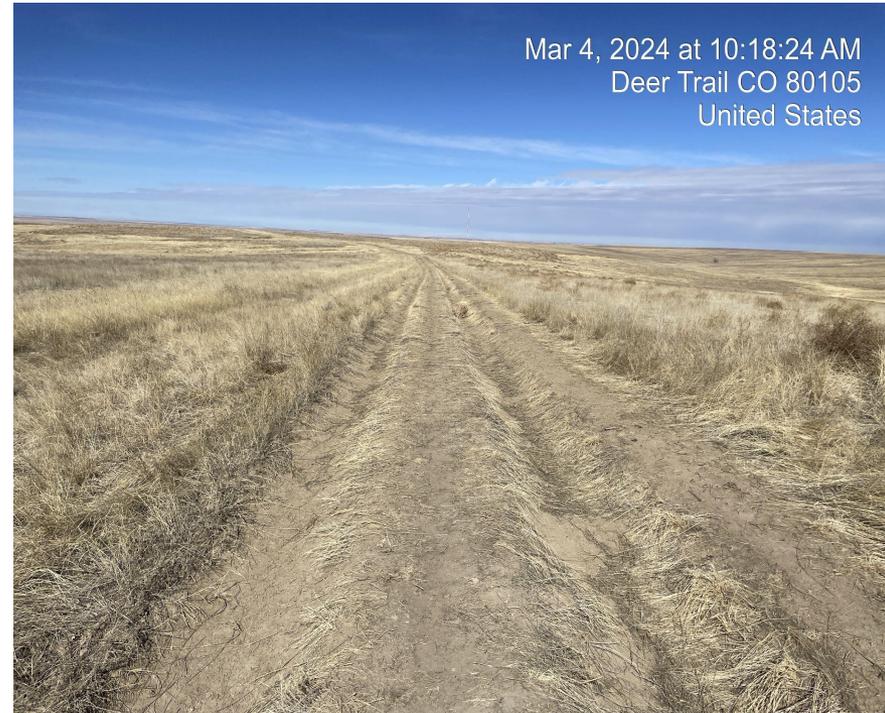
**Photo 15.** Photo taken facing northwest of rutted access road.

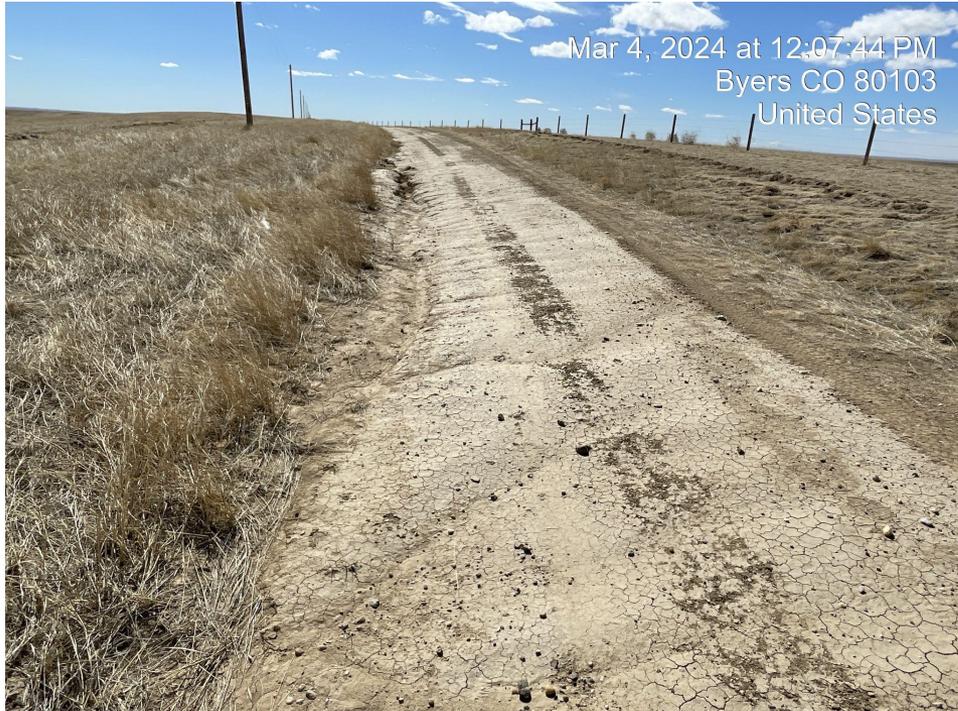
Mar 4, 2024 at 12:07:44 PM  
Byers CO 80103  
United States

**Photo 16.** Photo taken facing southwest of rutted access road with stormwater erosion..

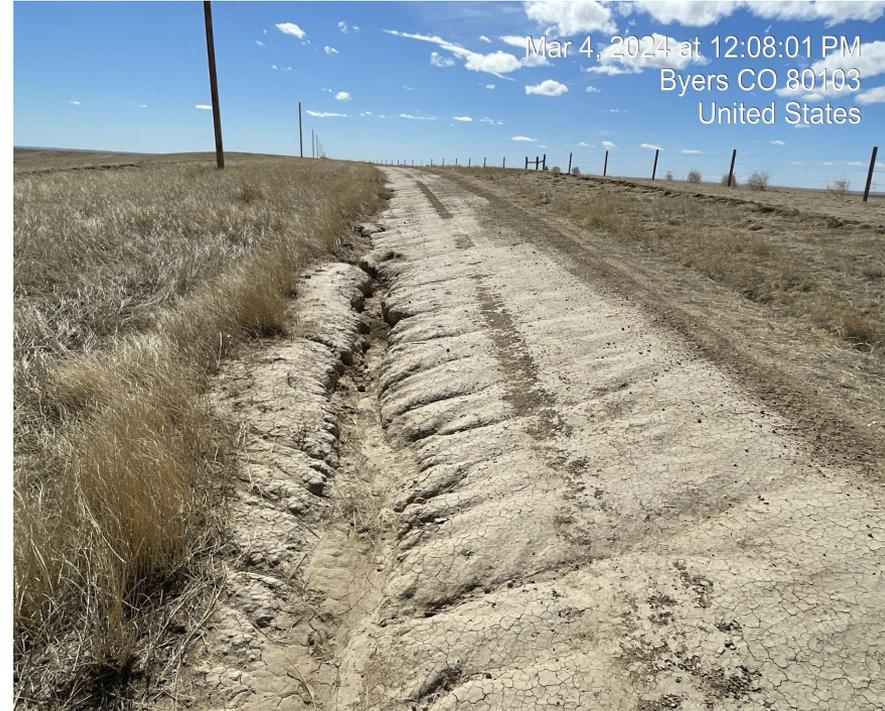
Mar 4, 2024 at 12:08:01 PM  
Byers CO 80103  
United States

**Photo 17.** Photo taken facing northwest of rutted access road with stormwater erosion. .
