# Final Reclamation and Stormwater Inspection

Operator: Petro- Canada Resources Inc- #72085

Location ID: 311698

Inspection Photos  
Location Name: Noonan UPRR 2-B  
Location ID: 311698

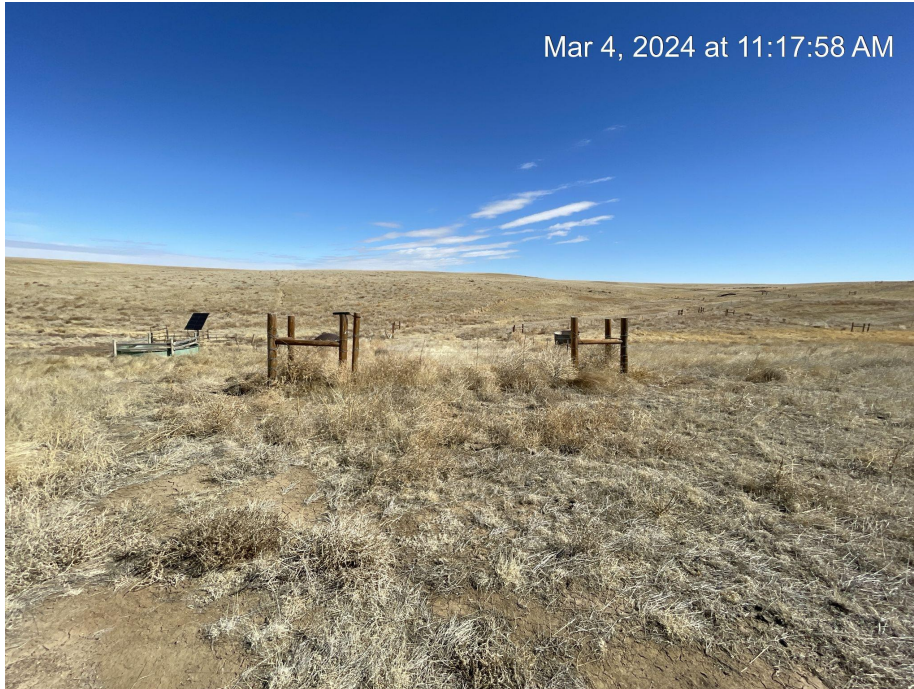
Mar 4, 2024 at 11:17:58 AM

**Photo 1.** Photo taken facing northeast of perimeter fence of reclaimed area vegetation and weeds (koachia & russian thistle).

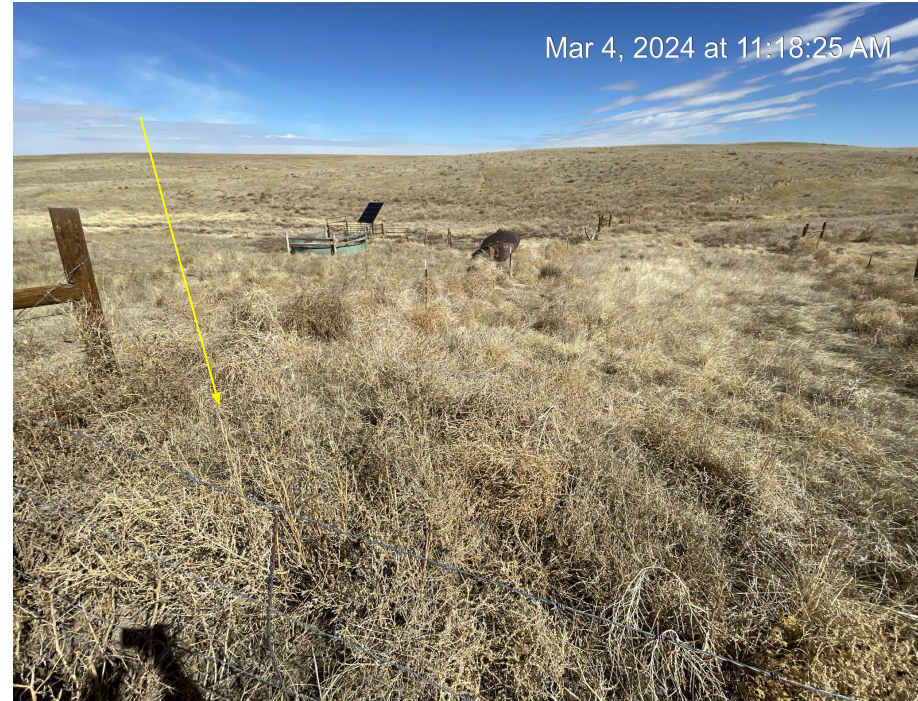
Mar 4, 2024 at 11:18:25 AM

**Photo 2.** Photo taken facing northeast of perimeter fence of reclaimed area vegetation and weeds (koachia & russian thistle). Weeds indicated by yellow arrow.

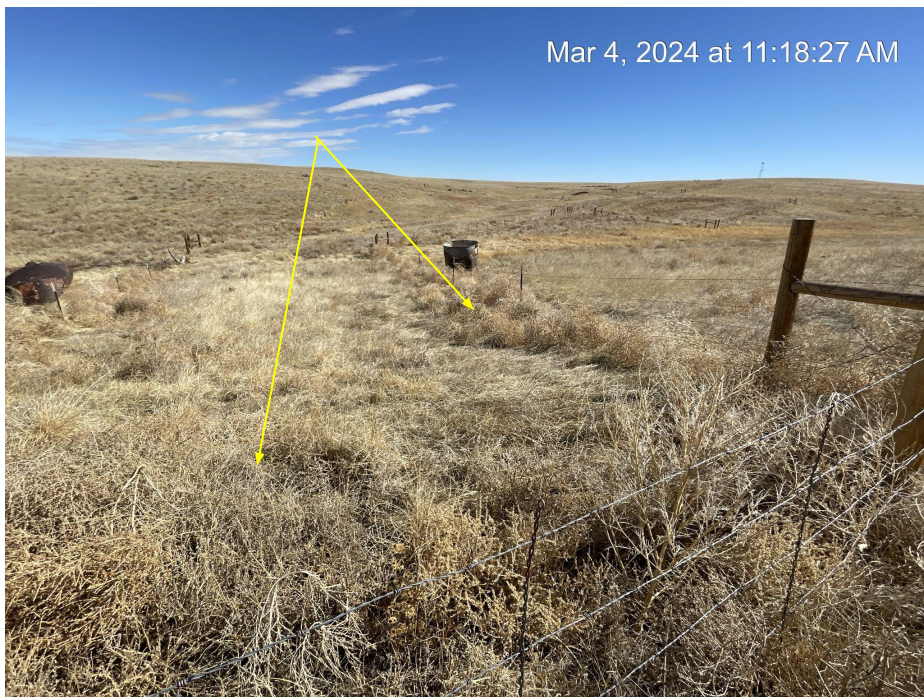
**Photo 3.** Photo taken facing east of reclaimed area vegetation and weeds (russian thistle & kochia). Weeds indicated by yellow arrow.

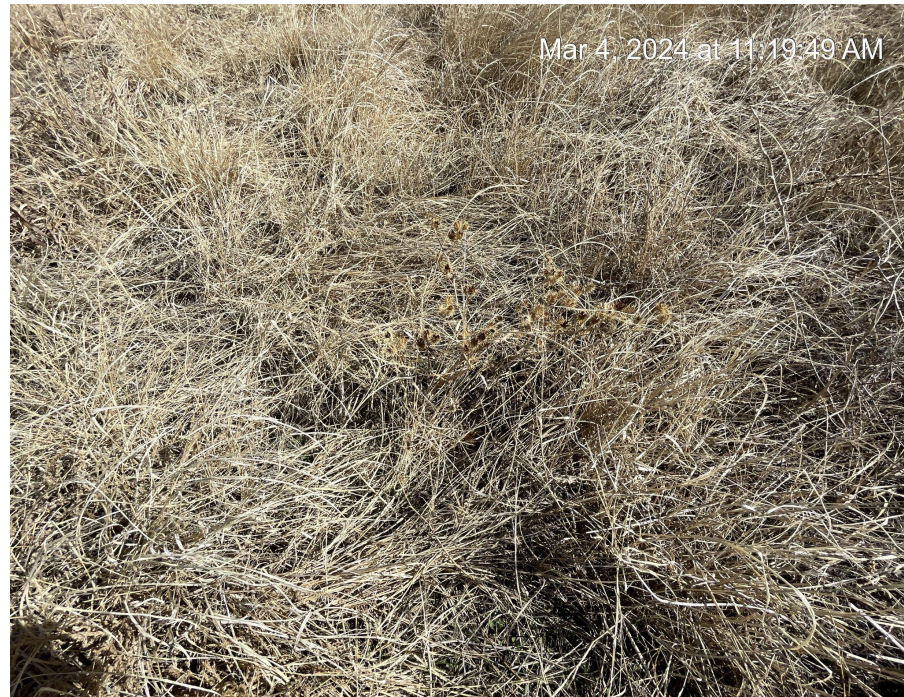
**Photo 4.** Photo taken facing north of close up of weeds (russian thistle & bull thistle).

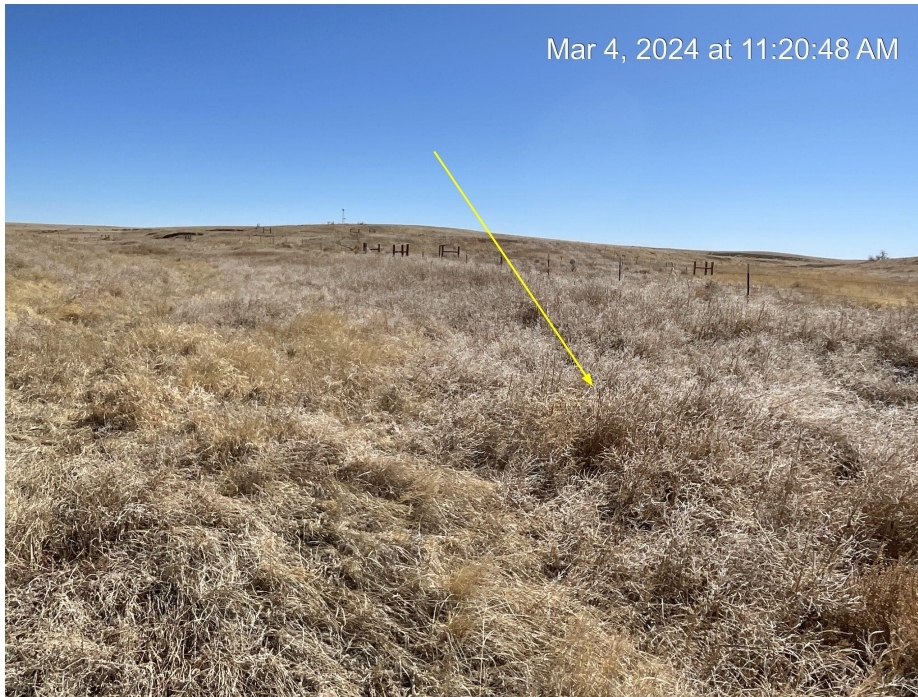
**Photo 5.** Photo taken facing southeast of reclamation area of vegetation and weeds (russian thistle, bull thistle & kochia). Weeds indicated by yellow arrow.

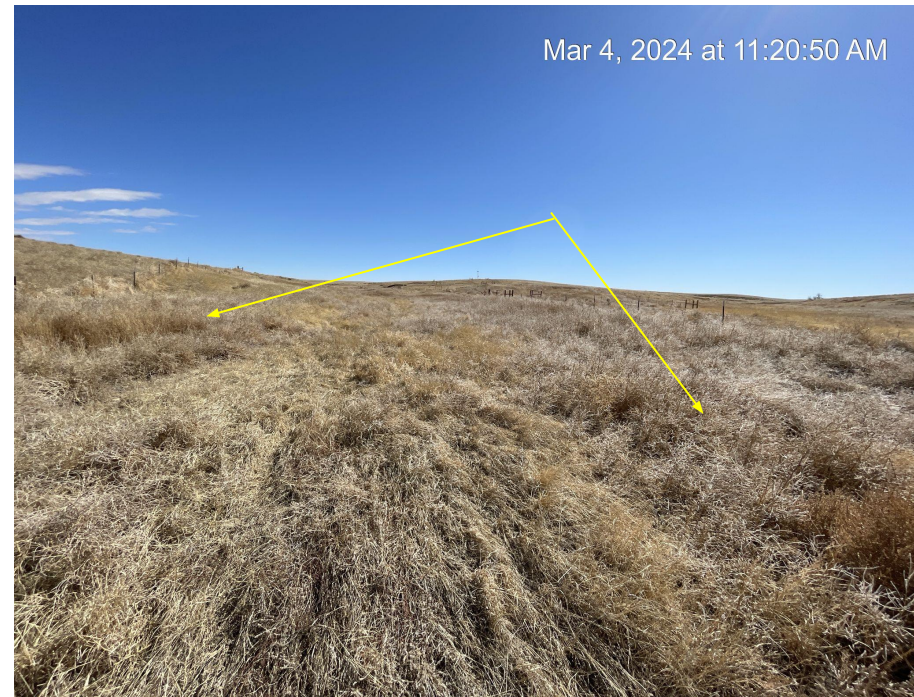
**Photo 6.** Photo taken facing southeast of pad reclamation area of vegetation and weeds (russian thistle & kochia). Weeds indicated by yellow arrow.

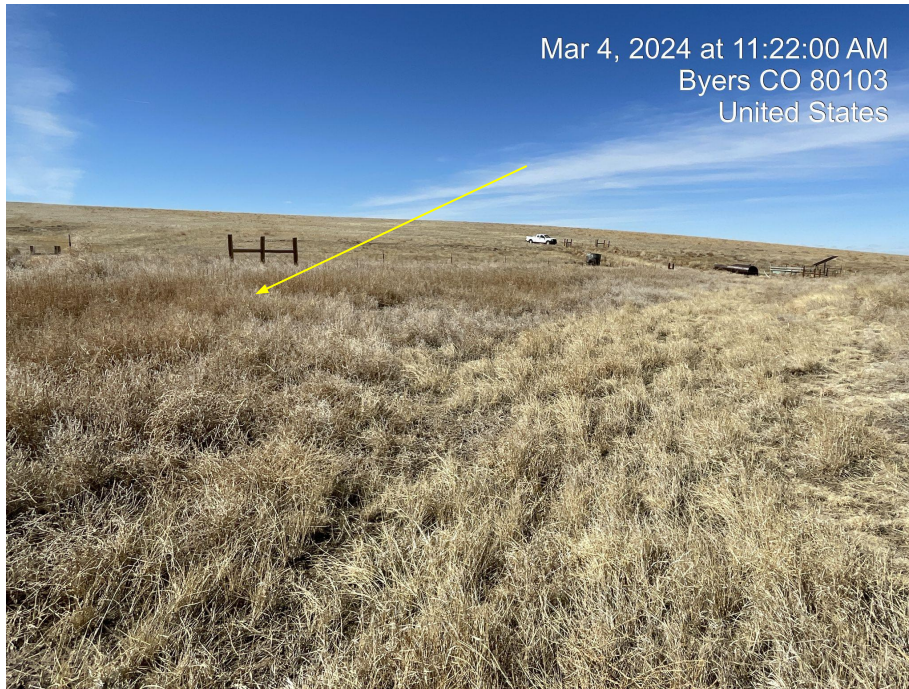
Mar 4, 2024 at 11:22:00 AM  
Byers CO 80103  
United States

**Photo 7.** Photo taken facing west of pad reclamation area of vegetation and weeds (russian thistle, bull thistle & kochia). Weeds indicated by yellow arrow.

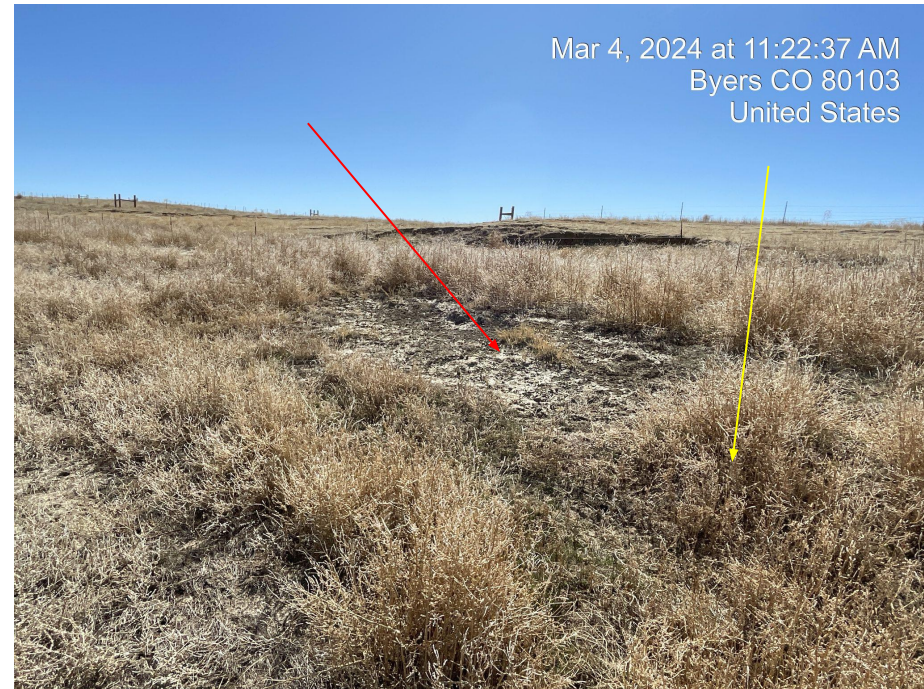
Mar 4, 2024 at 11:22:37 AM  
Byers CO 80103  
United States

**Photo 8.** Photo taken facing southeast of weeds and bare soil (red arrow) in reclaimed area. Red arrow of bare soil is an example of bare area from salt kill. Weeds indicated by yellow arrow.

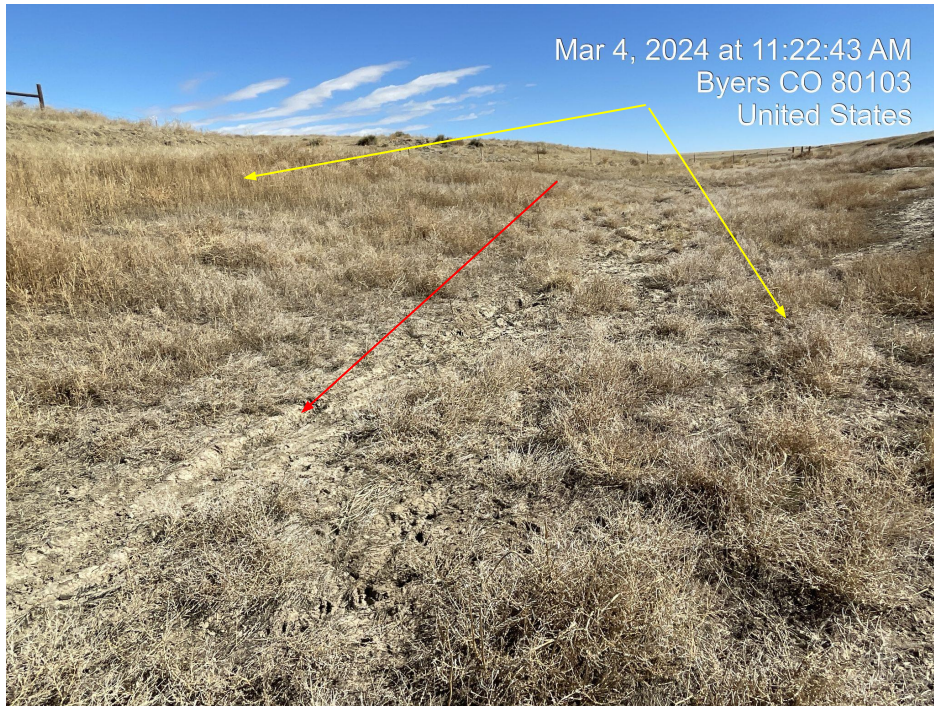
Mar 4, 2024 at 11:22:43 AM  
Byers CO 80103  
United States

**Photo 9.** Photo taken facing east of weeds (russian thistle, & kochia)( yellow arrow) and bare soil (Red arrow) in reclaimed area.

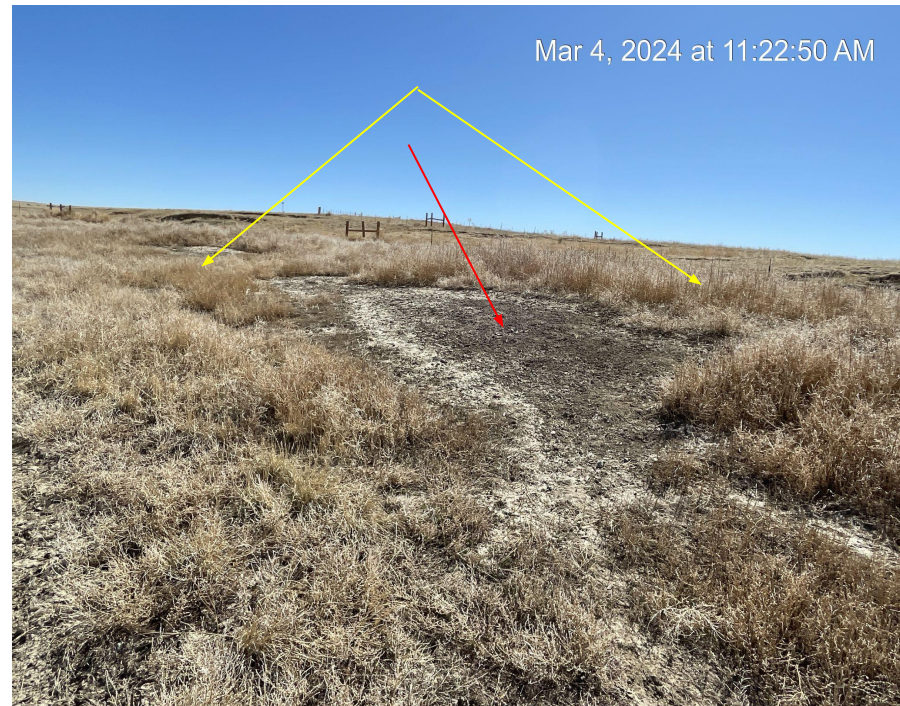
Mar 4, 2024 at 11:22:50 AM

**Photo 10.** Photo taken facing east of weeds (russian thistle, & kochia)( yellow arrow) and bare soil (Red arrow) in reclaimed area. Red arrow indicating bare soil is an example of bare area from salt kill.

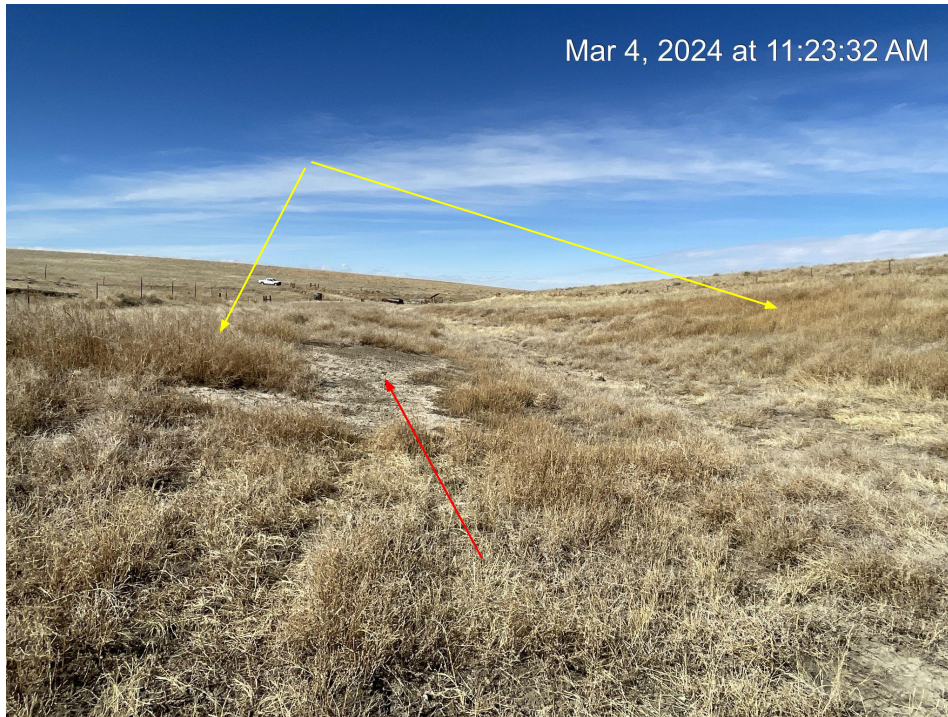
**Photo 11.** Photo taken facing west of weeds (russian thistle, & kochia)( yellow arrow) and bare soil (Red arrow) in reclaimed area. Red arrow indicating bare soil is an example of bare area from salt kill.

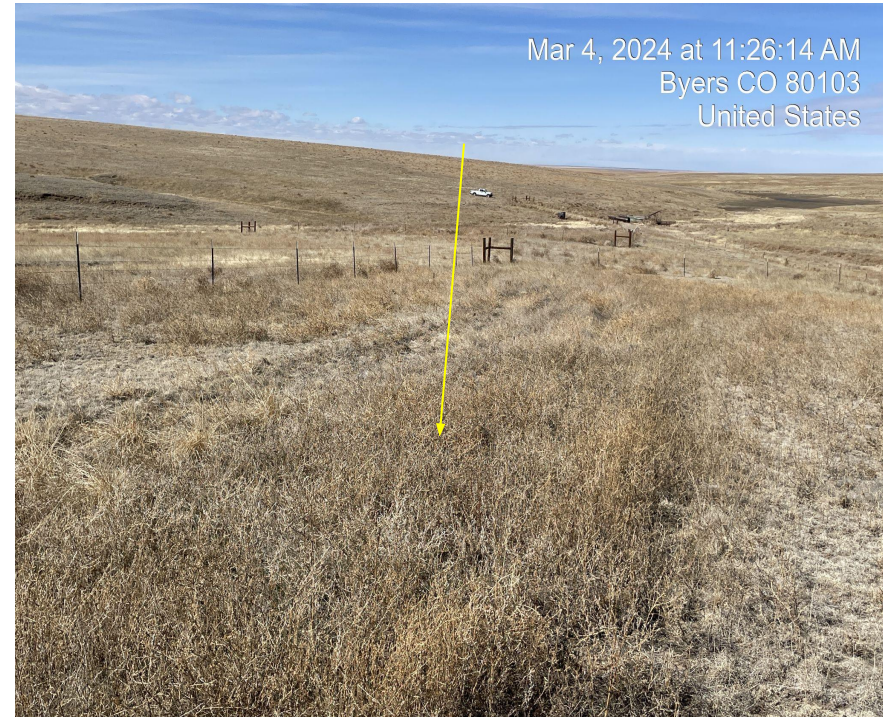
**Photo 12.** Photo taken facing northwest of reclaimed access road area of vegetation and weeds (russian thistle & kochia) Yellow arrow indicates the weeds .

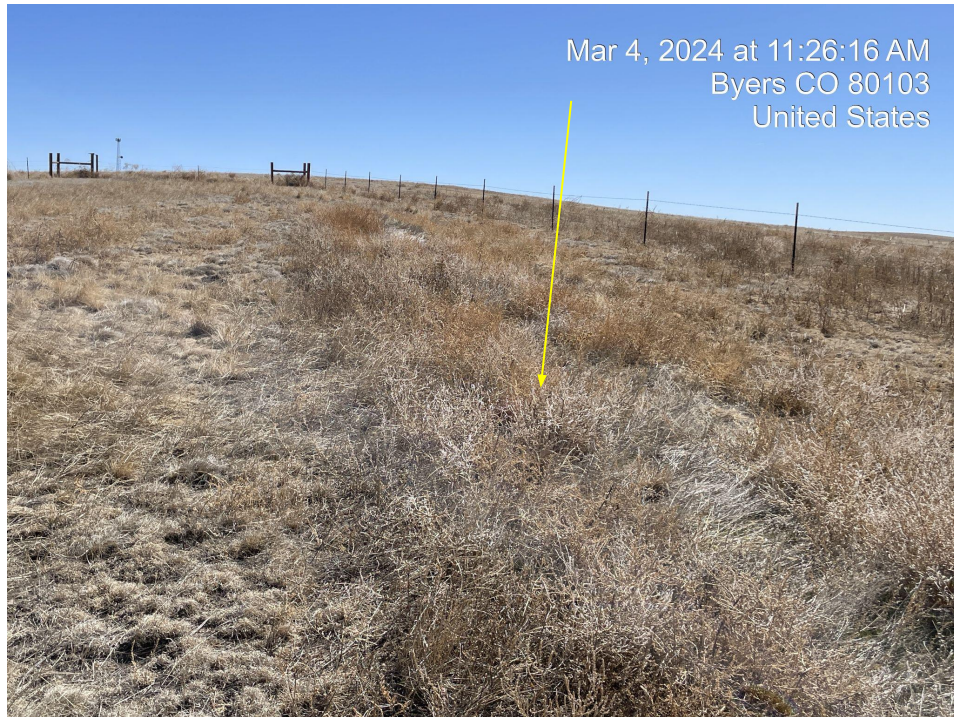
**Photo 13.** Photo taken facing southwest of access road to pad reclamation area of vegetation and weeds (russian thistle & kochia). Weeds indicated by yellow arrow.

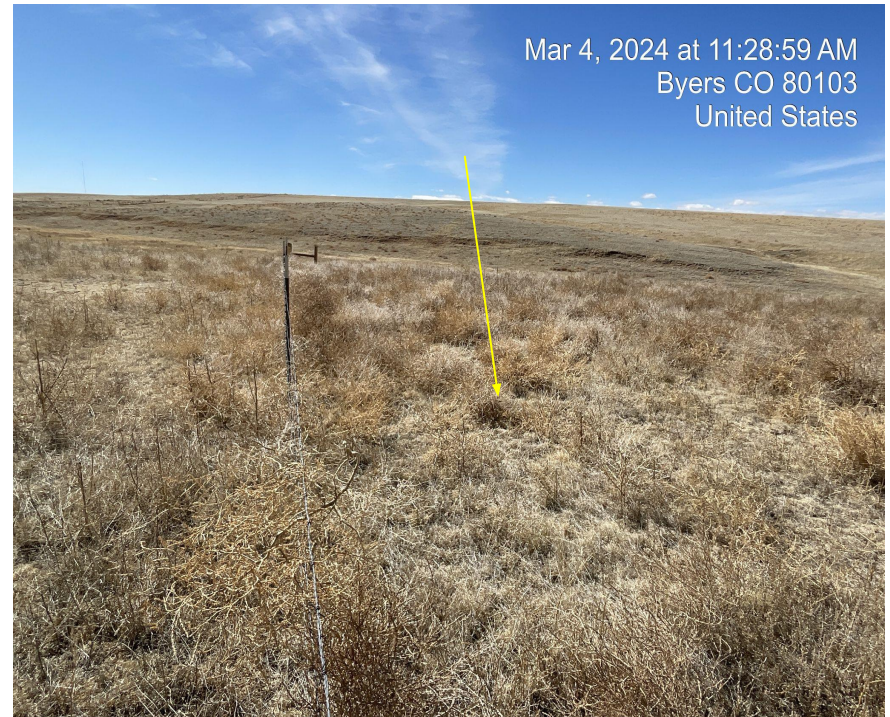
**Photo 14.** Photo taken facing southwest of pad reclamation area of vegetation and weeds (russian thistle & kochia). Weeds indicated by yellow arrow.

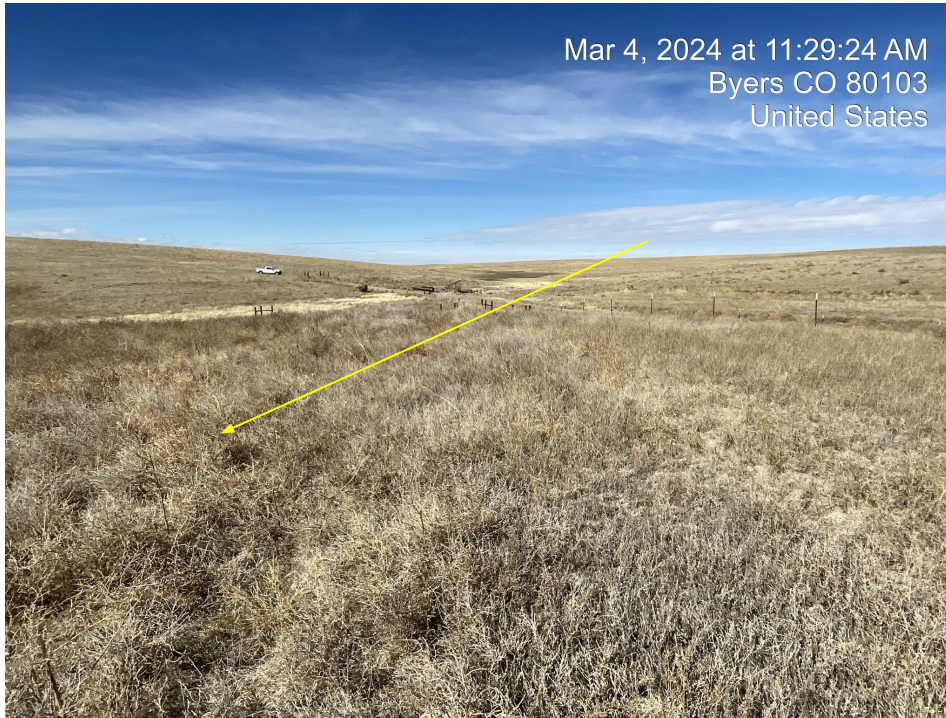
Mar 4, 2024 at 11:29:24 AM  
Byers CO 80103  
United States

**Photo 15.** Photo taken facing northwest of reclaimed access road area of vegetation and weeds (russian thistle & kochia). Weeds indicated by yellow arrow.

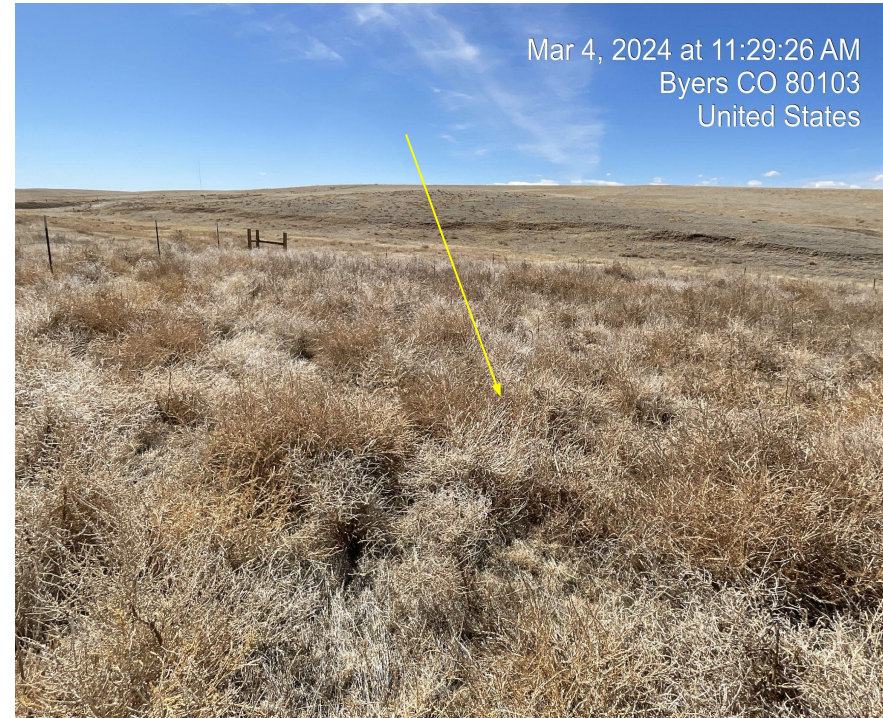
Mar 4, 2024 at 11:29:26 AM  
Byers CO 80103  
United States

**Photo 16.** Photo taken facing southwest of pad reclamation area of vegetation and weeds (russian thistle & kochia). Weeds indicated by yellow arrow.

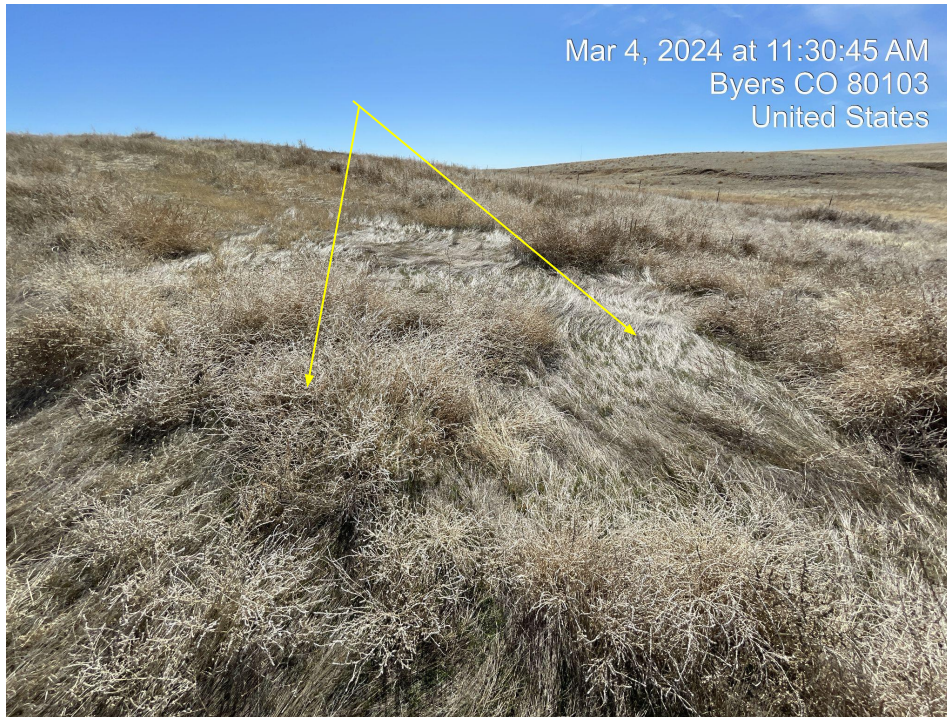
**Photo 17.** Photo taken facing southeast of pad reclamation area of vegetation and weeds (russian thistle, kochia & cheatgrass). Weeds indicated by yellow arrow.

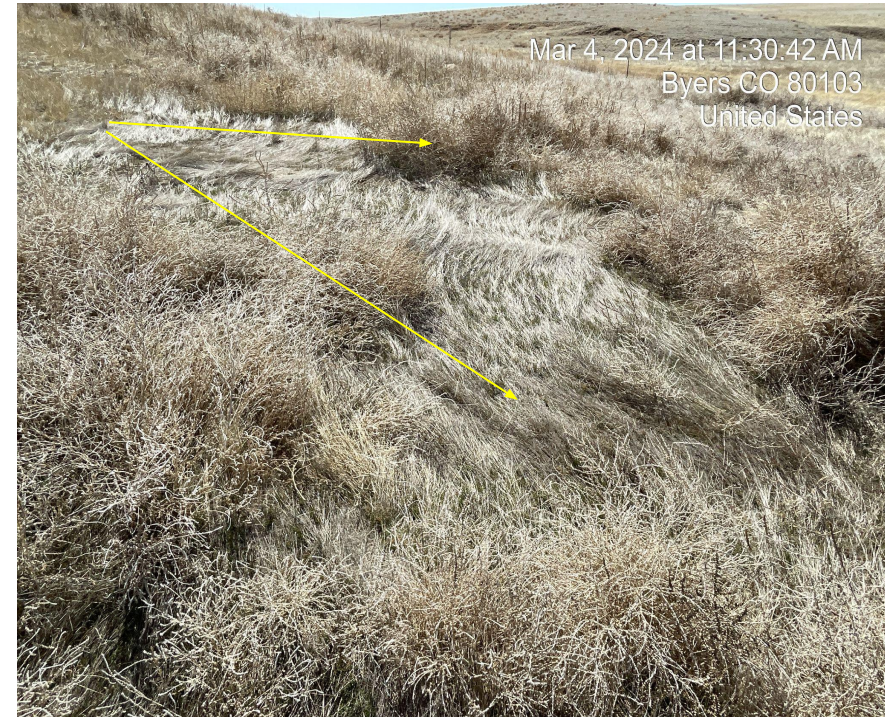
**Photo 18.** Photo taken facing southeast of pad reclamation area of vegetation and weeds (russian thistle, kochia & cheatgrass). Weeds indicated by yellow arrow.
