# Interim Reclamation and Stormwater Inspection

Operator: P O & G Operating LLC- #10634

Location ID: 324940

Inspection Photos  
Location Name: Bledso 1-34X  
Location ID: 324940

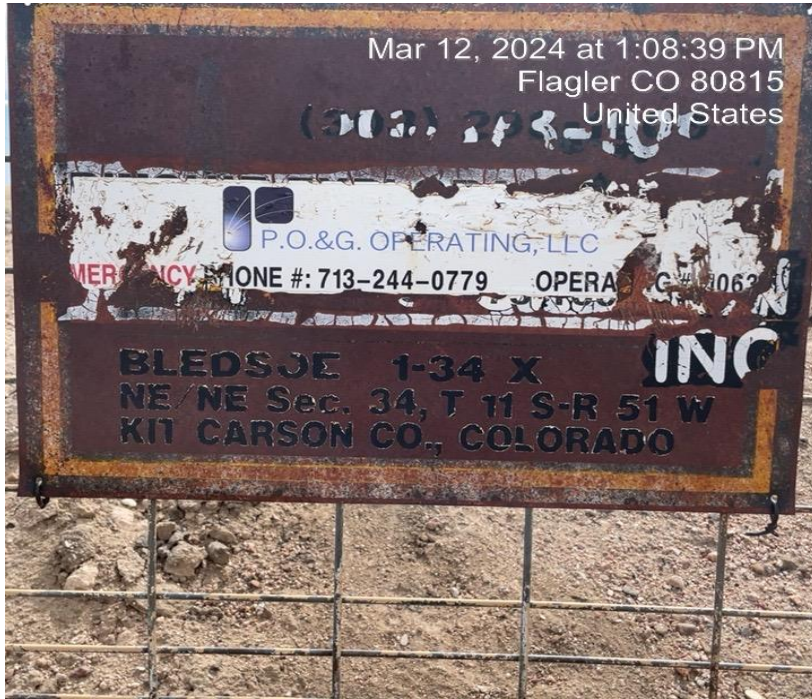
**Photo 1.** Photo taken of location sign. Information needs to be legible.

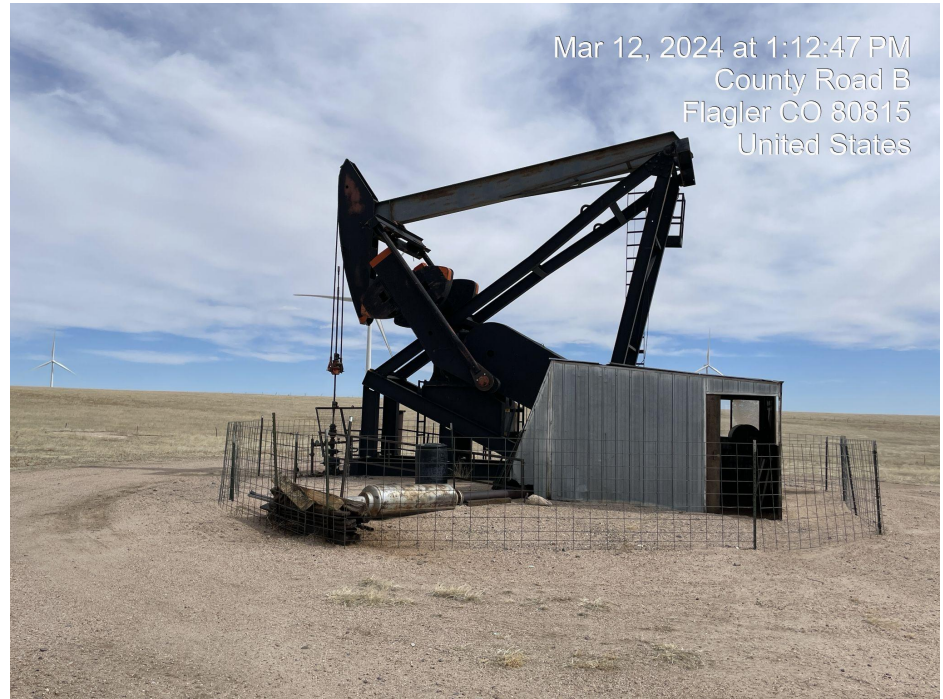
**Photo 2.** Photo taken facing east of wellhead.

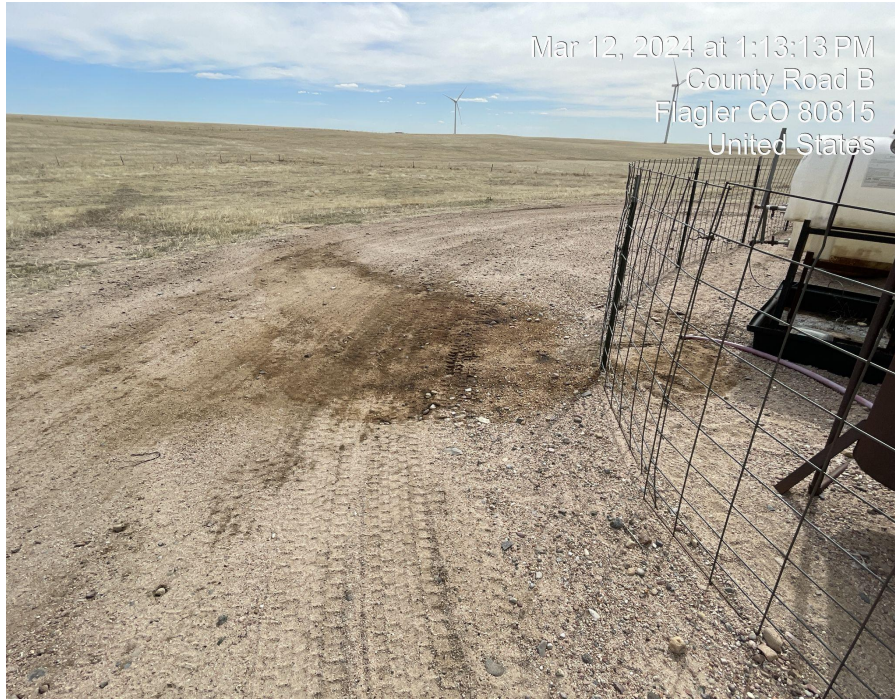
**Photo 3.** Photo taken facing southeast of stained soil from spill onsite.

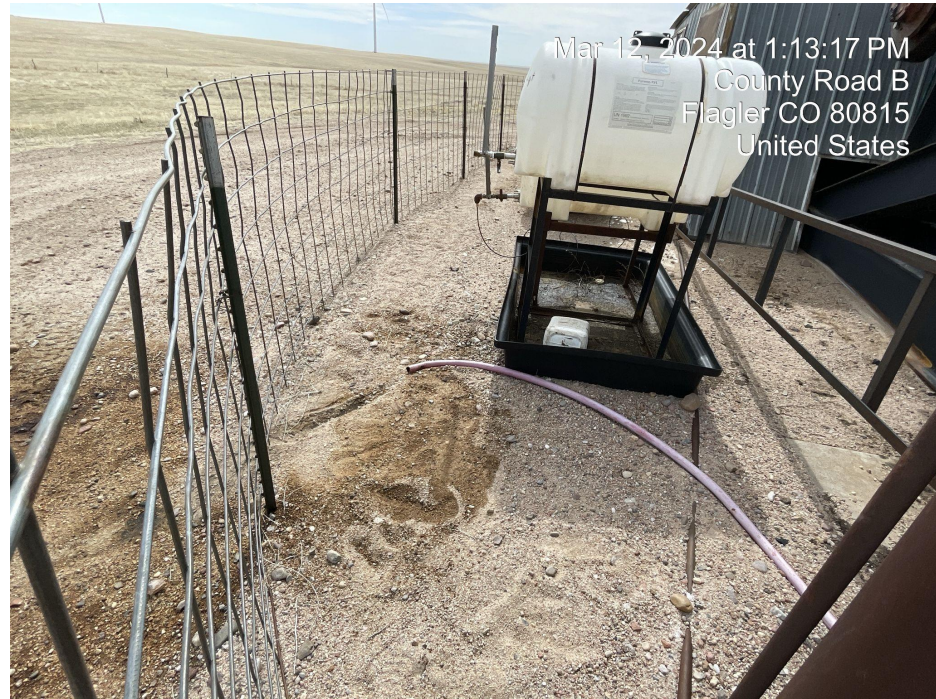
**Photo 4.** Photo taken facing east of secondary containment without wildlife protection, and stained soil from spill onsite.

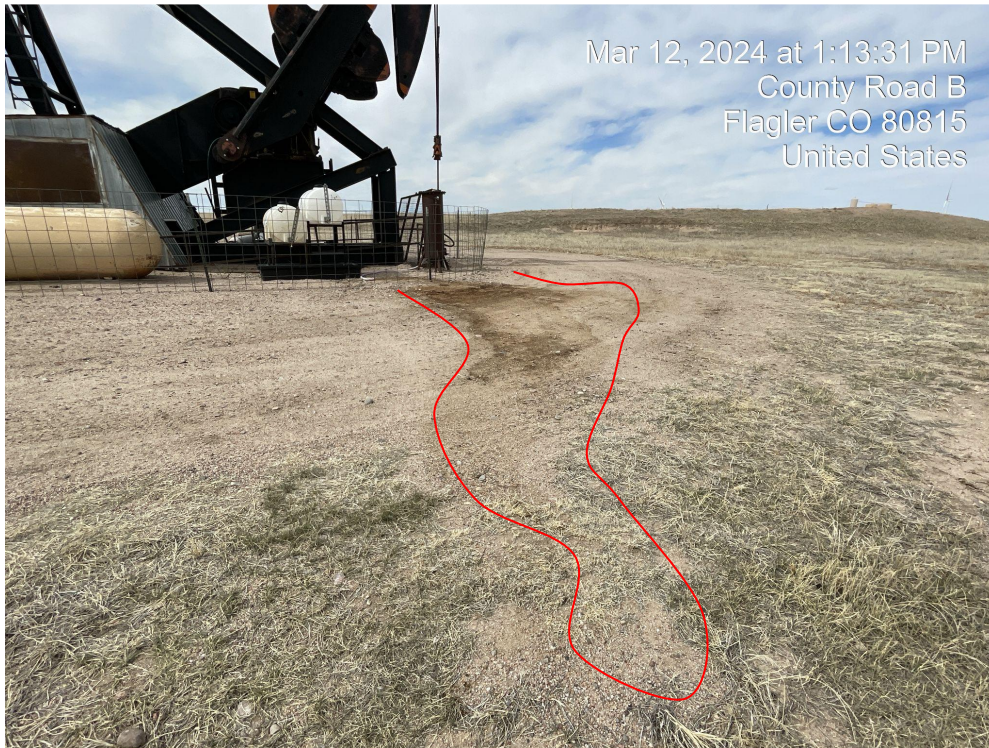
**Photo 5.** Photo taken facing southwest of stained soil leading into interim reclamation from pumpjack. Spill outlined in red.

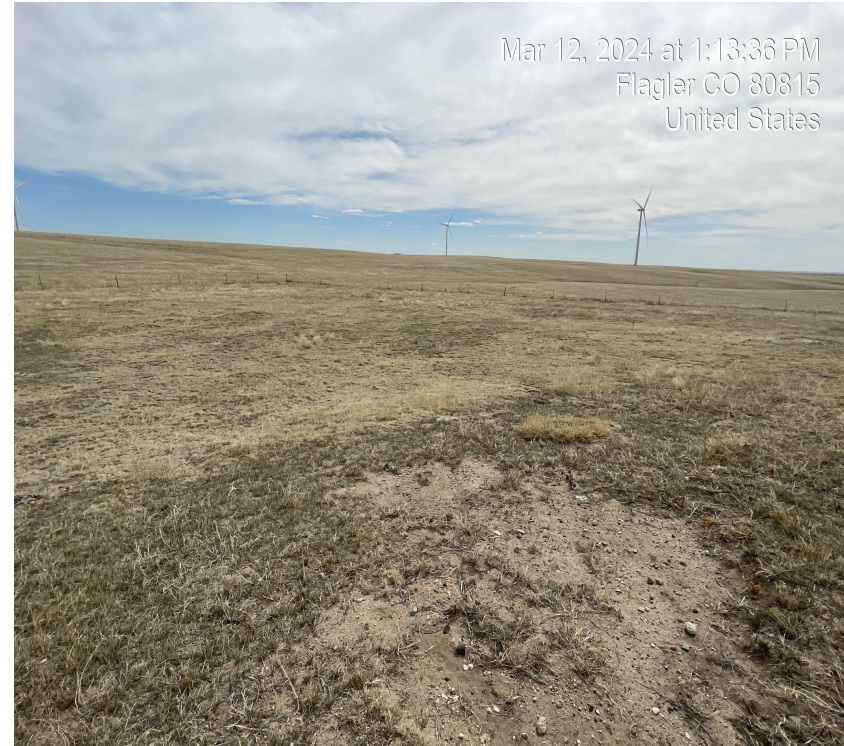
**Photo 6.** Photo taken facing east of terminus of stained soil from a spill at the jumpjack.

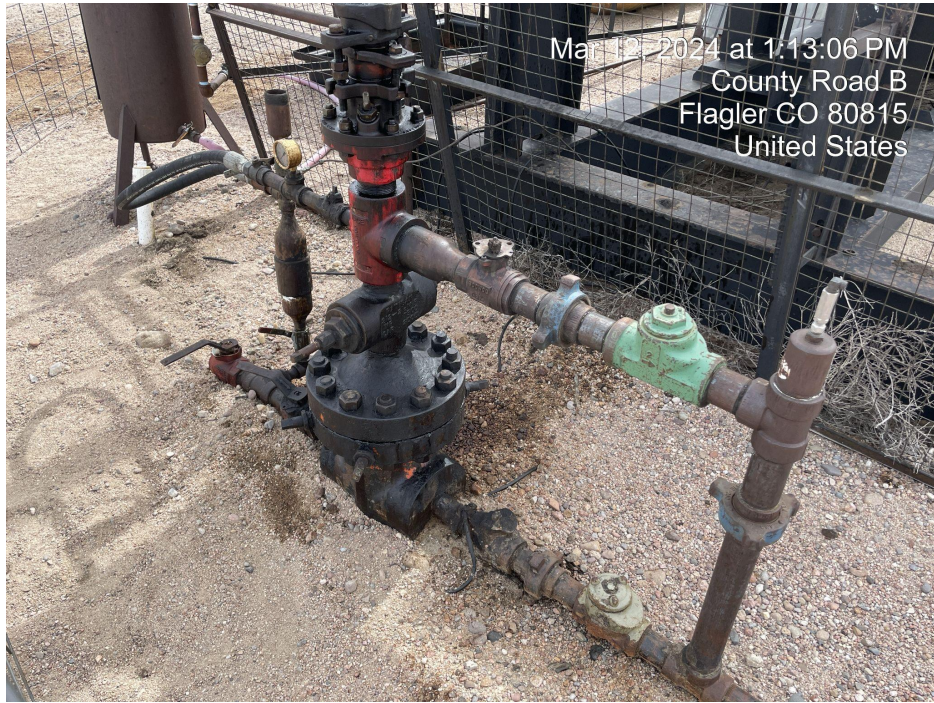
Mar 12, 2024 at 1:13:06 PM  
County Road B  
Flagler CO 80815  
United States

**Photo 7.** Photo taken facing northwest of wellhead and stained soil.

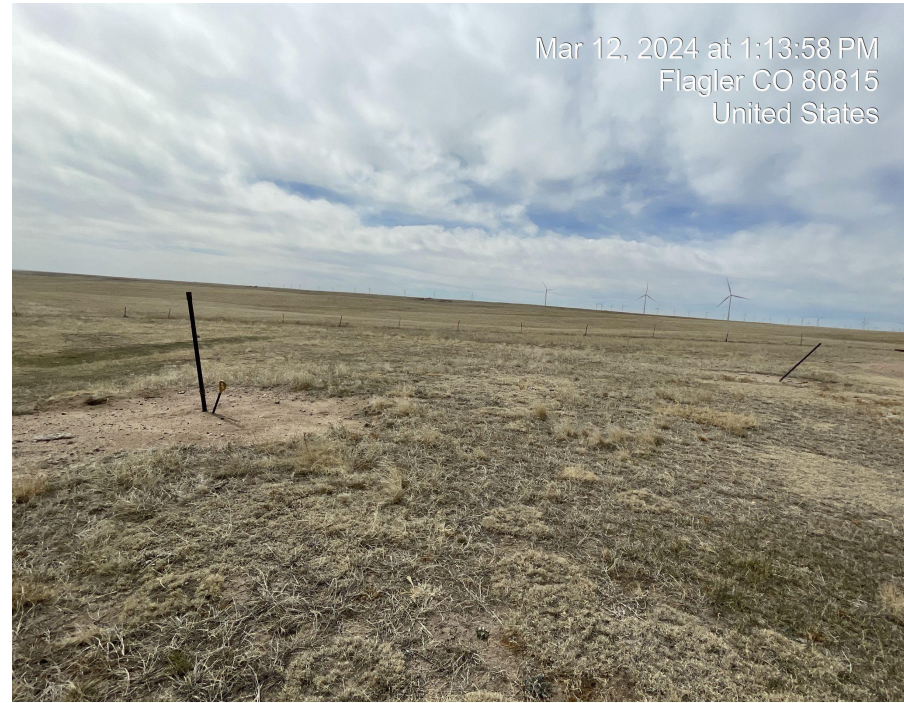
Mar 12, 2024 at 1:13:58 PM  
Flagler CO 80815  
United States

**Photo 8.** Photo taken facing west of mowed vegetation in the interim reclamation area.

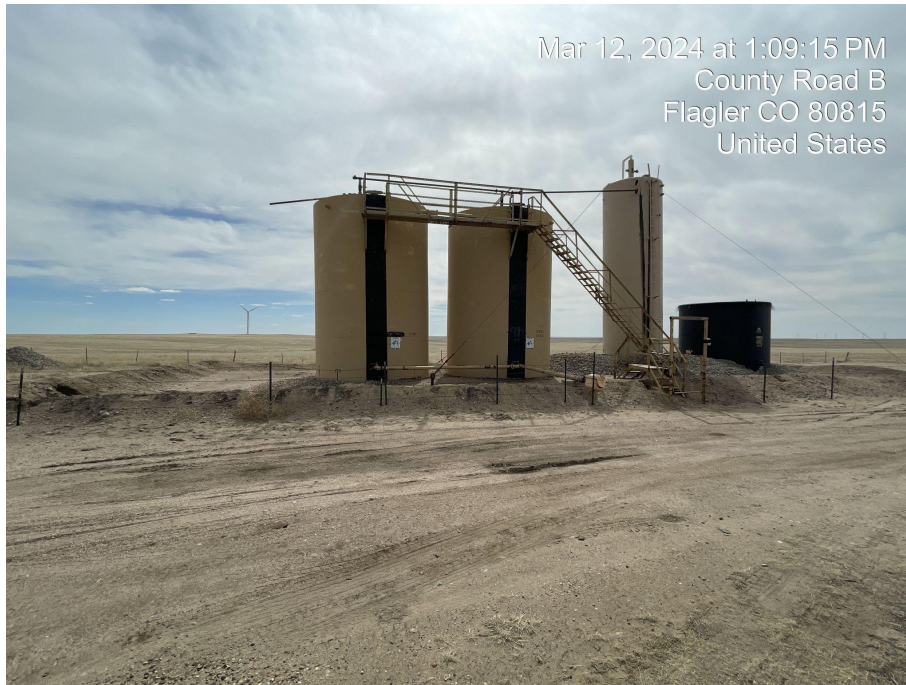
**Photo 9.** Photo taken facing southwest of tank battery.

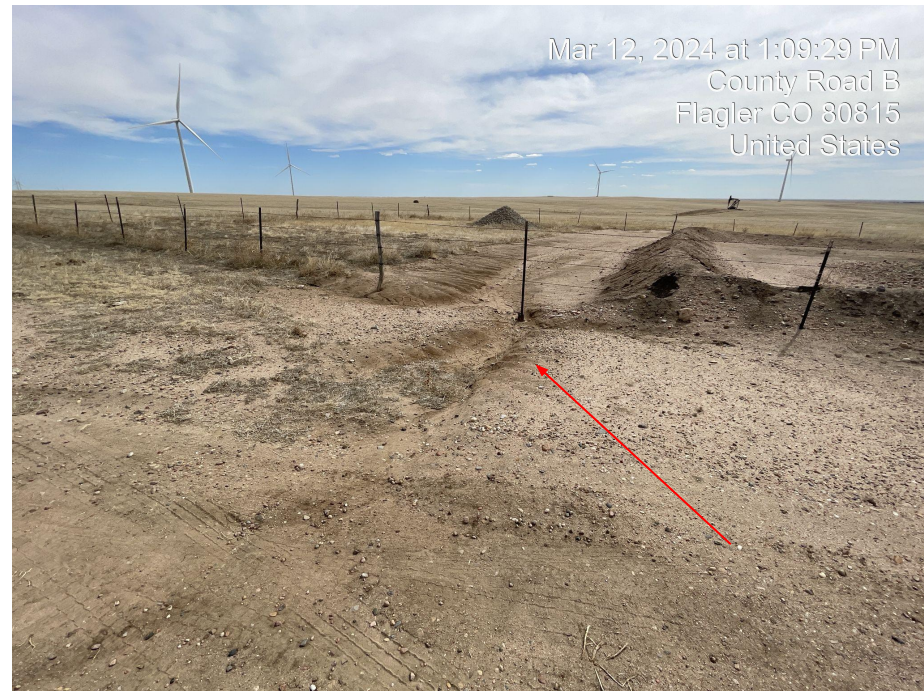
**Photo 10.** Photo taken facing southeast at tank battery pad and erosion crossing the access road and along side tank battery berm. indicated by red arrow.

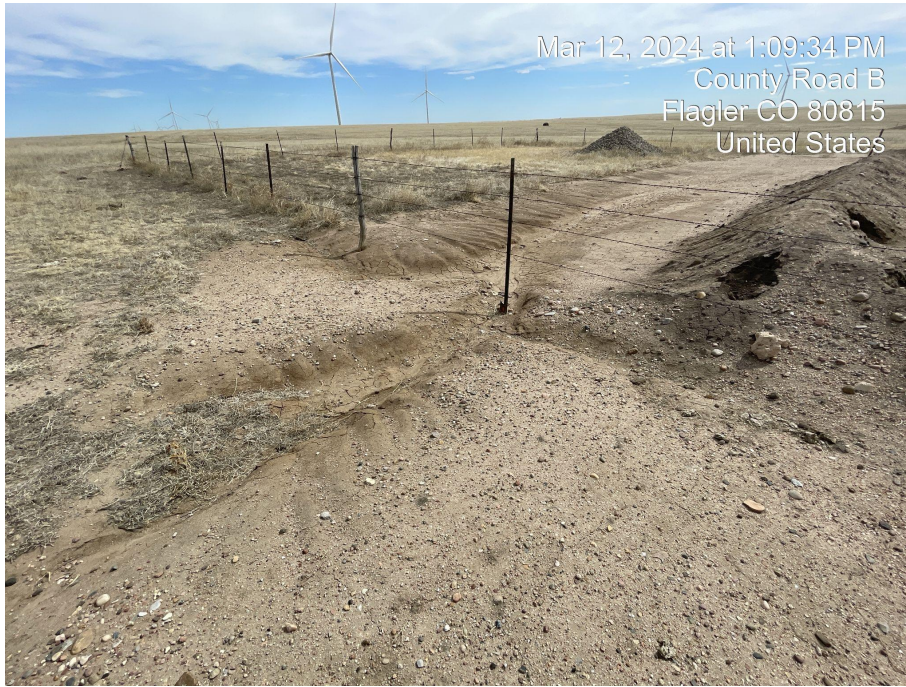
**Photo 11.** Photo taken facing south at tank battery pad and erosion crossing the access road and along side tank battery berm.

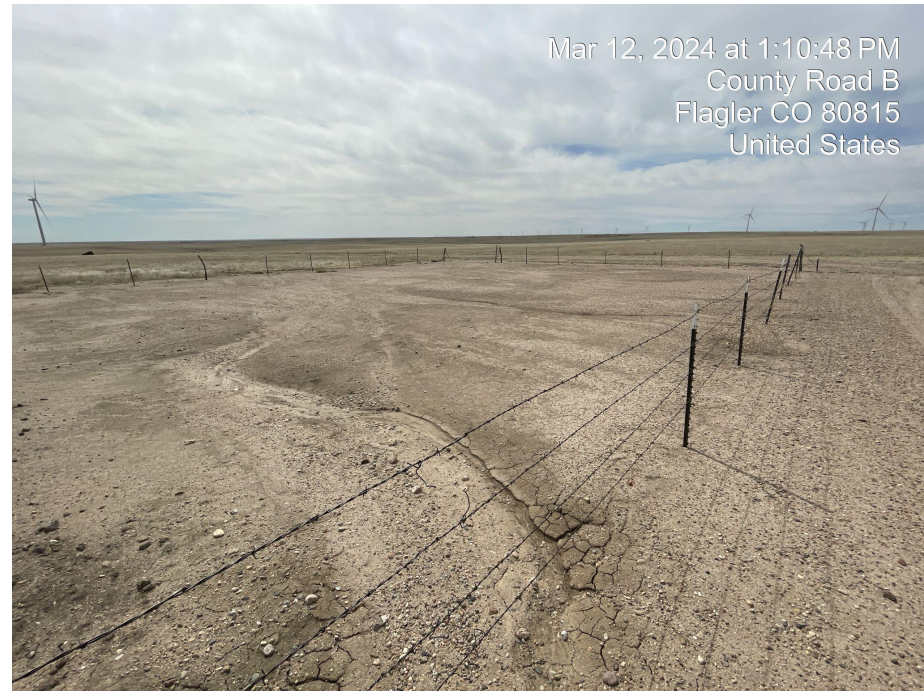
**Photo 12.** Photo taken facing southwest at tank battery pad, of bare soil and stormwater erosion.
