Inspection Photos and Issue Report

Operator: TEP ROCKY MOUNTAIN LLC #96850

Location ID: 316441

Inspection Doc: 696205682

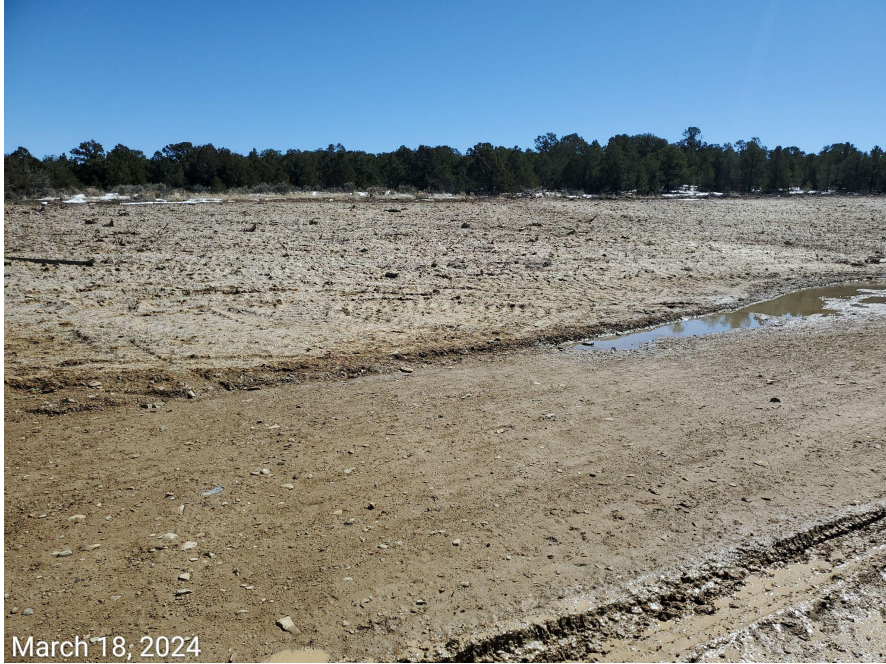
Photo 1: Photos 1-2 taken from the Location entrance on the north end of the site. Photos provide an overview of the Location from east, southeast, southwest to west. Photo also examples showing BMPs to stabilize the working pad surface are no longer in proper functioning condition; control measures to minimize tracking inadequate; control measures to minimize off-site sediment transport by equipment, such as a vehicle tracking pad, also not observed. Photo also shows interim reclamation has been performed on the Location.

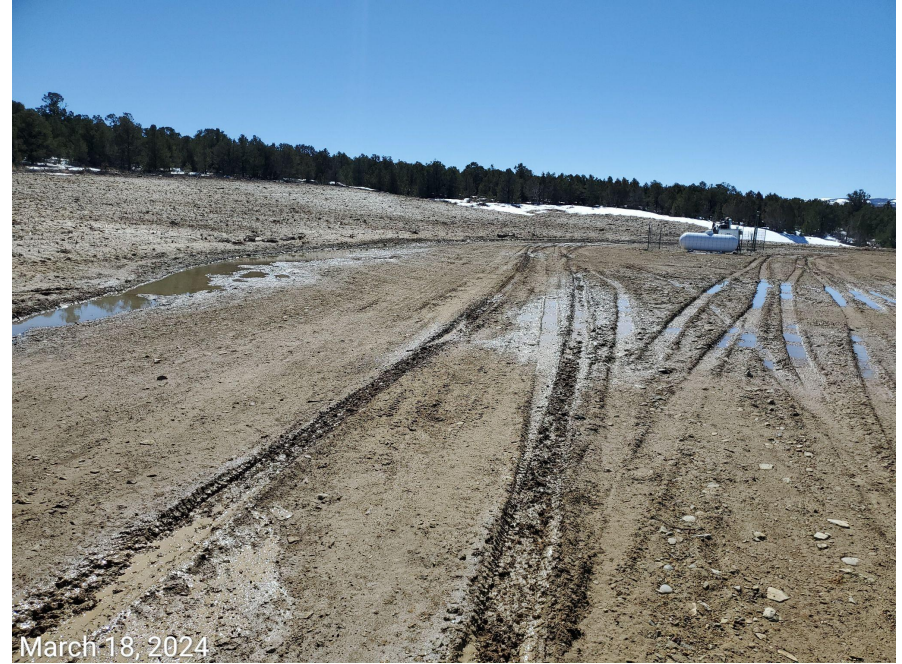
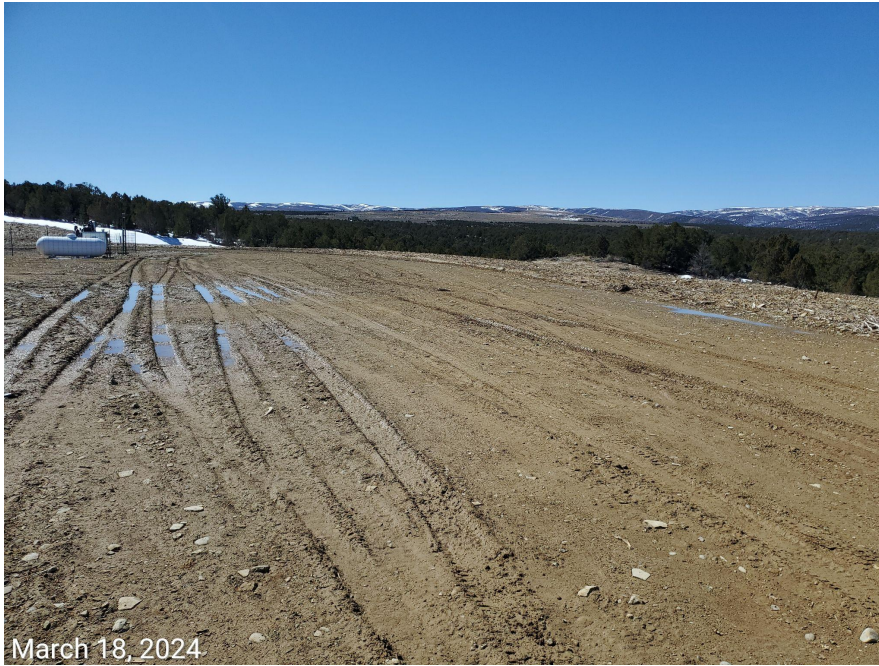
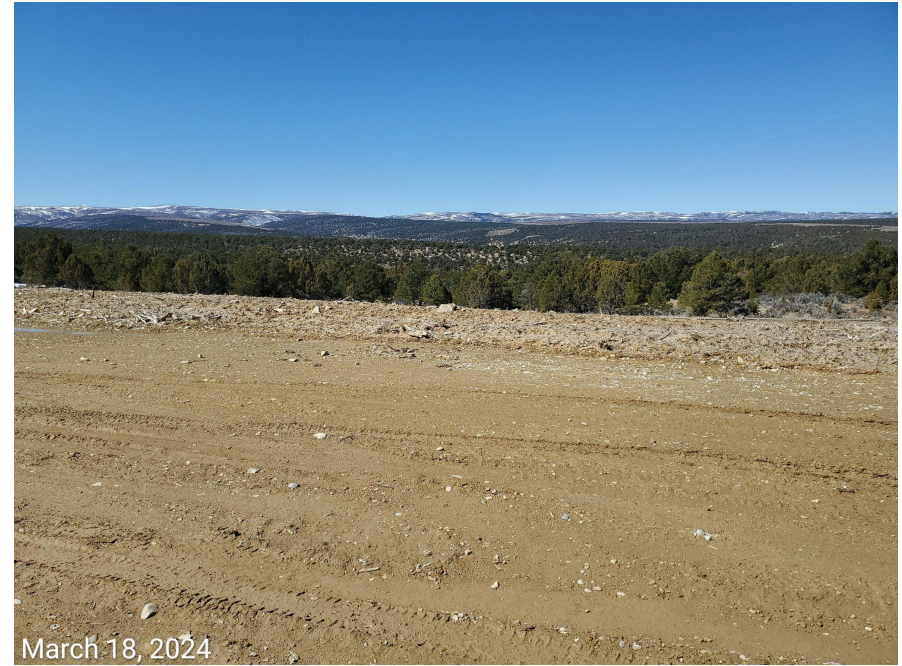
Photo 2: See comments under photo 1.

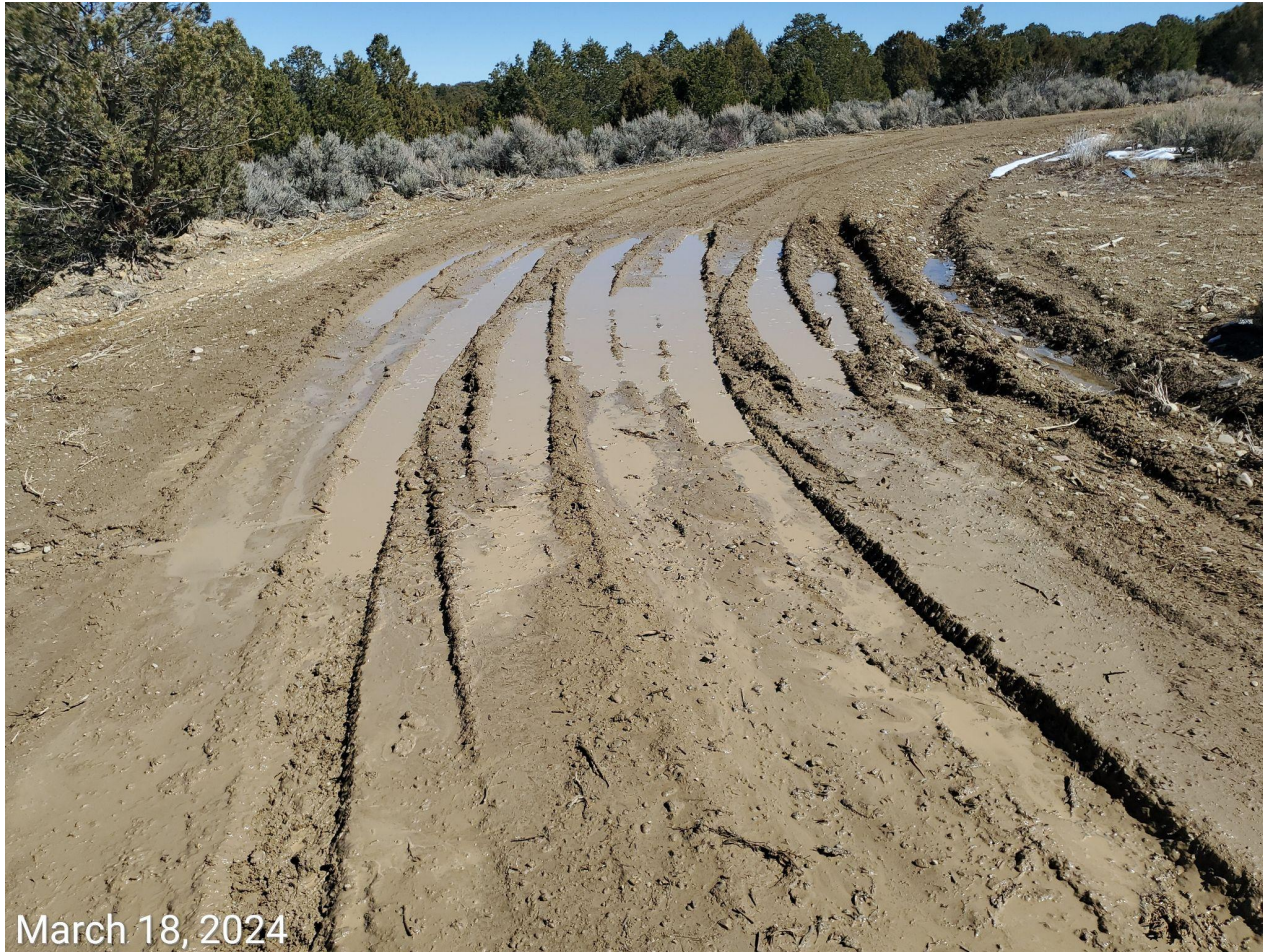
Photo 3: Photo example of areas of the access road that lacks stabilization. BMPs to stabilize the access road are no longer in proper functioning condition.

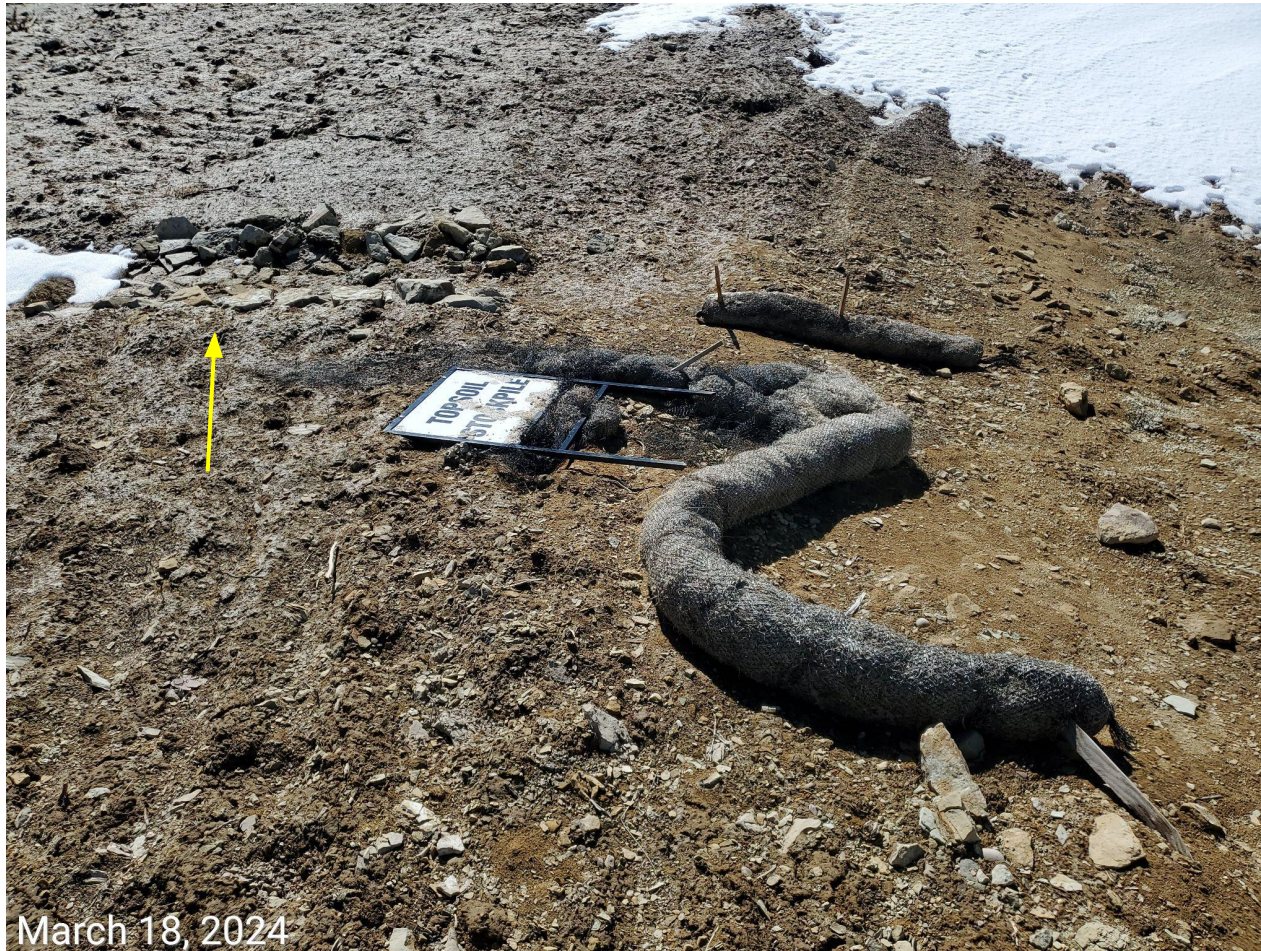
Photo 4: Photo taken from the sediment trap on the south end of the Location. Photo shows unused signage and wattles; this is now considered debris. Photo also shows inlet to trap appears inadequate in size.

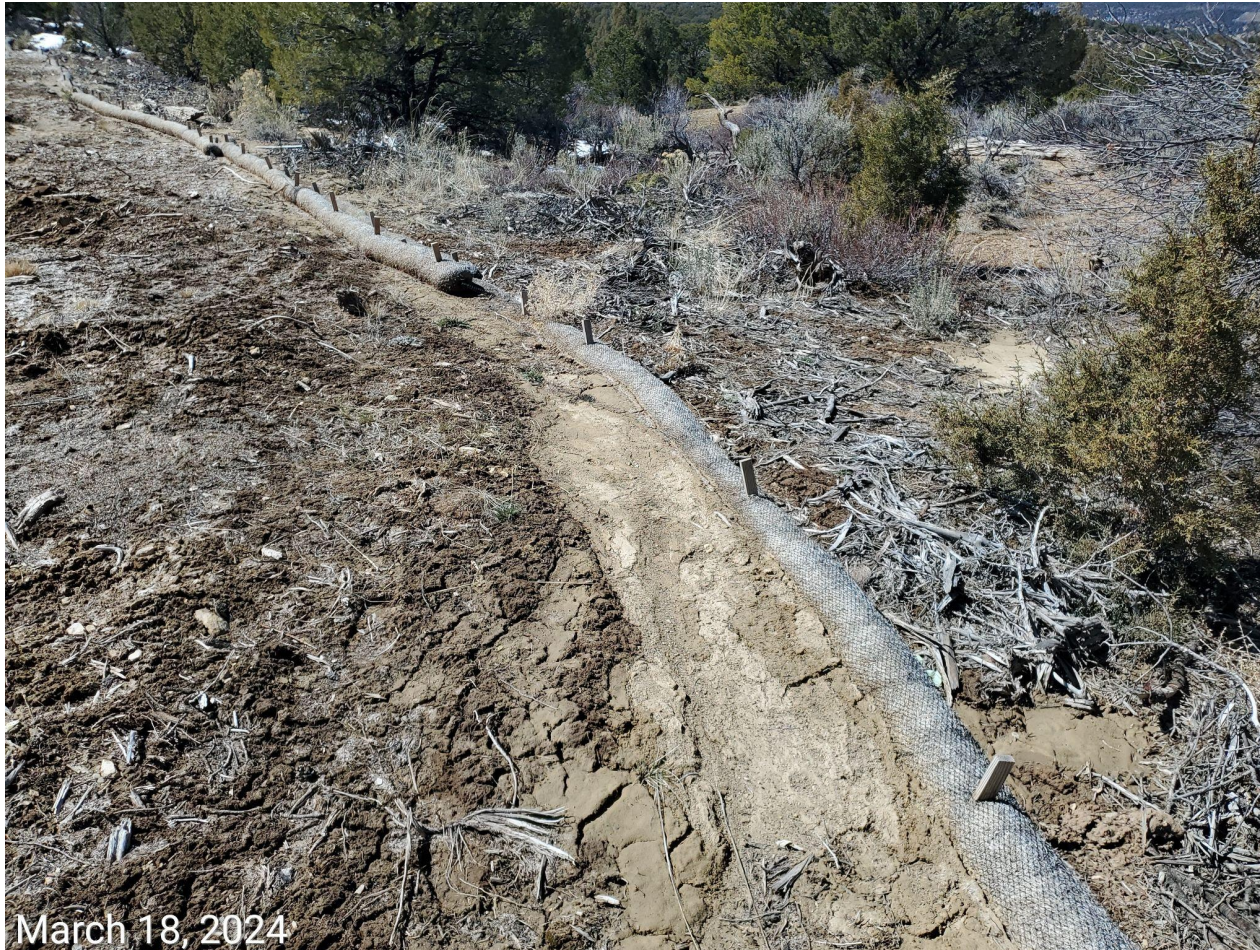
Photo 5: Photo example showing erosion logs along perimeter of the Location have filled with sediment.
