Operator: BONANZA CREEK ENERGY OPERATING COMPANY LLC

Location Name: Latham U-14 PAD

Loc ID: 437416

Inspection: 713900419

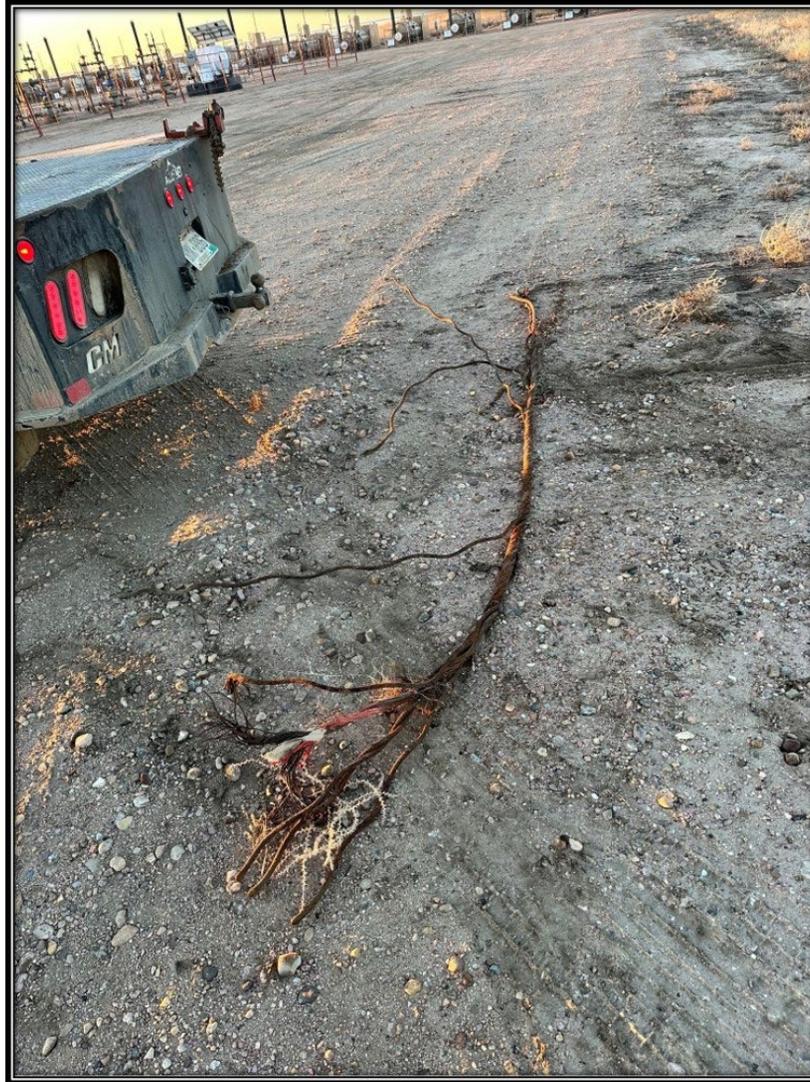
Exhibit A

CA: Broken cable is daylighting in the Northwest corner of the disturbance area just off the production pad in the interim area. Remove all debris and waste to comply with 1003 interim reclamation rules.

CA Resolution: Operator has reported that the broken cable has been appropriately removed to comply with Rules 1003 and 606.
