# Inspection Photos

**Operator:** TEP ROCKY MOUNTAIN LLC - 96850

**Location ID:** 482958

**Inspection Doc:** 696205697

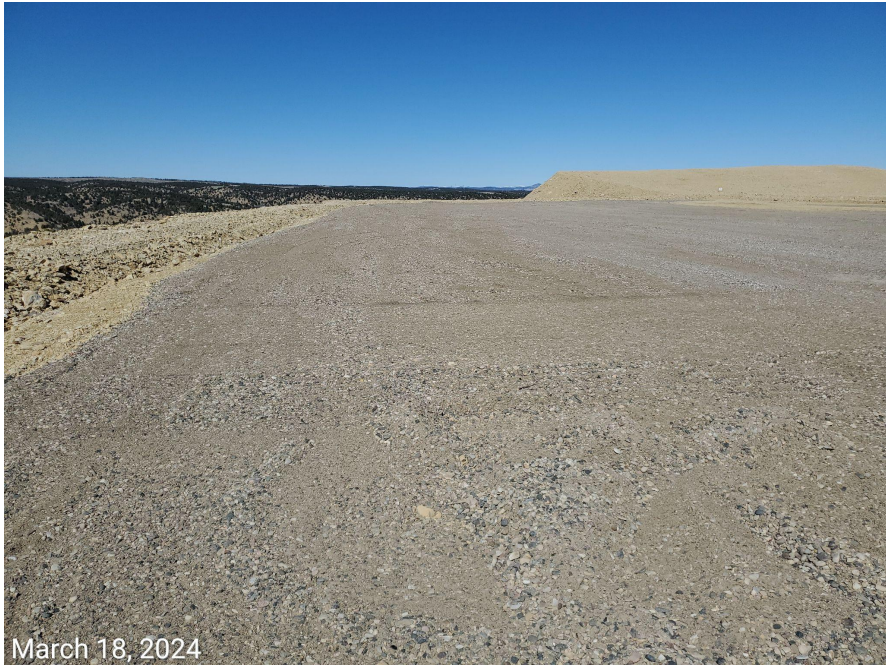
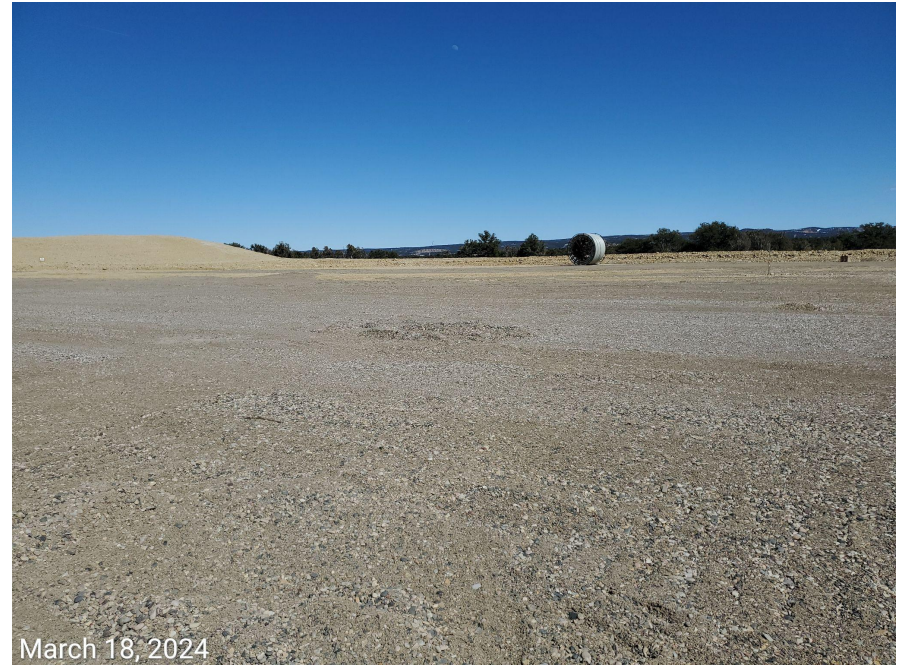
**Photo 1:** Photos 1-2 taken from the west end of the Location. Photos provide an overview of the Location from north, northeast and southeast

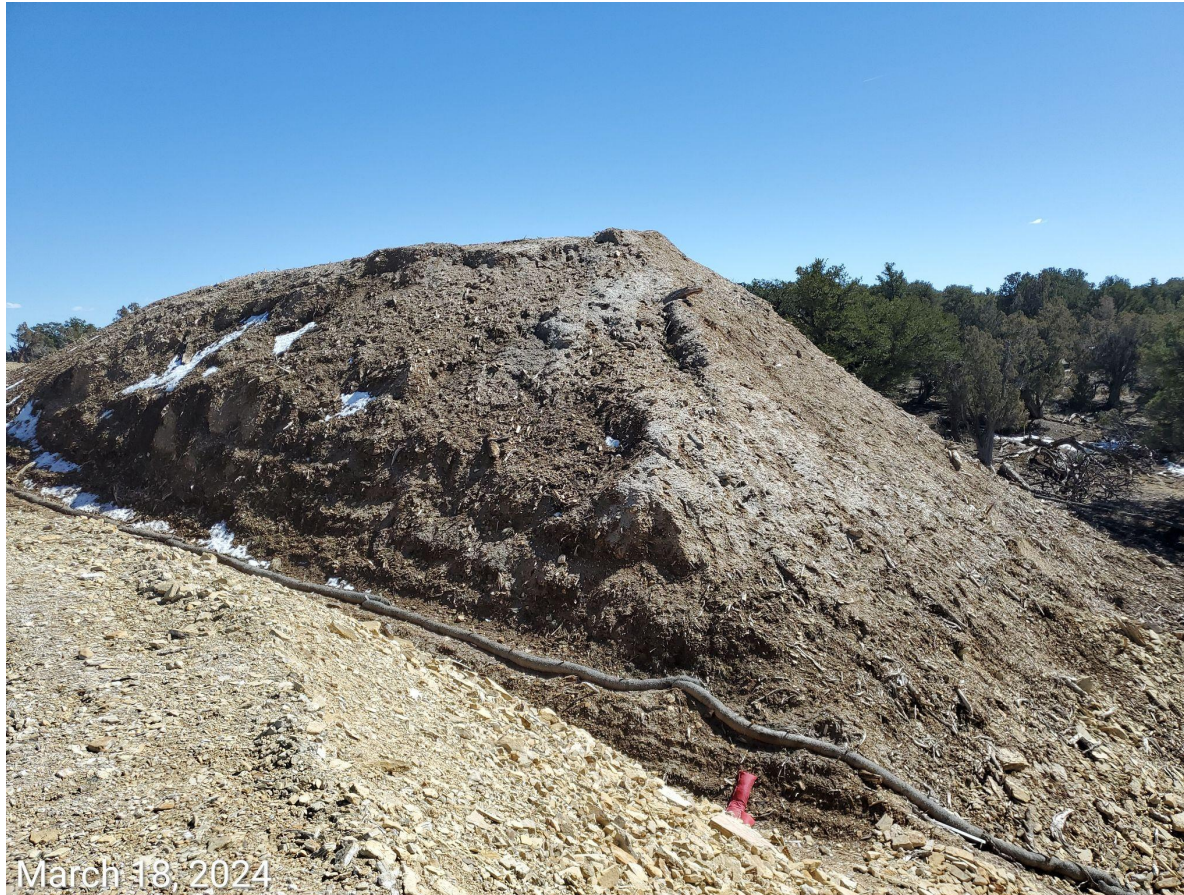
**Photo 3:** Hydromulch at topsoil stockpile beginning to fail.

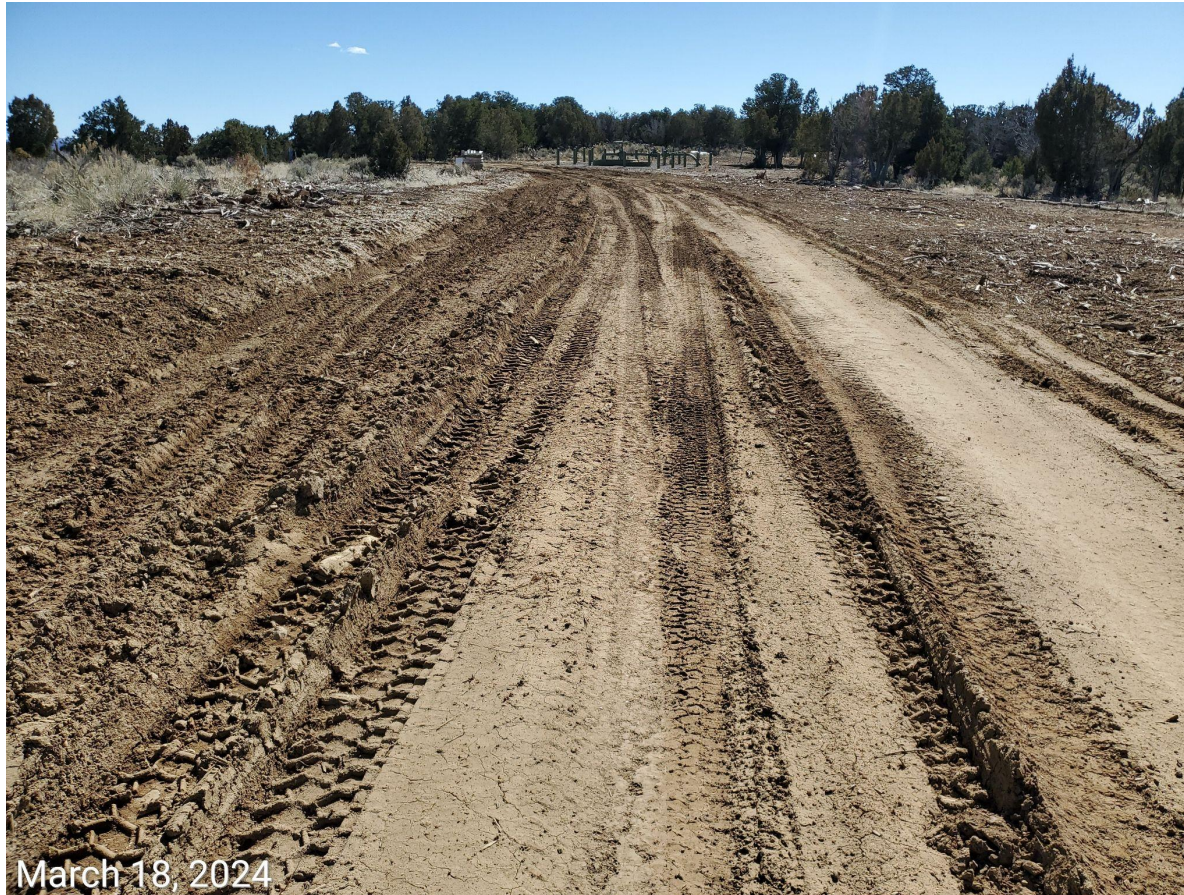
**Photo 5:** Photos 5-8 taken from along the access road. Erosion degradation due to tracking evident. Vehicle traffic appears to be expanding the the road
