WELLHEAD ABANDONMENT FORM

SITE NAME: Eckhardt 34-1 Wellhead							DATE: 3/10/2023	REM. PROJECT #:	WEATHER: Cloudy, 50's
SITE DIRECTIONS: CR 50 and CR57 N 0.25 W 0.125 S Into							CLIENT: PDC		
LEGALS AND LAT/LONG: (40.3540238, -104.5334620)							TASMAN PERSONNEL: AO		
SOIL TYPES: Poorly Graded Sand - SP							SURFACE GRADIENT: Southwest		
SOIL SAMPLING							FACILITY INFRASTRUCTURE		
Date/Time	Soil Sample ID	PID (ppm)	Visual	Olfactory	Photo?	Grab or Lab Sample?	EQUIPMENT	Quantity	
							Above Ground Storage Tank (AST)		
3/13/2023 14:00	FL01-01@4'	0.2	No Staining	No Odor	Yes	Lab	Buried or Partially Buried Vessel		
3/13/2023 14:10	FL01-02@4'	0.3	No Staining	No Odor	Yes	Lab	Separator		
3/13/2023 14:20	FL01-03@4'	2.7	Organic Content	Organic Odor	Yes	Lab	Emission Control Device (ECD)		
3/13/2023 14:30	FL01-04@4'	0.1	No Staining	No Odor	Yes	Lab	Dump Line		
3/14/2023 10:50	FL01-05@4'	0.3	No Staining	No Odor	Yes	Grab	Wellhead	1	
3/14/2023 10:40	FL01-06@4'	0.1	No Staining	No Odor	Yes	Lab	Flowline	1

GENERAL OBSERVATION FORM

Task/Location Description: Flowline and Wellhead Decommissioning

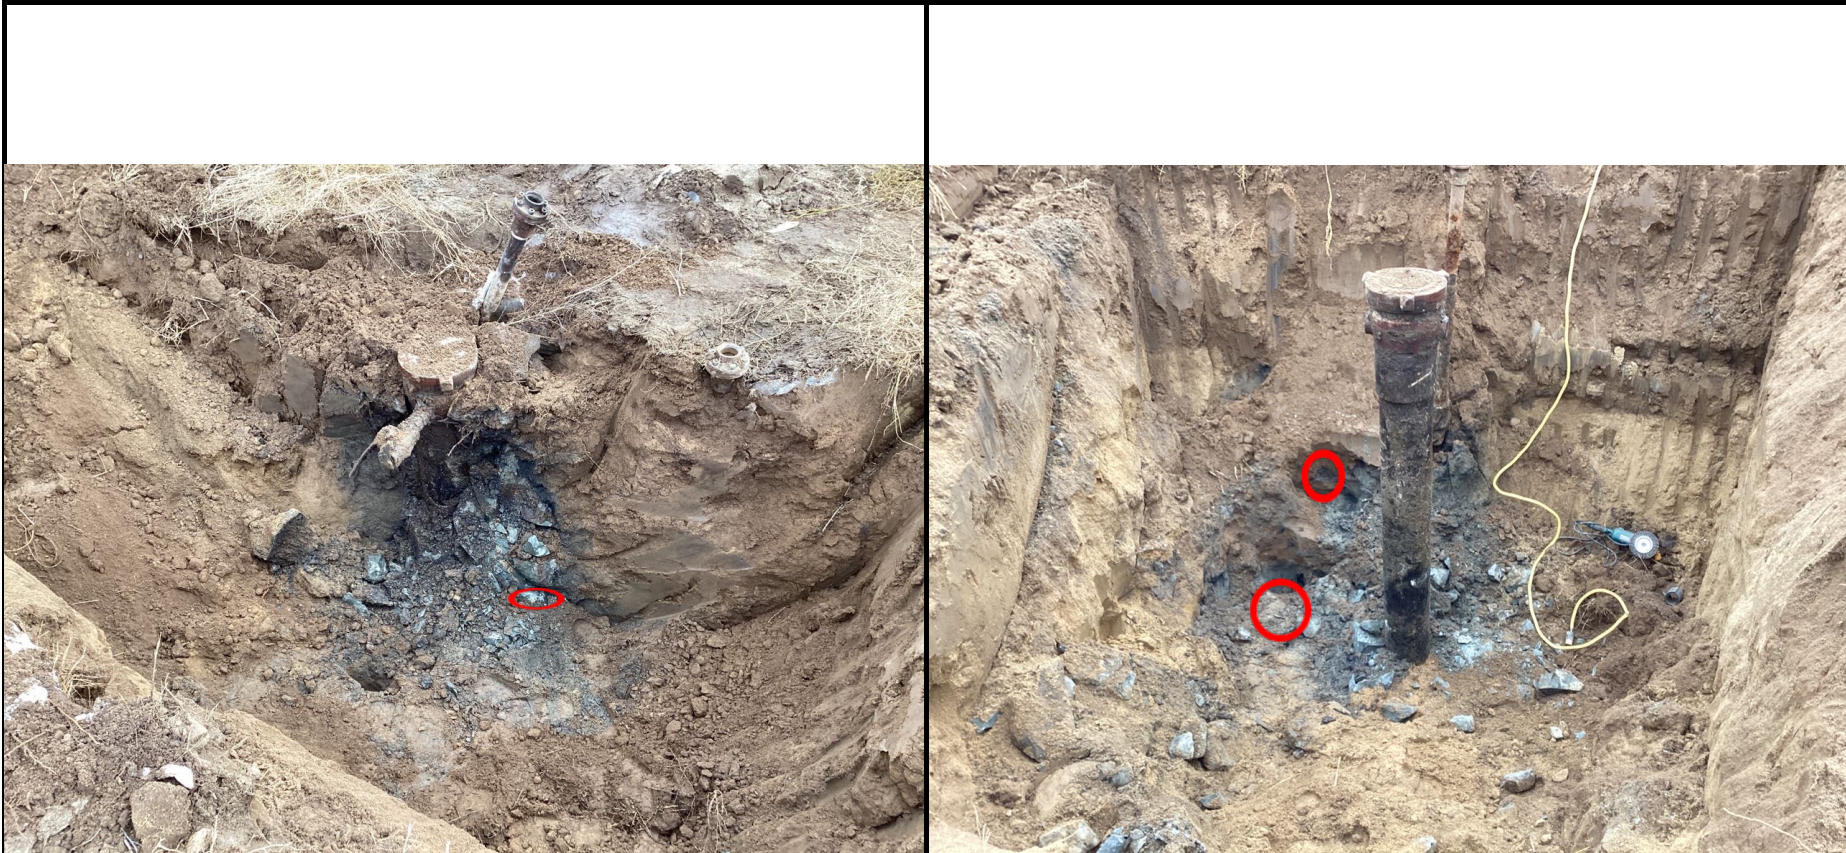
Equipment ID:		Equipment Type:		Equipment ID:		Equipment Type:	
Material:	Volume:	Contents:		Material:	Volume:	Contents:	
Notes/Conditions: GS01				Notes/Conditions: Top to Bottom: WH01-S, WH01-B

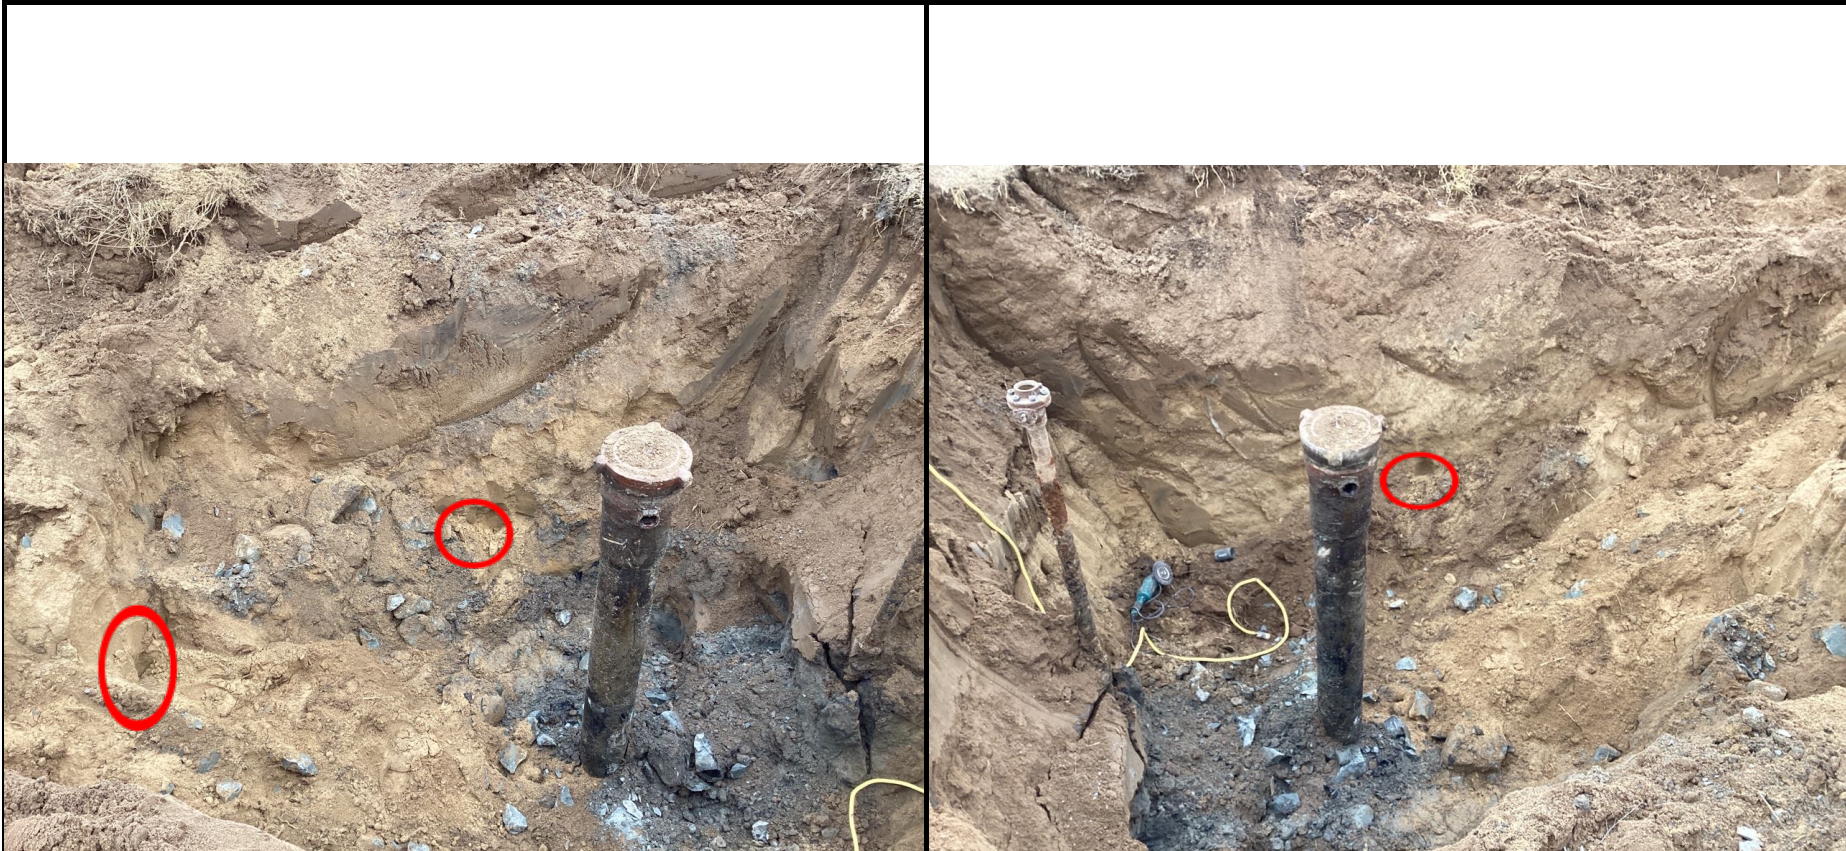
Equipment ID:		Equipment Type:		Equipment ID:		Equipment Type:	
Material:	Volume:	Contents:		Material:	Volume:	Contents:	
Notes/Conditions: LEft to Right: WH01-E, WH01-N				Notes/Conditions: WH01-W

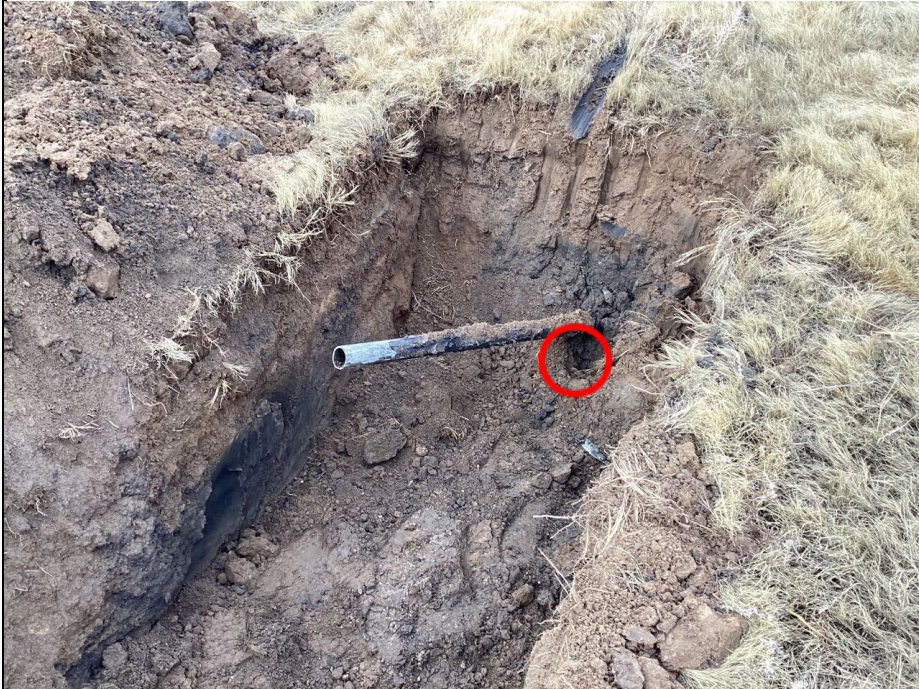
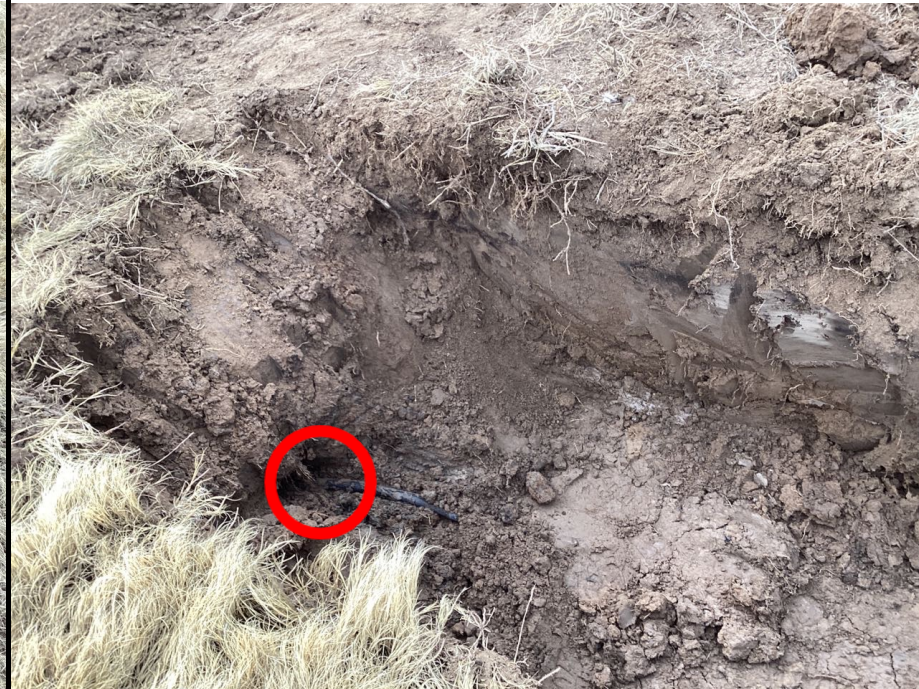
Equipment ID:		Equipment Type:	Equipment ID:		Equipment Type:
Material:	Volume:	Contents:	Material:	Volume:	Contents:
Notes/Conditions: FL01-05			Notes/Conditions: FL01-06

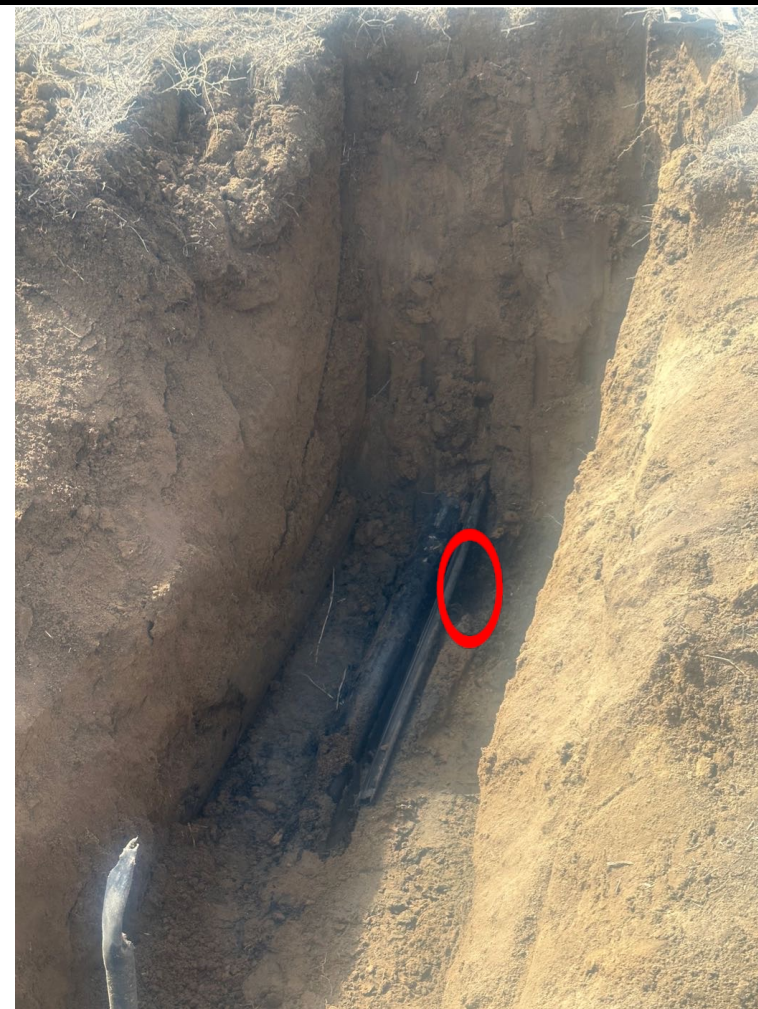
Equipment ID:		Equipment Type:	
Material:	Volume:	Contents:	
Notes/Conditions: FL01-03 Heavy Organic Staining /Organic Odor

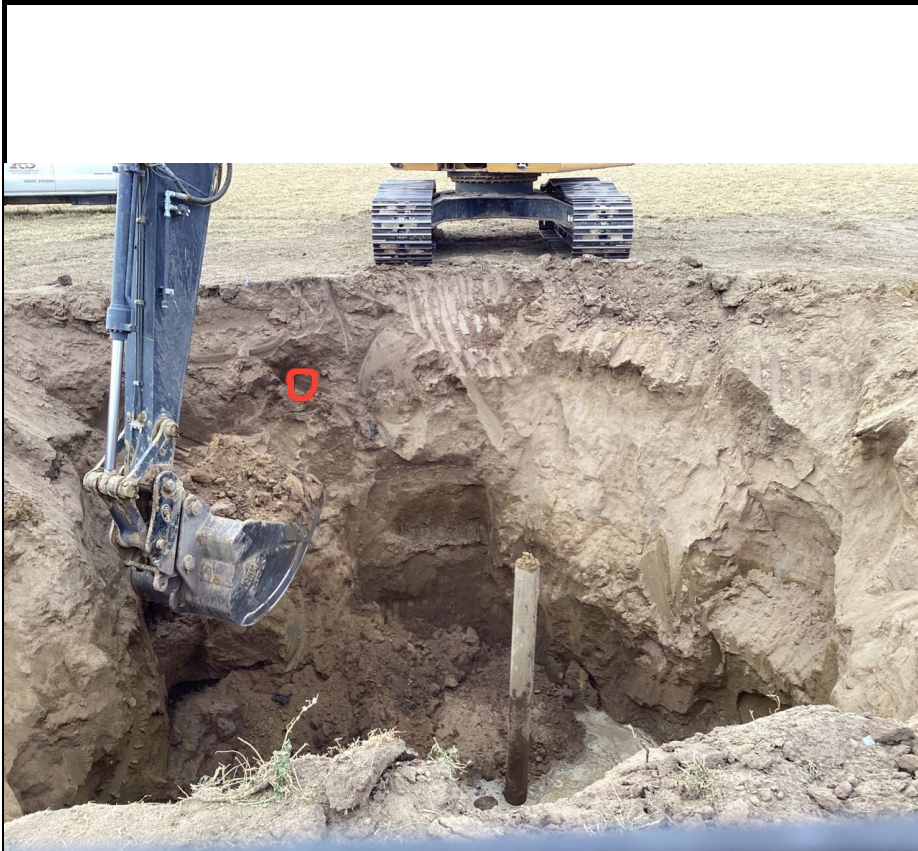
Notes/Conditions: 0-3: Silty sand, 3-12': Fine grained sand, 12-20': Sandy clay
