Attachment B

| SITE NAME: IKENOUE F29-22, 23 TANK BATTERY | | | | | | | DATE: 10/30/2023 | REM. PROJECT #: 31424 | WEATHER: 30S SUNNY | | |
| SITE DIRECTIONS: CR 52 X CR 41, TRAVEL W ON CR 52 0.25 MILES, GO N INTO SITE 0.5 MILES | | | | | | | CLIENT: PDC | | | | |

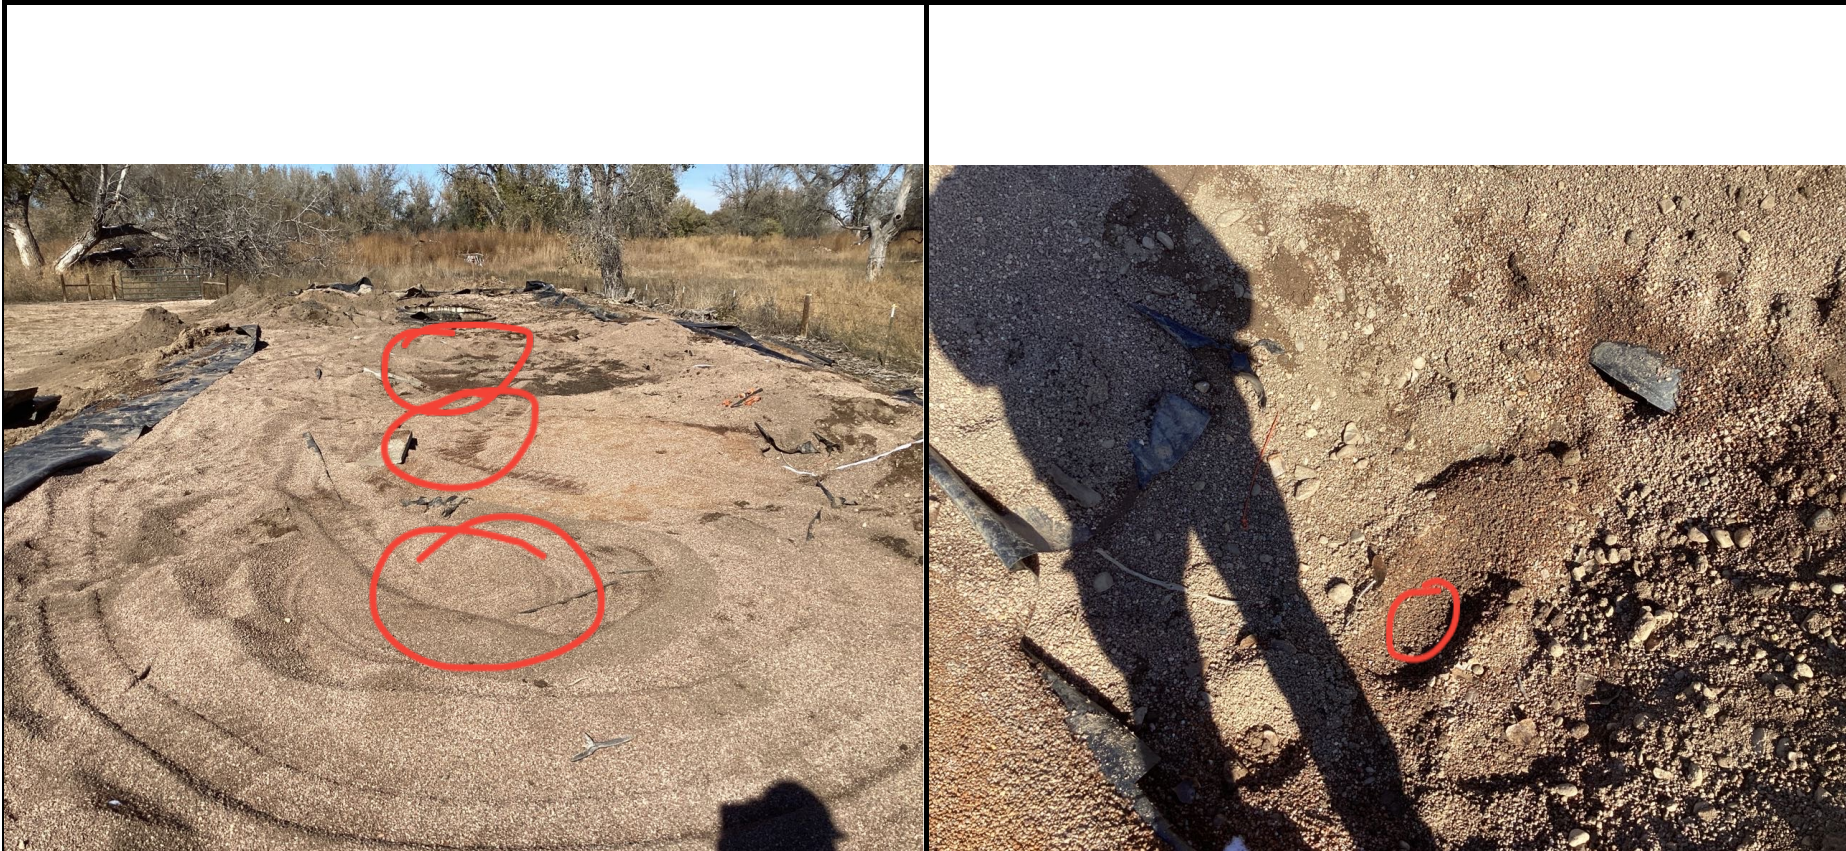
| Equipment ID: AST01, AST02, AST03 | | | Equipment Type: | | |

| SITE NAME: IKENOUE F29-22, 23 TANK BATTERY | | | | | | | DATE: 10/30/2023 | REM. PROJECT #: 31424 | WEATHER: 30S SUNNY | | |
|---|---|---|---|---|---|---|---|---|---|---|--|
| 10/30/2023 12:44 | AST01 @ 0-6" | 2.1 | No Staining | No Odor | Yes | Lab | Buried or Partially Buried Vessel | | 3 | | |
| 10/30/2023 12:42 | AST02 @ 0-6" | 1.4 | No Staining | No Odor | Yes | Lab | Separator | | 2 | | |
| 10/30/2023 12:40 | AST03 @ 0-6" | 0.9 | No Staining | No Odor | Yes | Lab | Emission Control Device (ECD) | | 2 | | |

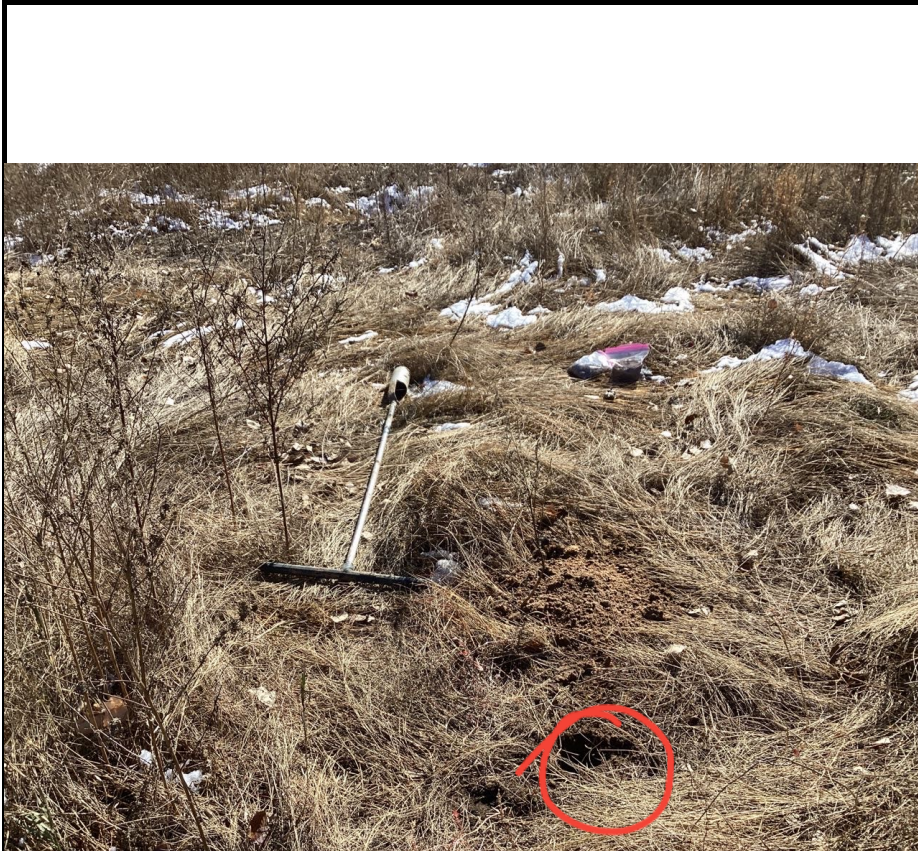
| Equipment ID: BKG01 | | Equipment Type: | |

| SITE NAME: IKENOUE F29-22, 23 TANK BATTERY | | | | | | | DATE: 10/30/2023 | REM. PROJECT #: 31424 | WEATHER: 30S SUNNY | | |
|---|---|---|---|---|---|---|---|---|---|---|--|
| 10/30/2023 14:09 | BKG01 @ 2.5' | 0.0 | No Staining | No Odor | Yes | Lab | IMPACTED SOIL IDENTIFIED? Yes | | | | |
| 10/30/2023 14:12 | BKG01 @ 4' | 0.2 | No Staining | No Odor | Yes | Lab | ESTIMATED VOLUME OF IMPACTS: | | | | |

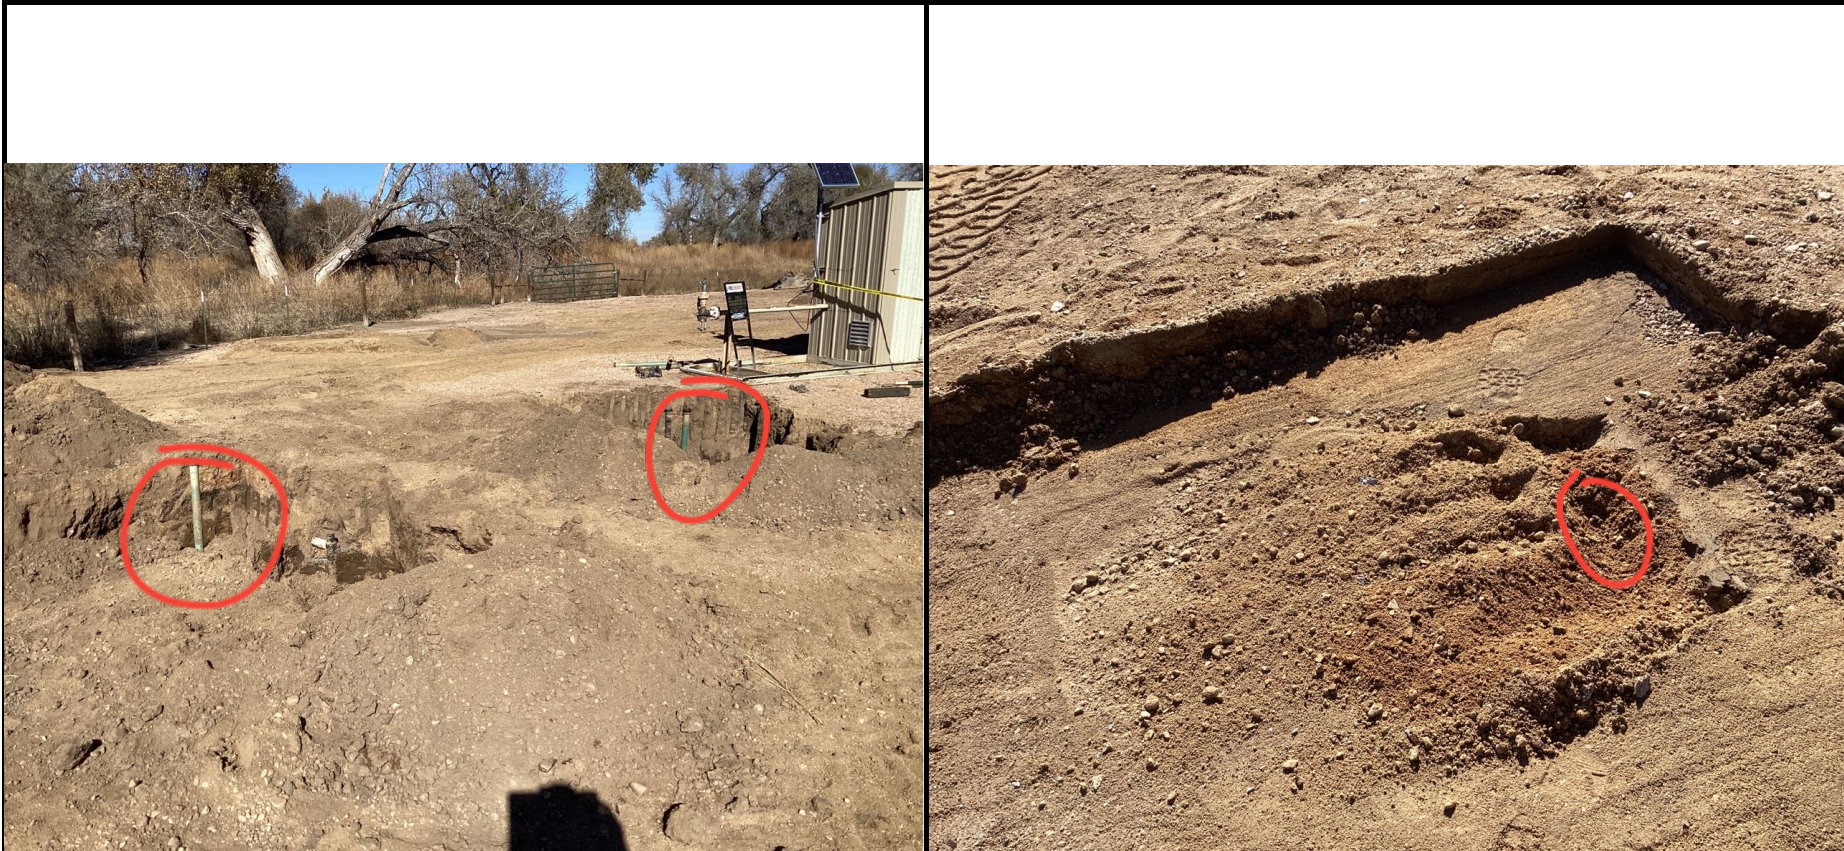
| Equipment ID: SEP01, SEP02 | | Equipment Type: | | Equipment ID: ECD01 | | Equipment Type: | |

| SITE NAME: IKENOUE F29-22, 23 TANK BATTERY | | | | | | | DATE: 10/30/2023 | REM. PROJECT #: 31424 | WEATHER: 30S SUNNY | | |
|---|---|---|---|---|---|---|---|---|---|---|--|
| 10/30/2023 13:46 | SEP01-FL @ 4' | 0.3 | No Staining | No Odor | Yes | Lab | Wellhead | | | | |
| 10/30/2023 13:49 | SEP01-DL @ 4' | 0.6 | No Staining | No Odor | Yes | Lab | Flowline | | | | |
| 10/30/2023 13:52 | SEP02-FL @ 4' | 0.1 | No Staining | No Odor | Yes | Lab | Other: Meterhouse | | 1 | | |
| 10/30/2023 13:55 | SEP02-DL @ 4' | 0.1 | No Staining | No Odor | Yes | Lab | Soil Loads Removed | | | | |

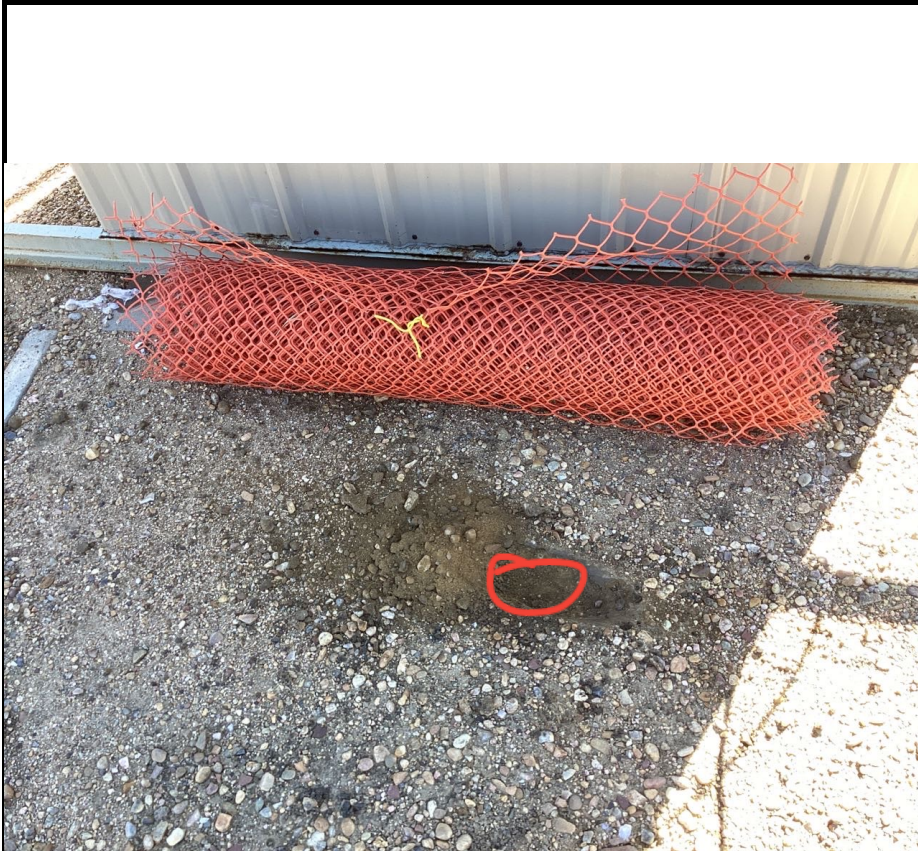
| Equipment ID: MH01 | | Equipment Type: | |

| SITE NAME: IKENOUE F29-22, 23 TANK BATTERY | | | | | | | DATE: 10/30/2023 | REM. PROJECT #: 31424 | WEATHER: 30S SUNNY | | |
|---|---|---|---|---|---|---|---|---|---|---|--|
| 10/31/2023 12:45 | MH01 @ 0-6" | 0.0 | No Staining | No Odor | Yes | Grab | Dump Line | | 2 | | |

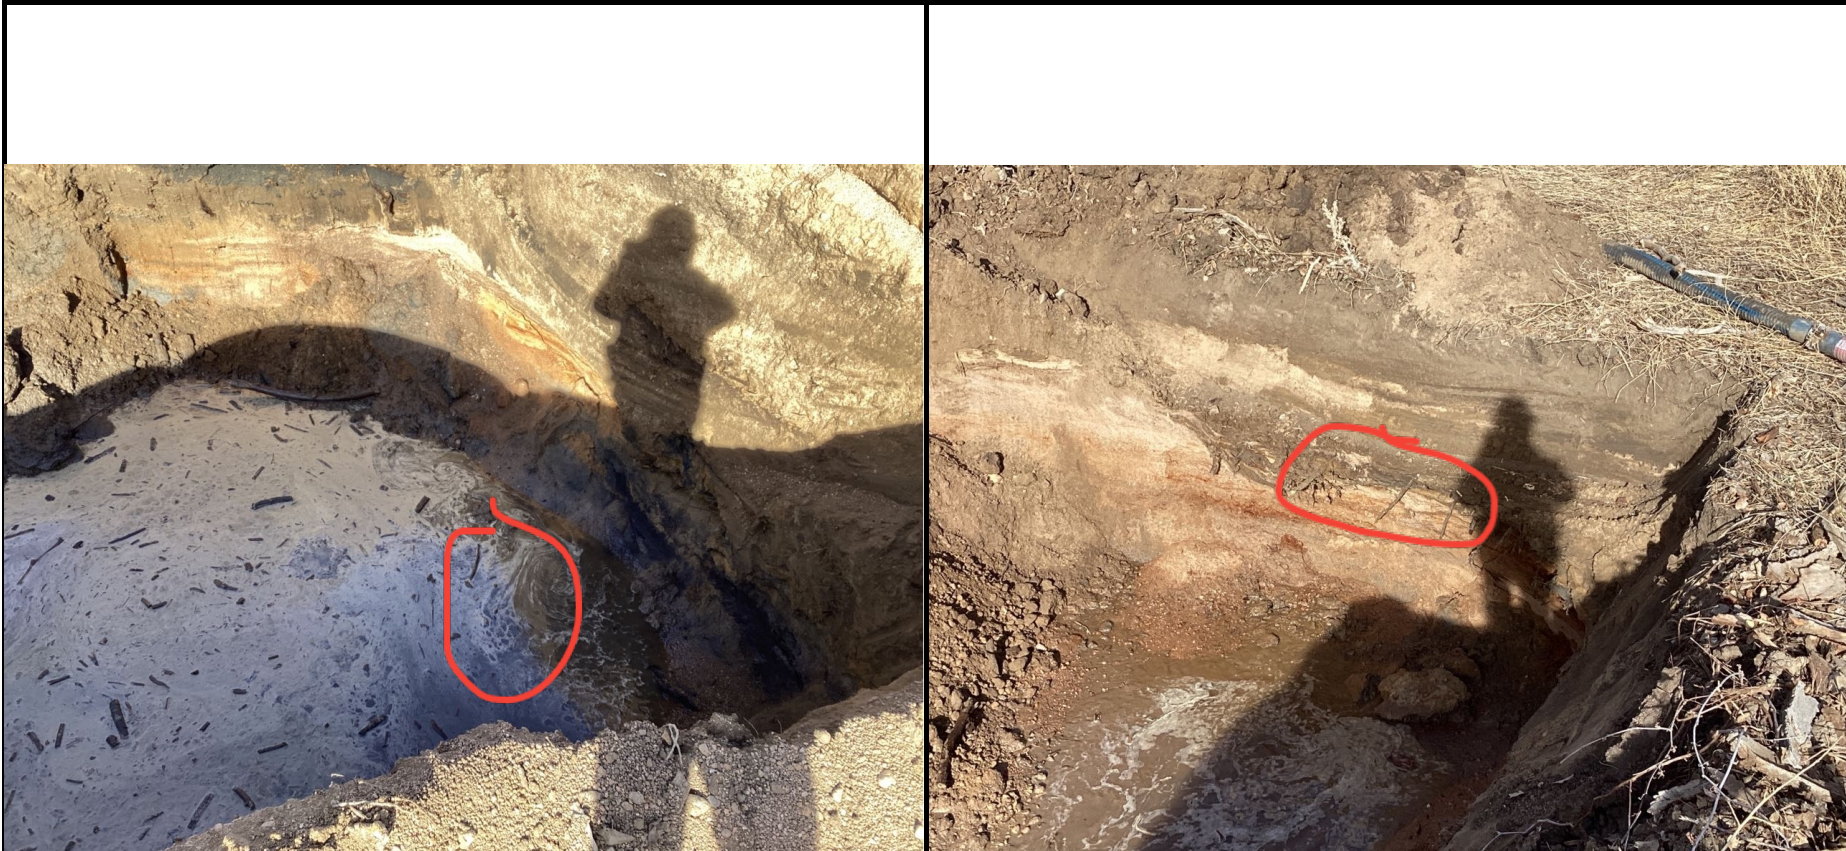
| Equipment ID: SS01@7 | | Equipment Type: | | Equipment ID: SS02@4 | | Equipment Type: | |

| SITE NAME: IKENOUEYE F29-22, 23 TANK BATTERY | | | | | | | DATE: 1/9/2024 | REM. PROJECT #: 31424 | WEATHER: 30S PARTLY CLOUDY | | |
|--|---|---|---|---|---|---|--|---|---|---|--|
| 1/9/2024 10:45 | SS01@7' | 10.3 | HC Staining | Slight HC Odor | Yes | Lab | Buried or Partially Buried Vessel | | 1 | | |
| 1/9/2024 12:50 | SS02@4' | 0.5 | No Staining | No Odor | Yes | Lab | Separator | | | | |

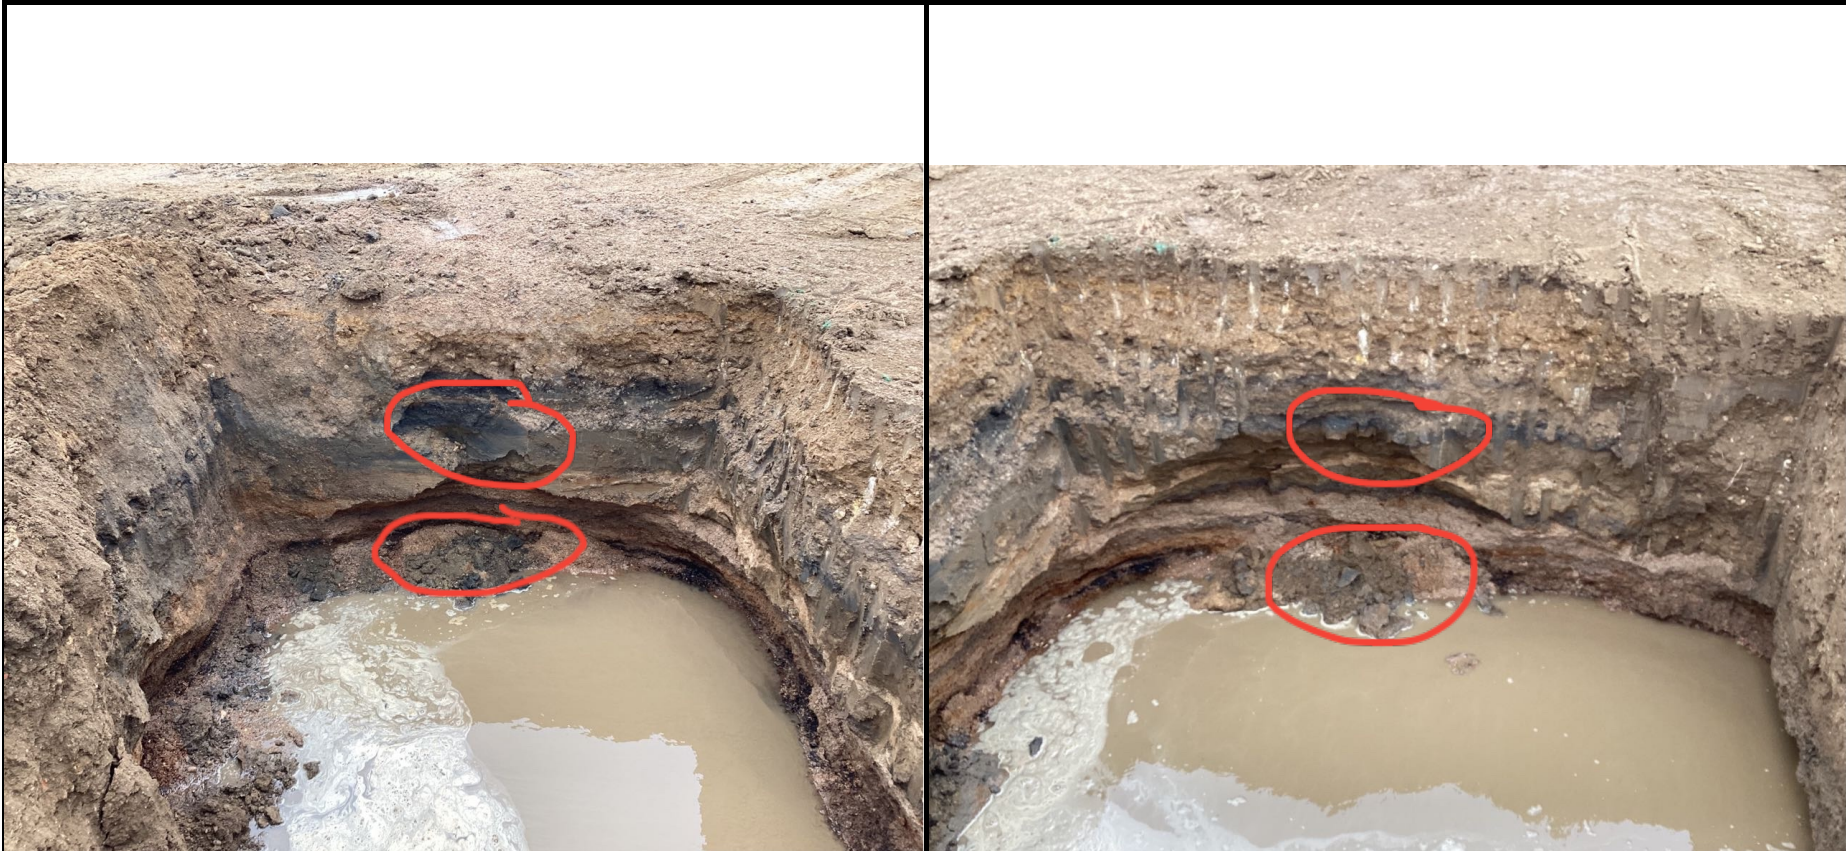
Equipment ID:SS70, SS71

Notes/Conditions: SS71 SAMPLE TAKEN PRIOR TO SOIL FALLING.

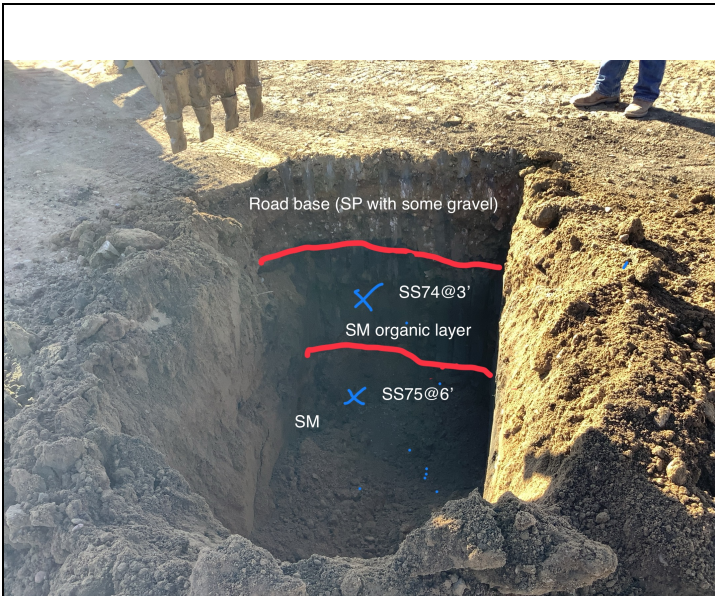
Photo 5 Date&Time: _____

Notes Facing southwest
 0-2' (SP)
 2-4' (SM)
 4-6 (SP) Saturated

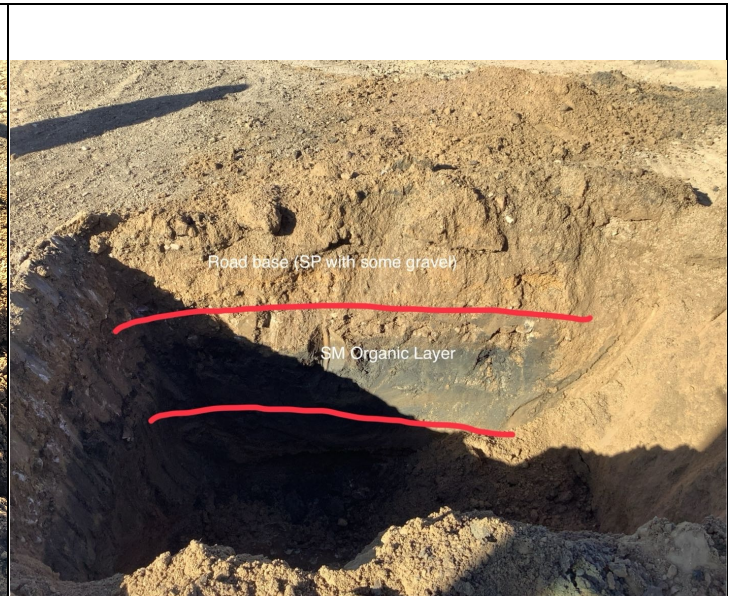
Photo 6 Date&Time: _____

Notes Facing west
 0-2' (SP)
 2-4' (SM)
 4-6 (SP) Saturated

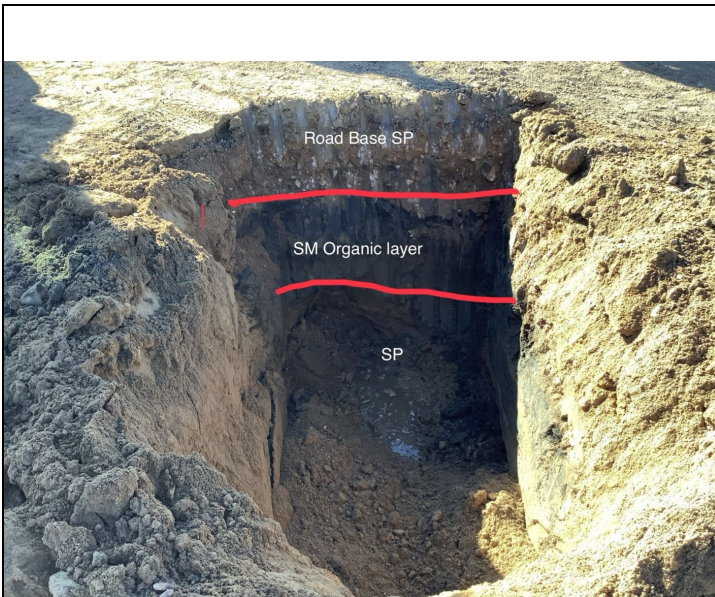
Photo 7 Date&Time: _____

Notes Facing southwest
 0-2' (SP)
 2-4' (SM)
 4-6 (SP) Saturated

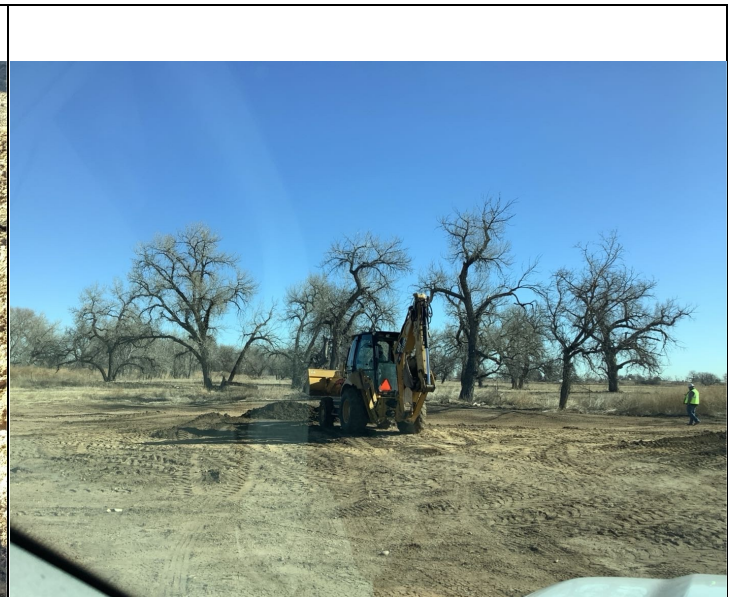
Photo 8 Date&Time: _____

Notes Clean soil being added to the original excavation

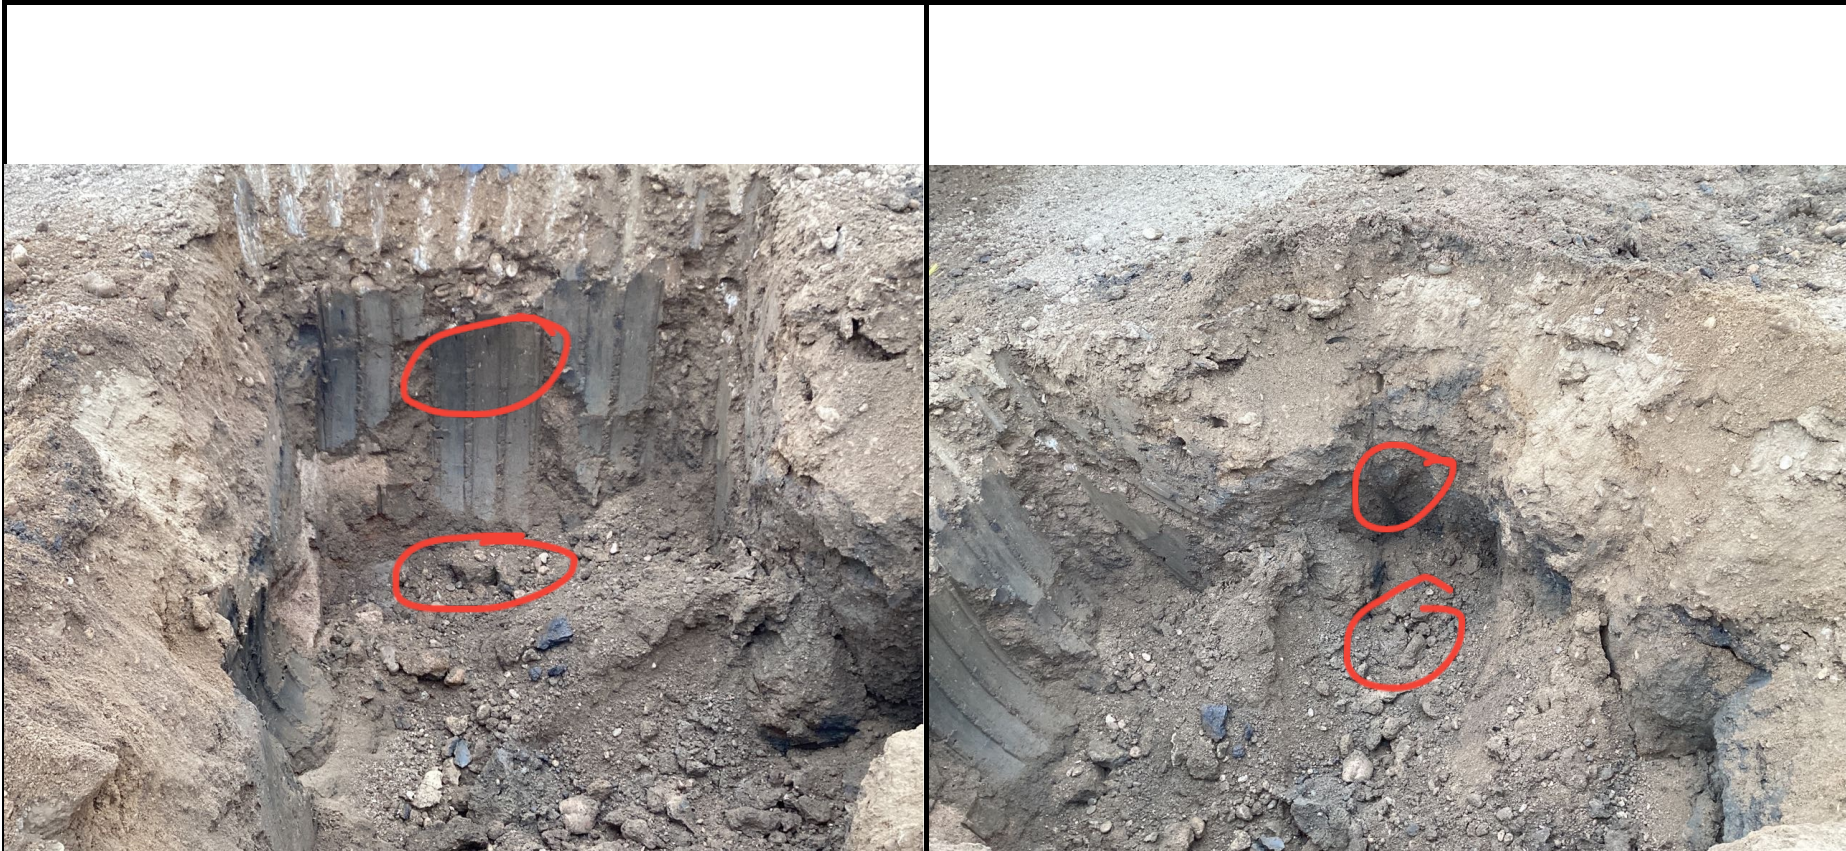
| Equipment ID: SS76-SS77 | | | Equipment Type: | | | Equipment ID: SS78-79 | | | Equipment Type: | | |

| SITE NAME: IKENOUE F29-22, 23 TANK BATTERY | | | | | | | DATE: 3/11/2024 | REM. PROJECT #: 31424 | WEATHER: 40S PARTLY CLOUDY | |
|---|---|---|---|---|---|---|--|---|---|--|
| 3/11/2024 09:43 | SS76 @ 3' | 0.0 | No Staining | No Odor | Yes | Lab | Buried or Partially Buried Vessel | | | |
| 3/11/2024 09:45 | SS77 @ 6' | 0.1 | No Staining | No Odor | Yes | Lab | Separator | | | |
| 3/11/2024 09:48 | SS78 @ 3' | 0.0 | No Staining | No Odor | Yes | Lab | Emission Control Device (ECD) | | | |
| 3/11/2024 09:50 | SS79 @ 6' | 0.0 | No Staining | No Odor | Yes | Lab | Dump Line | | | |

| Notes/Conditions: SE WALL | | | | | | Notes/Conditions: SW WALL | | | | | |

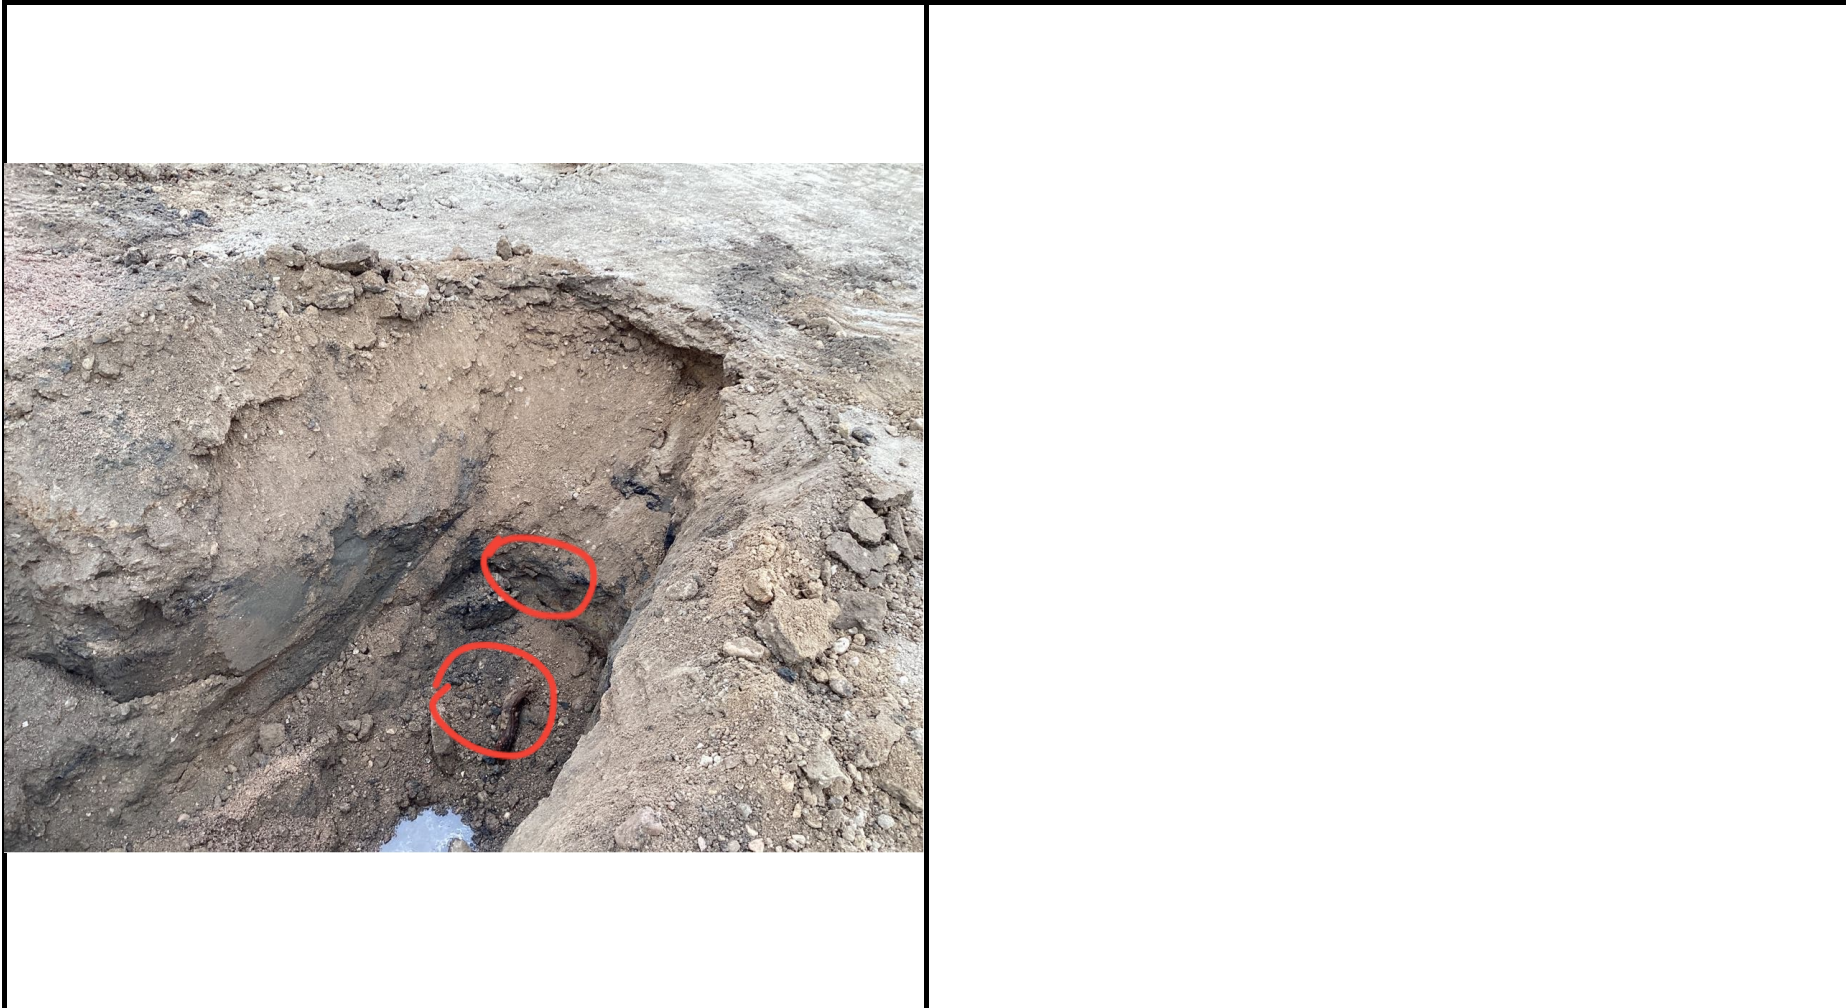
| Equipment ID: SS80-81 | | Equipment Type: | | Equipment ID: | | Equipment Type: | |

| SITE NAME: IKENOUE F29-22, 23 TANK BATTERY | | | | | | | DATE: 3/11/2024 | REM. PROJECT #: 31424 | WEATHER: 40S PARTLY CLOUDY | |
|---|---|---|---|---|---|---|--|---|---|--|
| 3/11/2024 10:00 | SS80 @ 3' | 0.0 | No Staining | No Odor | Yes | Lab | Wellhead | | | |
| 3/11/2024 10:02 | SS81 @ 6' | 0.1 | No Staining | No Odor | Yes | Lab | Flowline | | | |

| Notes/Conditions: NW WALL | | | | Notes/Conditions: | | | |
