Inspection Photos

API: 017-06507

Operator: **CITATION OIL & GAS CORP**

Inspection Date: 3/26/2024

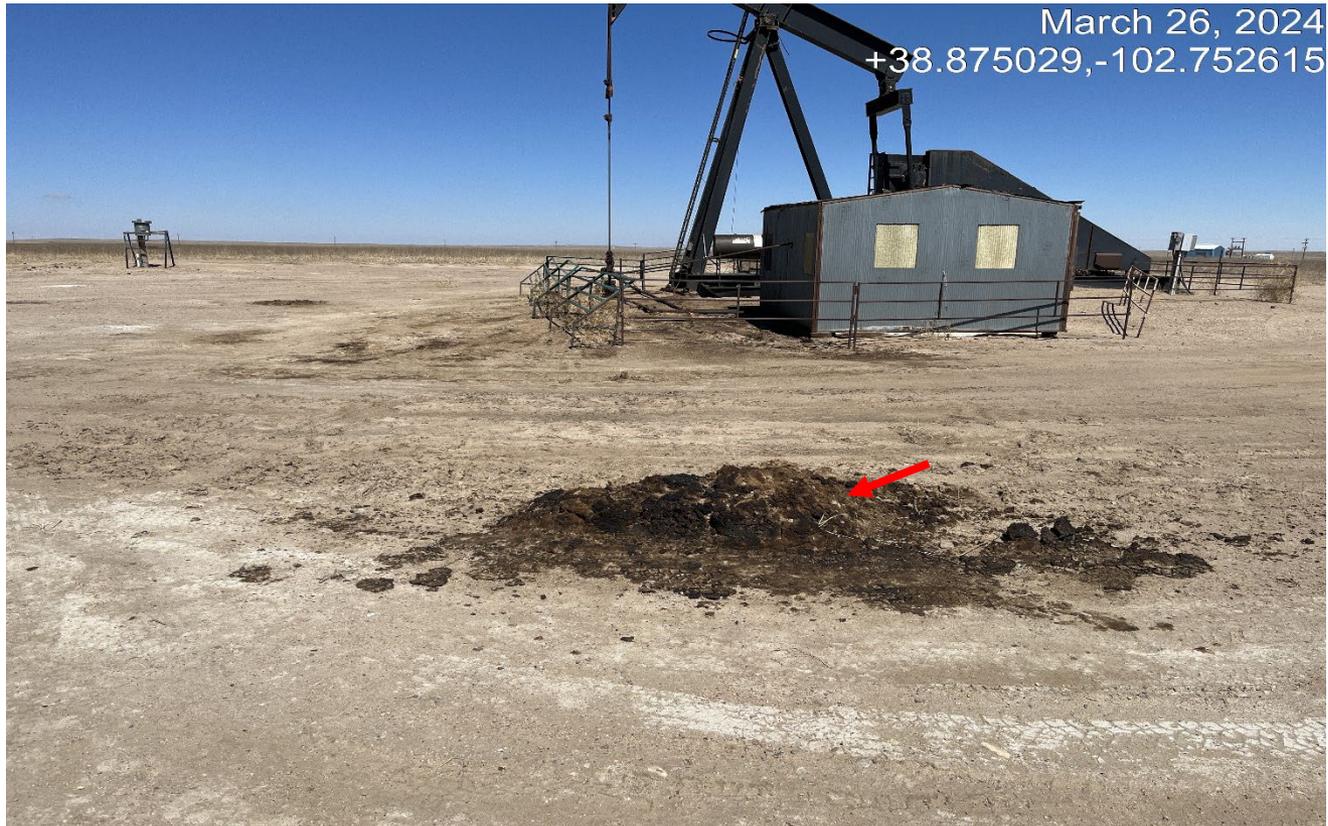
Photo 2. There is a pile of oily E&P waste at the south side of the well. It appears there was a leak at the well and impacted material has not been cleaned and there are even vehicle track thru the oily waste pile.

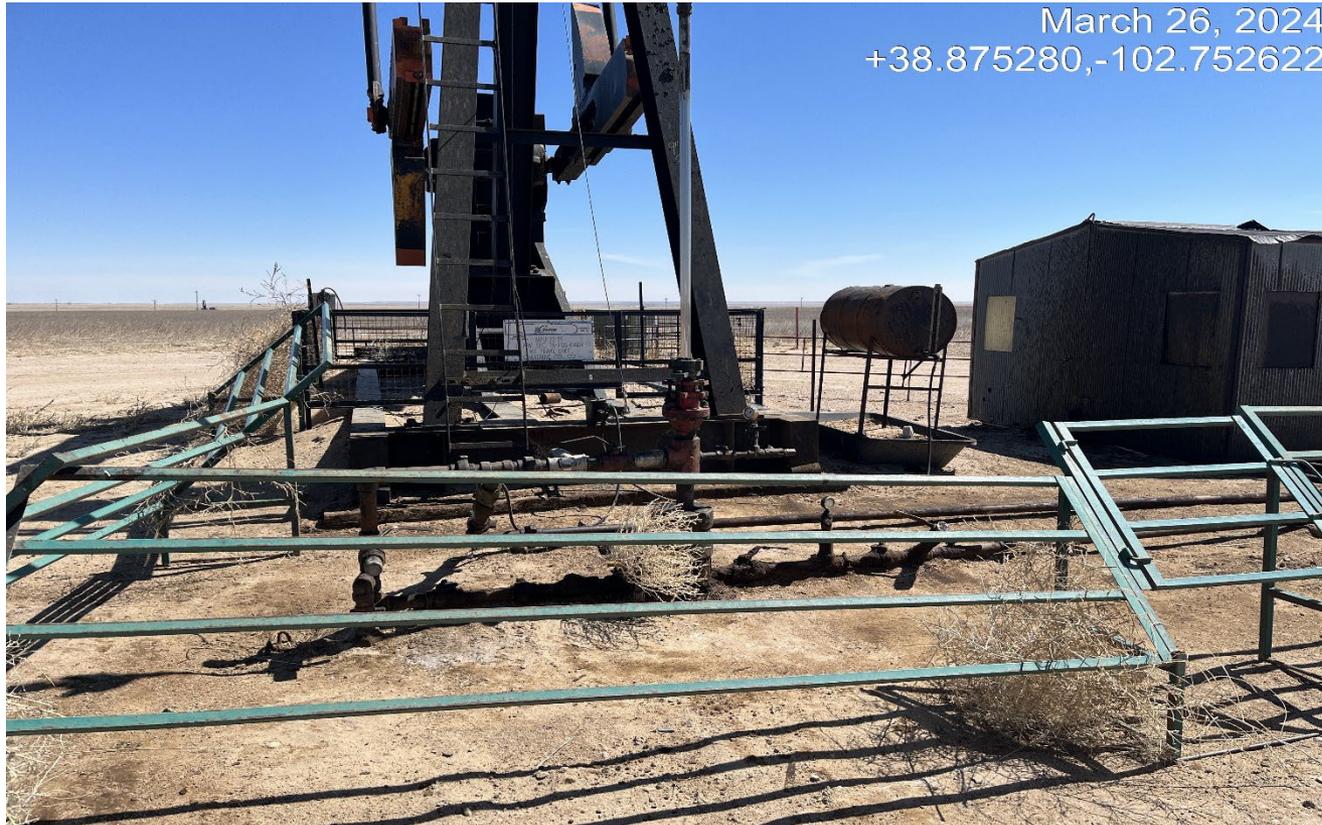
Photo 3. Facing toward the well. There are stained soils around the well which appear to have sprayed out oil to the south of the well.

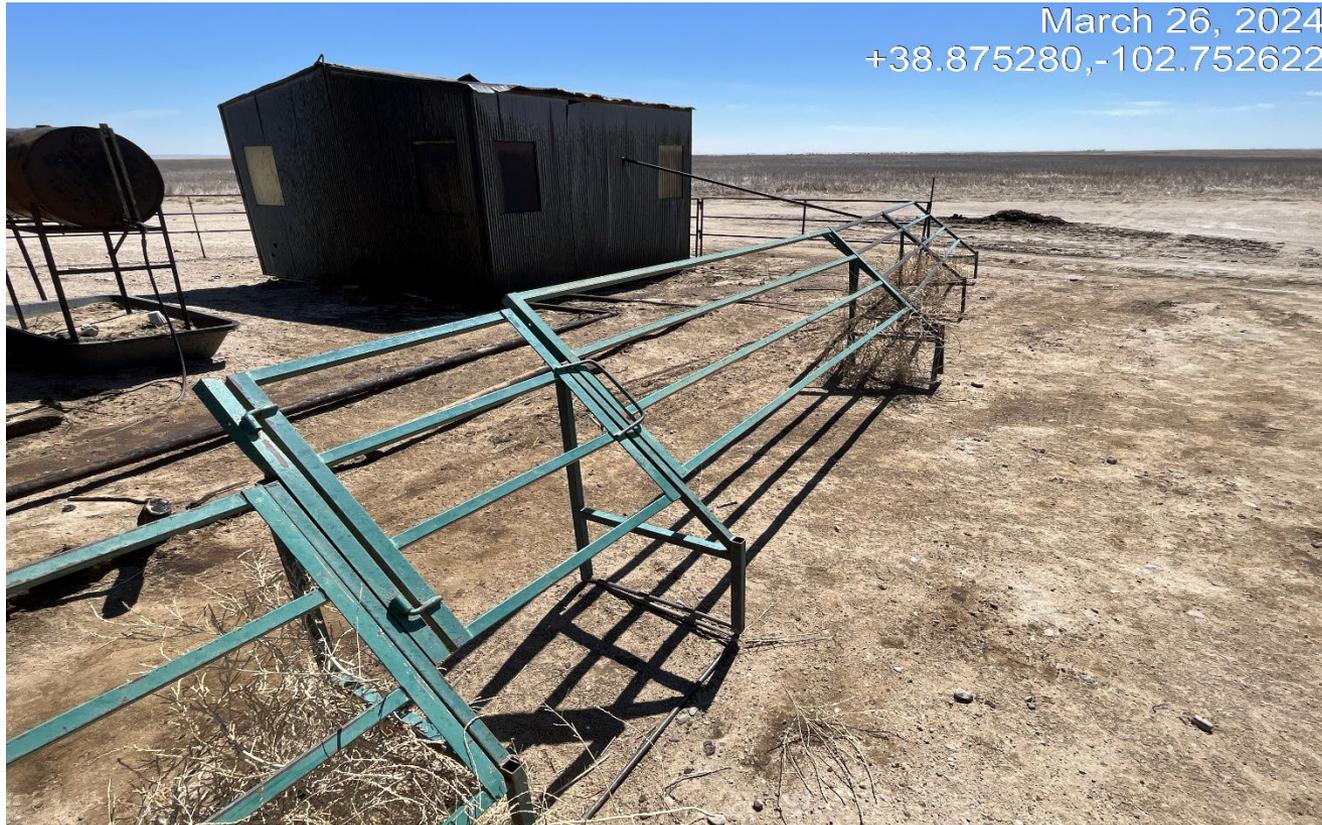
Photo 4. Facing southeast. There are stained soils and the shed is stained black from the leak that occurred from the well.

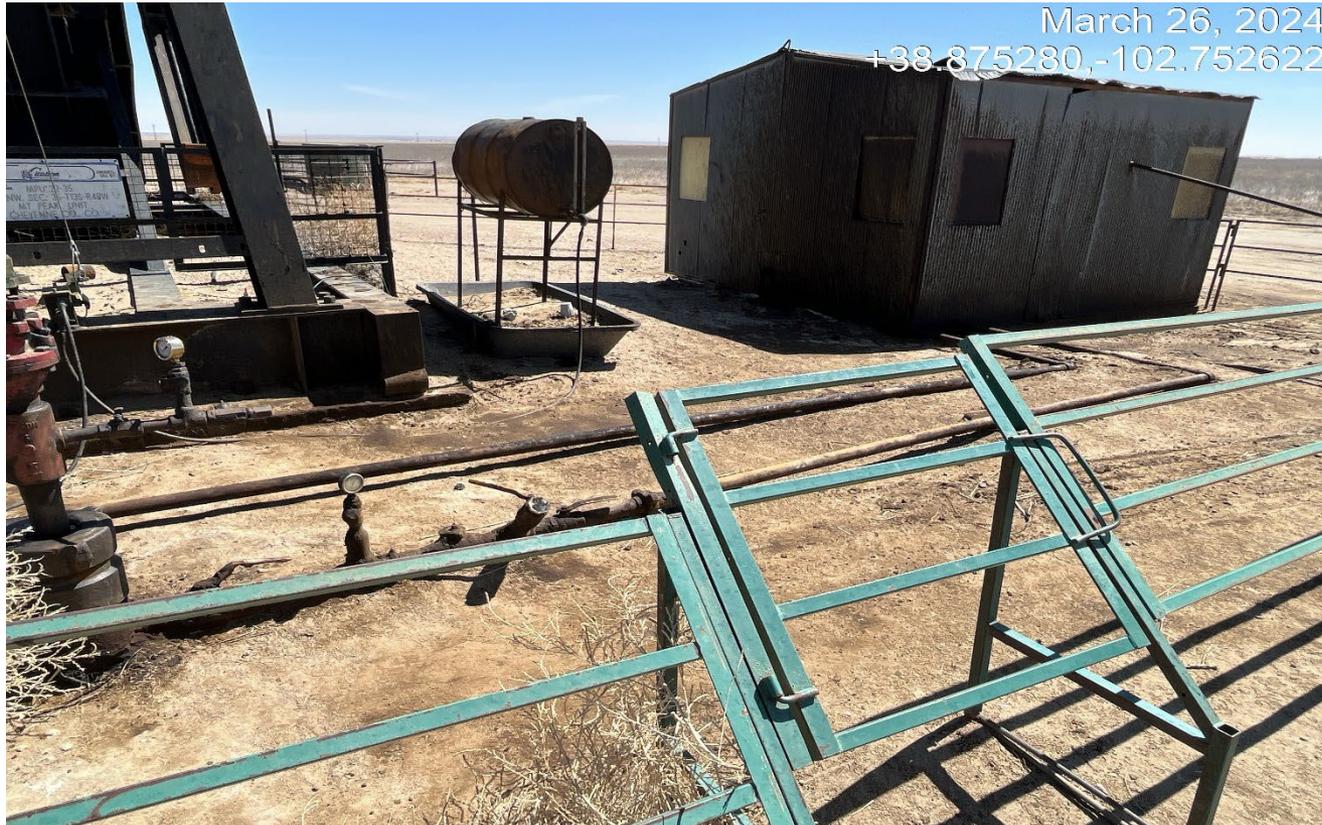
Photo 5. Facing southeast. There are stained soils and the shed is stained black from the leak that occurred from the well.
