**Storm Water Management and Erosion control**  
**Location Name: TEP Rocky Mountain LLC Juhan Tank facility**  
**Facility ID # 479723**

**Location Overview: Location is within High Priority/Density/NSO/Black Bear Habitat areas & in close proximity to Bald Eagle Roost site. Location is approximately 99 yards from Porcupine Creek.**

**Section/Township/Range: 26 6S94W**

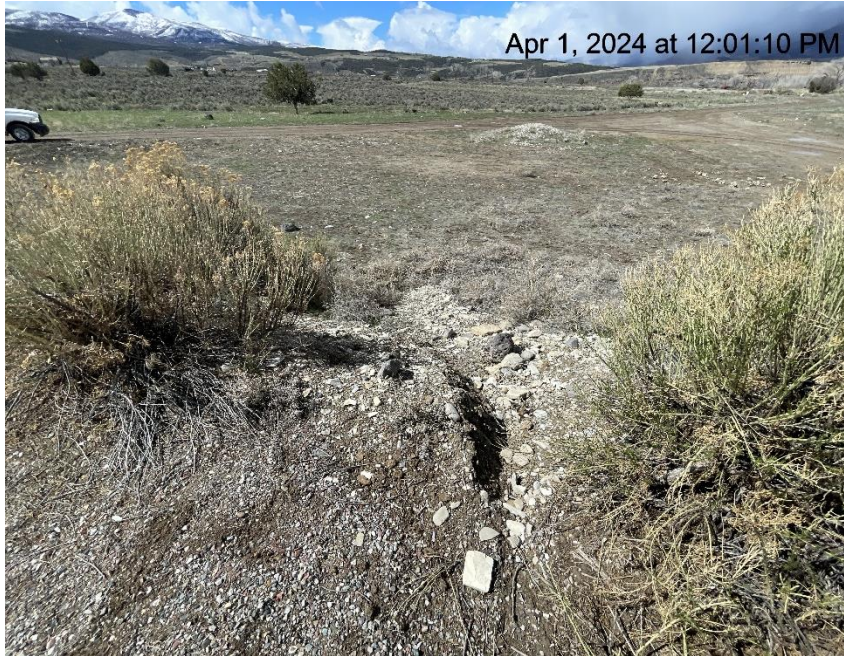
**Photo # 2054 Berm/BMP needs maintenance, berm breached/eroded & sediment is being transported off location into a vegetated area. (near NW corner of location)**

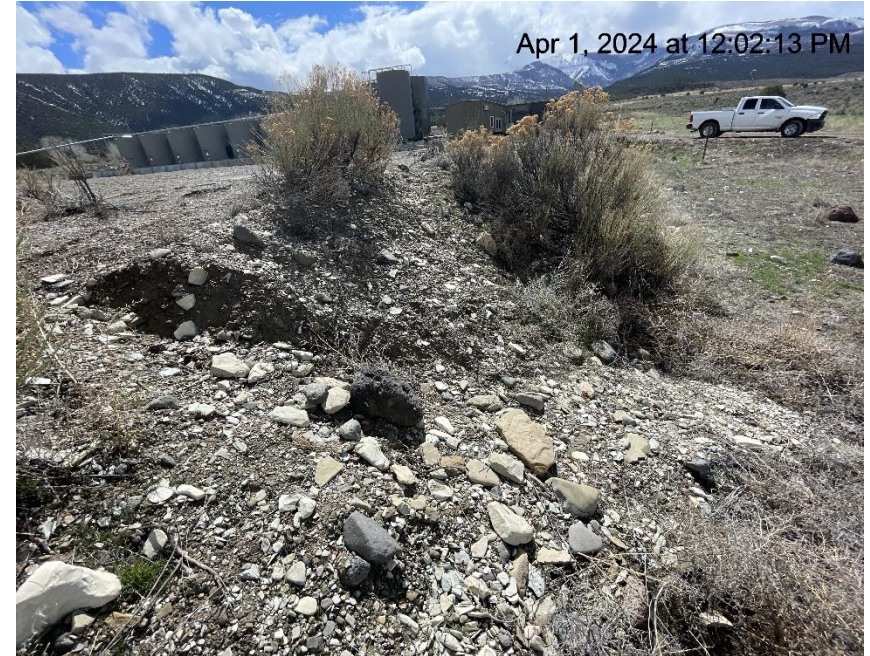
**Photo # 2055 Berm/BMP needs maintenance, berm breached/eroded & sediment is being transported off location into a vegetated area. (near NW corner of location)**

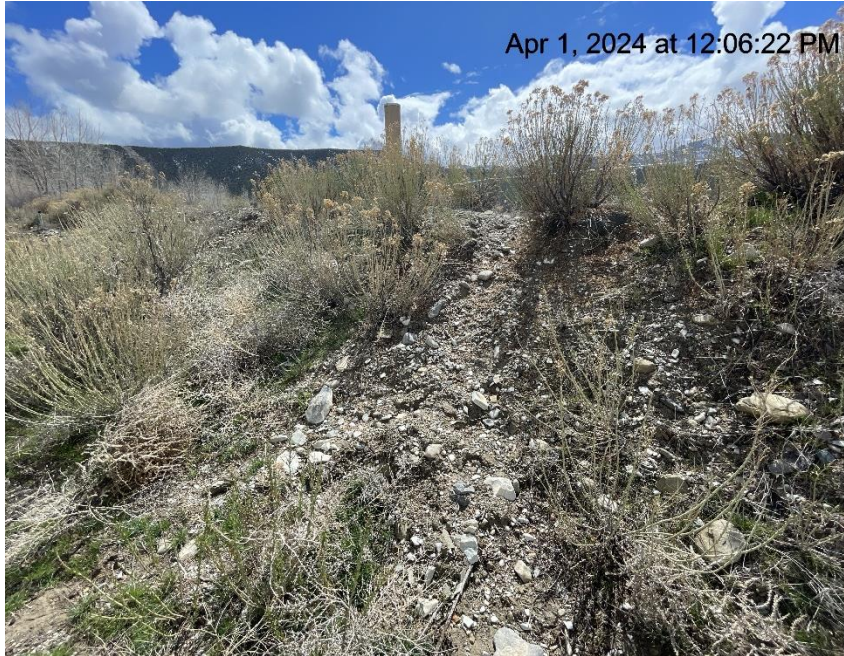
**Photo # 2056 Berm/BMP needs maintenance, berm breached/eroded & sediment is being transported off location into a vegetated area. (Berm on north side of location)**

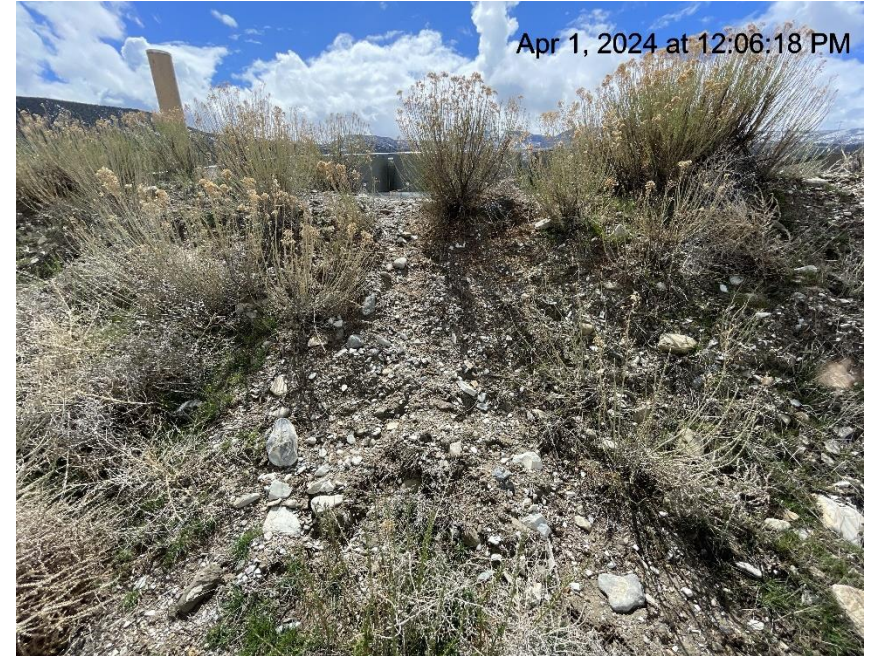
**Photo # 2057 Berm/BMP needs maintenance, berm breached/eroded & sediment is being transported off location into a vegetated area. (Berm on north side of location)**

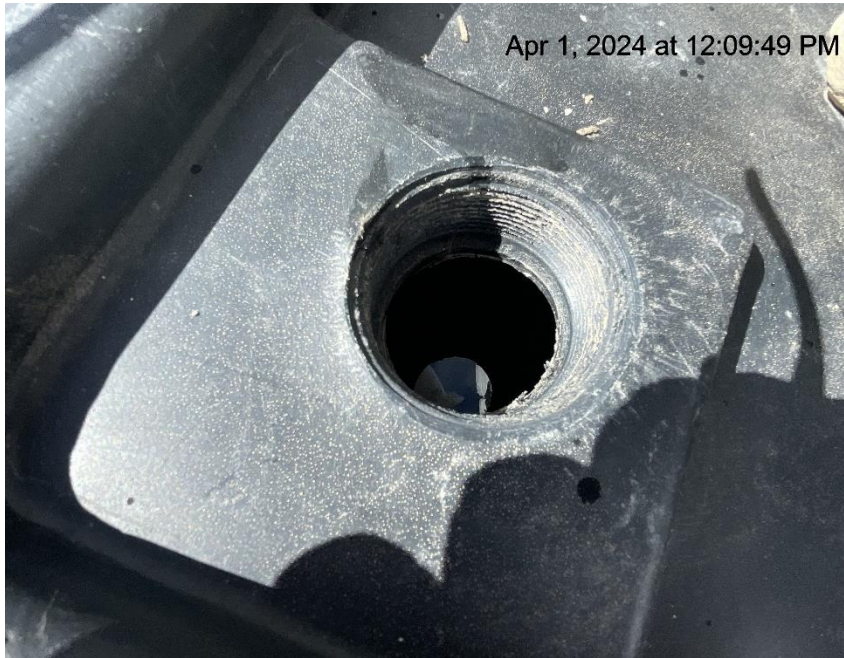
**Photo # 2058 Failure to maintain chemical BMP/chemical containment approximately 3/4 full of fluid/BMP insufficient to contain possible spill.**
