## **MIGRATORY BIRD / RAPTOR SURVEY REPORT**

**WELBA PEAK UNIT OIL & GAS LOCATION  
DUNCAN FACILITY & 14-1 WELL PAD LOCATIONS  
Moffat County, Colorado**

**April 4, 2024**

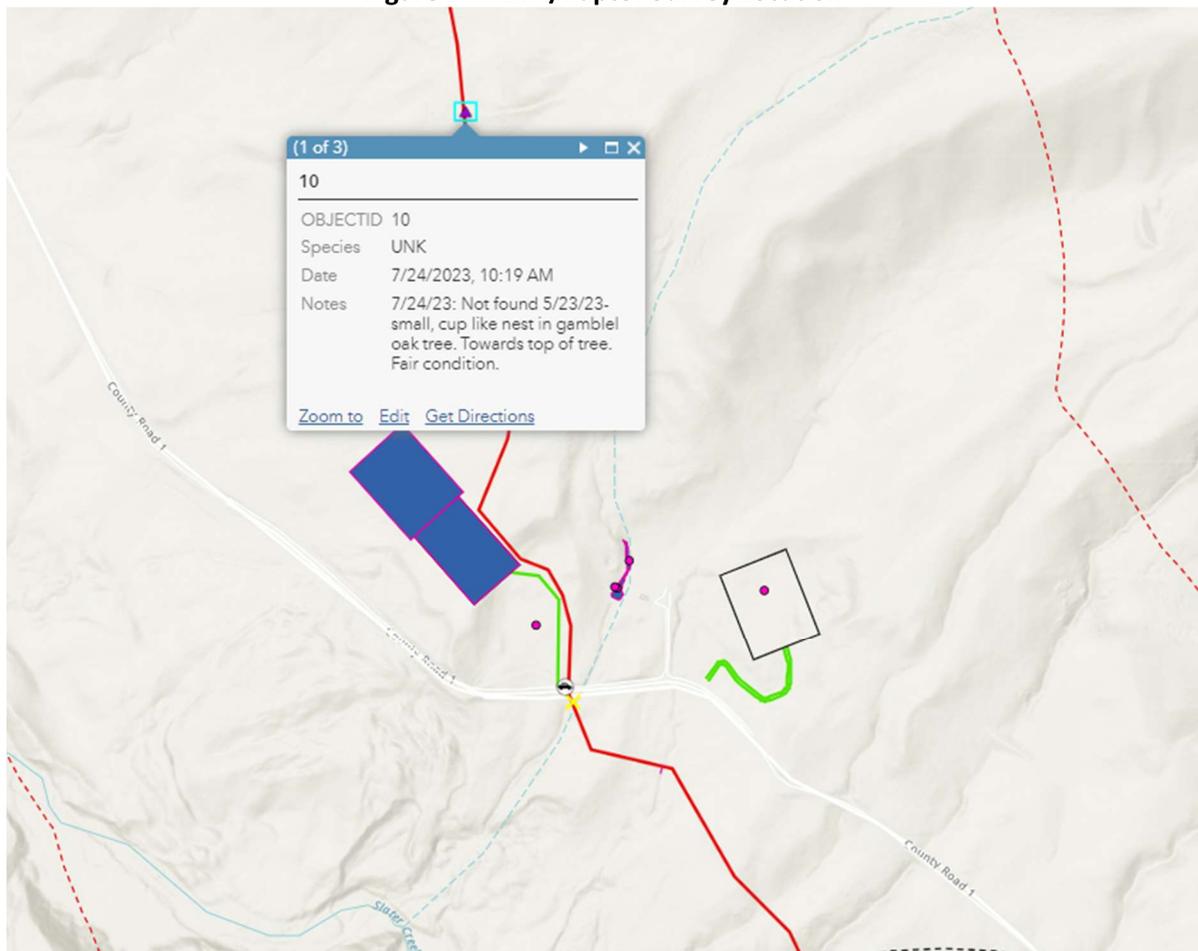
**Figure 1. MBTA/Raptor Survey Location**

There is suitable habitat for nesting migratory birds within and adjacent to the Location, predominately in the form of tall grasses and ground-nesting habitat for ground-nesting birds. Surveys conducted on May 23, 2023, and again on July 24, 2023, found no active MBTA nest within Location.

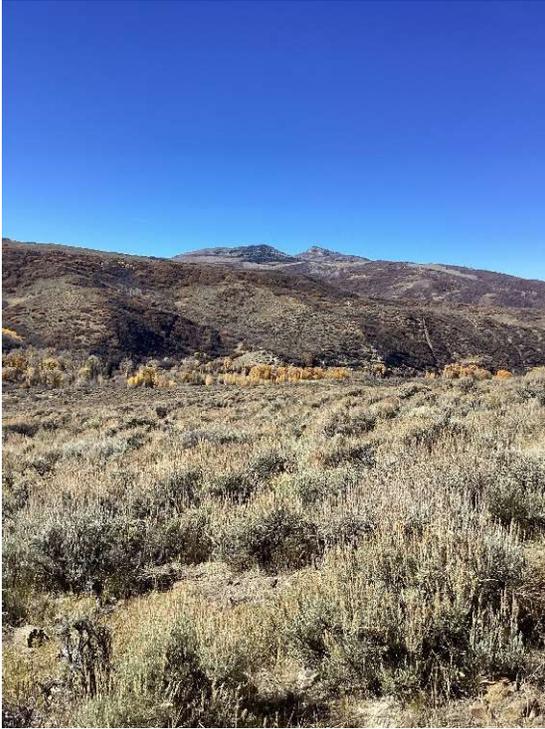
Photo 1. Duncan / 14-1 Location.

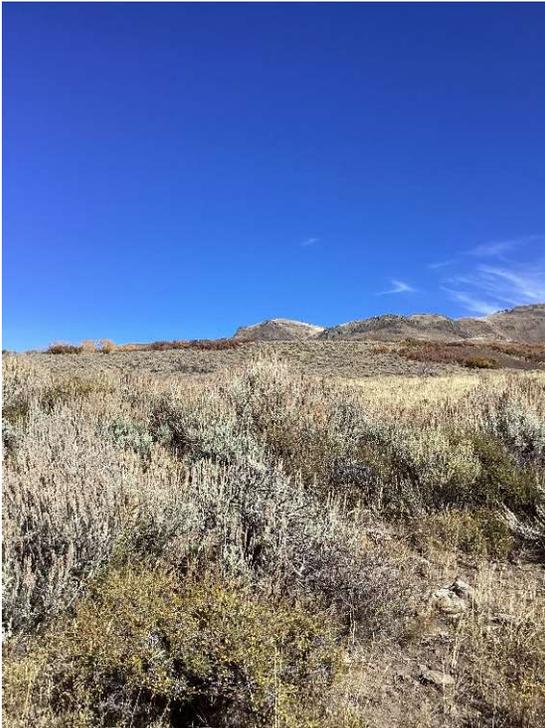
Photo 2. Duncan / 14-1 Location.

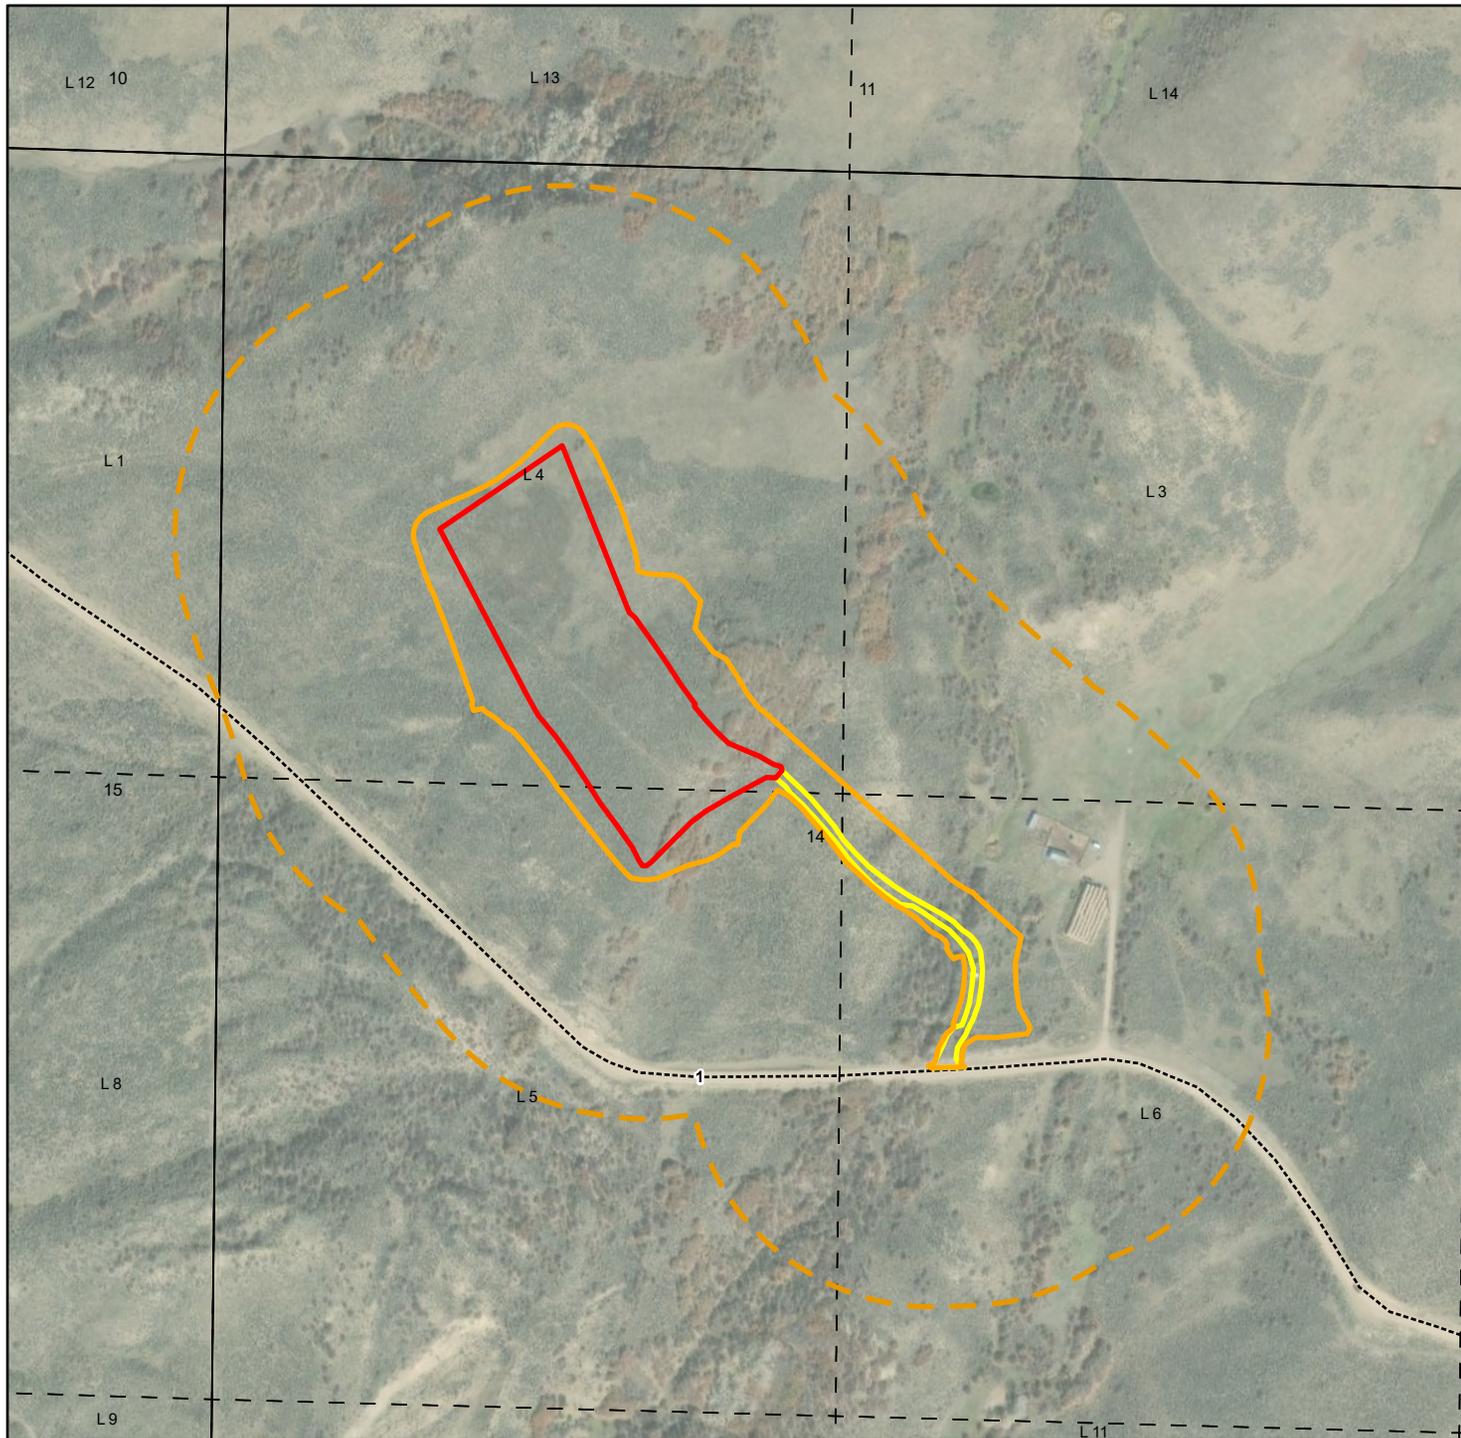
**Figure 2. Duncan Facility 14-1 Pad OGD Site Location Map**

Disturbance Area: 11.21 Acres  
 40.91267, -107.35227  
 Lot 3, 4, 5, & 6, Sec 14, T11N, R89W, 6PM  
 Moffat County, CO
