Storm Water Management and Erosion control
Location Name: CAERUS PICEANCE LLC Rulison Compressor Station
Location # 466236

**Location Overview: Location is within High
Priority/Density/Black Bear Habitat areas & in close proximity
to NSO Habitat area. Location is approximately 317 yards
from Spruce creek.**

Section/Township/Range: 8 7S94W

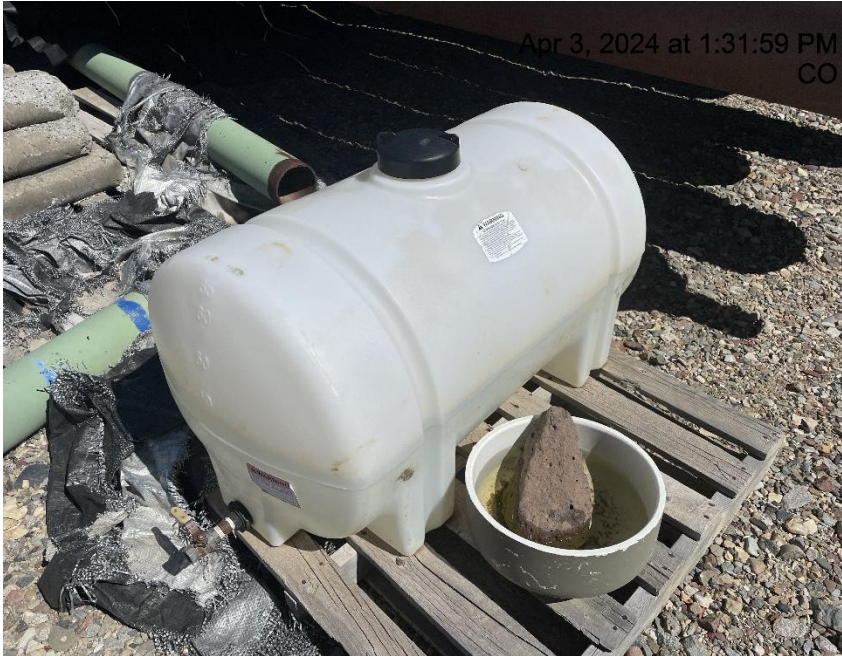
**Photo # 2663 Chemical tank lacks containment/BMP
(chemical tank is not labeled & is approximately half full of
unknown fluid)**

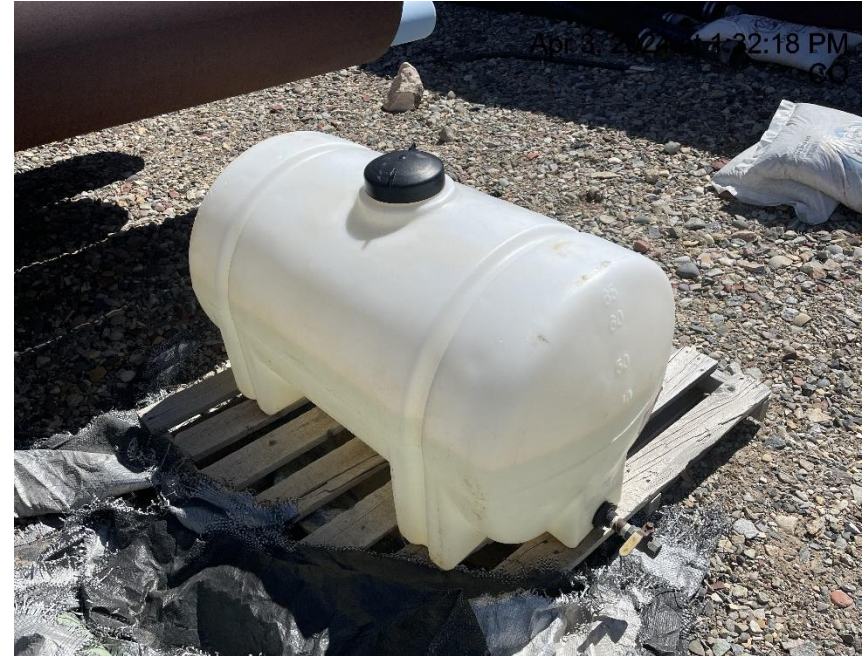
**Photo # 2664 Chemical tank lacks containment/BMP
(chemical tank is not labeled & is approximately half full of
unknown fluid)**

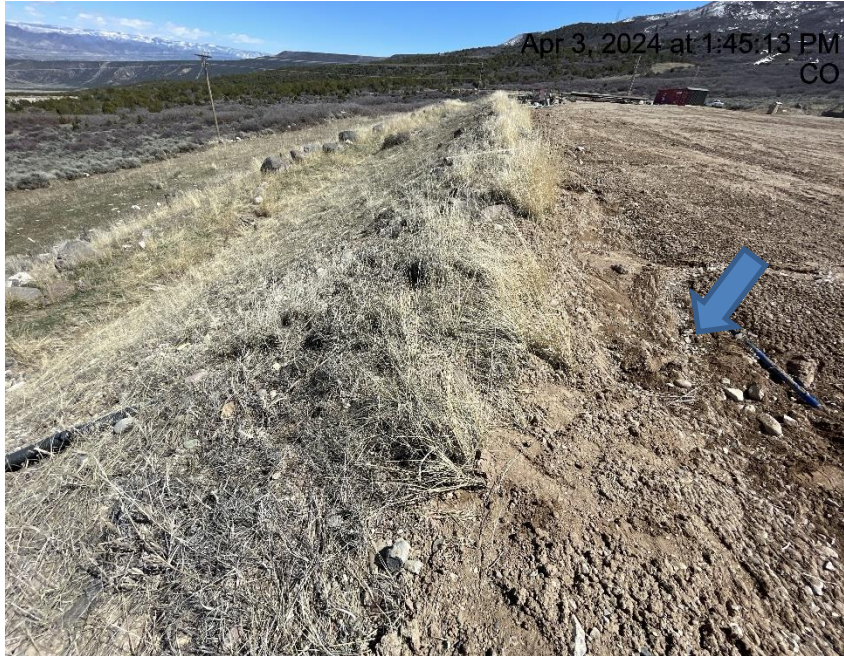
Photo # 2665 Drain/BMP needs maintenance/drain clogged with sediment (drain is near NW corner of location)

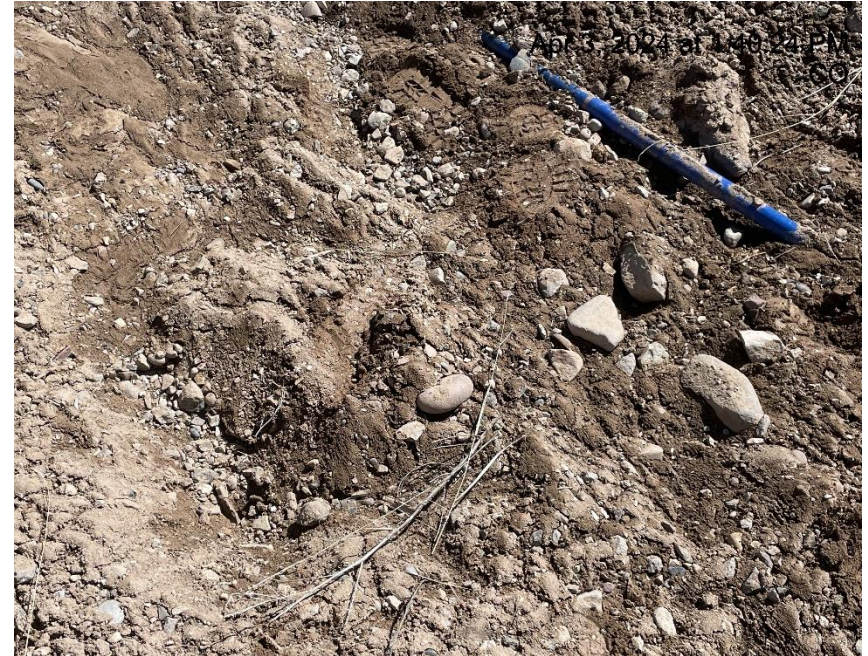
Photo # 2666 Drain/BMP needs maintenance/drain clogged with sediment (drain is near NW corner of location)

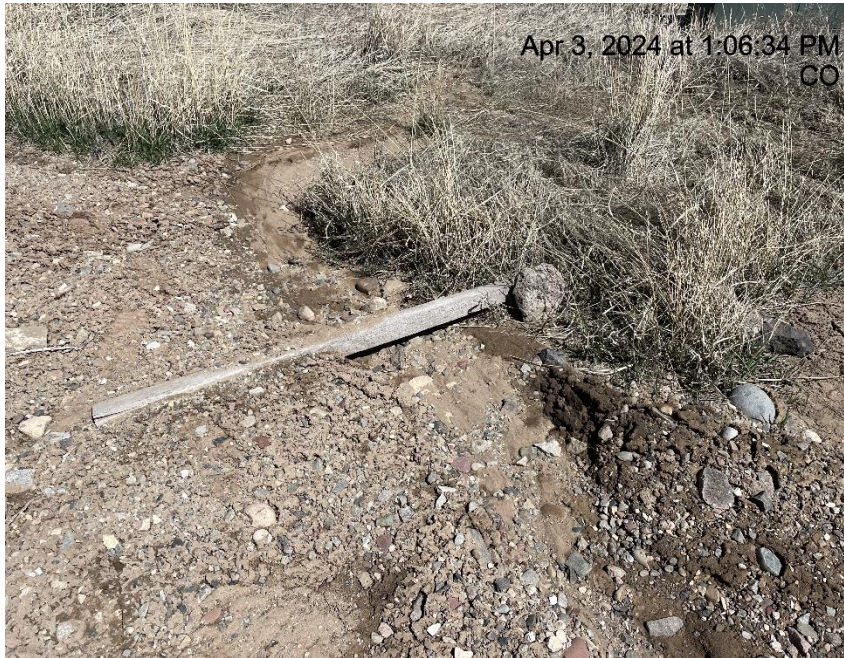
Photo # 2667 Erosion & transport of sediment off location into a vegetated area/sediment choking off vegetation /insufficient BMP's

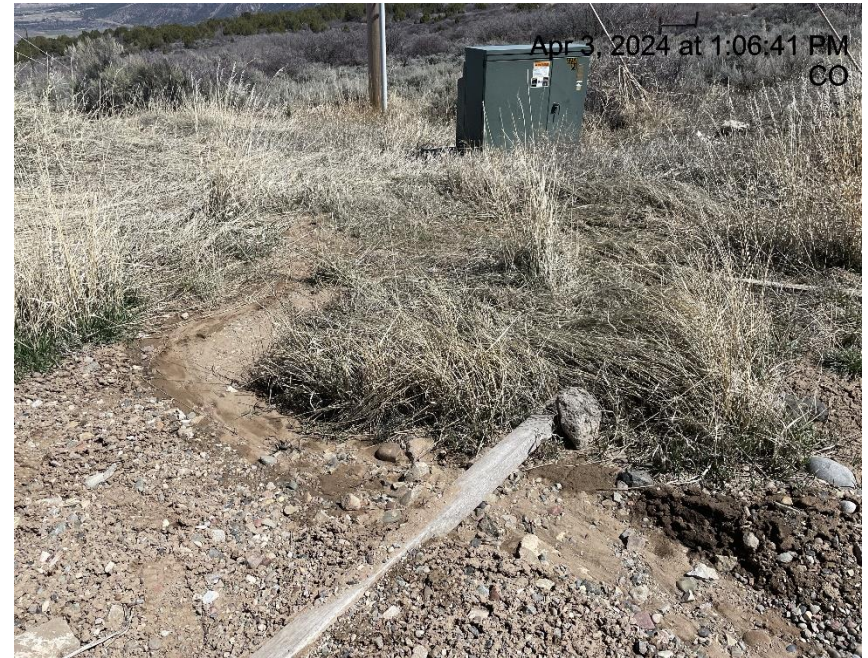
Photo # 2668 Erosion & transport of sediment off location into a vegetated area/sediment choking off vegetation /insufficient BMP's

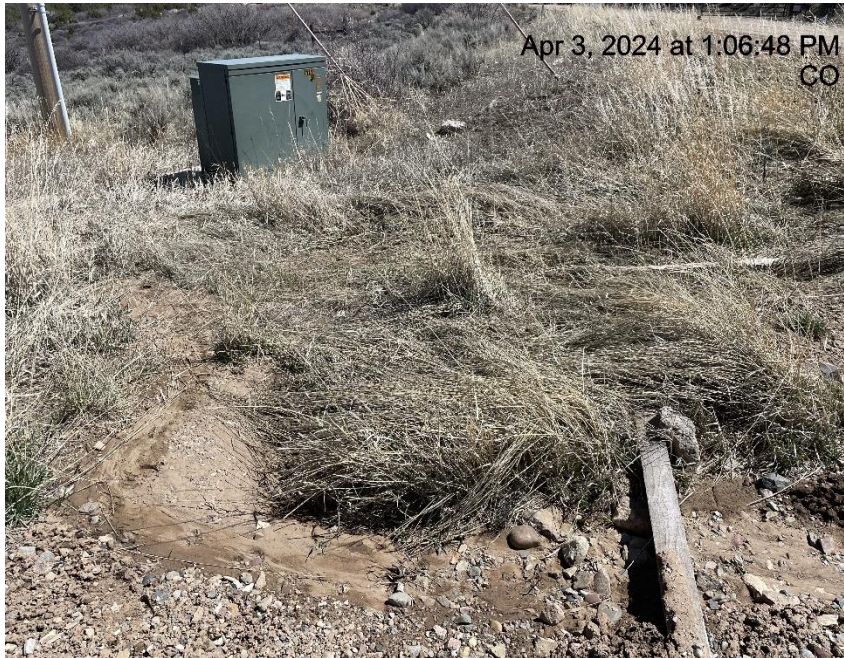
**Photo # 2669 Erosion & transport of sediment off location
into a vegetated area/sediment choking off vegetation
/insufficient BMP's**
