Final Reclamation Inspection

Operator: Arkoma Operations LLC - 10766

Location ID: 311924

Inspection Photos
Location Name: Ige 127, Olson Smith GU 2
Location ID: 311924

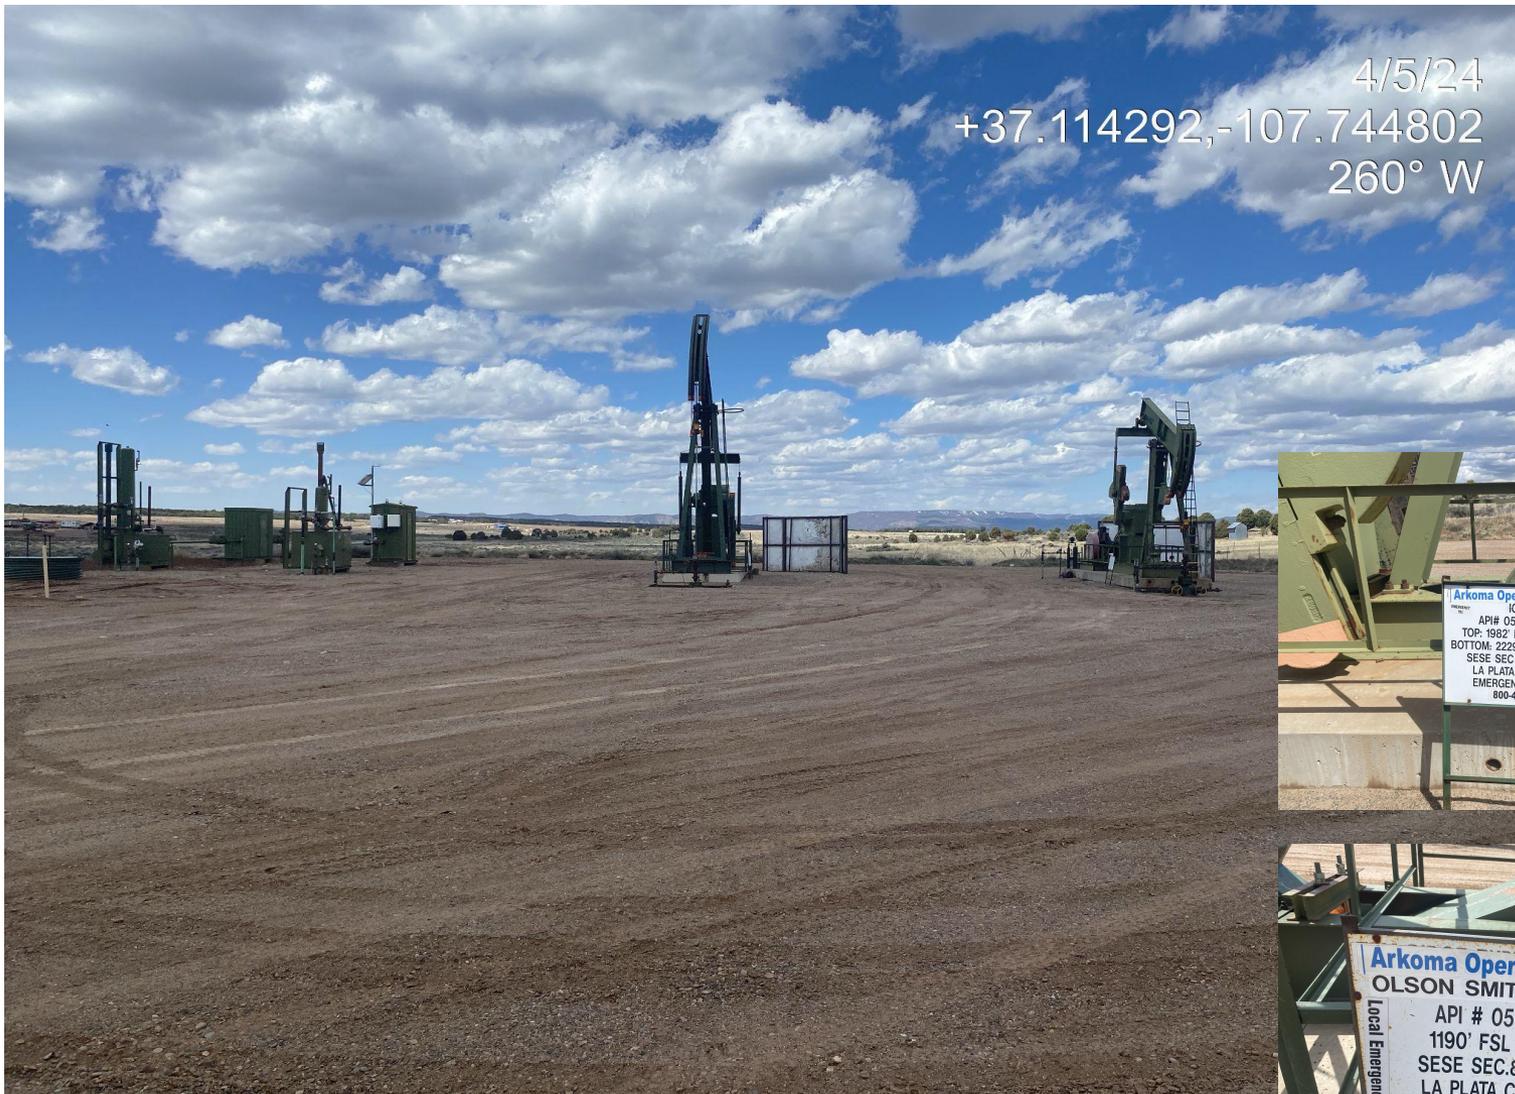
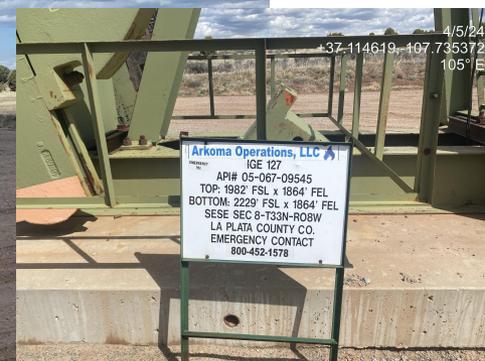
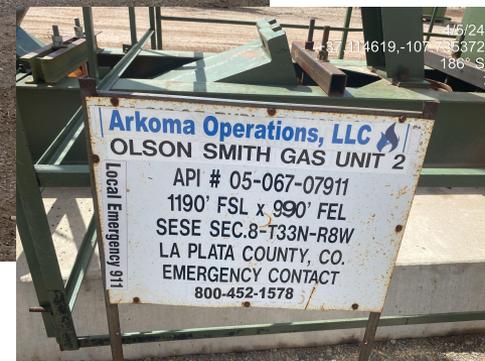
Photo 1. Overview of the well pad disturbance the access point facing center.

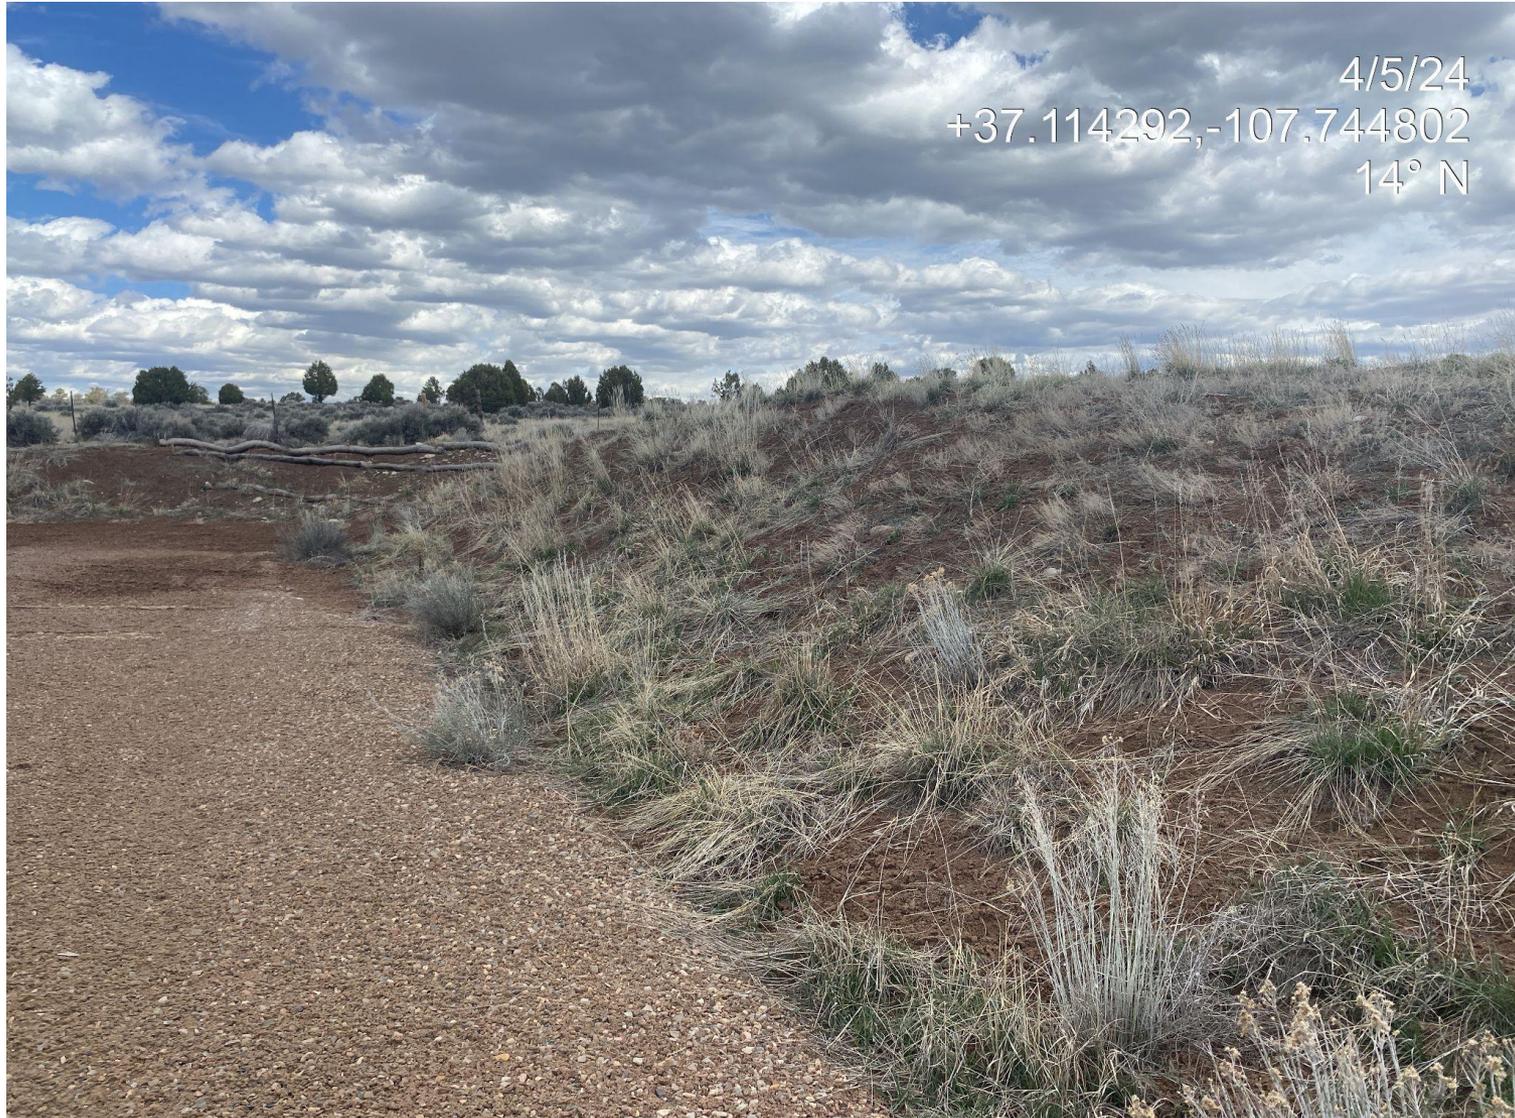
Photo 2. View of the eastern interim reclamation area facing north. Vegetation comprised of smooth brome, crested wheatgrass and rabbitbrush.

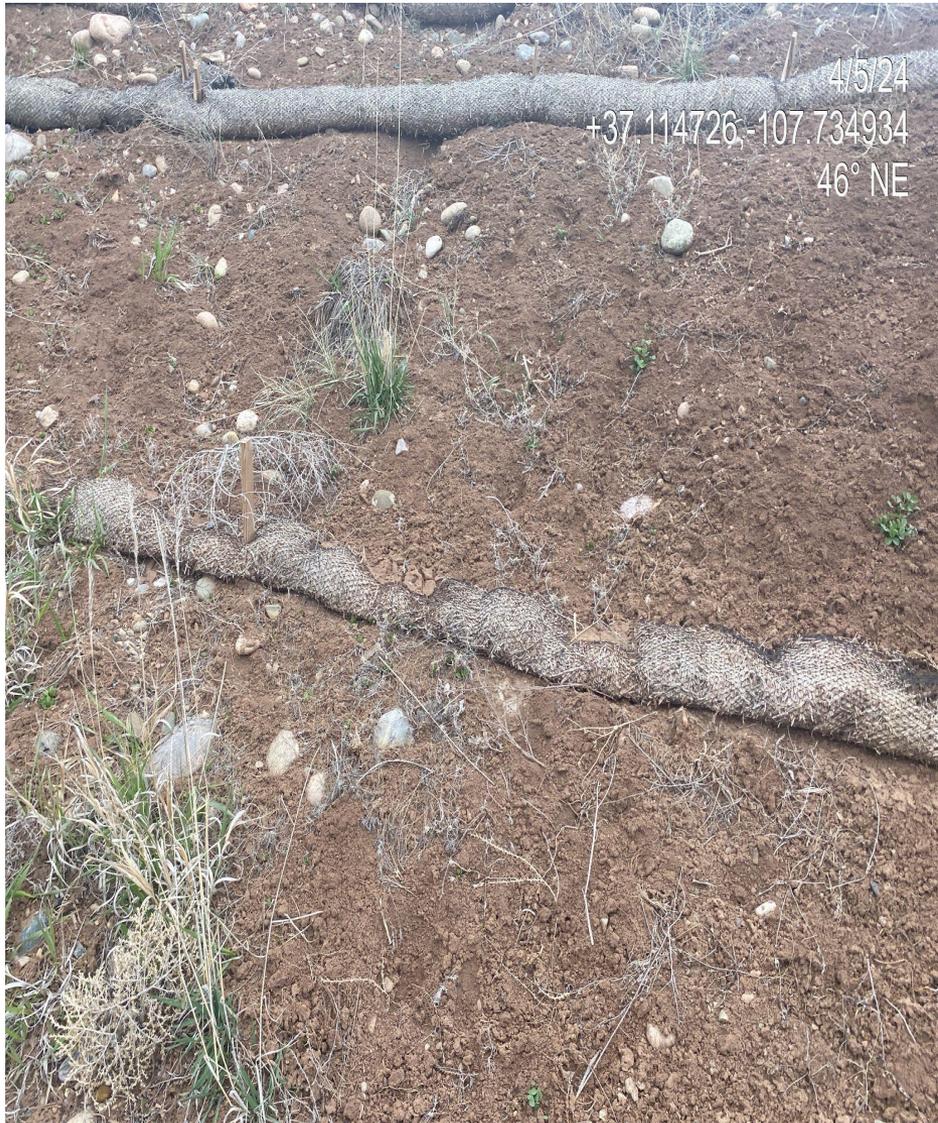
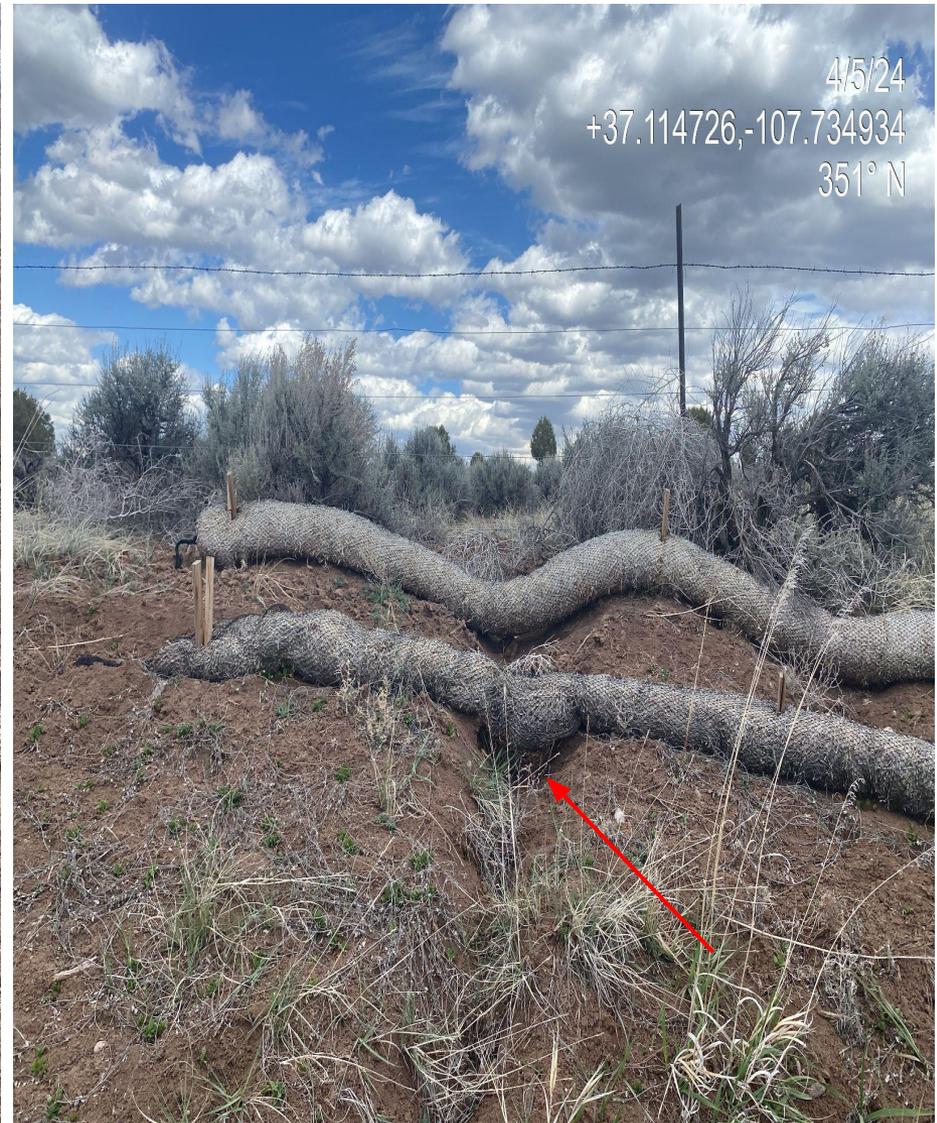
Photo 3. Wattle BMPs in the northeast corner of the disturbance area no longer functioning and need maintenance. Rill erosion forming below installed wattles.

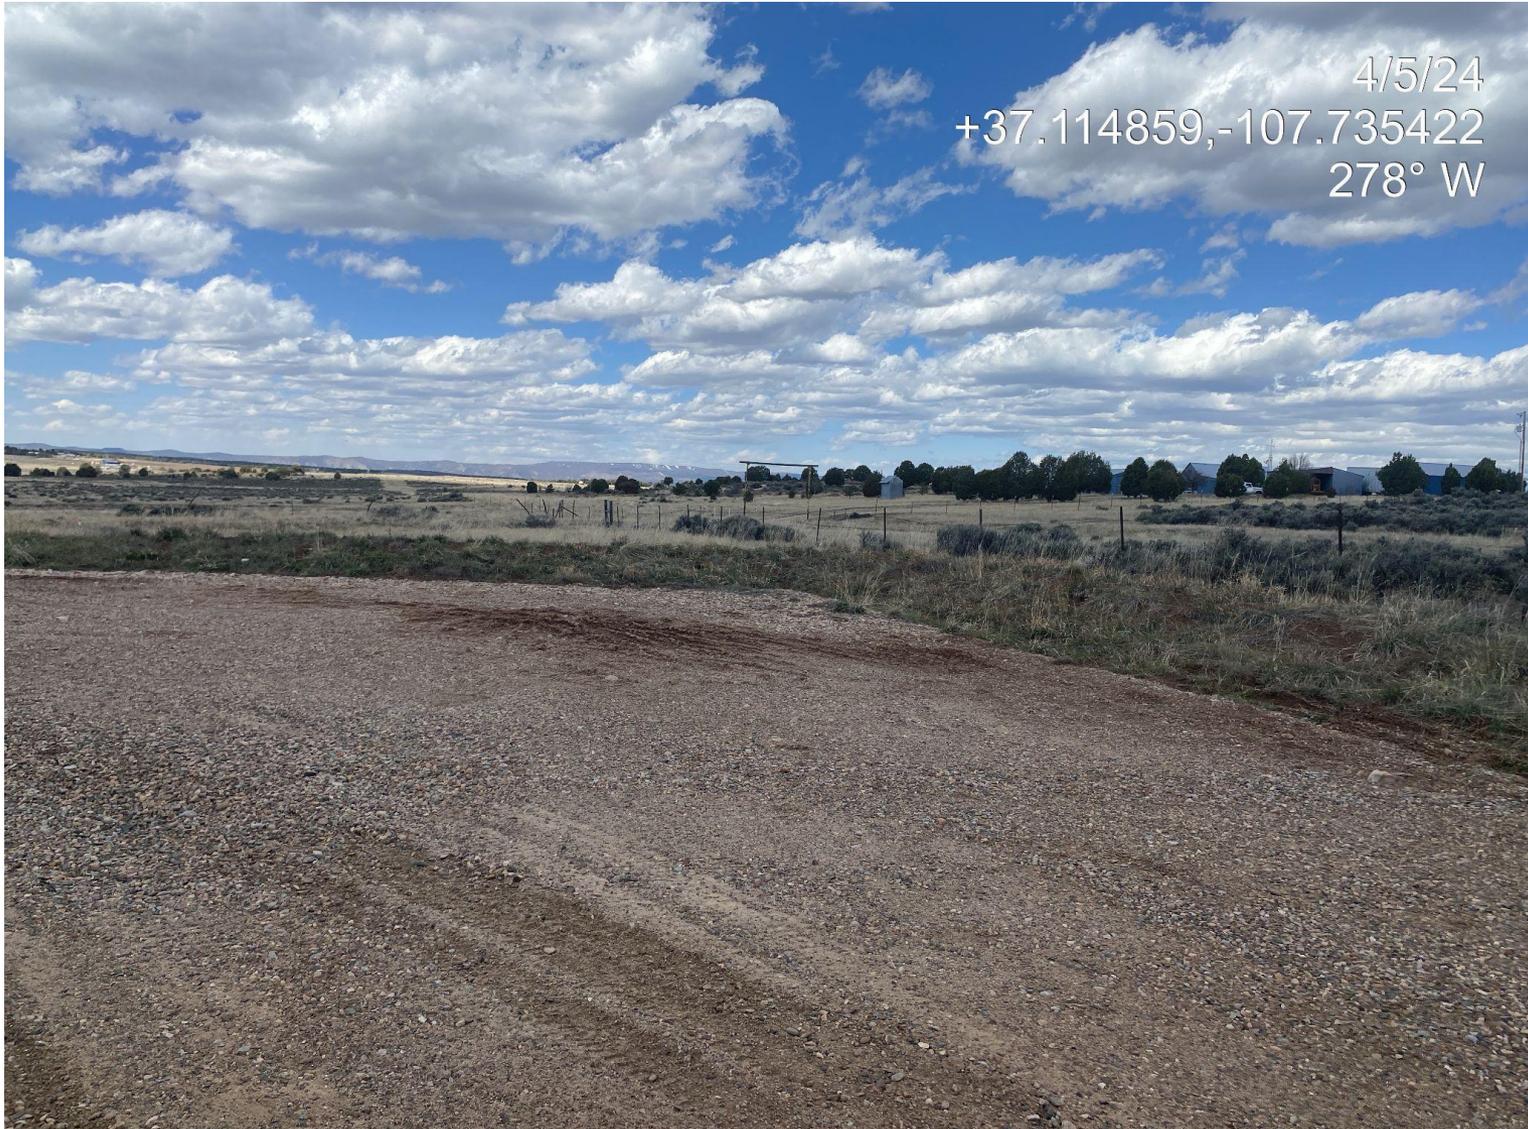
Photo 4. Unused equipment corrective action identified in the previous inspection doc #702500775 has been addressed/resolved.

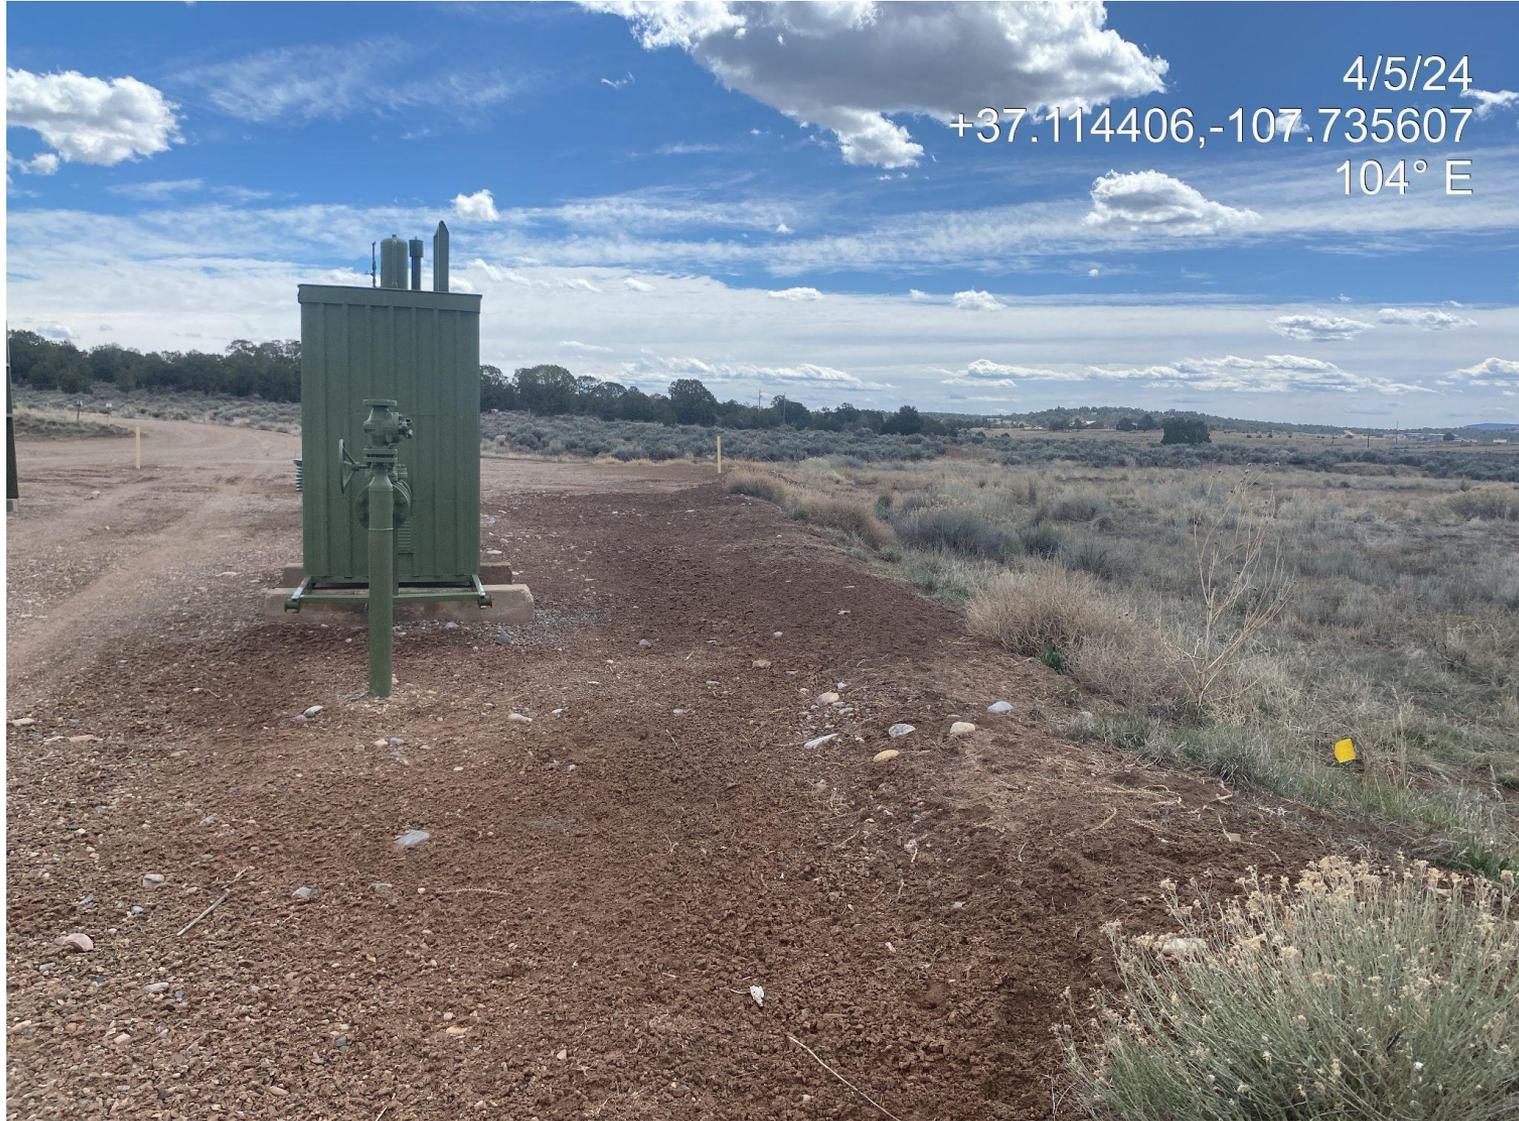
Photo 5. Weed corrective action identified in the previous inspection doc #702500775 has been addressed/resolved.

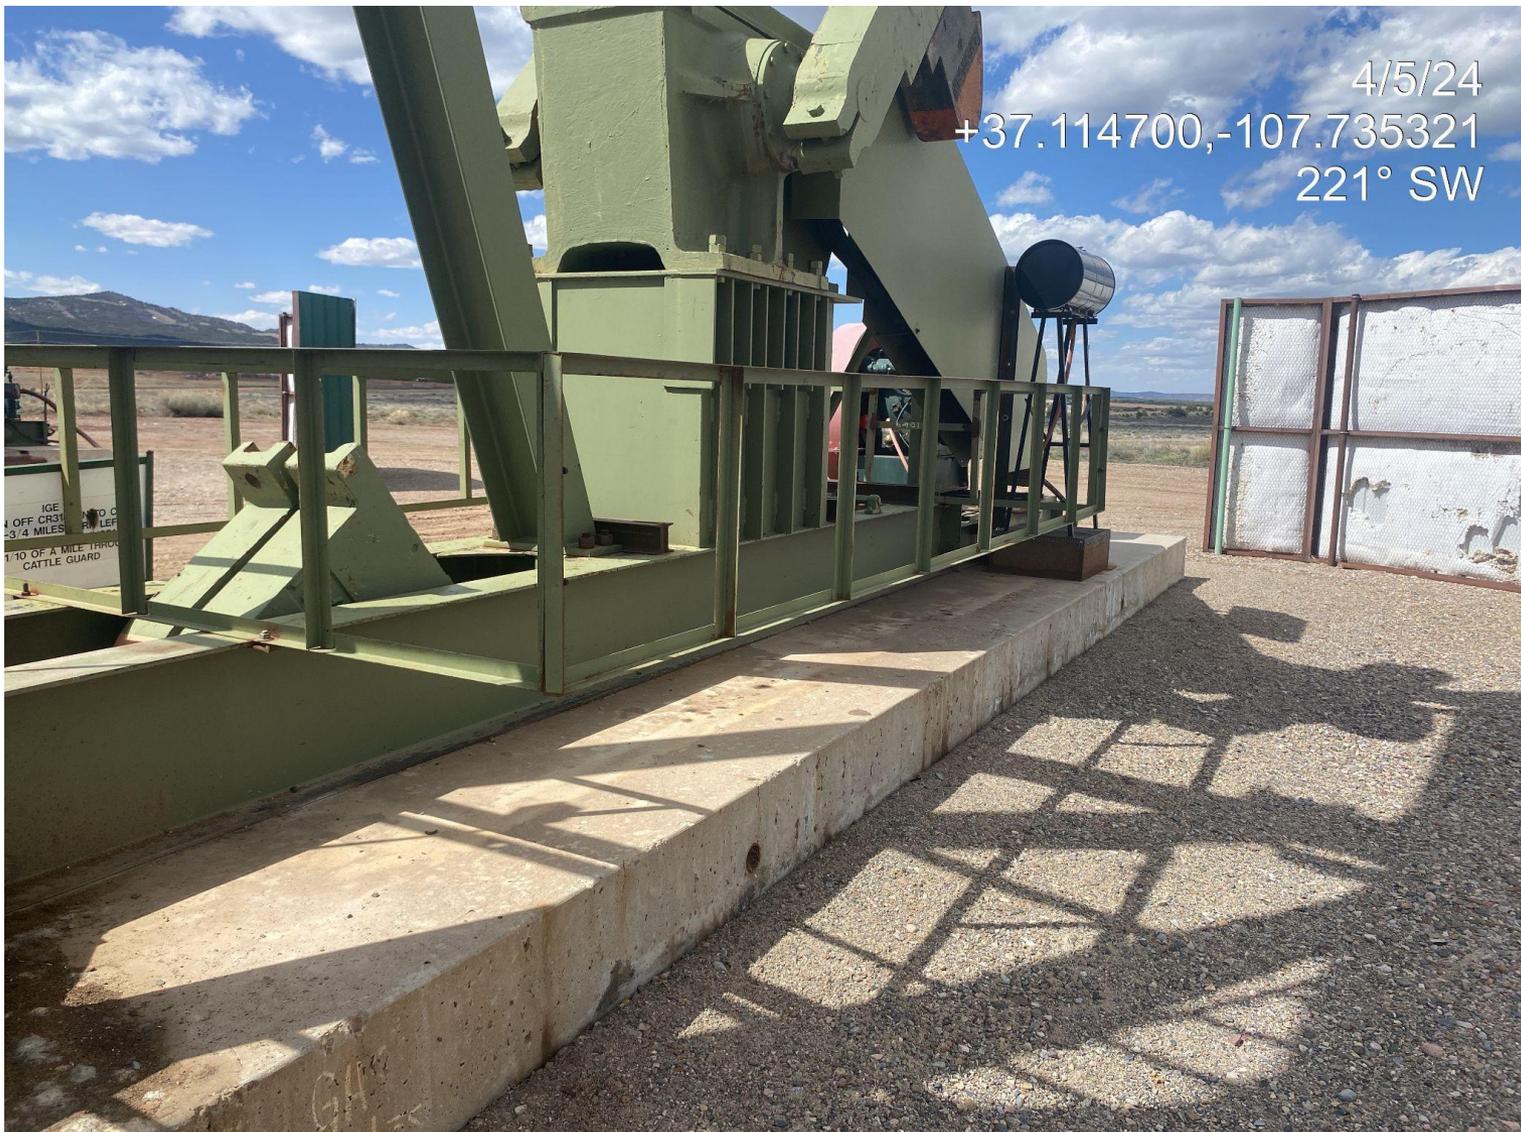
Photo 6. Impacted surface material corrective action identified in the previous inspection doc #702500775 has been addressed/resolved.

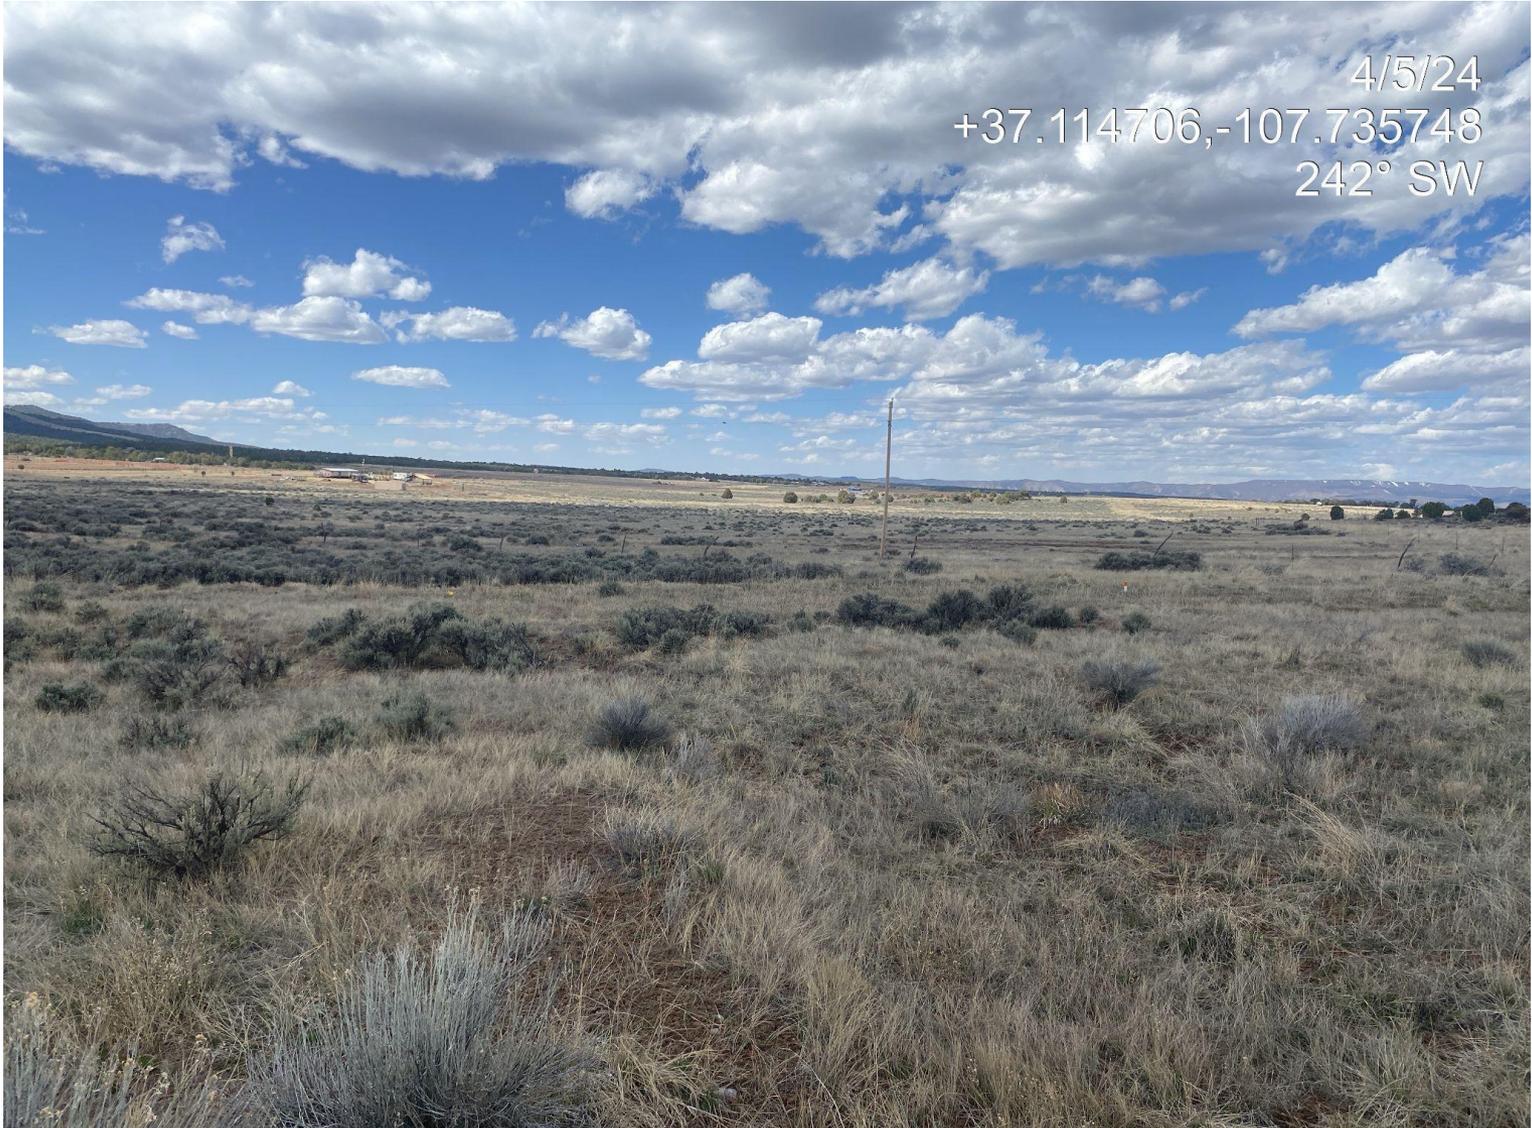
Photo 7. Reference area comprised of crested wheatgrass and sagebrush.
