Inspection Photos

Operator: LARAMIE ENERGY LLC 10433

Location ID: 312625

Inspection Doc: 696205730

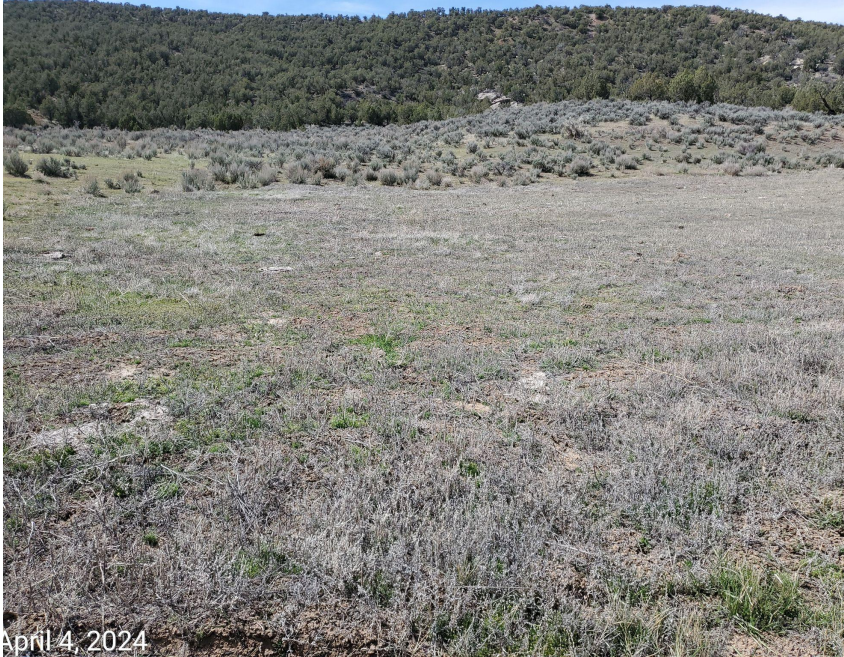
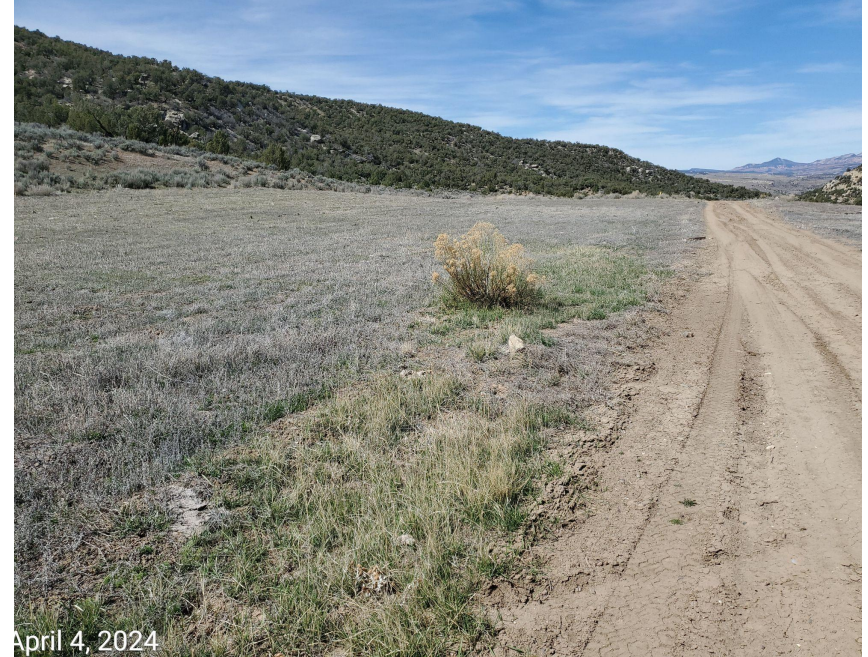
Photo 1: Photos 1-2 taken from the east end of the Location. Photos provide an overview of the Location from south, southwest, northwest to west.

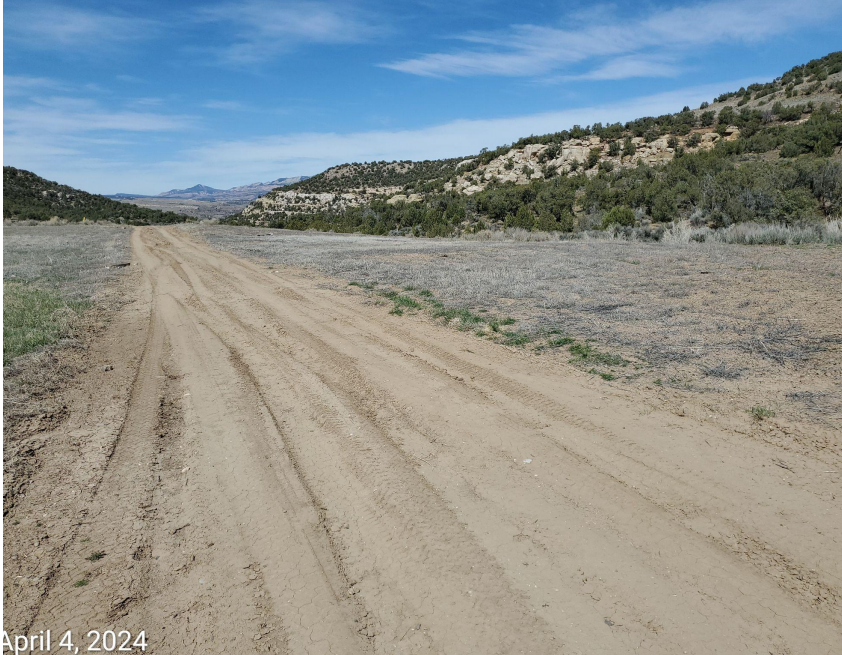
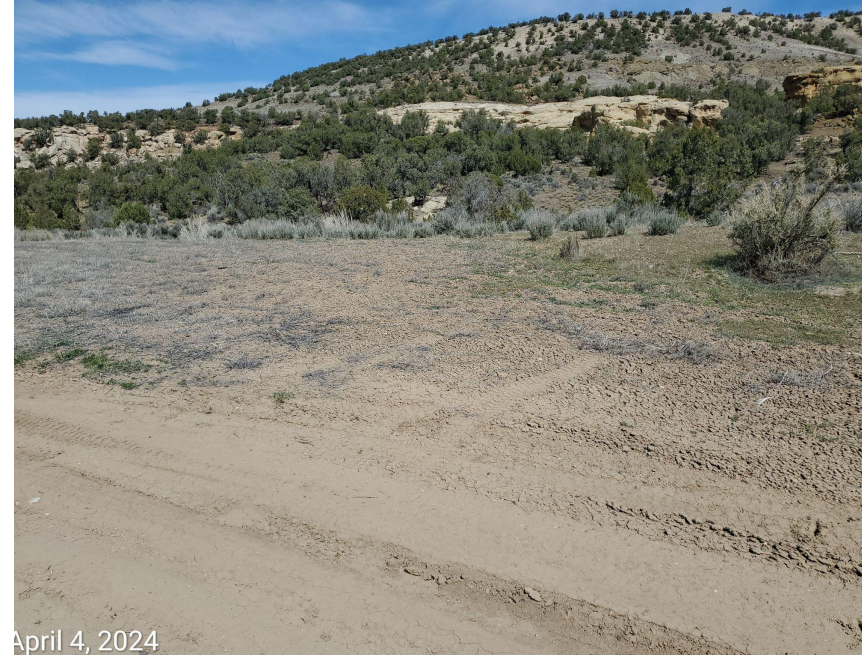
Photo 2: See comments under photo 1.

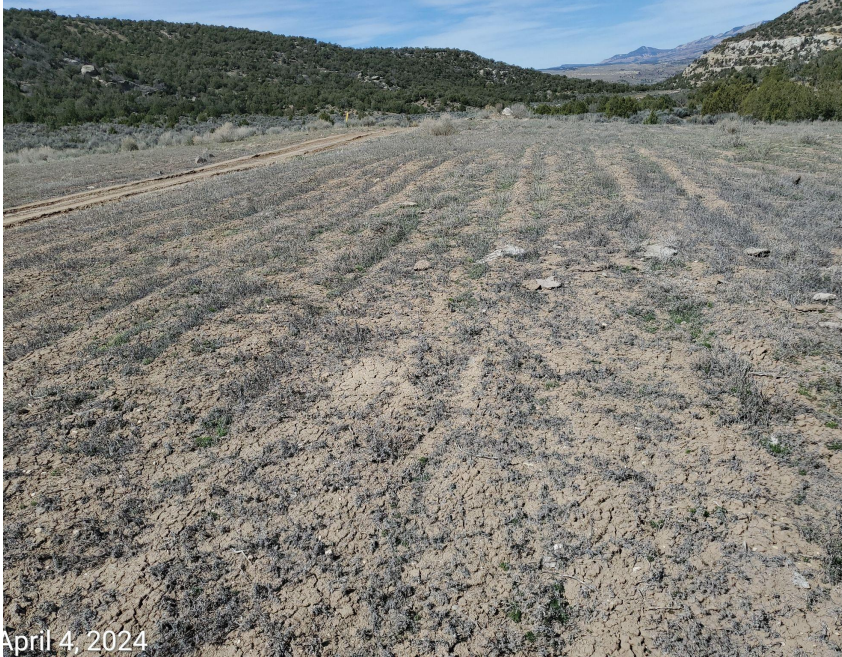
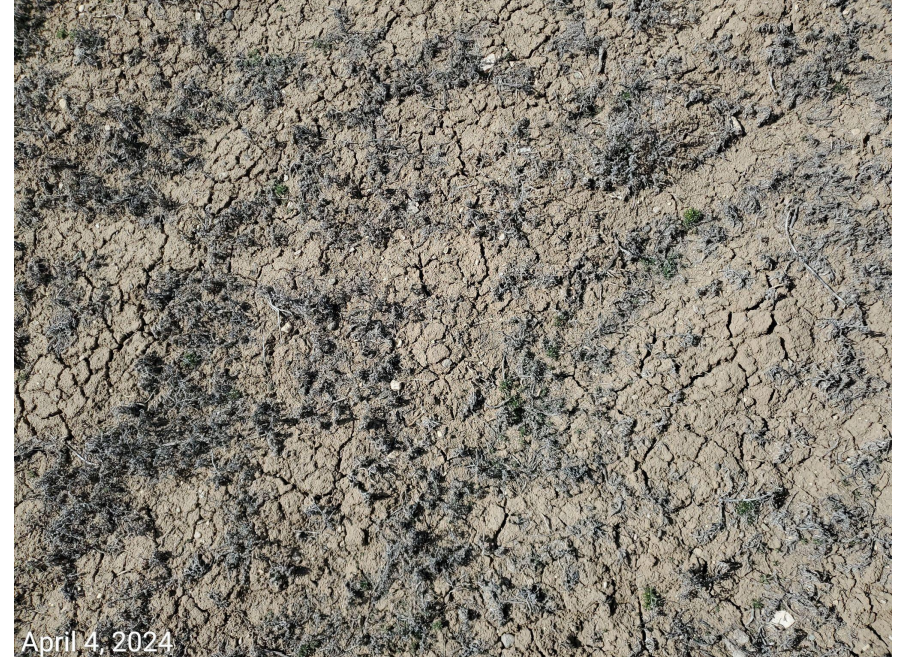
Photo 4: Photo taken from the north end of the Location, facing west. Desirable perennial vegetative establishment throughout the Location is sparse, and not progressing towards ECMC uniform standards.

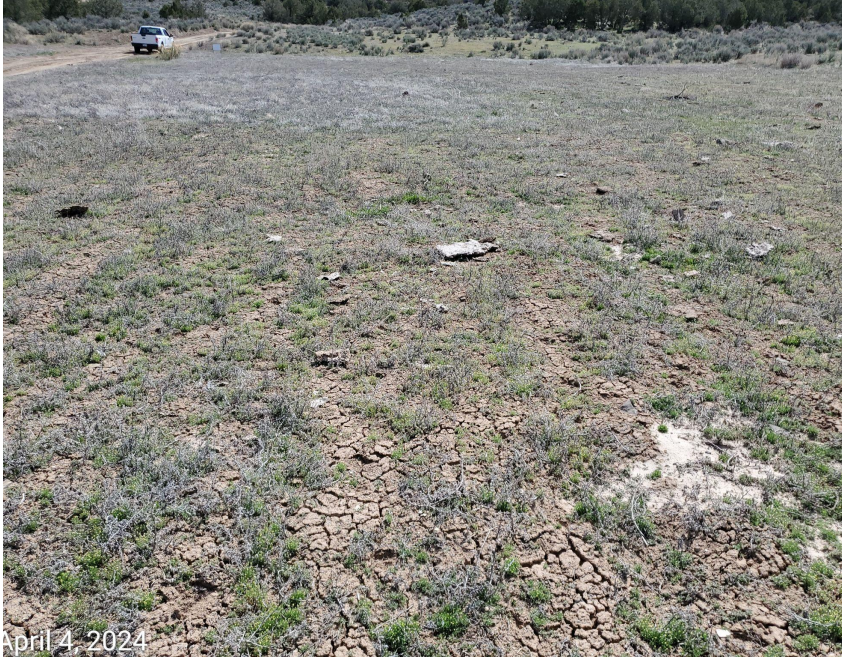
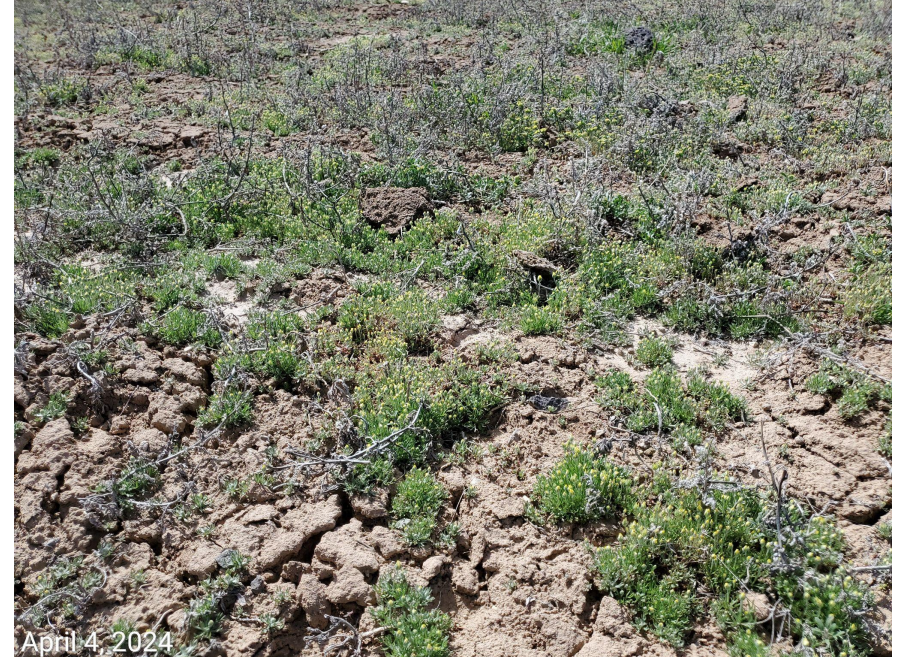
Photo 5: Photo taken from the south end of the Location, facing east. Desirable perennial vegetative establishment throughout the Location is sparse, and not progressing towards ECMC uniform standards. Green vegetation within the photos are predominantly annual forbs, such as *Ranunculus testiculatus*.

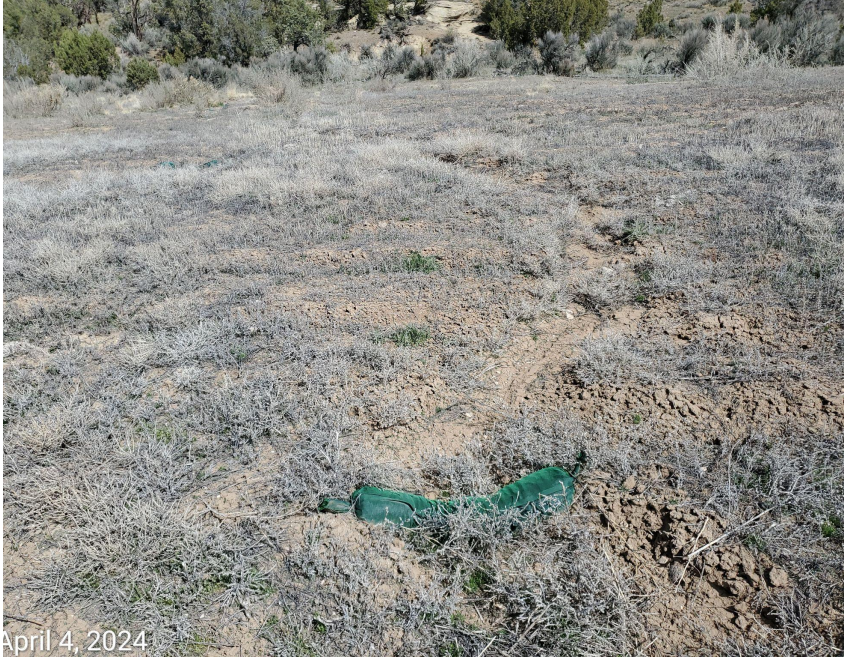
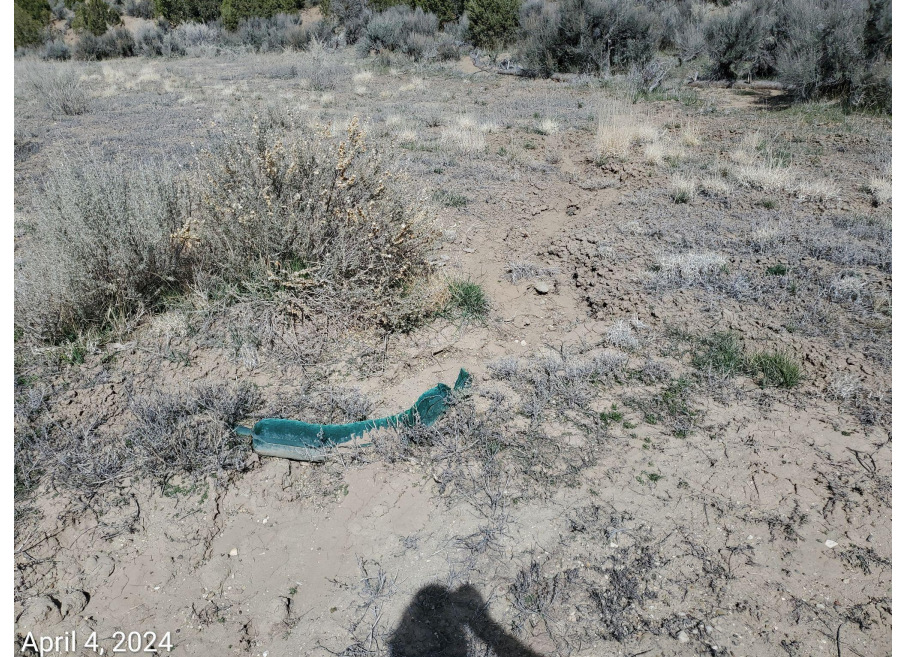
Photo 6: Photo taken from the northeast end of the Location. Runoff on the north end of the Location is resulting in a gully. Operator appears to have previously placed rock socks within the channel. BMP alone is inadequate to manage runoff and allow for proper stormwater discharge.

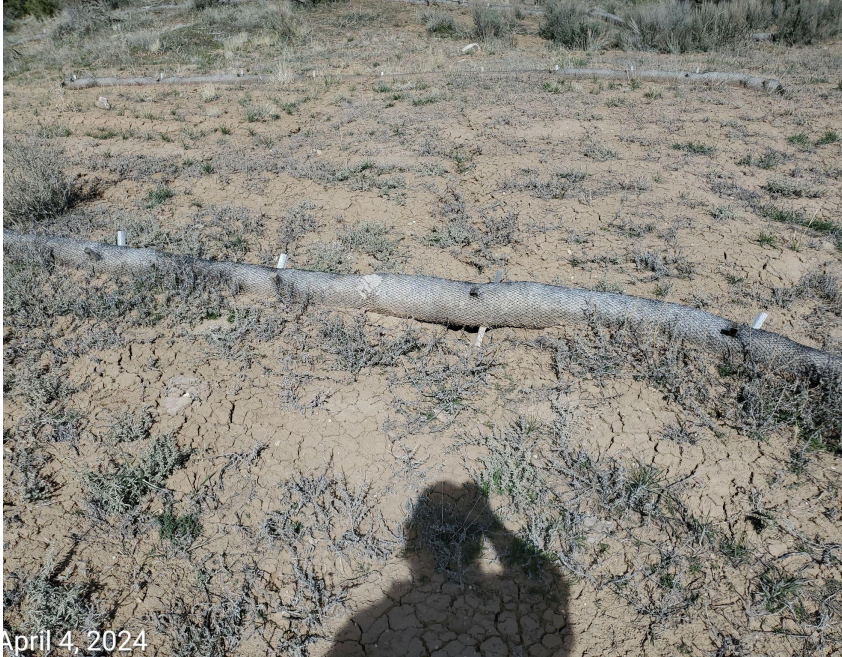
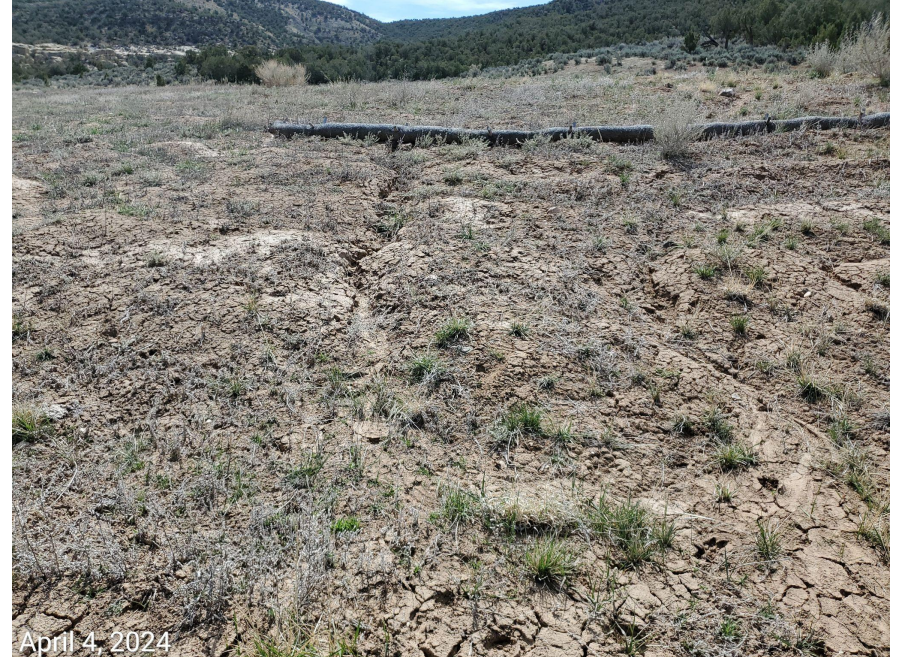
Photo 7: Photo taken from the northwest end of the Location. Photo example showing erosion logs have not been maintained in proper functioning condition. No other BMPs in conjunction with erosion logs observed. Erosion degradation evident.
