Storm Water Management and Erosion control
Location Name: TEP ROCKY MOUNTAIN LLC PA 24-26 Pad
Location ID: 324192

**Location Overview: Location is within High Priority/Density
Habitat areas.**

Section/Township/Range: 26 6S95W

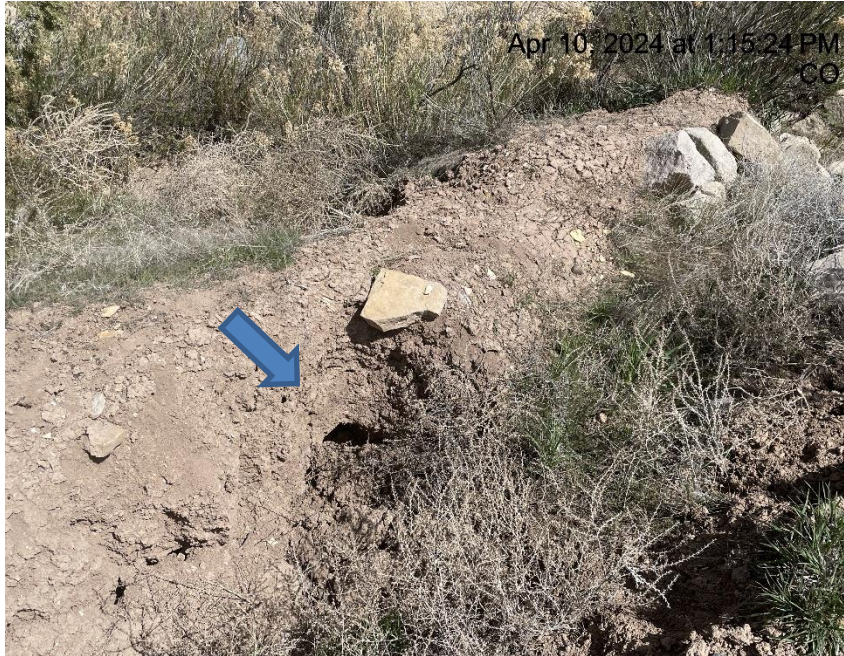
Photo # 3464 Tunnel erosion in ditch/BMP needs maintenance (ditch is near sediment trap along lease road approximately 70 yards from entrance to location)

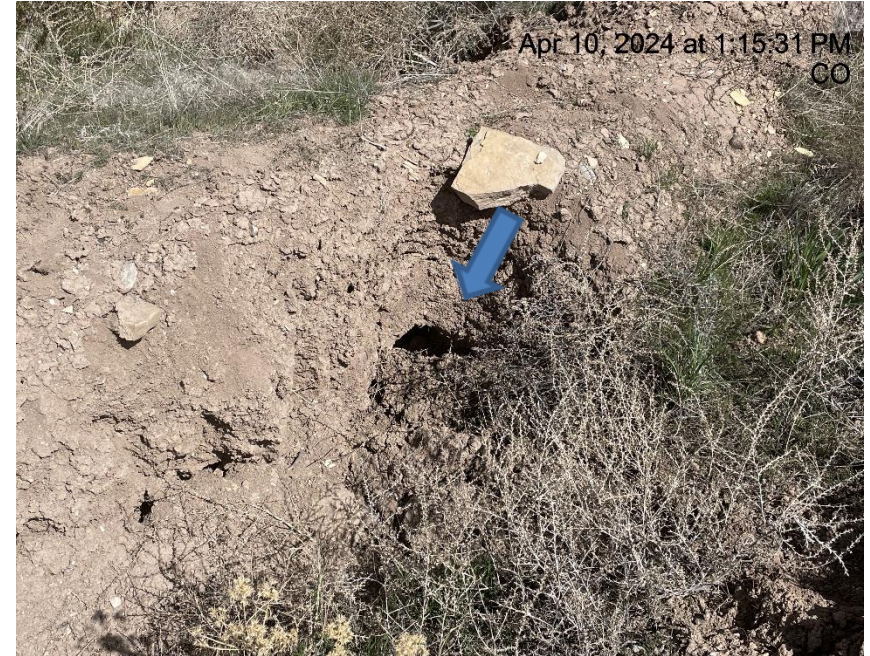
Photo # 3465 Tunnel erosion in ditch/BMP needs maintenance (ditch is near sediment trap along lease road approximately 70 yards from entrance to location)

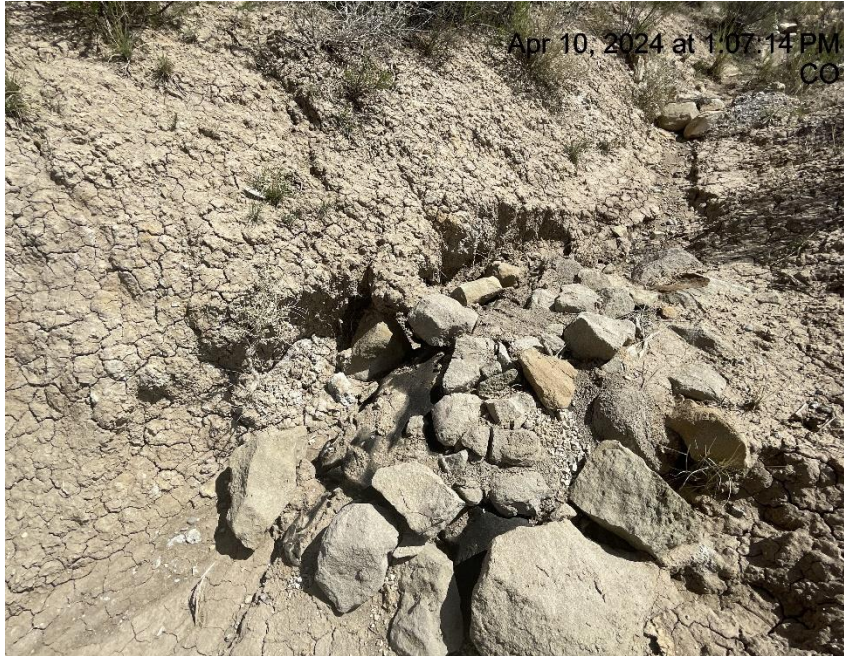
Photo # 3466 Rip Rap/BMP on sediment trap inlet needs maintenance - stormwater is cutting/eroding around edge of Rip Rap. (N/NW area of location)

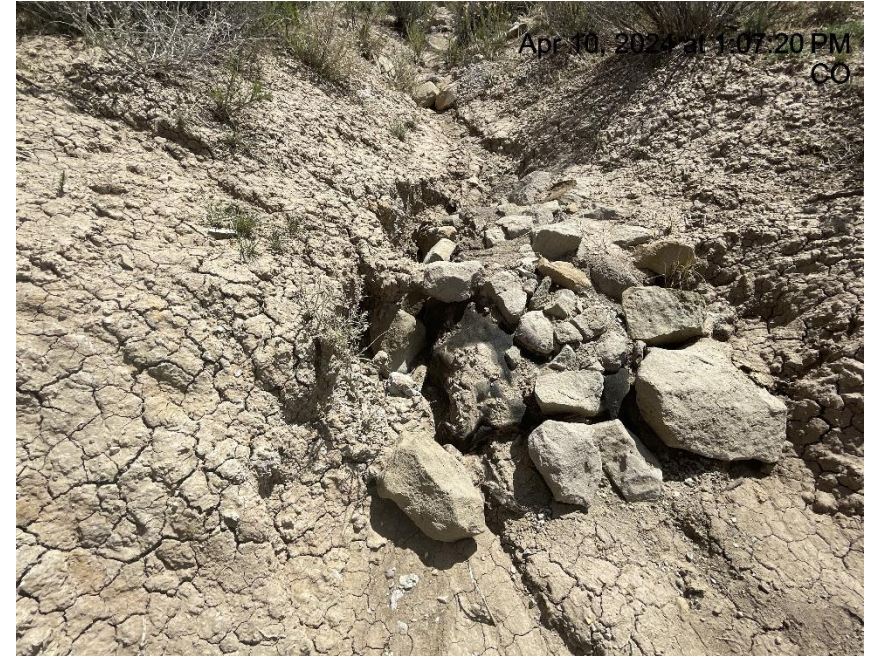
Photo # 3467 Rip Rap/BMP on sediment trap inlet needs maintenance - stormwater is cutting/eroding around edge of Rip Rap. (N/NW area of location)
