# Final Reclamation and Stormwater Inspection

Operator: PDC ENERGY INC - 327116

Inspection Document #: 708201188

Inspection Photos  
Location Name: Law 44-12  
Location ID: 327116

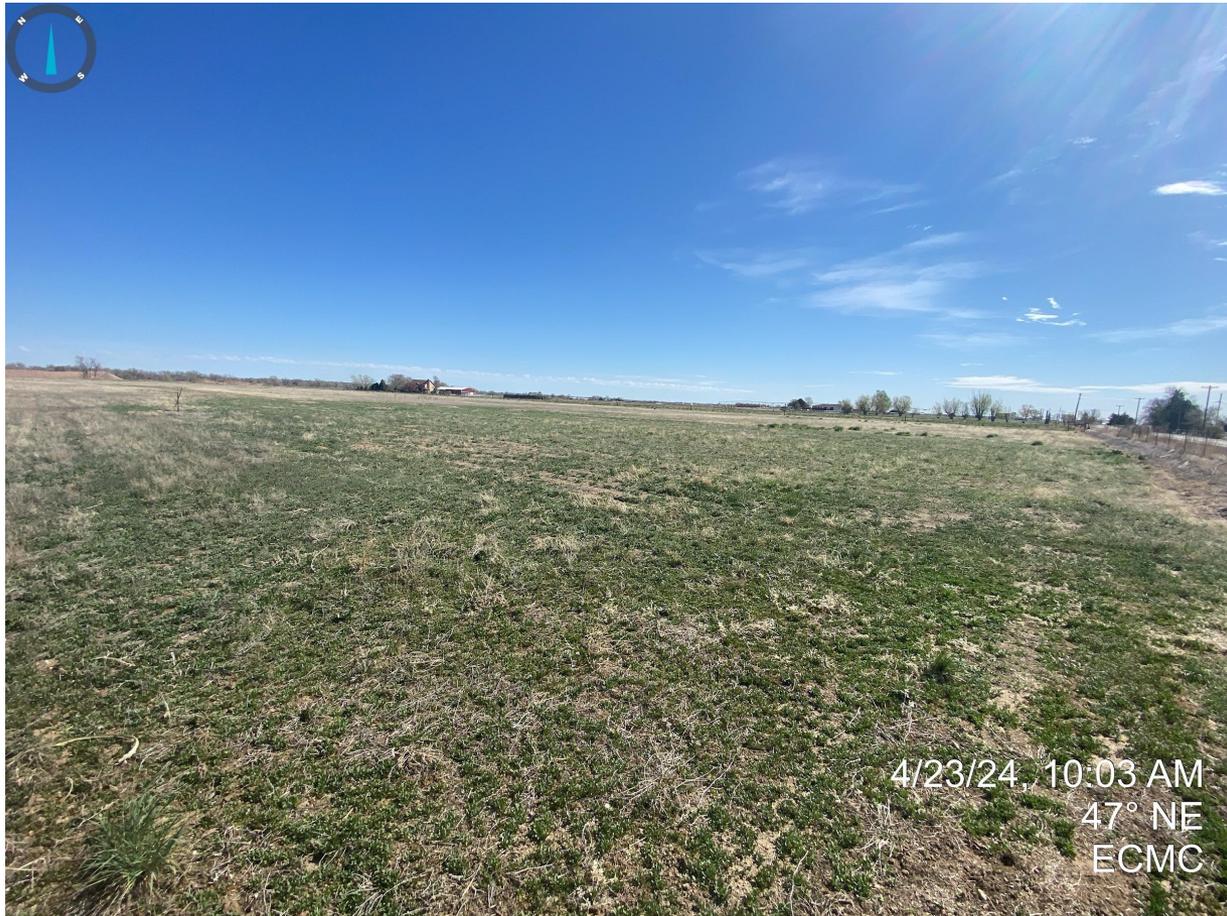
**Photo 1.** Taken from the western portion of the former tank battery. The reclaimed areas are predominantly undesirable vegetation including kochia, purple mustard and CO List C Noxious weed - puncturevine.

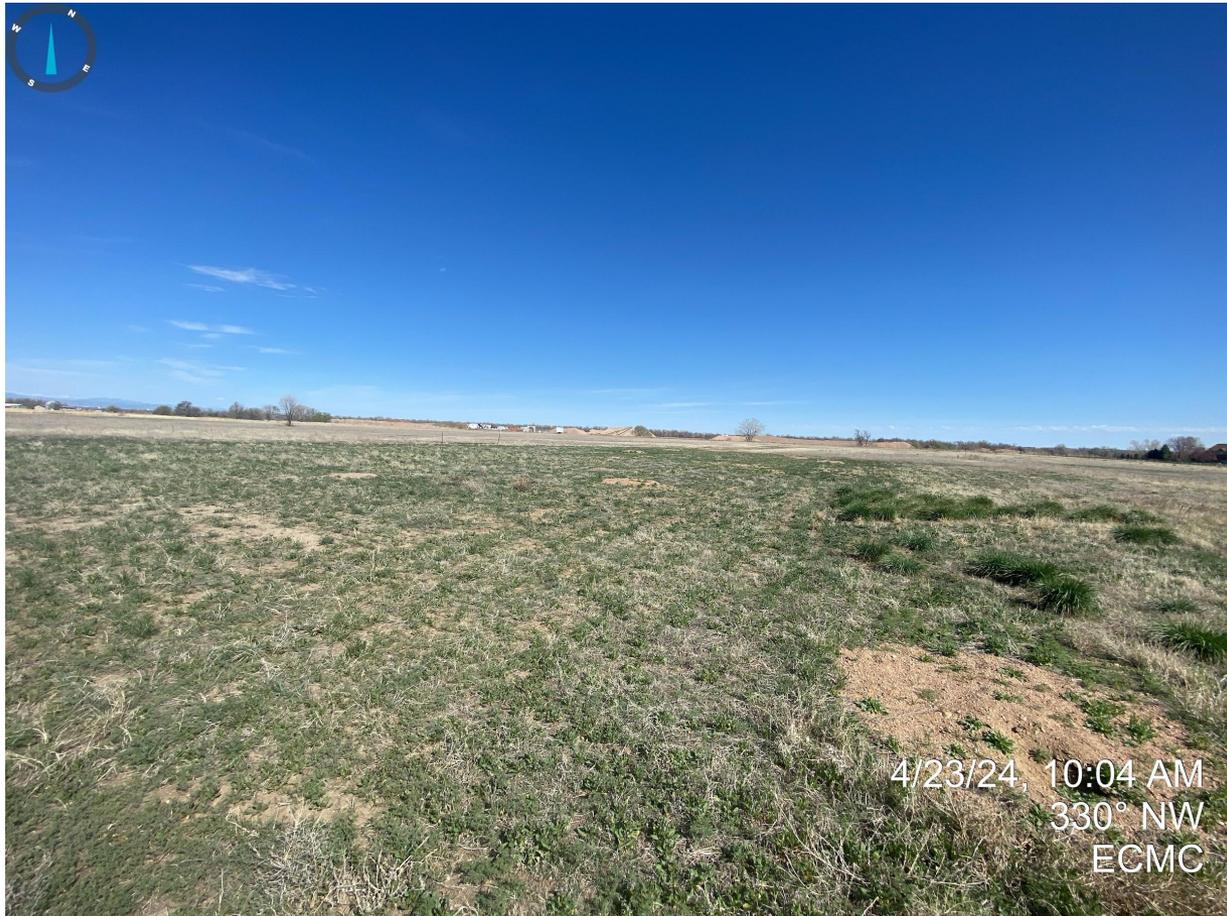
**Photo 2.** Taken from the eastern portion of the former tank battery; see comments in Photo 1.

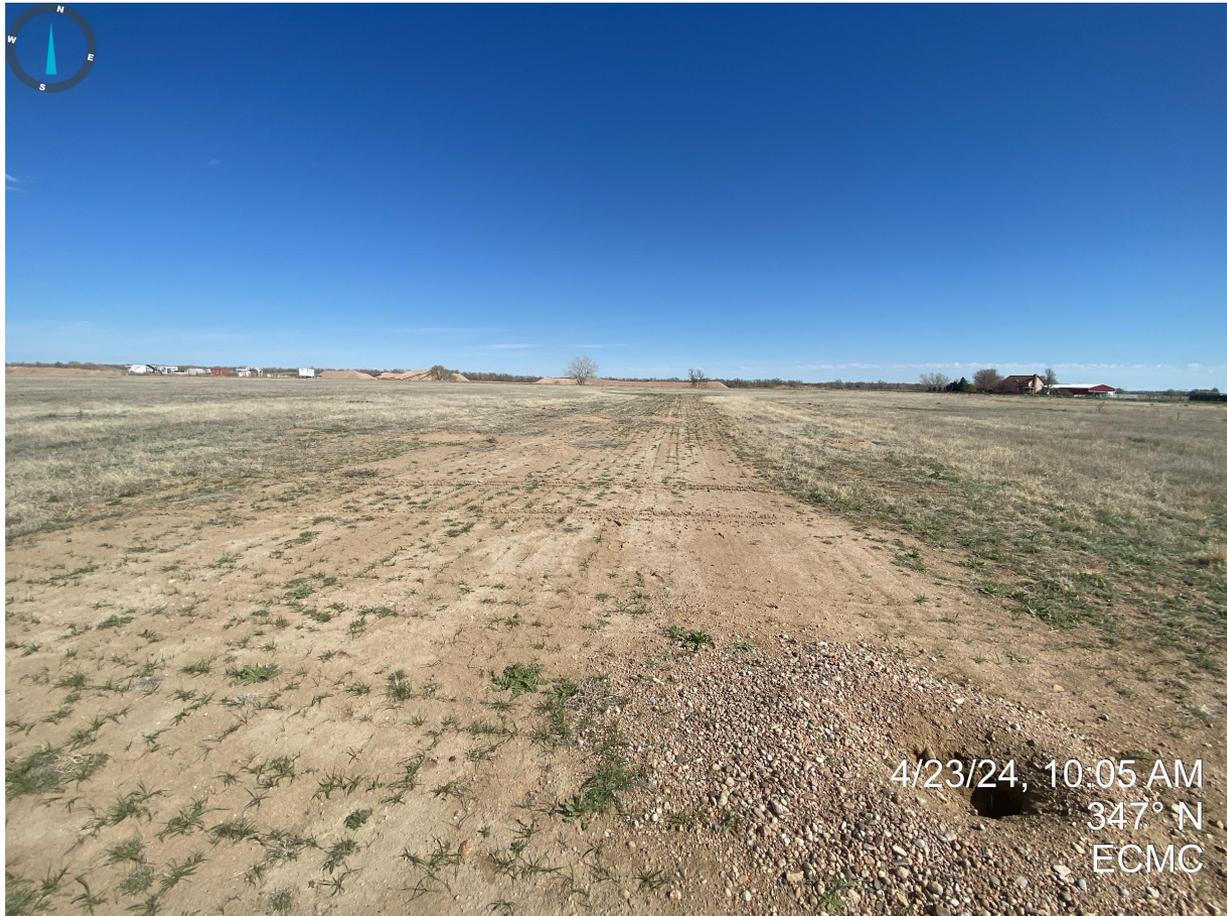
**Photo 3.** Taken along the access road from the tank battery to the well location. While it appears the area has been recently drill seeded, non-uniform vegetation cover (bare soils) and gravel remain.

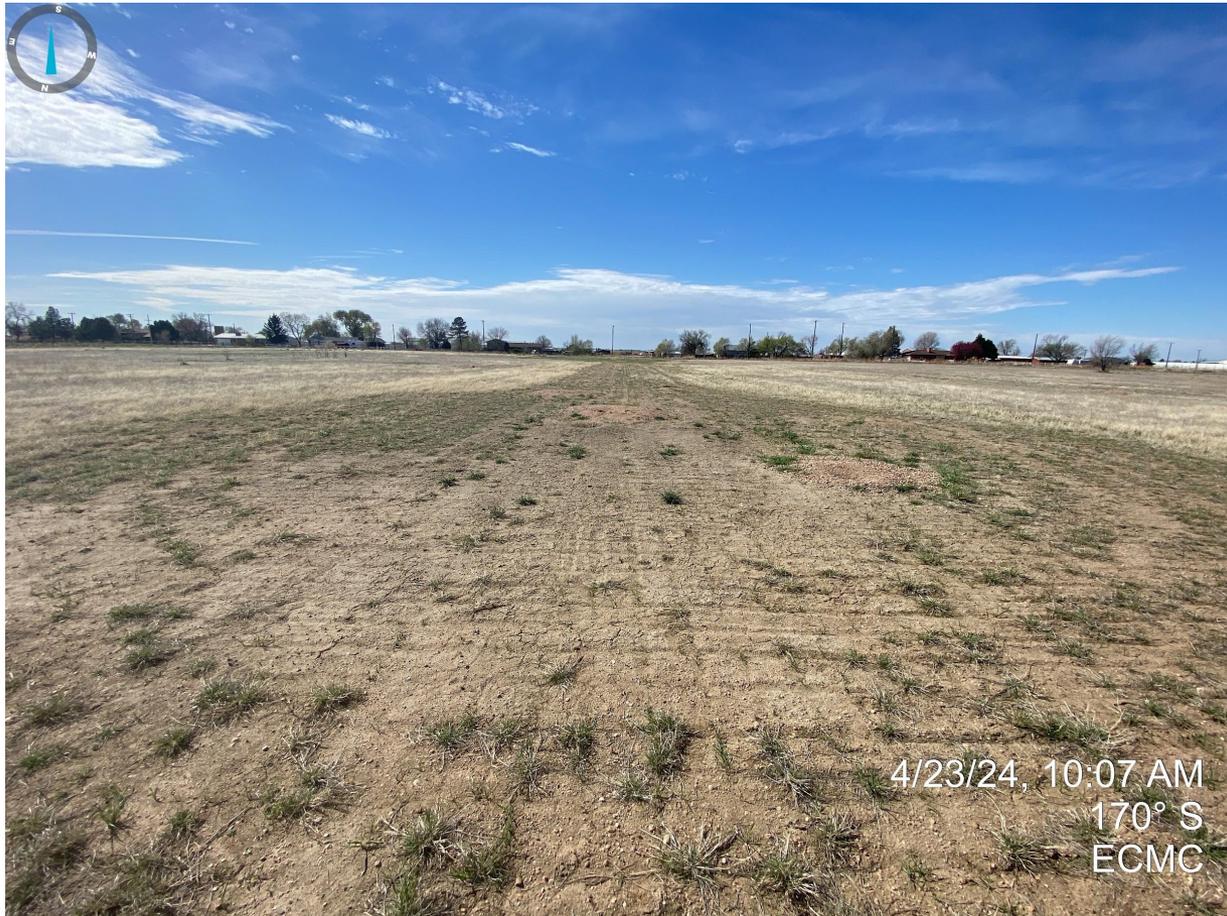
**Photo 4.** Facing south from the former well location; see comments in Photo 3.

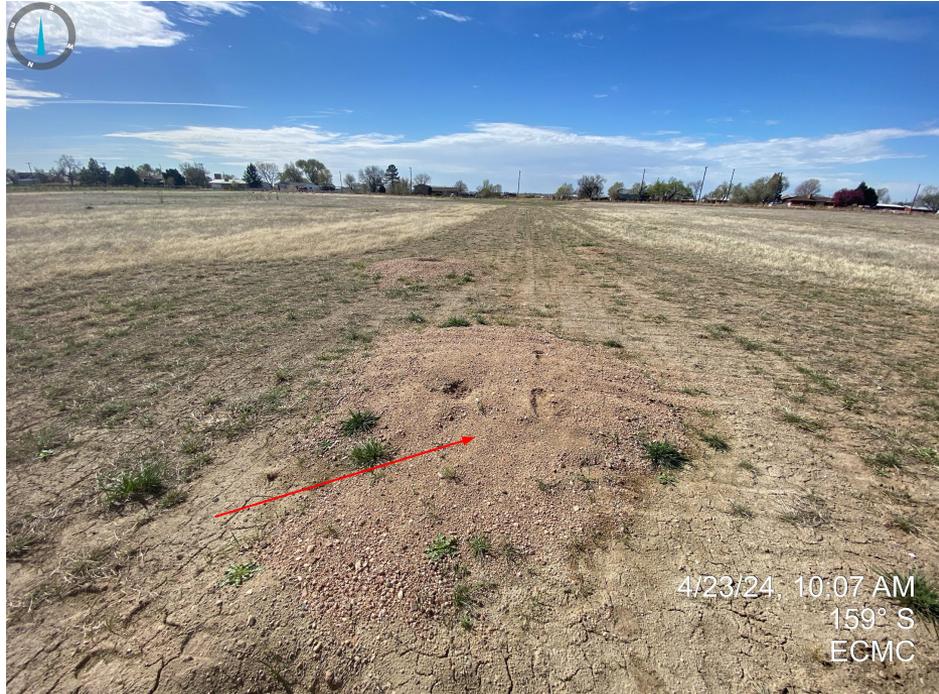
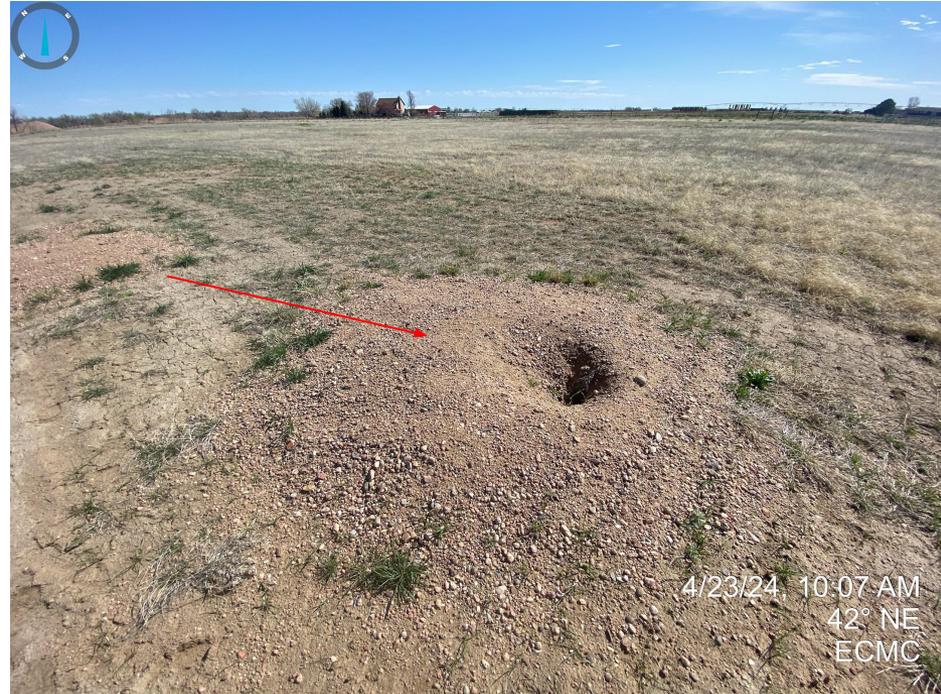
**Photos 5 & 6.** Gravel/road base remains on location and appears to have been dug up through animal burrowing.

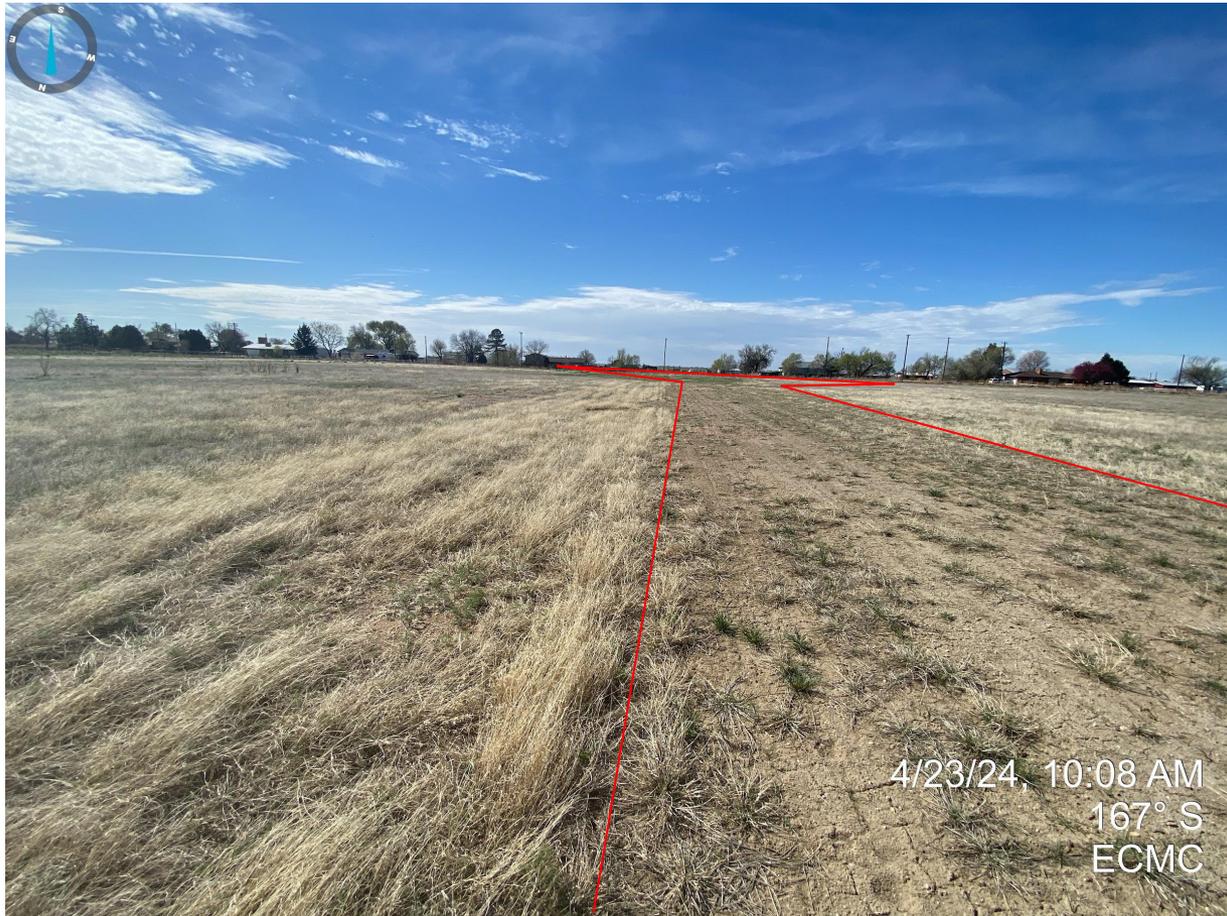
**Photo 7.** Former tank battery and access road outlined in red. Adjacent reference area pictured left and right of outline.
