Inspection Photos

API: 071-07981

Operator: EVERGREEN NATURAL
RESOURCES LLC

Inspection Date: 4/24/2024

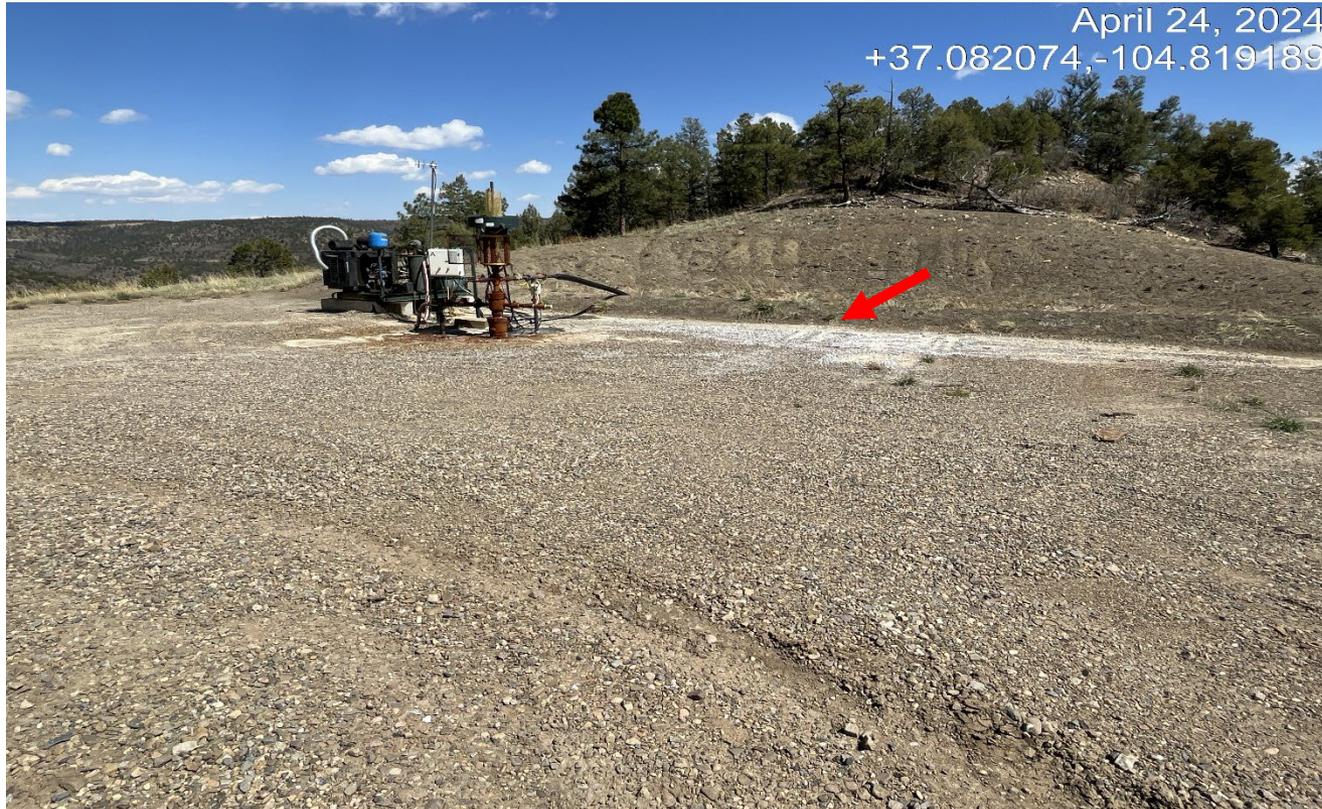
Photo 1. Facing northeast toward the wellsite. There was a leak at the wellhead that left a white residue.

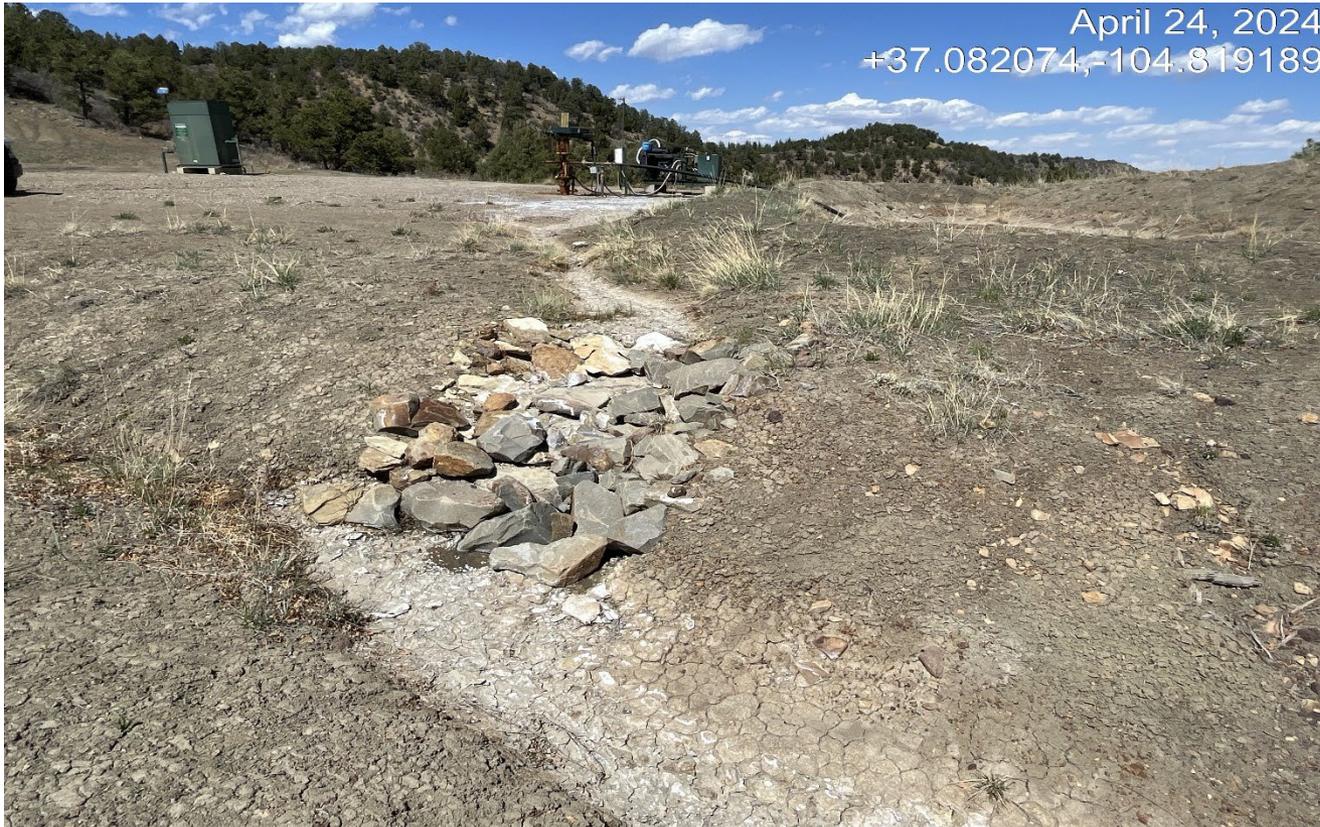
Photo 2. South side of the location facing north. There is white residue and wet soils that flowed off location at this area. th

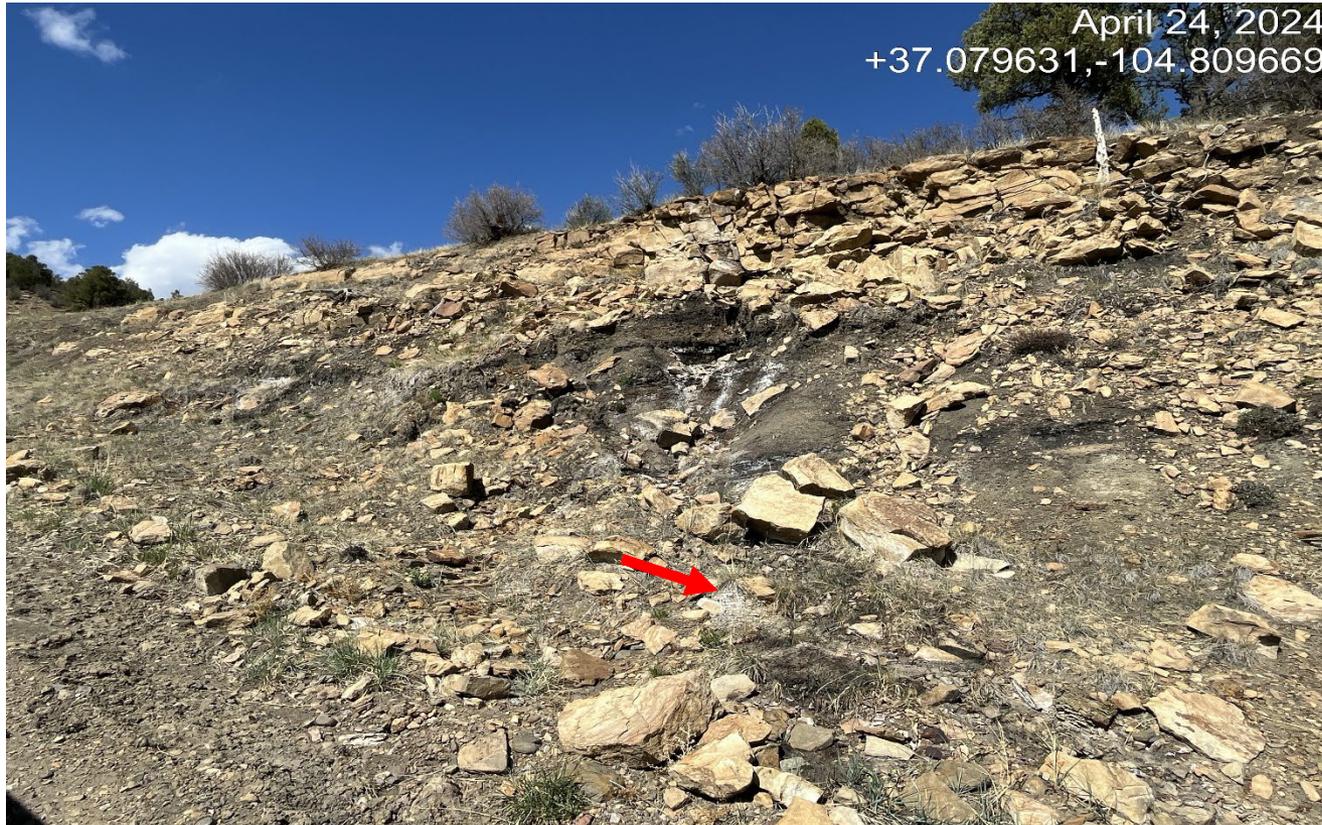
Photo 3. There are signs that produced water flowed off the location to the main road. Red arrow points to wet and white residue.
