Stormwater Inspection

Operator: KP KAUFFMAN COMPANY INC - 46290

Location ID: 324591

Inspection Photos
Location Name: DWINELL 1
Location ID: 324591

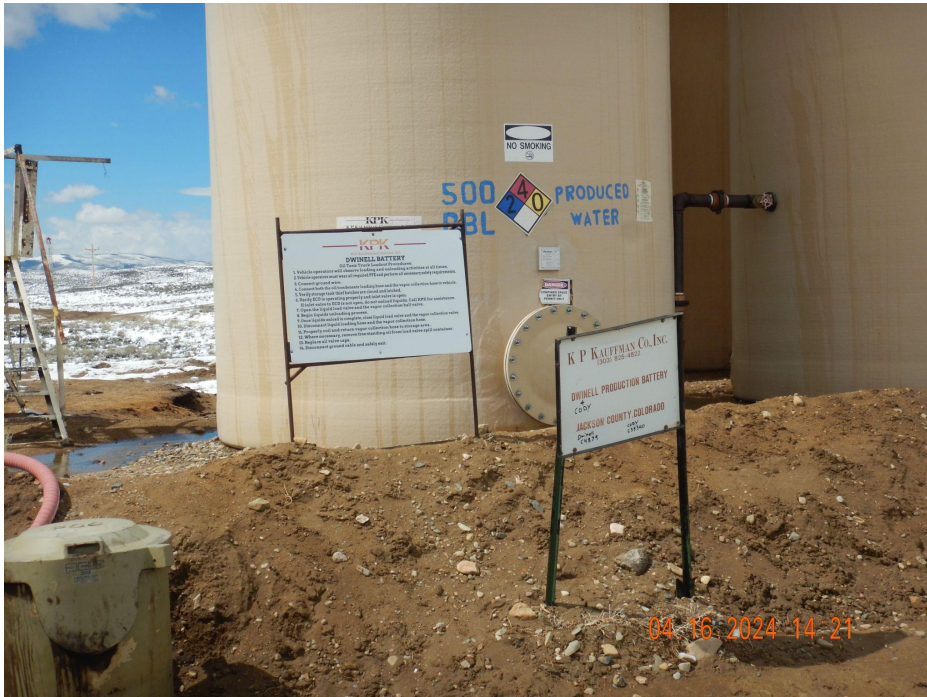
Photo 1. Photo taken of the Operator sign at the tank battery.

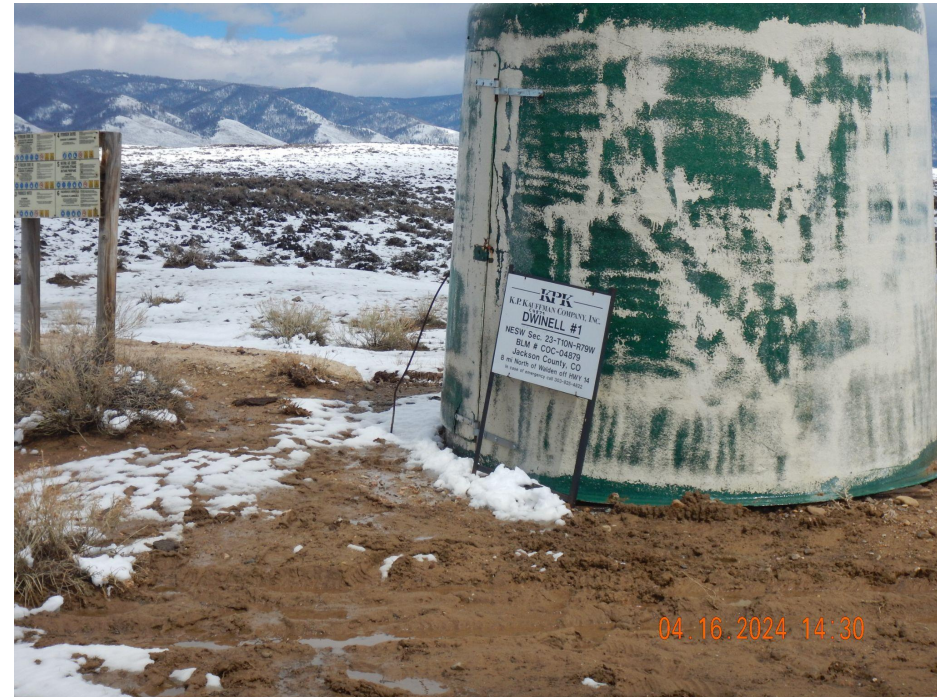
Photo 2. Photo taken of the Operator sign at the wellhead.

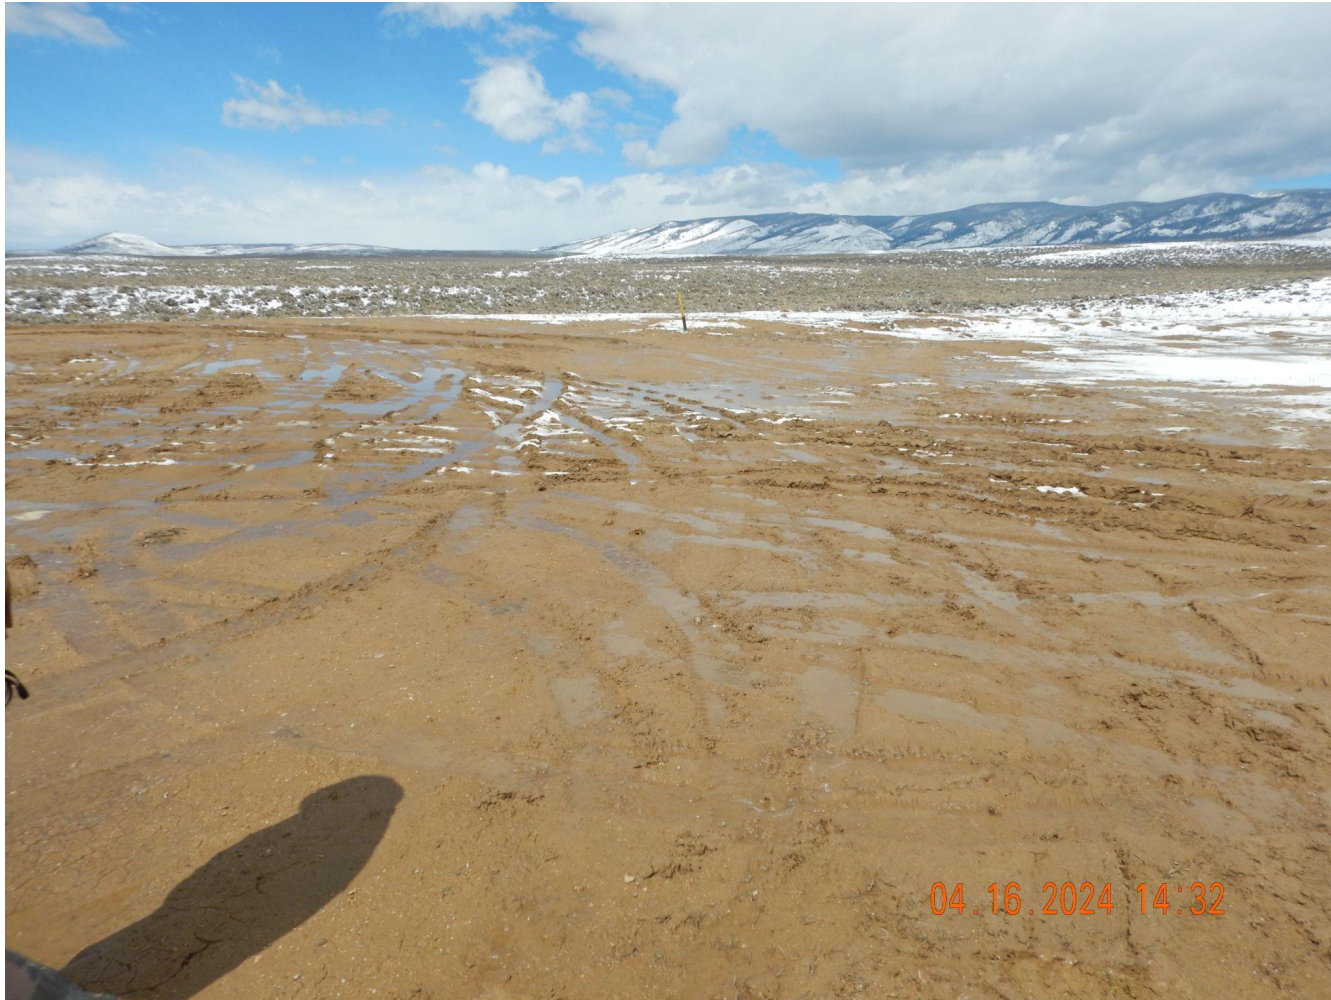
Photo 3. Photo taken from the southeastern location, facing North. Photo illustrates the location has not been adequately stabilized to minimize erosion, alteration of natural features, removal of surface materials and degradation due to contamination per Rule 1002.e.(1).

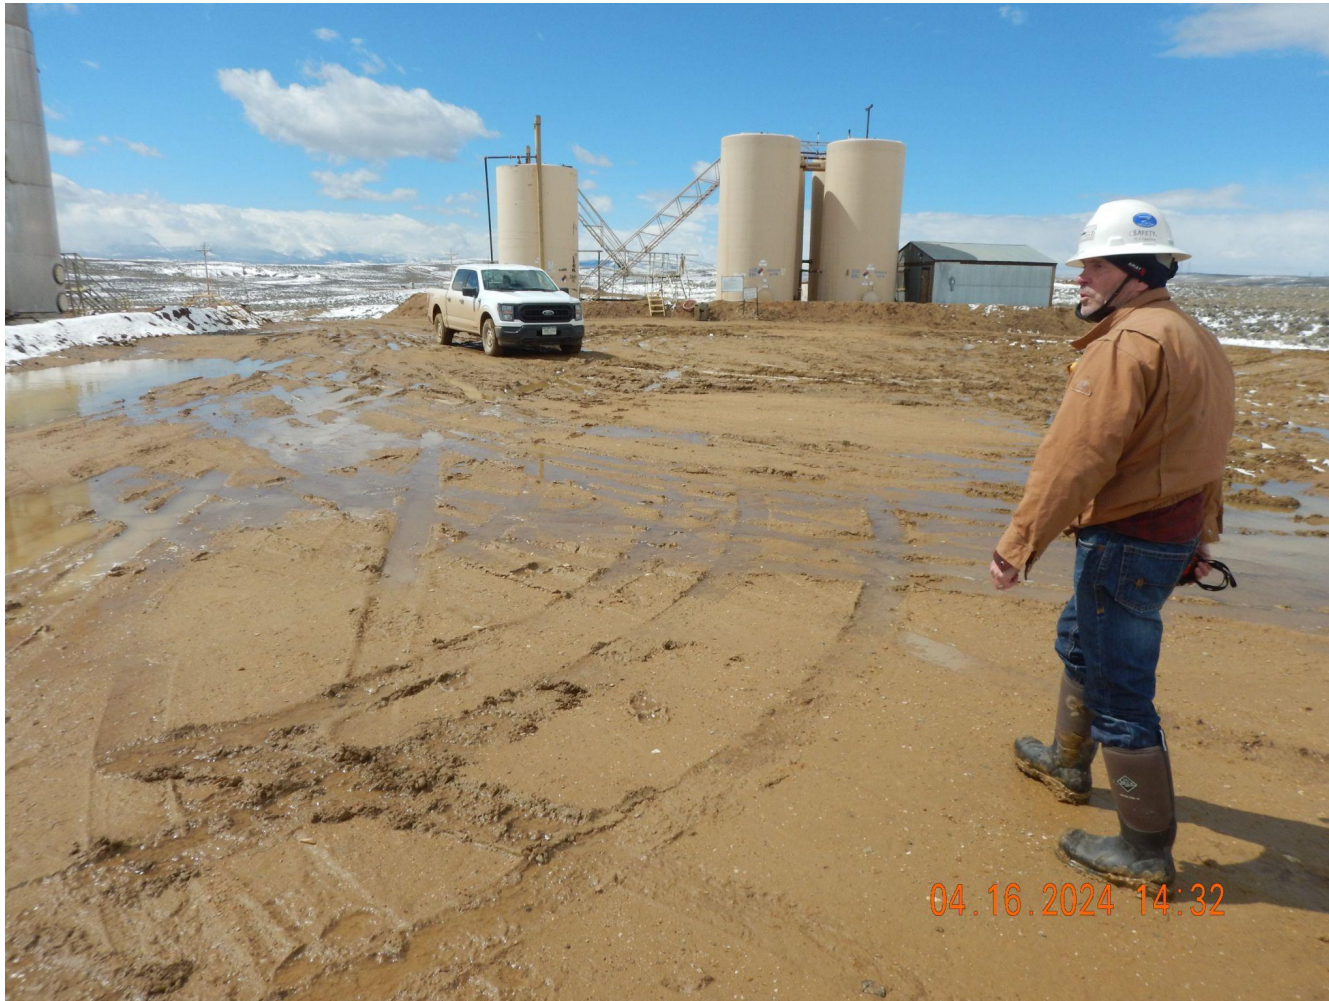
Photo 4. Photo taken from the southeastern location, facing West. See comments under Photo 3.

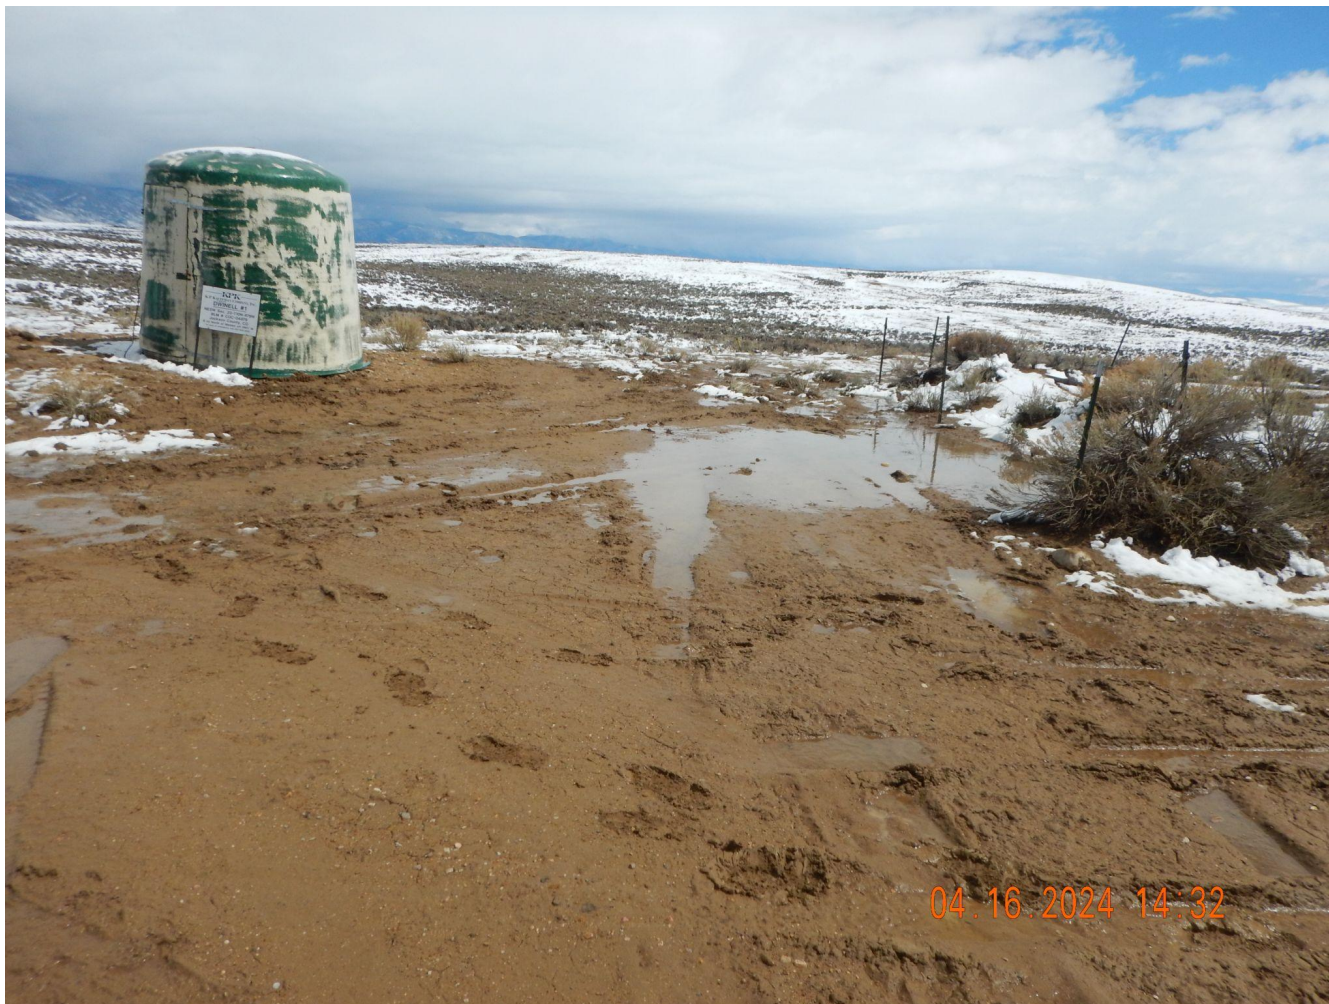
Photo 5. Photo taken from the southeastern location, facing East. See comments under Photo 3.

Note- photo also illustrates sediment laden stormwater is discharging off location.

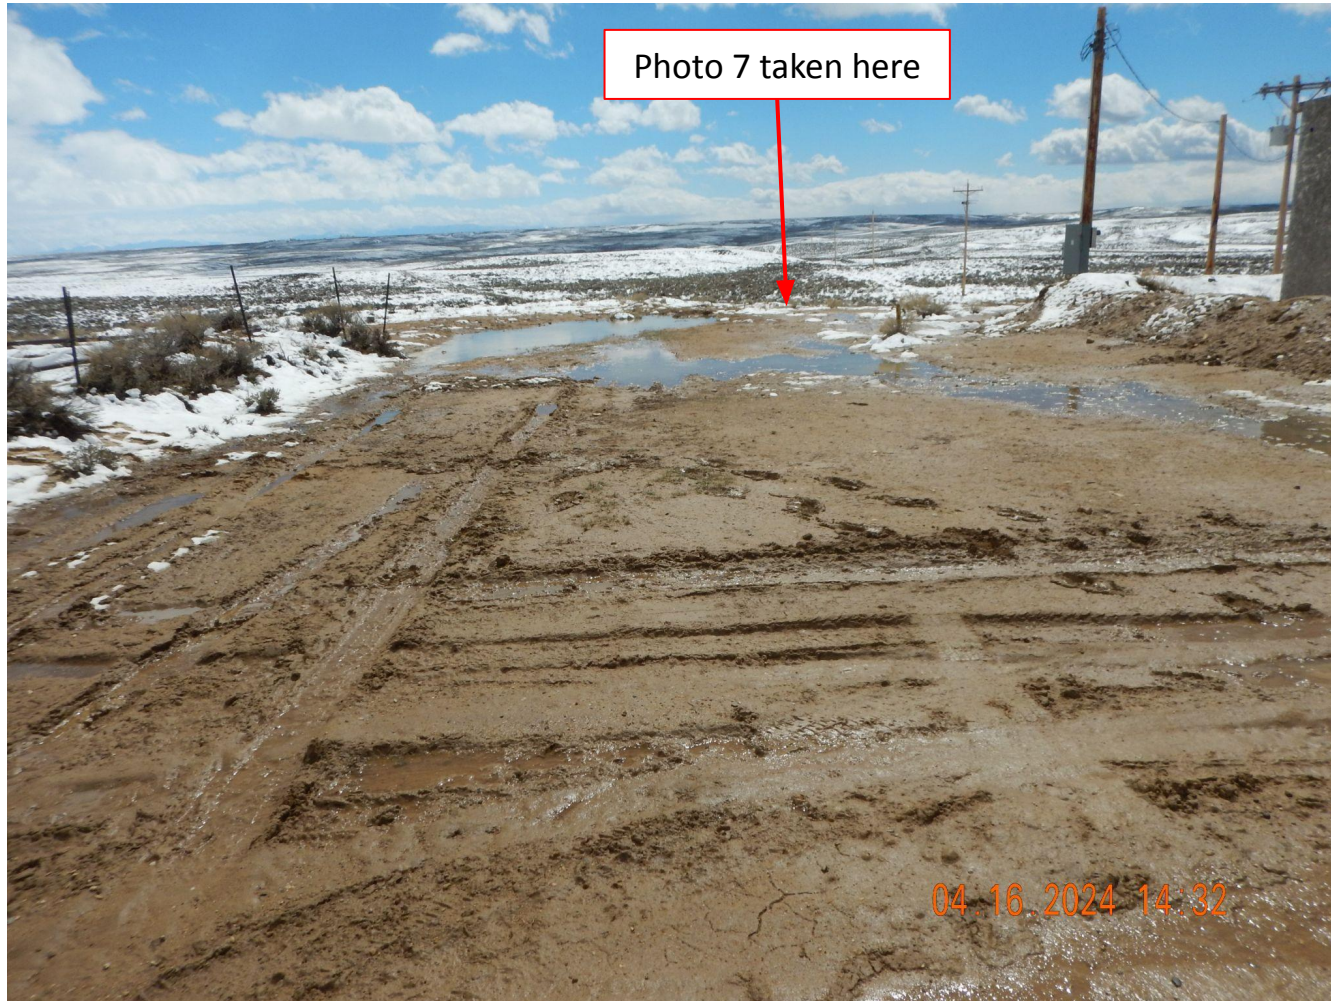
Photo 6. Photo taken from the southeastern location, facing South. See comments under Photo 3.

Note- photo also illustrates sediment laden stormwater is discharging off location.

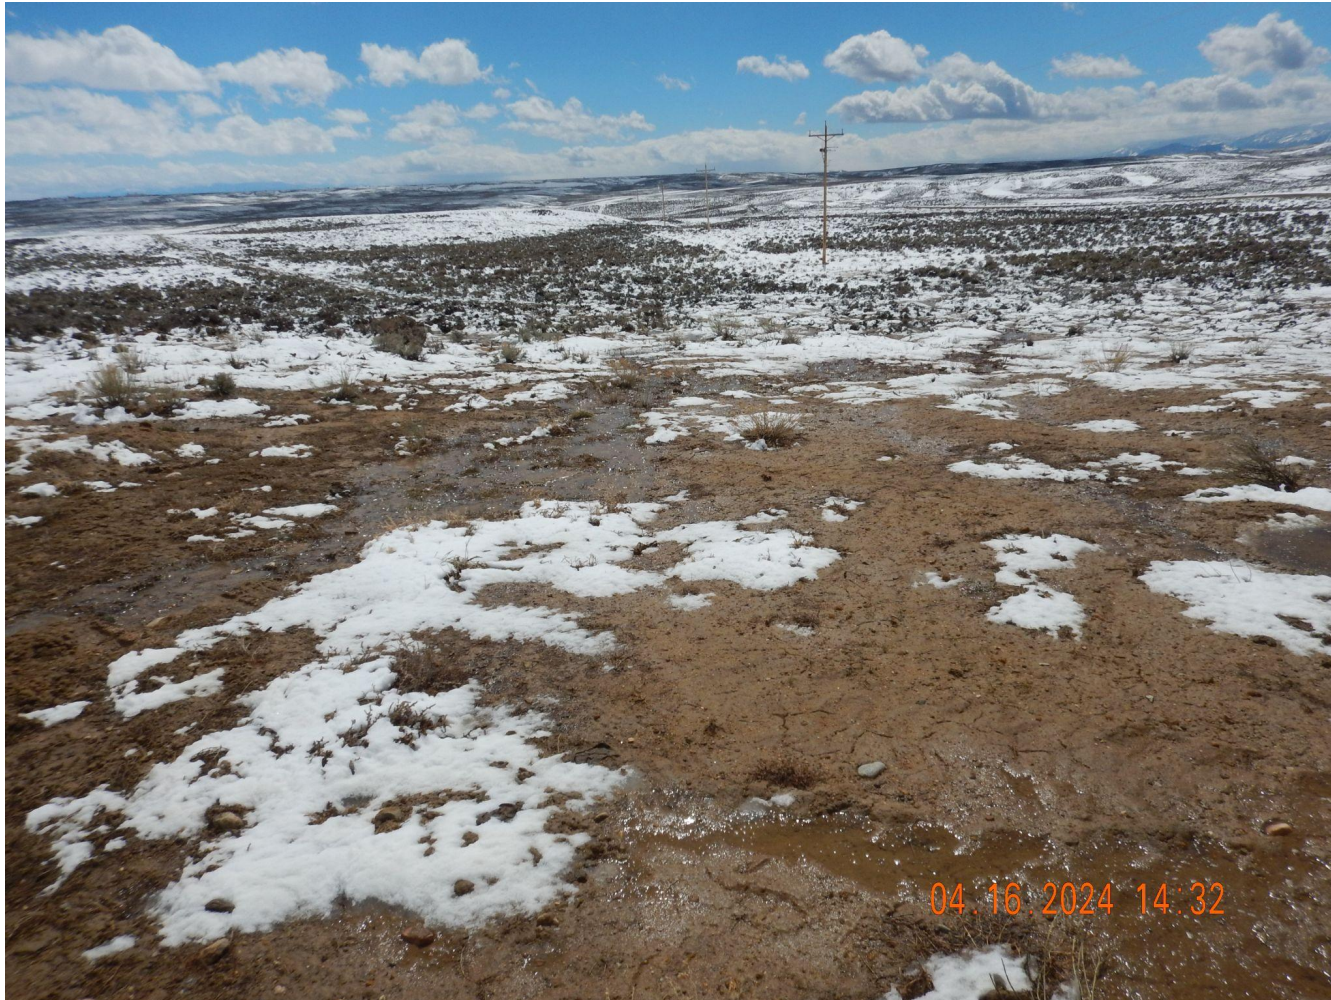
Photo 7. Photo taken from the southeastern location, facing South. Photo illustrates sediment laden stormwater discharging off location in violation of Rule 1002.f.

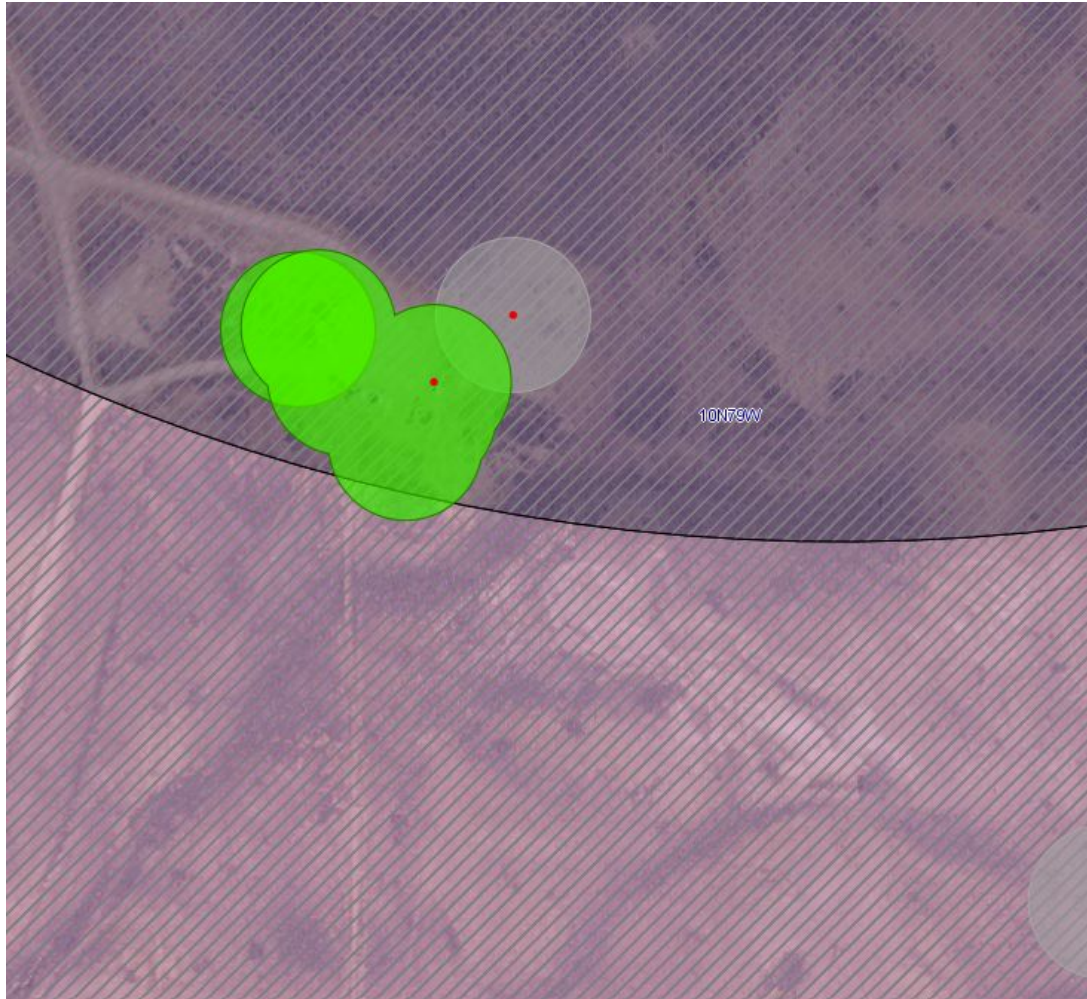
Photo 8. ECMC GIS aerial imagery illustrates the location falls within Greater Sage Grouse Priority Habitat Management Area, as well as Greater Sage Grouse General Habitat Management Area surrounding the location. Note- there are other big game priority habitats nearby.
